**Evaluation of Canal Lining Projects  
in the Lower Rio Grande Valley of Texas  
2011 Ratings and Analysis**

**By  
Gabriele Bonaiti, Askar Karimov, Guy Fipps, P.E.  
Texas AgriLife Extension Service  
College Station, Texas**

**Texas Water Resources Institute Technical Report No. 412  
Texas A&M University System  
College Station, Texas 77843-2118**

## **2011 Ratings and Analysis**

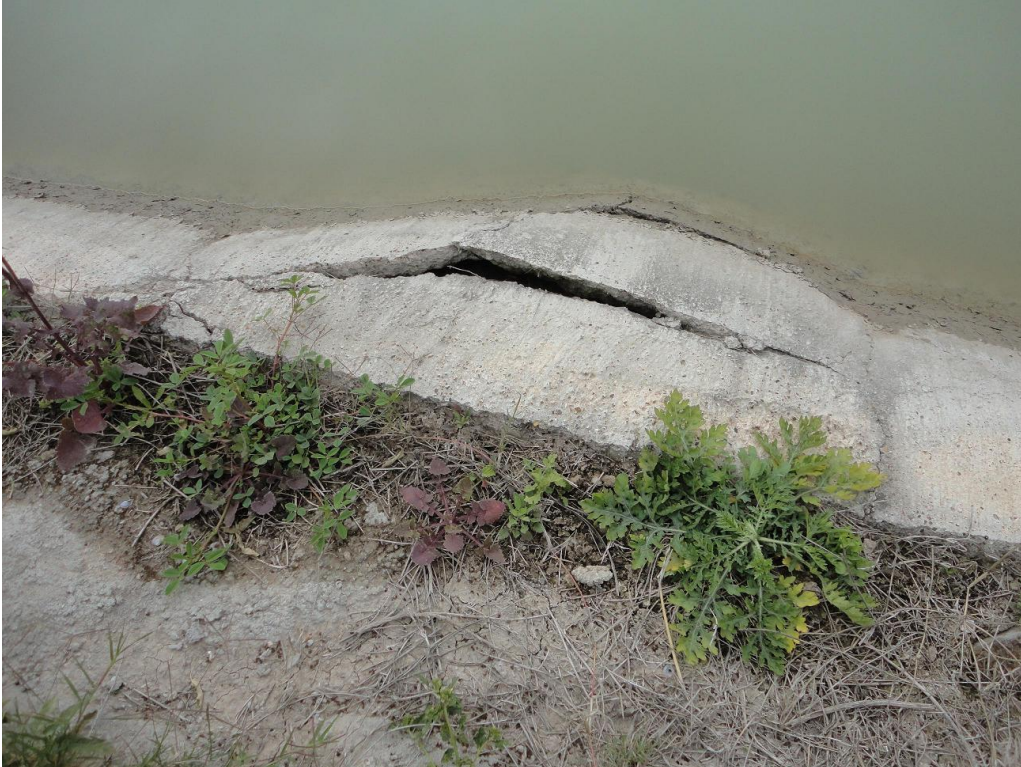
An example of buckling is shown in Figure 5. Most buckles were found in the eastern section of Project No.5. These buckles appear to have been caused by water seeping through the levee due to improper installation of the liner (i.e., not properly anchored). However, this buckling

appears to have had no impact on the condition and performance of the synthetic liner. Insufficient free-board in some sections also caused some erosion of soil under the synthetic liner (Fig. 6).

Figure 5. A buckle on the shotcrete protective barrier

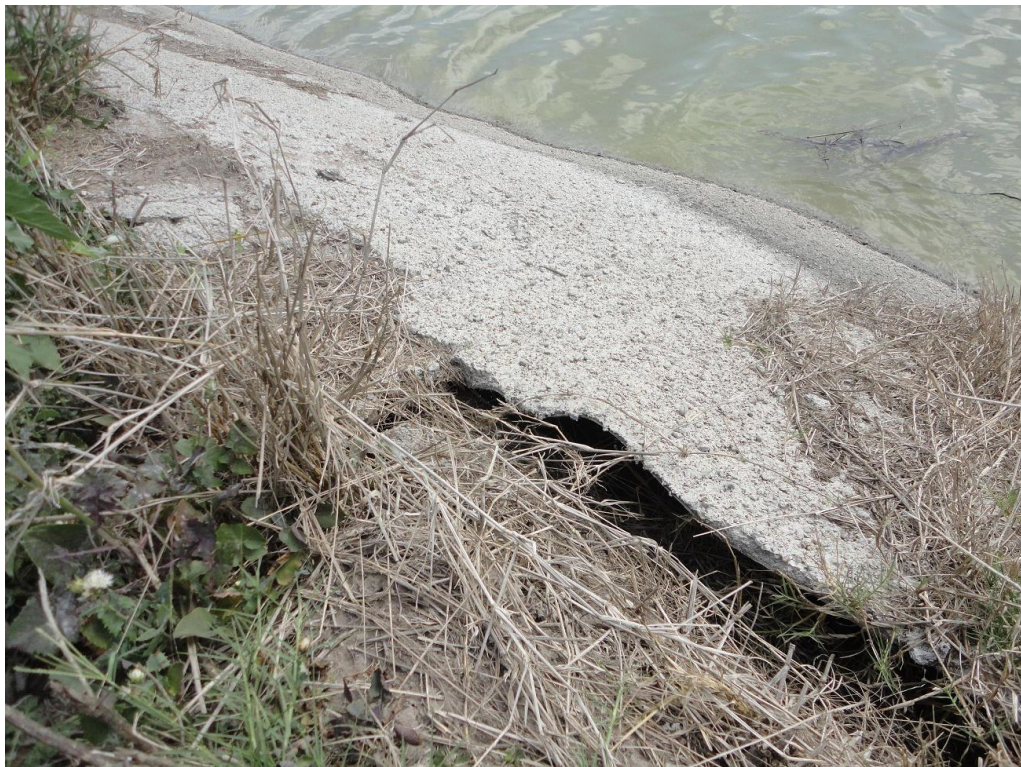
Figure 6. Erosion underneath the synthetic liner

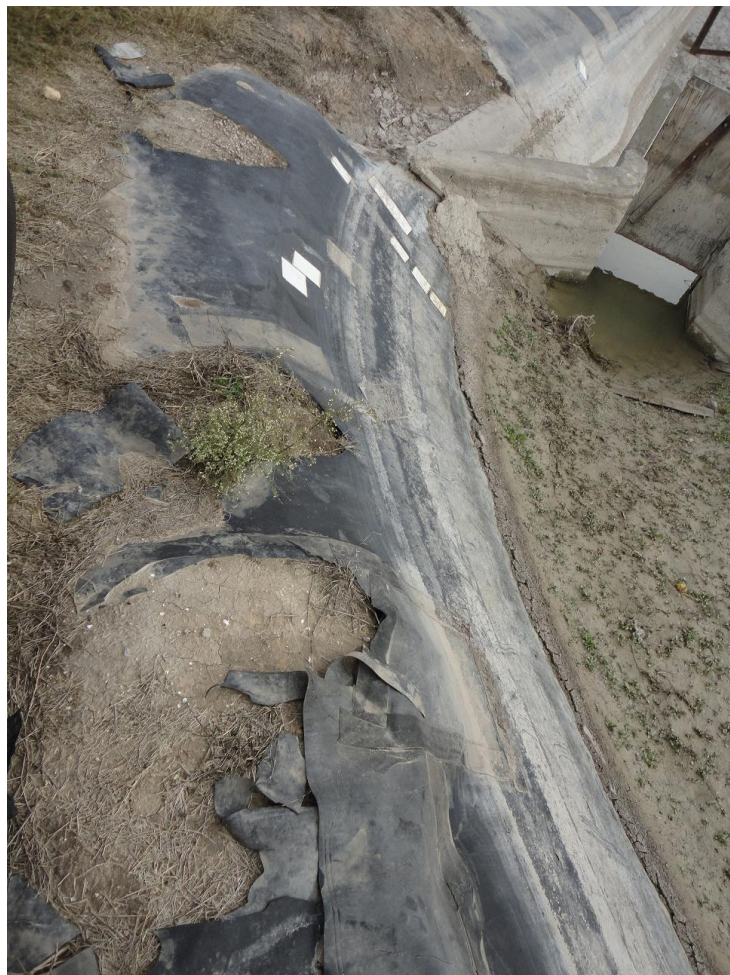
Figure 7. Damage on the anchor likely caused by mowers.

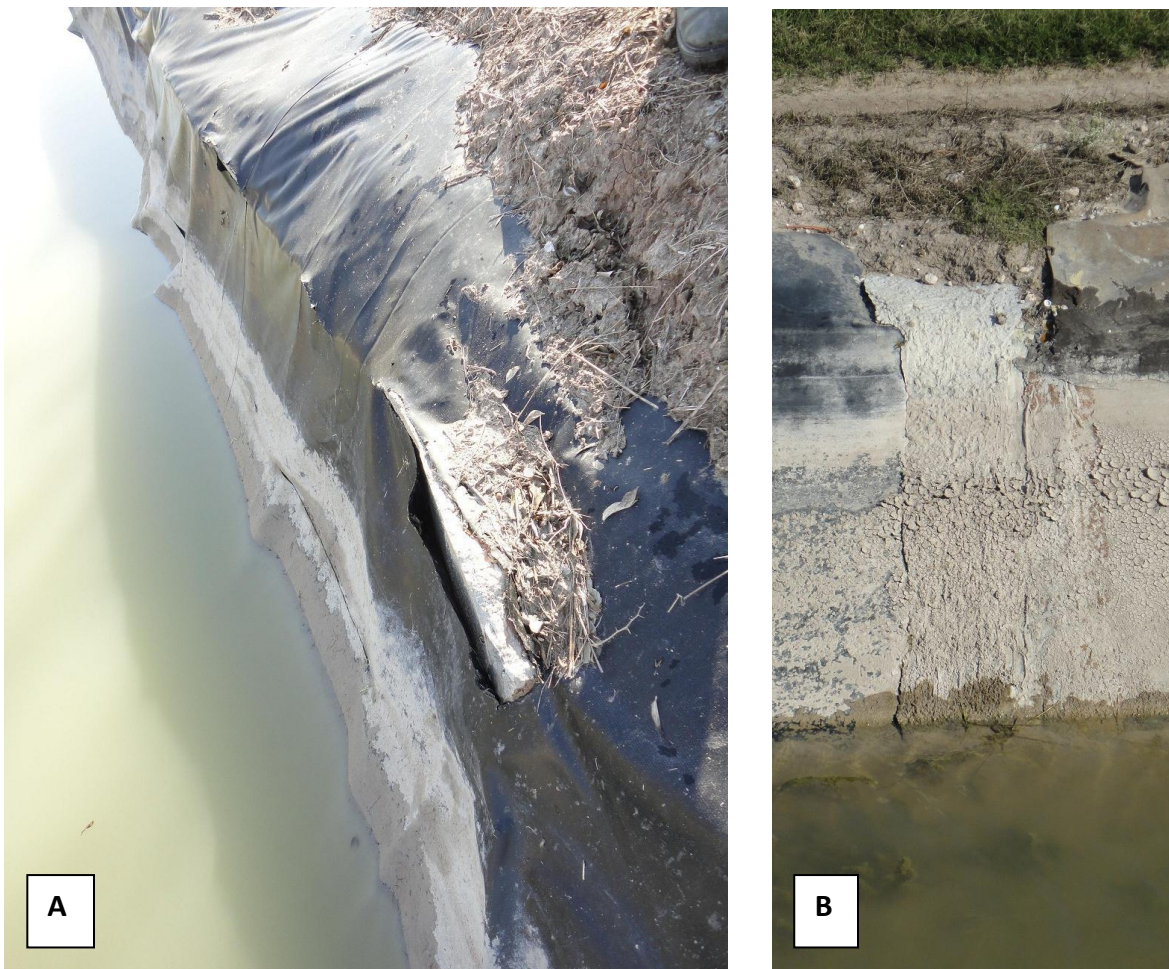
Project No.9 (5-years old) was rated as *Serious Problems* due to extensive damage caused by the collapsing and very sharp-edged canal concrete sections (Fig. 8A). Also in project No.9, concrete sections approximately 1-foot wide were poured on top of the liner at a spacing of 500 feet (Fig. 8B). The purpose of the concrete sections is reported to have been to keep the liner in place and provide access points for sediment removal. Our conclusion is that long-term evaluation is needed to determine if such sections are useful for these purposes.

Figure 8. A: Collapsing and very sharp-edged canal concrete sections. B: Concrete sections poured on top of a polypropylene liner to hold the material in place

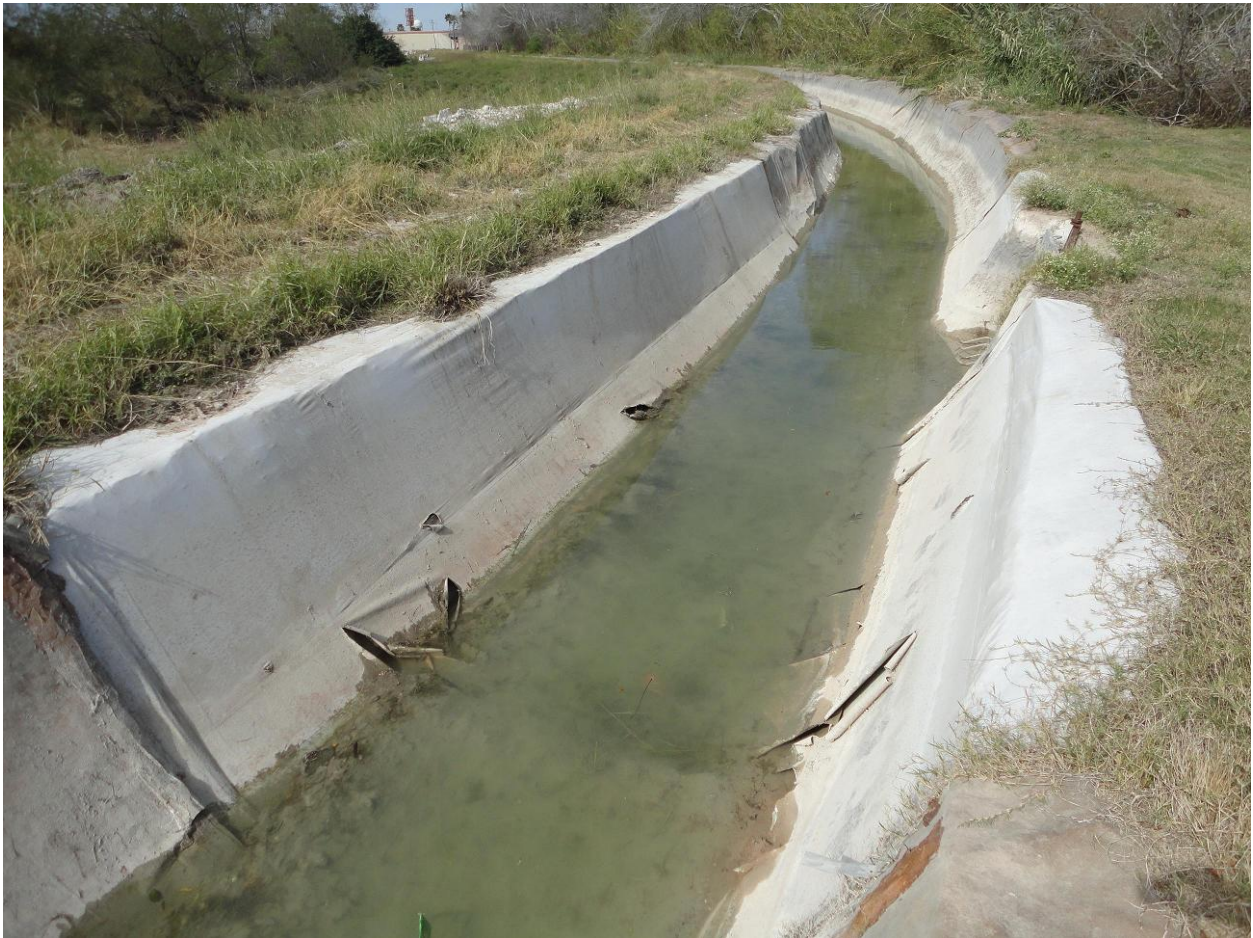
Of the three (3) PVC projects, two (2) were rated *Good* after 12 years (No.16 and 22), and one as *Serious Problems* (No.24). In two projects, this material has performed well, requiring little maintenance with no major damage observed. The cuts and tears that have occurred have not developed into larger problems. However, in Project No.24, significant amount of damage was caused by the combination of shrinking and hollow areas under the liner which resulted in tears, and road workers who used a portable pump to supply water for road construction (Fig. 9).

Figure 9. PVC Alloy liner damage.

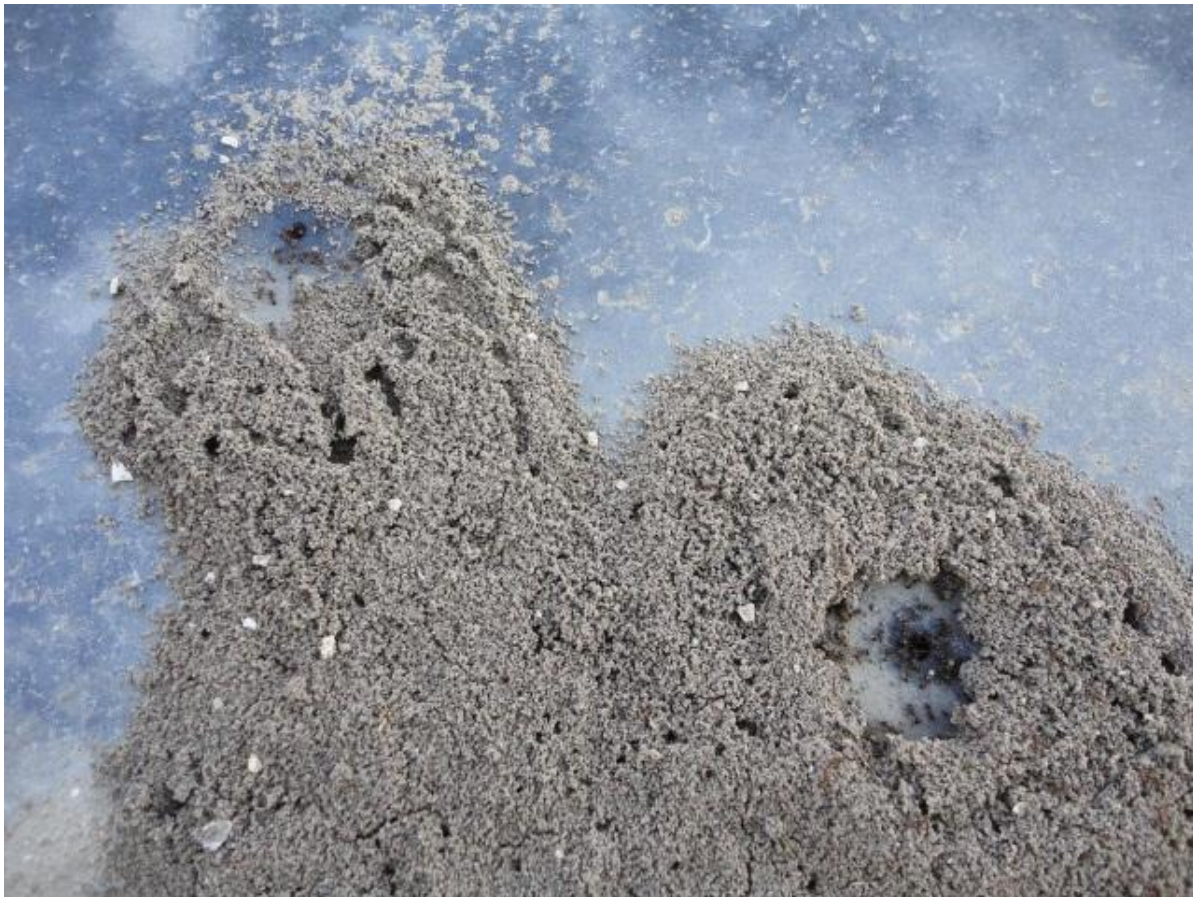
EPDM rubber is very susceptible to vandalism and punctures caused by animals, including ants (Fig. 10). Children were reported to cutoff portions of the liner for use as rubber bands. It also appears that many cuts and tears initially occurred on the exposed areas which experience the most human and animal traffic. Unless repaired in a timely manner, these tears quickly enlarge (Fig. 11). In some cases, steel and concrete anchors were added to try to keep the liner from shrinking and floating (Fig. 12).

Figure 10. Ant colony in the EPDM rubber liner

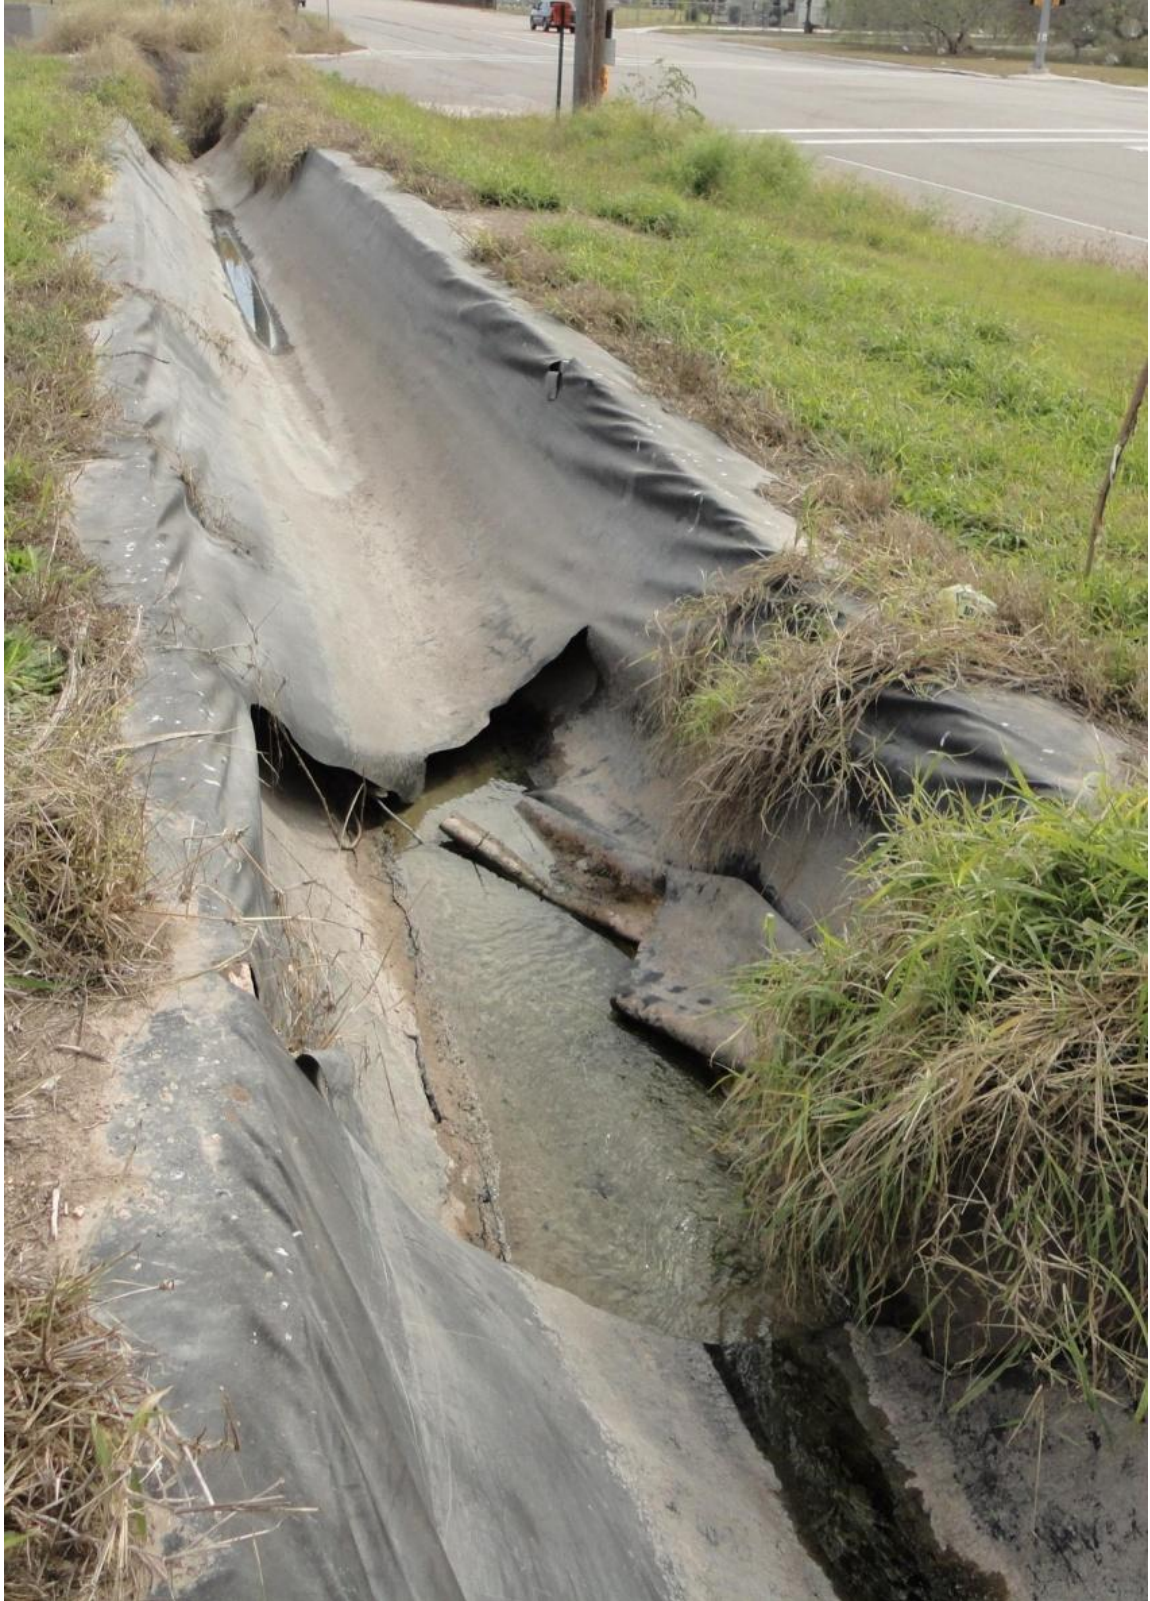
Figure 11. Cuts/tears caused by vandalism or traffic, and quickly enlarging due to shrinkage

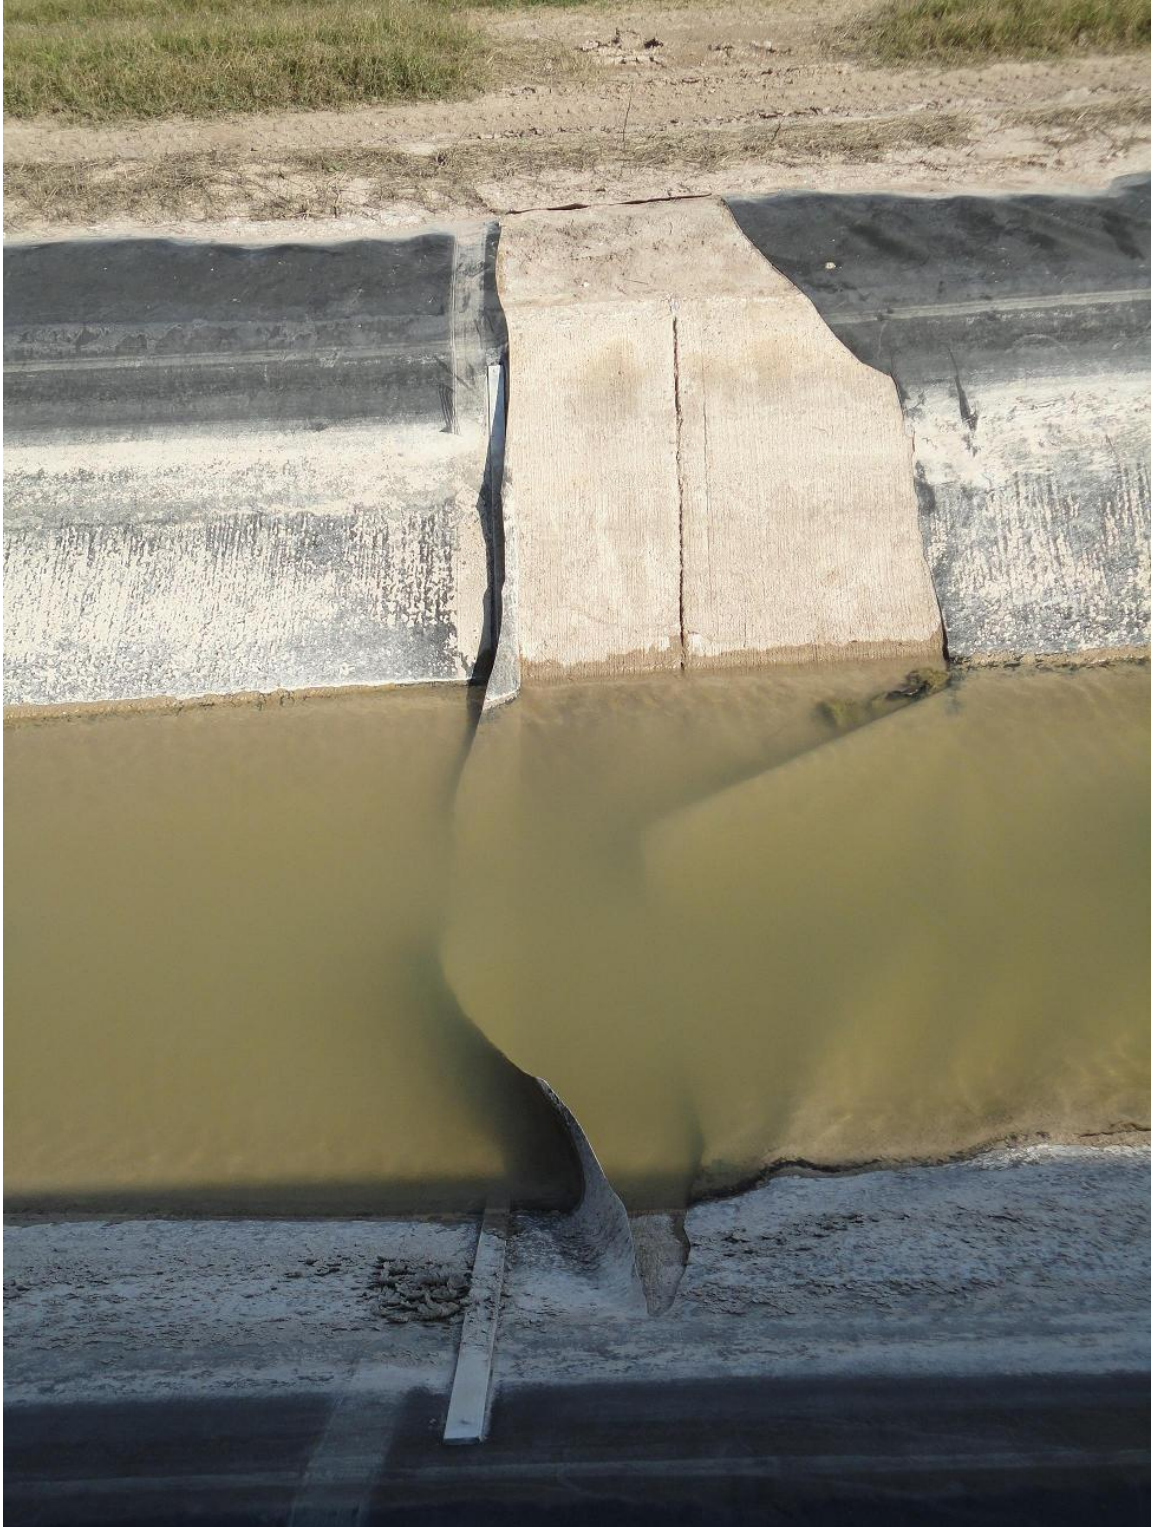
Figure 12. Steel anchors added to try to keep the liner from shrinking and floating

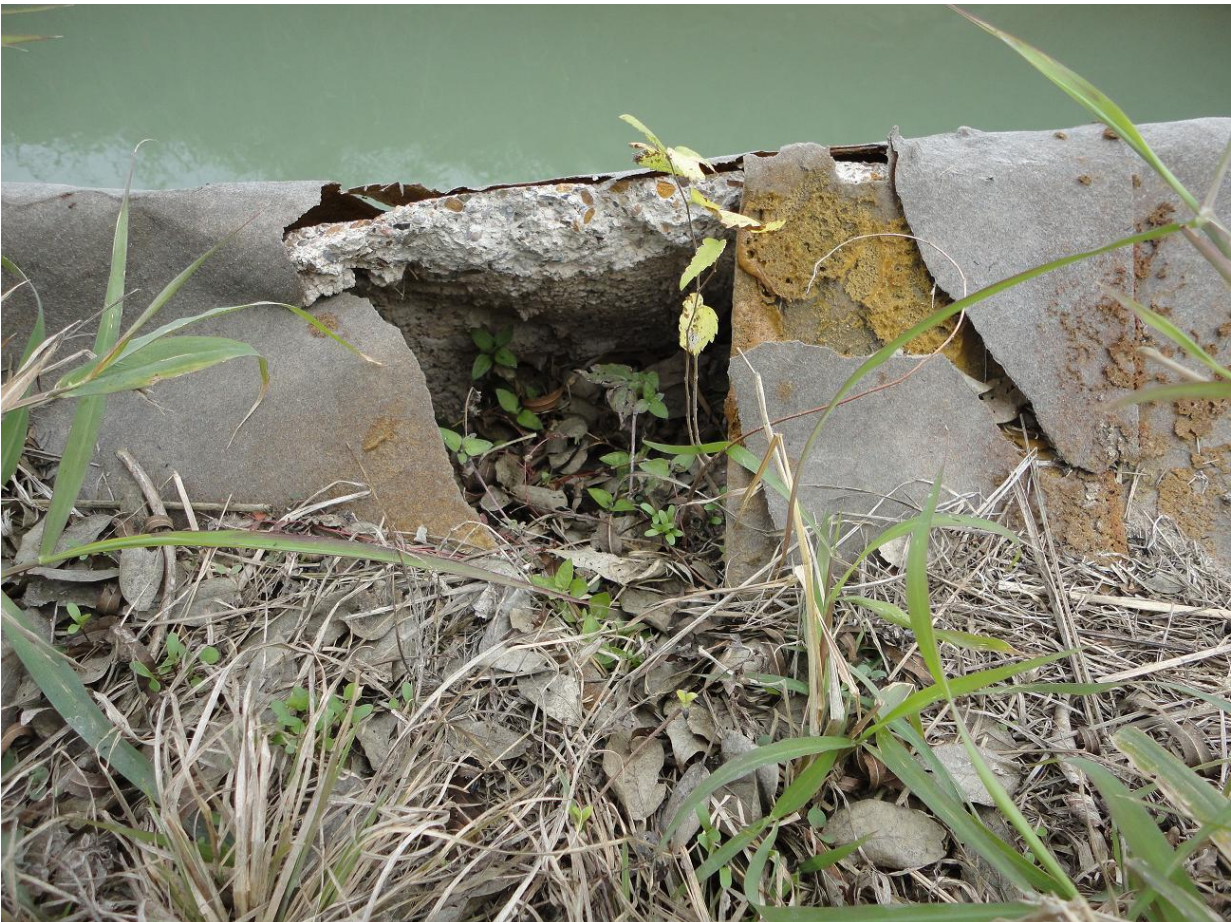
Observed problems include the liner falling off the canal walls which was likely caused by a combination of weather damage, vandalism, traffic, mowing, and sharp concrete edges (Fig. 13 and 14). In some segments, the top layer of the material has peeled off, but this had a minor effect on performance (Fig. 15). Figure 16 shows one lining project where the polyurethane project is rated as *Fair* in spite of serious problems in the anchor area.

Figure 13. Damage caused by the sharp edge of the concrete underneath

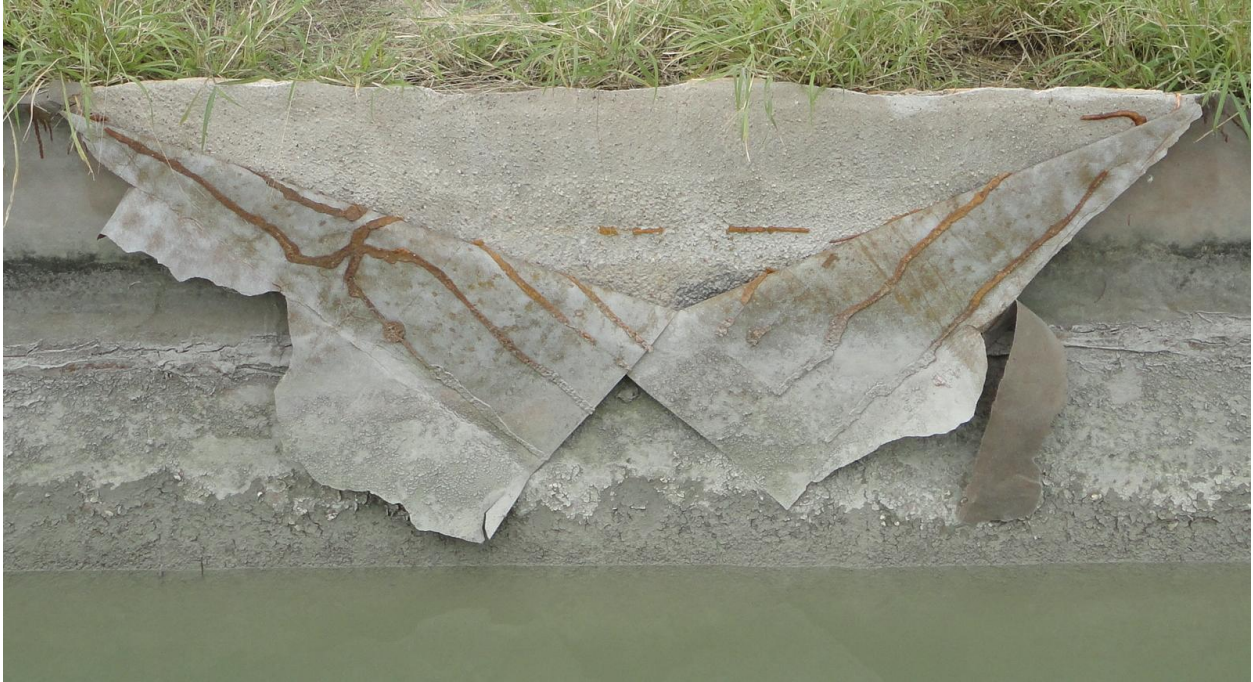
Figure 14. Polyurethane liner hanging off the canal side

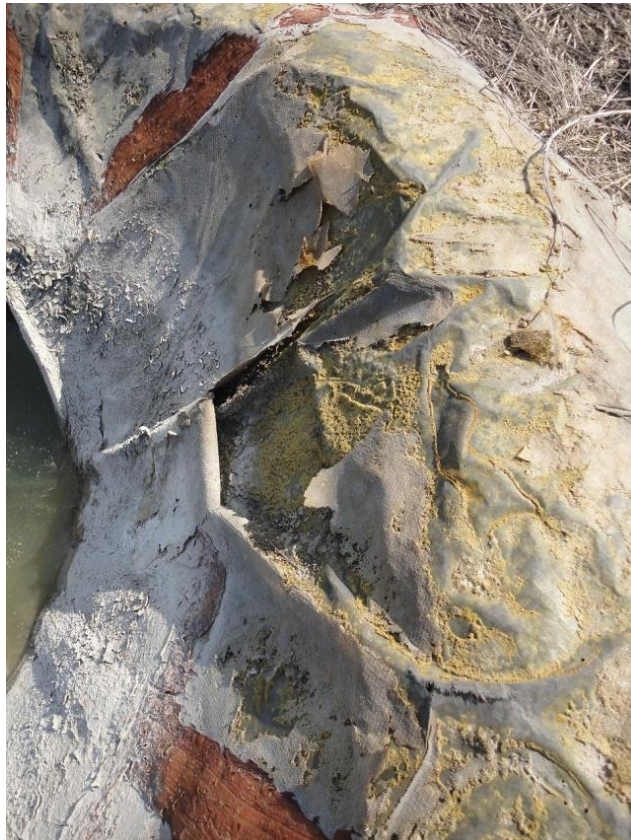
Figure 15. Top layer of the material peeling off

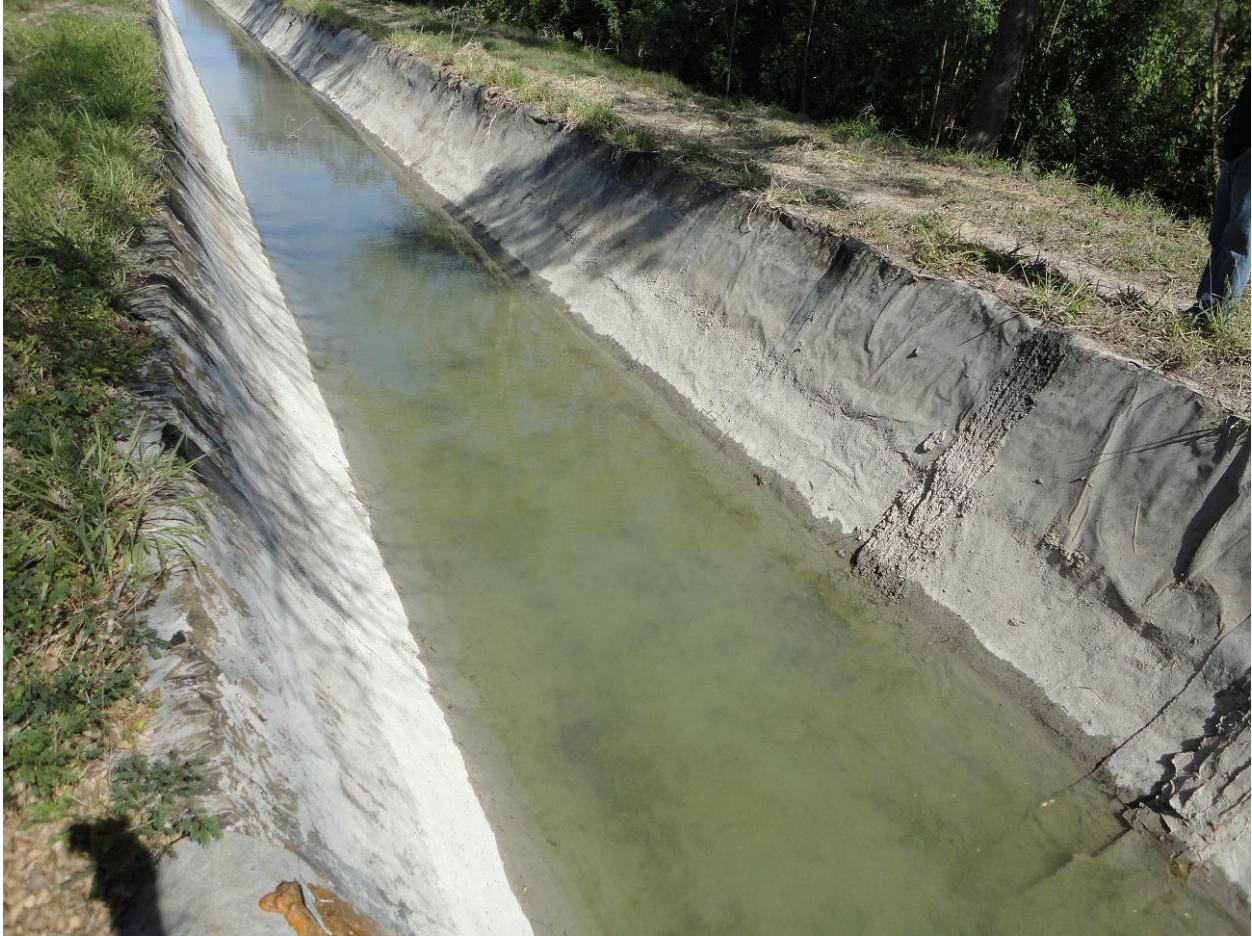
Figure 16. One polyurethane-lined segment in Fair condition after 12 years of use

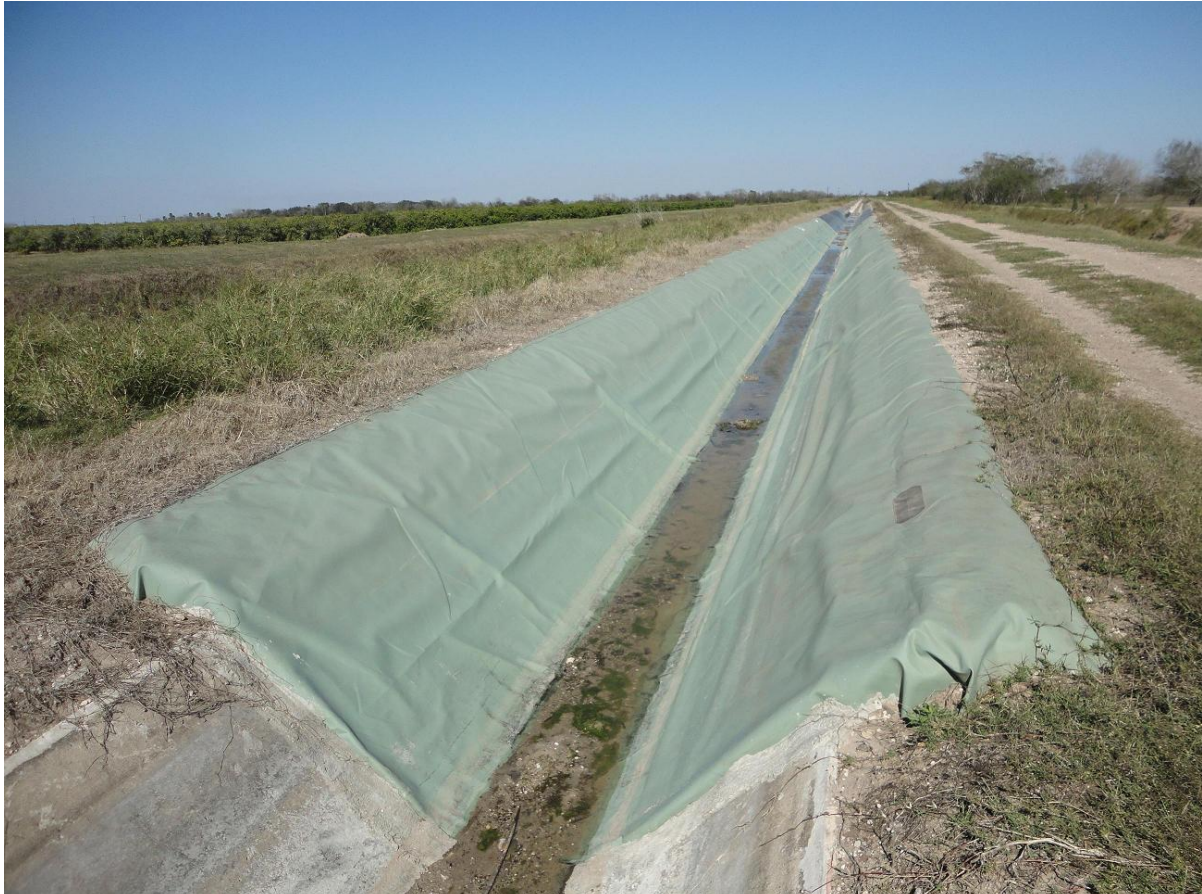
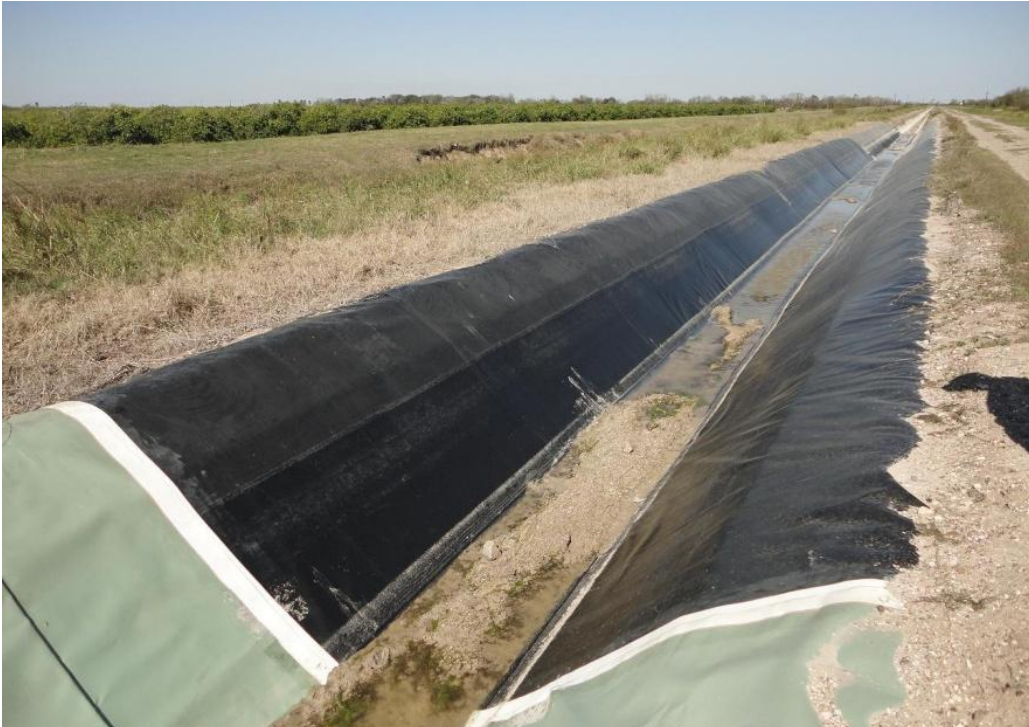
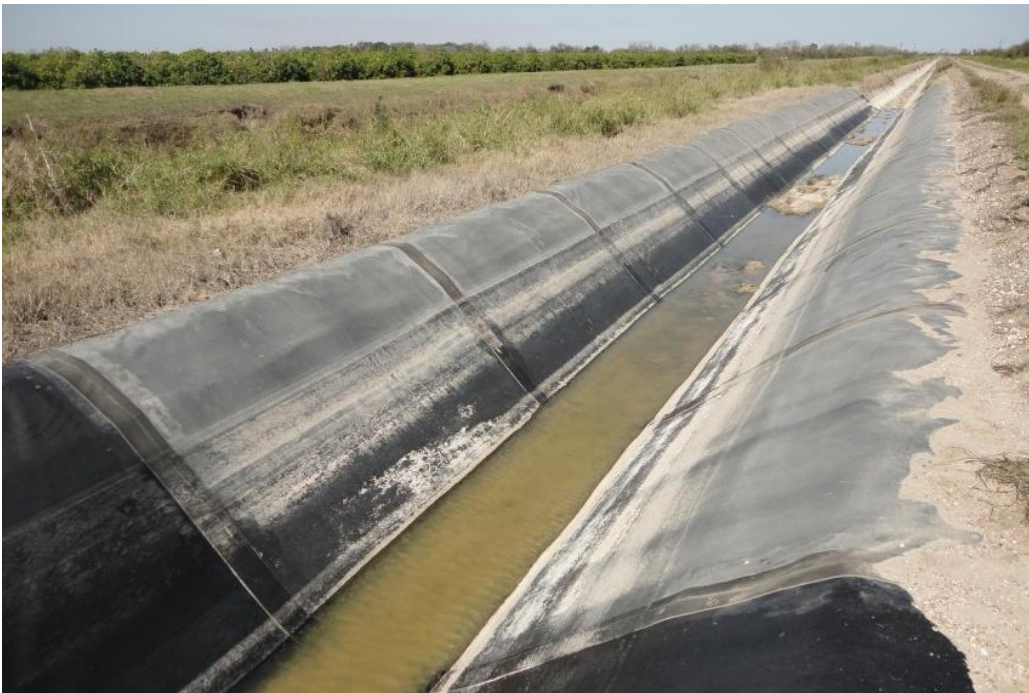
In our 2009 ratings, the rubber liners performed the worst. Since then, the manufacturer, Firestone, Inc., has modified the product. In 2010, Firestone donated three new formulations of this material (Green TPO-R, Reinforced EPDM, and Reinforced FPP-R) for evaluation purposes which were installed in the Adams Garden irrigation district (Figure A-2). All three projects were rated as *Excellent* (Figs. 17-19).
