THE FIRST AFRICAN BAPTIST CHURCH
A STUDY OF THE ARCHITECTURAL DESIGN AND CONSTRUCTION OF A
19TH CENTURY CHURCH HOUSE

A Thesis

CHRISTOPHER SCOTT HUNTER

The intent of this study is to examine, document, and develop a record of the existing building of the FABC. This examination will also include a study of the building systems and the materials and methods used for construction.

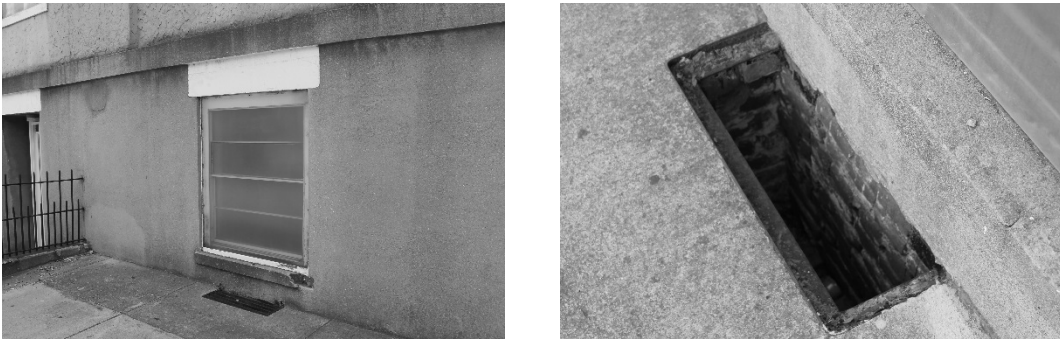
The foundation of the church is of masonry construction. Most 19th century foundations were of either stone or brick masonry laid directly on the subsoil in an excavated trench. The foundation masonry was laid about twice as wide as the upper foundation wall, and the width was diminished slightly as each course was laid, resulting in a wedge-shaped cross-section at the bottom of the foundation wall. The wider bottom of the foundation masonry served to distribute the weight of the building walls over a wider soil area, thus reducing the pressure on the soil and lessening chances of building settlement (Jones, 2001). There are small openings along the sidewalk located at the base of the building, directly under each window, as shown in Figure 28. The sidewalk opening is covered with a removable metal grate. Once the grate is removed there is a clear view of the foundation wall of the church below grade. The brick wall below the sidewalk is not covered and is fully exposed.

FIGURE 28. Brick foundation detail below sidewalk of the First African Baptist Church (Photograph by the author)

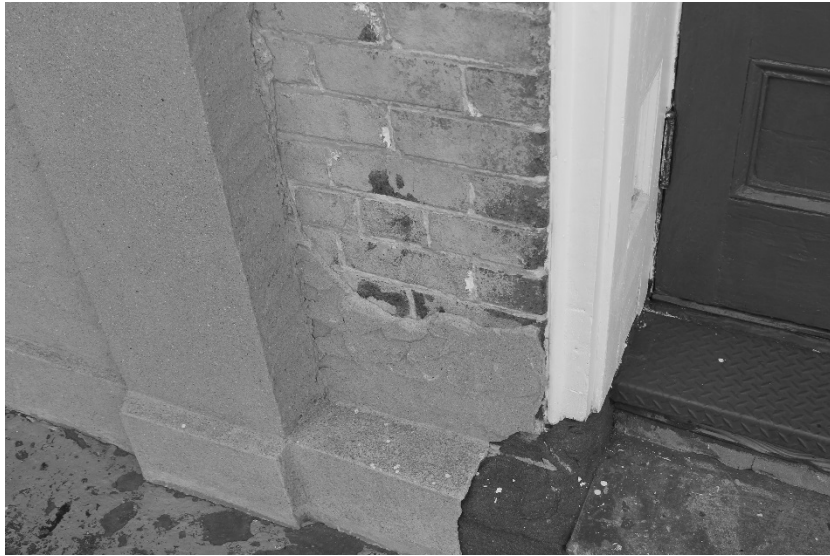
FIGURE 53. Image of stucco finish and exposed brick. (Photograph by the author)

The current condition of the stucco shows a slow deterioration of the finish, with some small cracking and portions falling off the building, exposing the brick underneath. Figures 53, Figure 54, and Figure 55 are photographic examples of the deterioration.

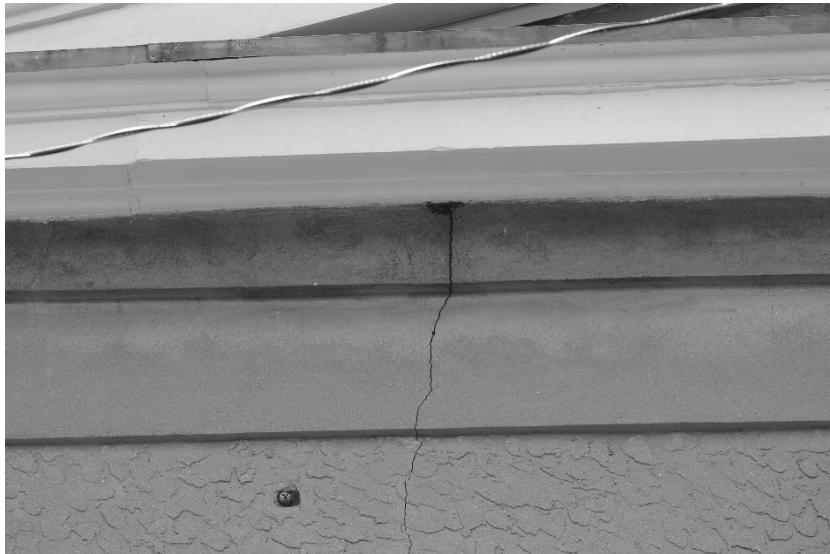
FIGURE 54. Image of cracking in the stucco finish. (Photograph by the author)

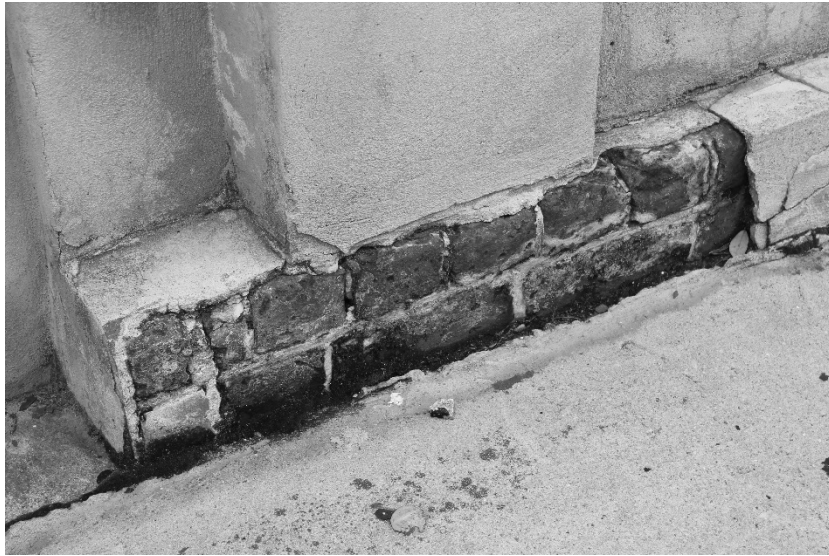
FIGURE 55. Image of stucco finish and exposed brick. (Photograph by the author)

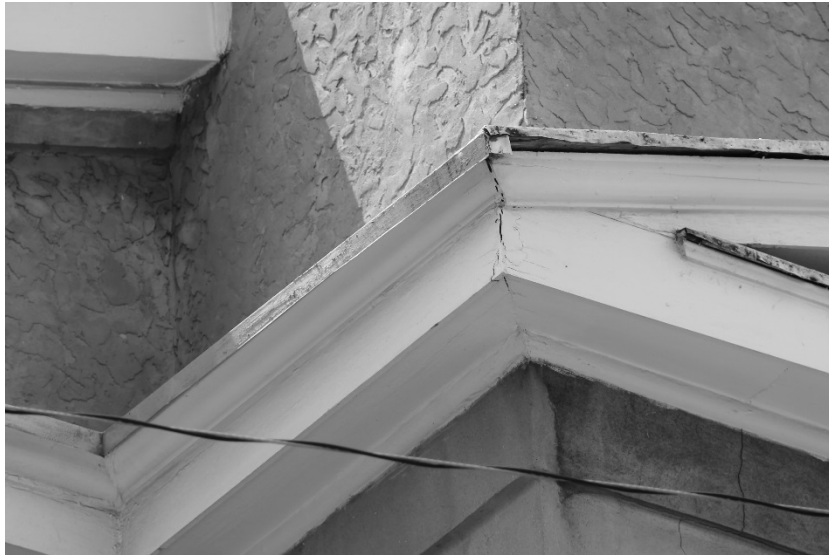
Wood trim is used as an accent detail primarily over openings in the exterior wall at the doors. Concrete lintels are used to span the opening for the windows. Wood trimming is original to the building, with detailing at the head (top) of the doors. Trimming is also located at the raking cornice at the roof. The HABS 1936 photographs show that the wood elements on the building façade have not been painted. It can be concluded that sometime after 1936 paint was applied to the wood trim elements. Time is beginning to impact small portions of the wood, with small cracking appearing in a few wooden members, as shown in Figure 56.

FIGURE 56. Image of cracking wood trim. (Photograph by the author)

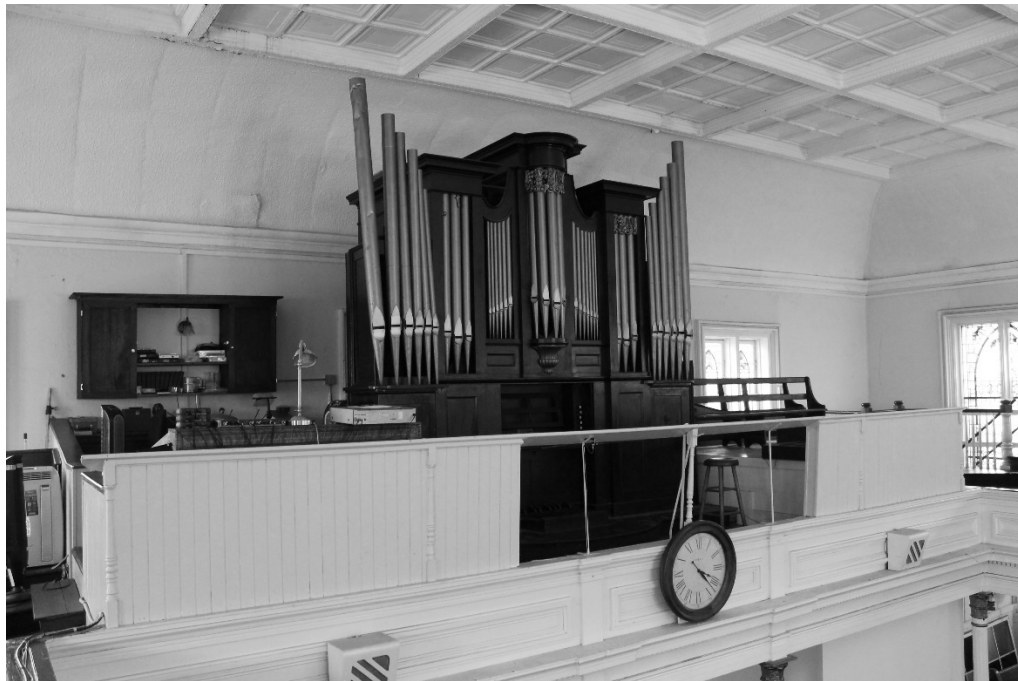
- The organ is in a gallery-level case at the rear of the room. There is an attached keydesk.
- The organ is in an unaltered state from its installation.
- The organ is not in playable condition.
- The organ has one manual. 10 stops.
- Slider chests. Mechanical key action
- There are draw knobs in vertical rows on flat jams. No combination action. Flat straight pedalboard.
- Most pipes are gone.

FIGURE 72. Image of the church organ located in the balcony (Photograph by the author).

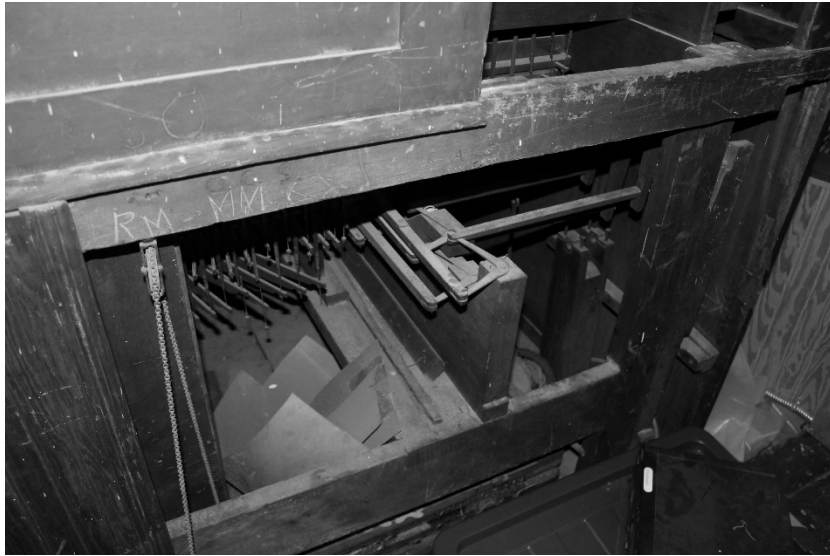
This report did document that the FABC was interested in having it restored and at the time this report was prepared, FABC was seeking estimates for the work. (The Organ Society, 2013). Figure 73 shows the extent of repair needed for a portion of the organ while Figure 74 shows the organ's kinetic blower, a device that provides wind to the organ pipes.

FIGURE 73. Image of the rear of the church organ (Photograph by the author).
