45TH **TURBOMACHINERY** & 32ND **PUMP SYMPOSIA**
HOUSTON, TEXAS | SEPTEMBER 12 – 15, 2016
GEORGE R. BROWN CONVENTION CENTER

Investigation of Steam Turbine blade

Blade failure was observed on a backpressure steam turbine (driving a centrifugal compressor) after it was in service for more than one year.

This paper presents details of observations, inspections carried out and root cause analysis of the turbine blade failure.

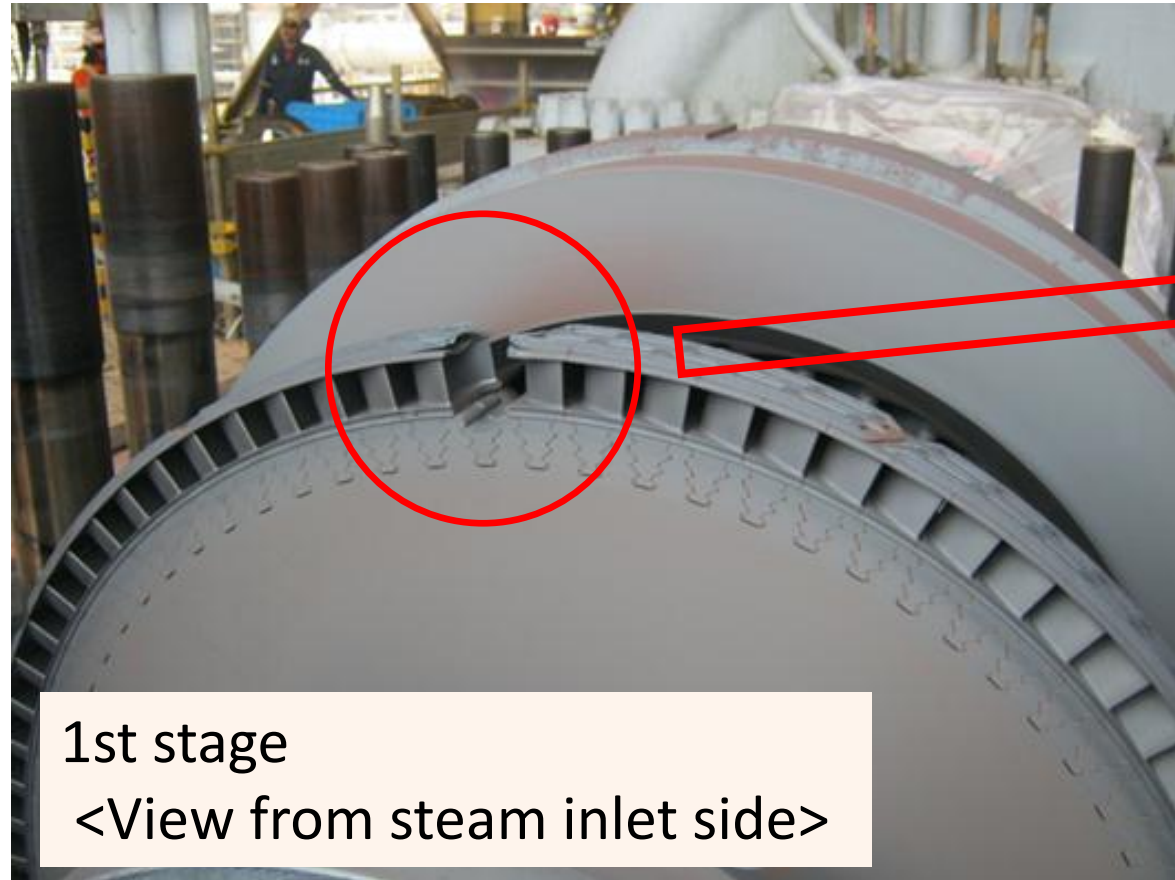
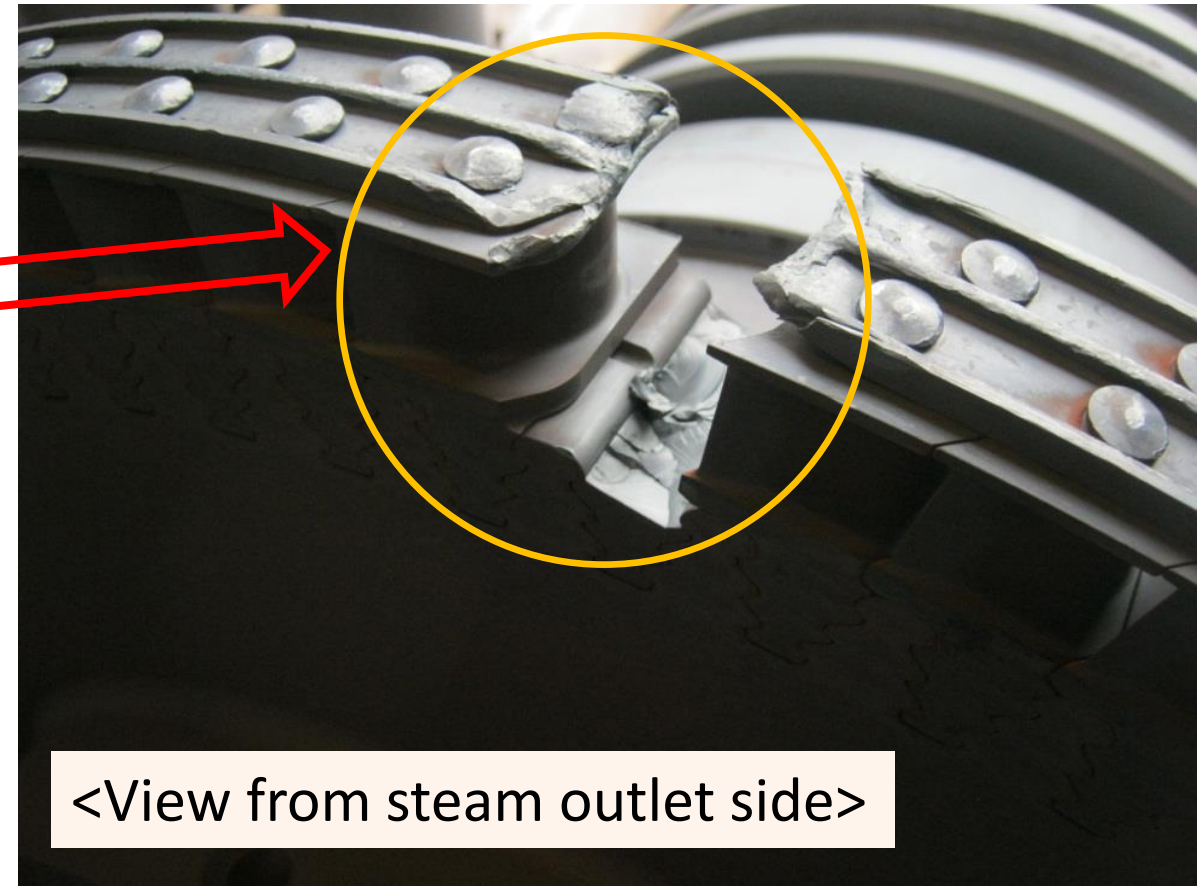
First stage wheel : Broken blade at one location. No damage on other components.

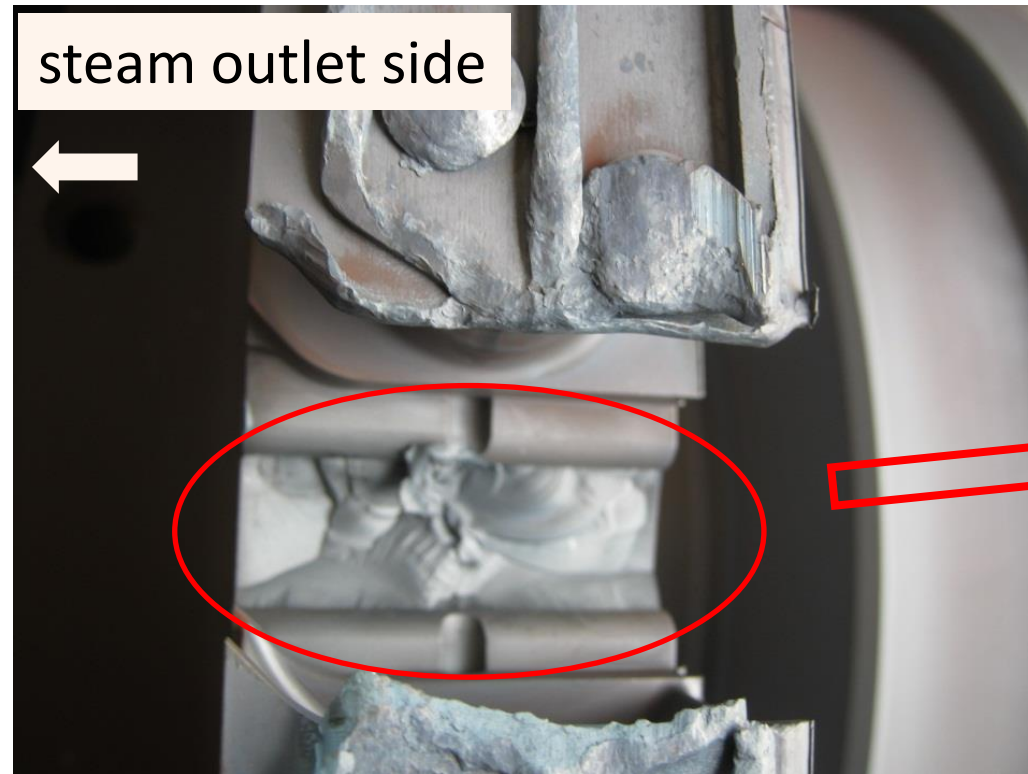
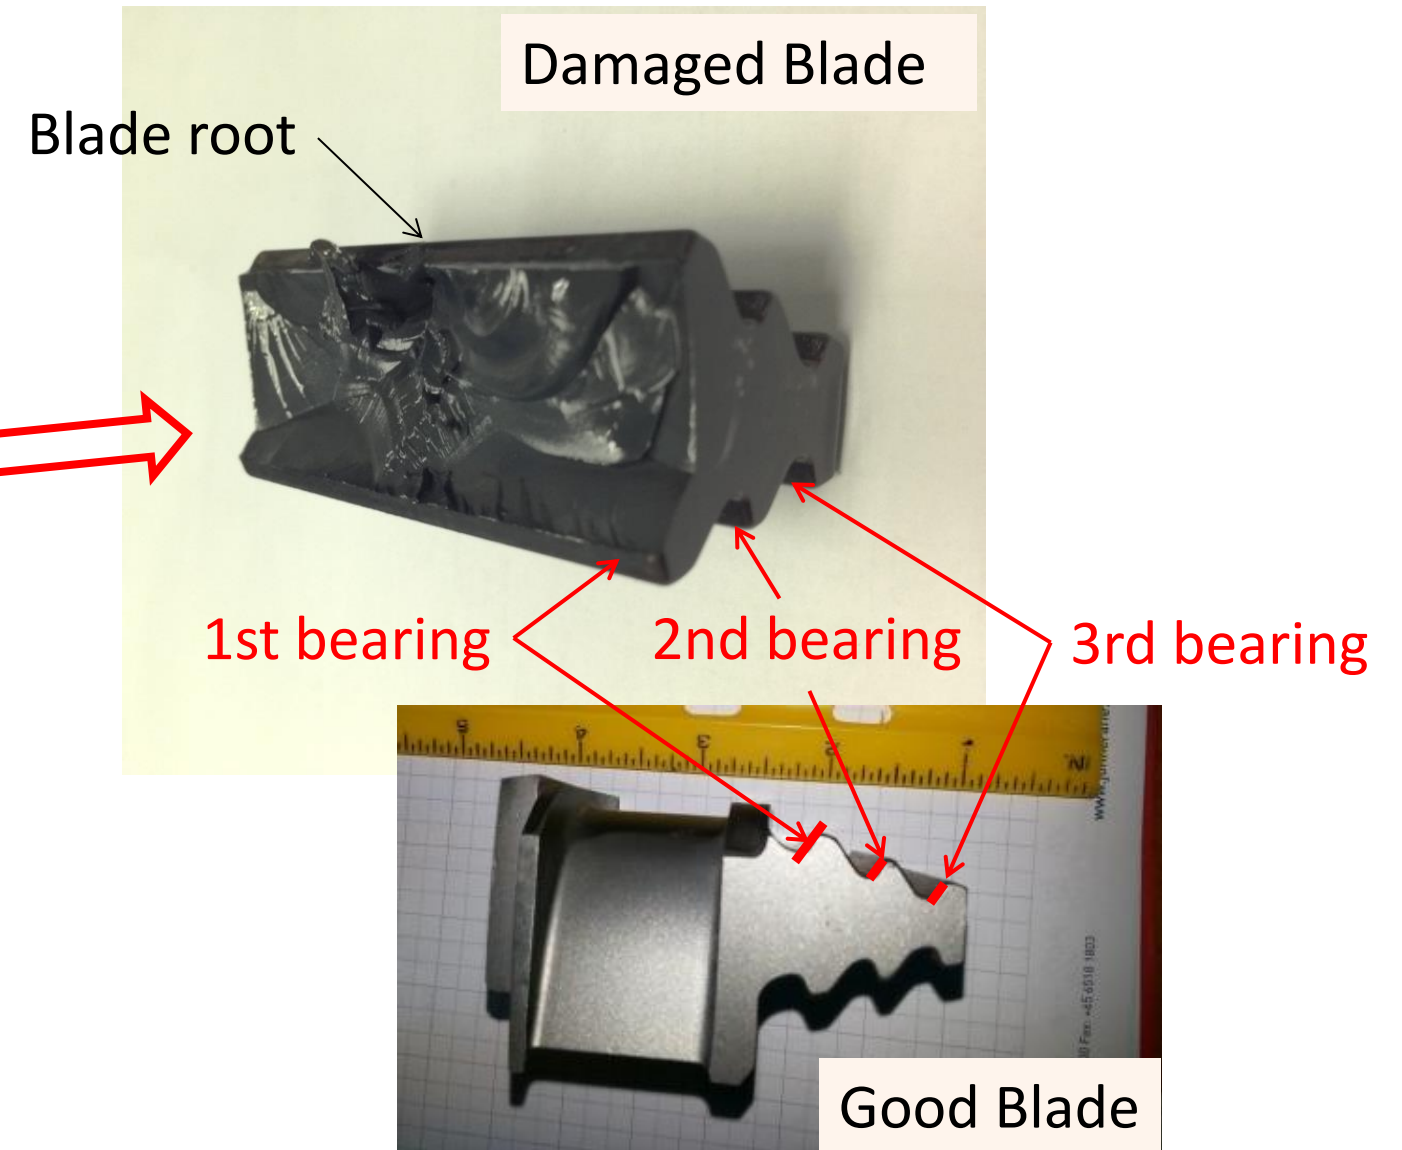
One blade damaged out of 78 blades, and fracture was located at the 1st bearing portion of blade root. Other components (2nd and 3rd stage) not damaged

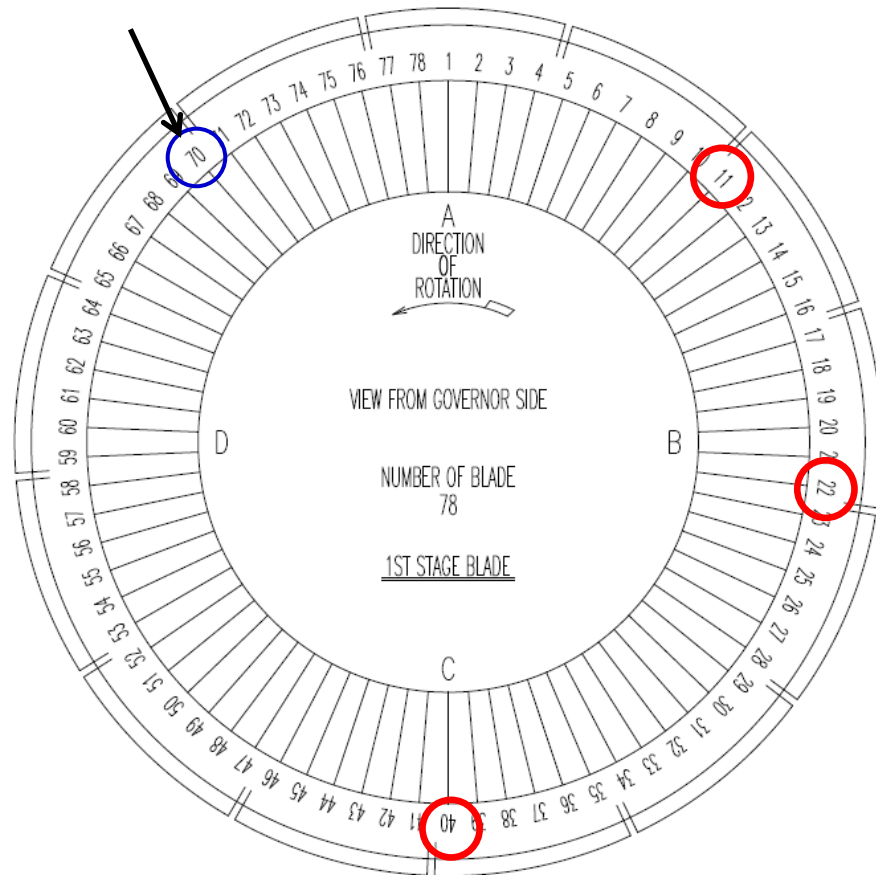
○ : Crack indication

Failed blade and crack indicated blades were located on the first/last of shroud.

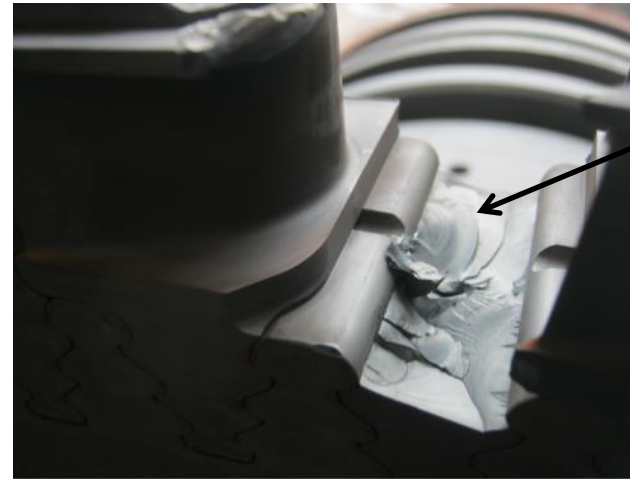
No.70 blade root

Failed blade was No.70 on blue colored circle part.

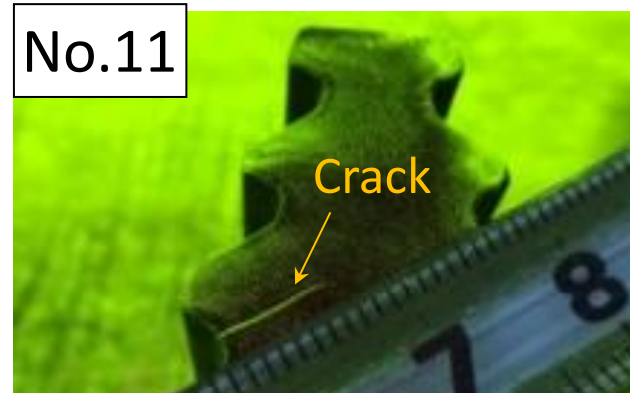
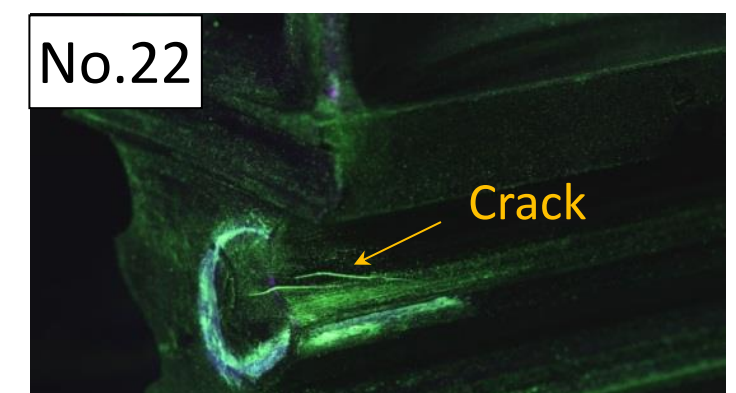
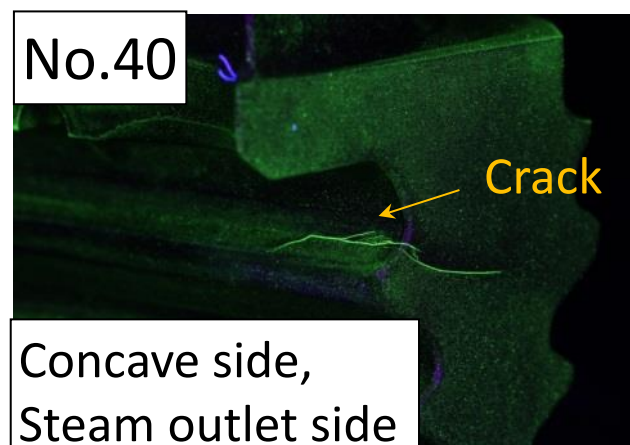
Crack indication was detected on No.11, No.22 and No.40 blade root in MT inspection.

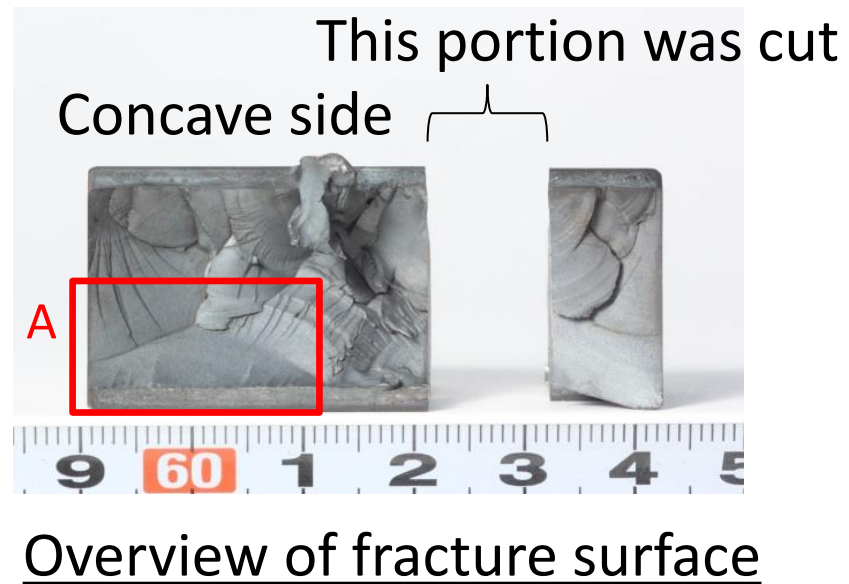
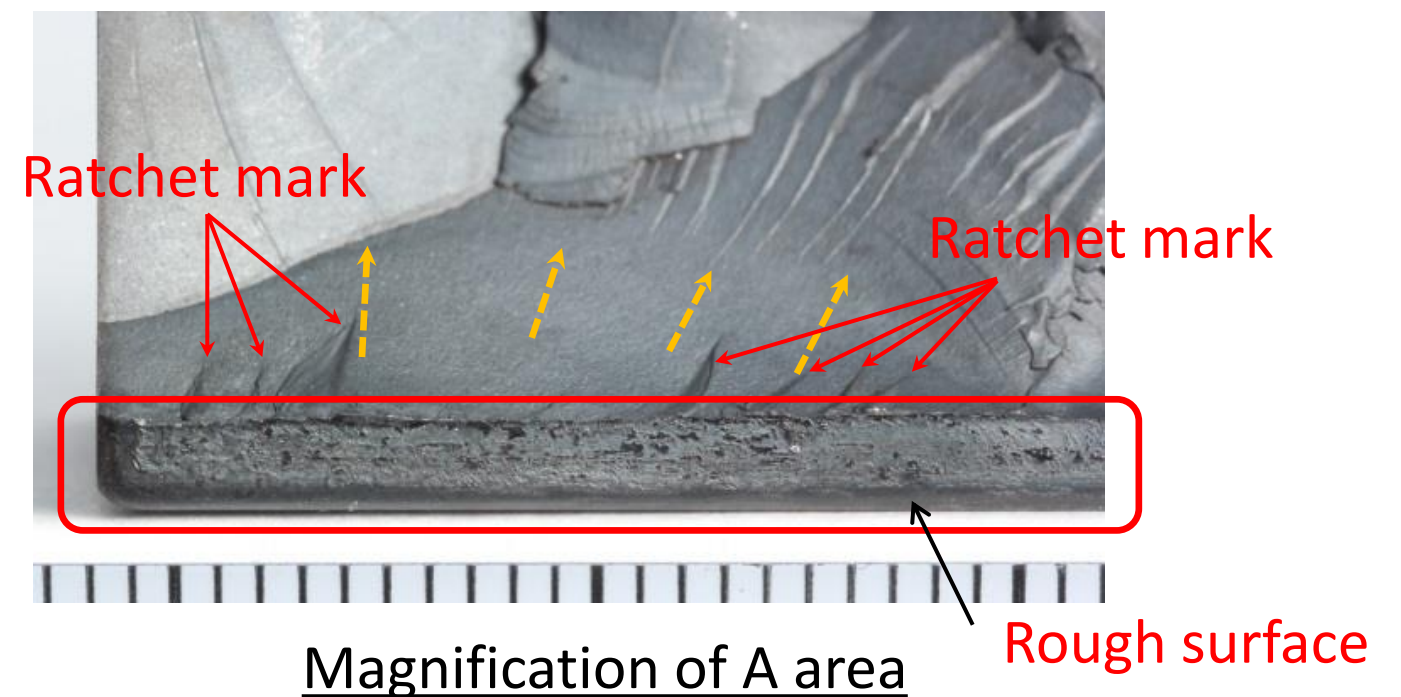
- Ratchet mark was observed on fracture surface, so the crack has multiple origin.
- Rough surface was observed around crack origin.
- Crack was started from rough surface.
- No corrosion pit was observed.
- Chemical components and hardness were satisfied the required specification.

Initial crack was initiated by fretting fatigue, and blade failed from high cycle low stress fatigue.

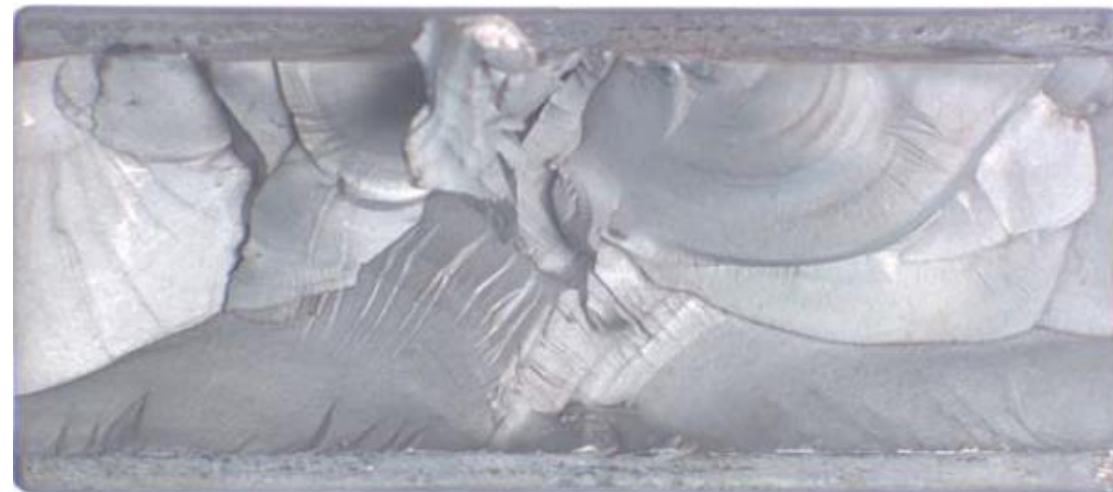
Fig.1 Fracture surface of No.70 blade

The followings are observed from fracture surface of No.70 blade.

- 1) The blade failed from high cycle fatigue.
- 2) Fatigue cracks start in 4 areas on both sides of the blade root.
This and the presence of ratchet marks support a high cycle low stress fatigue mode.
- 3) In the fatigue crack initiation locations multiple fretting marks are present.
Fretting fatigue cracks start from these locations.
- 4) The failed blade steel is made of good quality.
- 5) No evidence of an external factor related to steam quality was found.

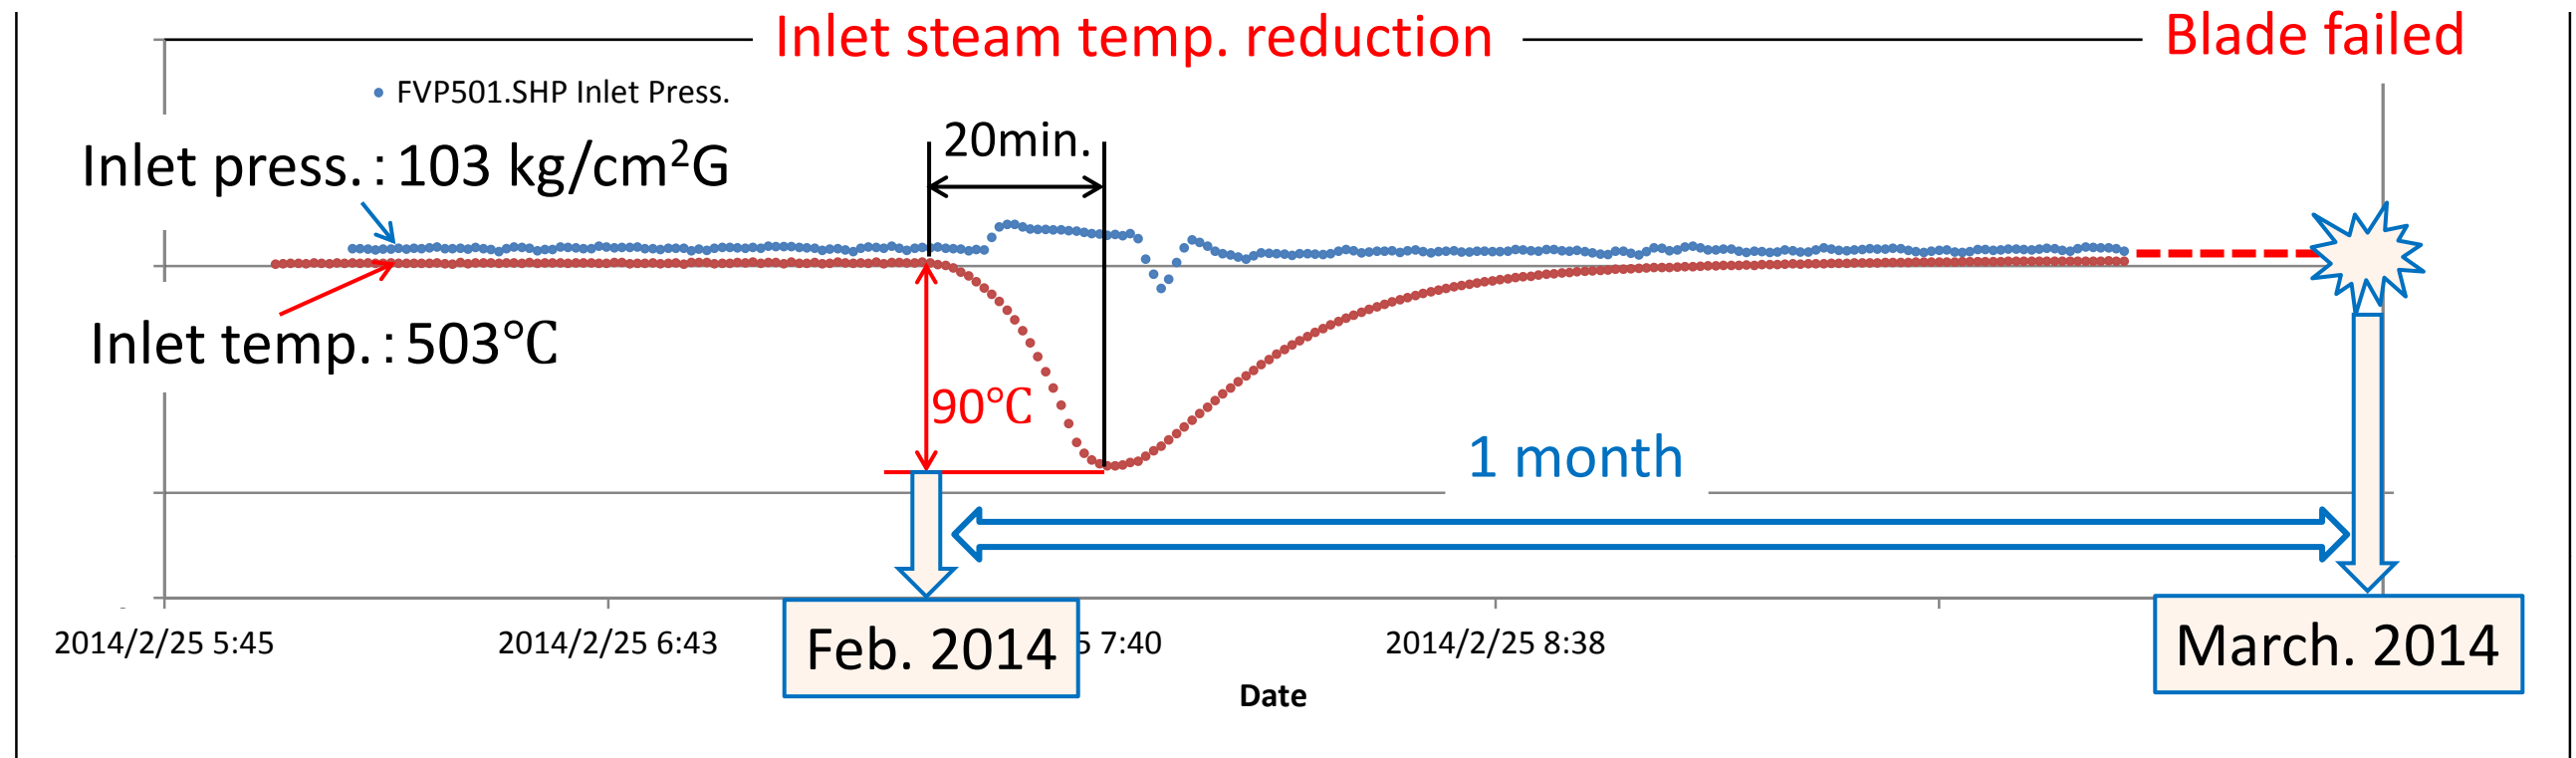
The temperature changed from approximately from 500 degree C to 410 degree C in roughly 20 minutes and then recovered to rated temperatures in approximately 30 minutes.
This event had occurred approximately 1 month before the failure of the turbine blade.

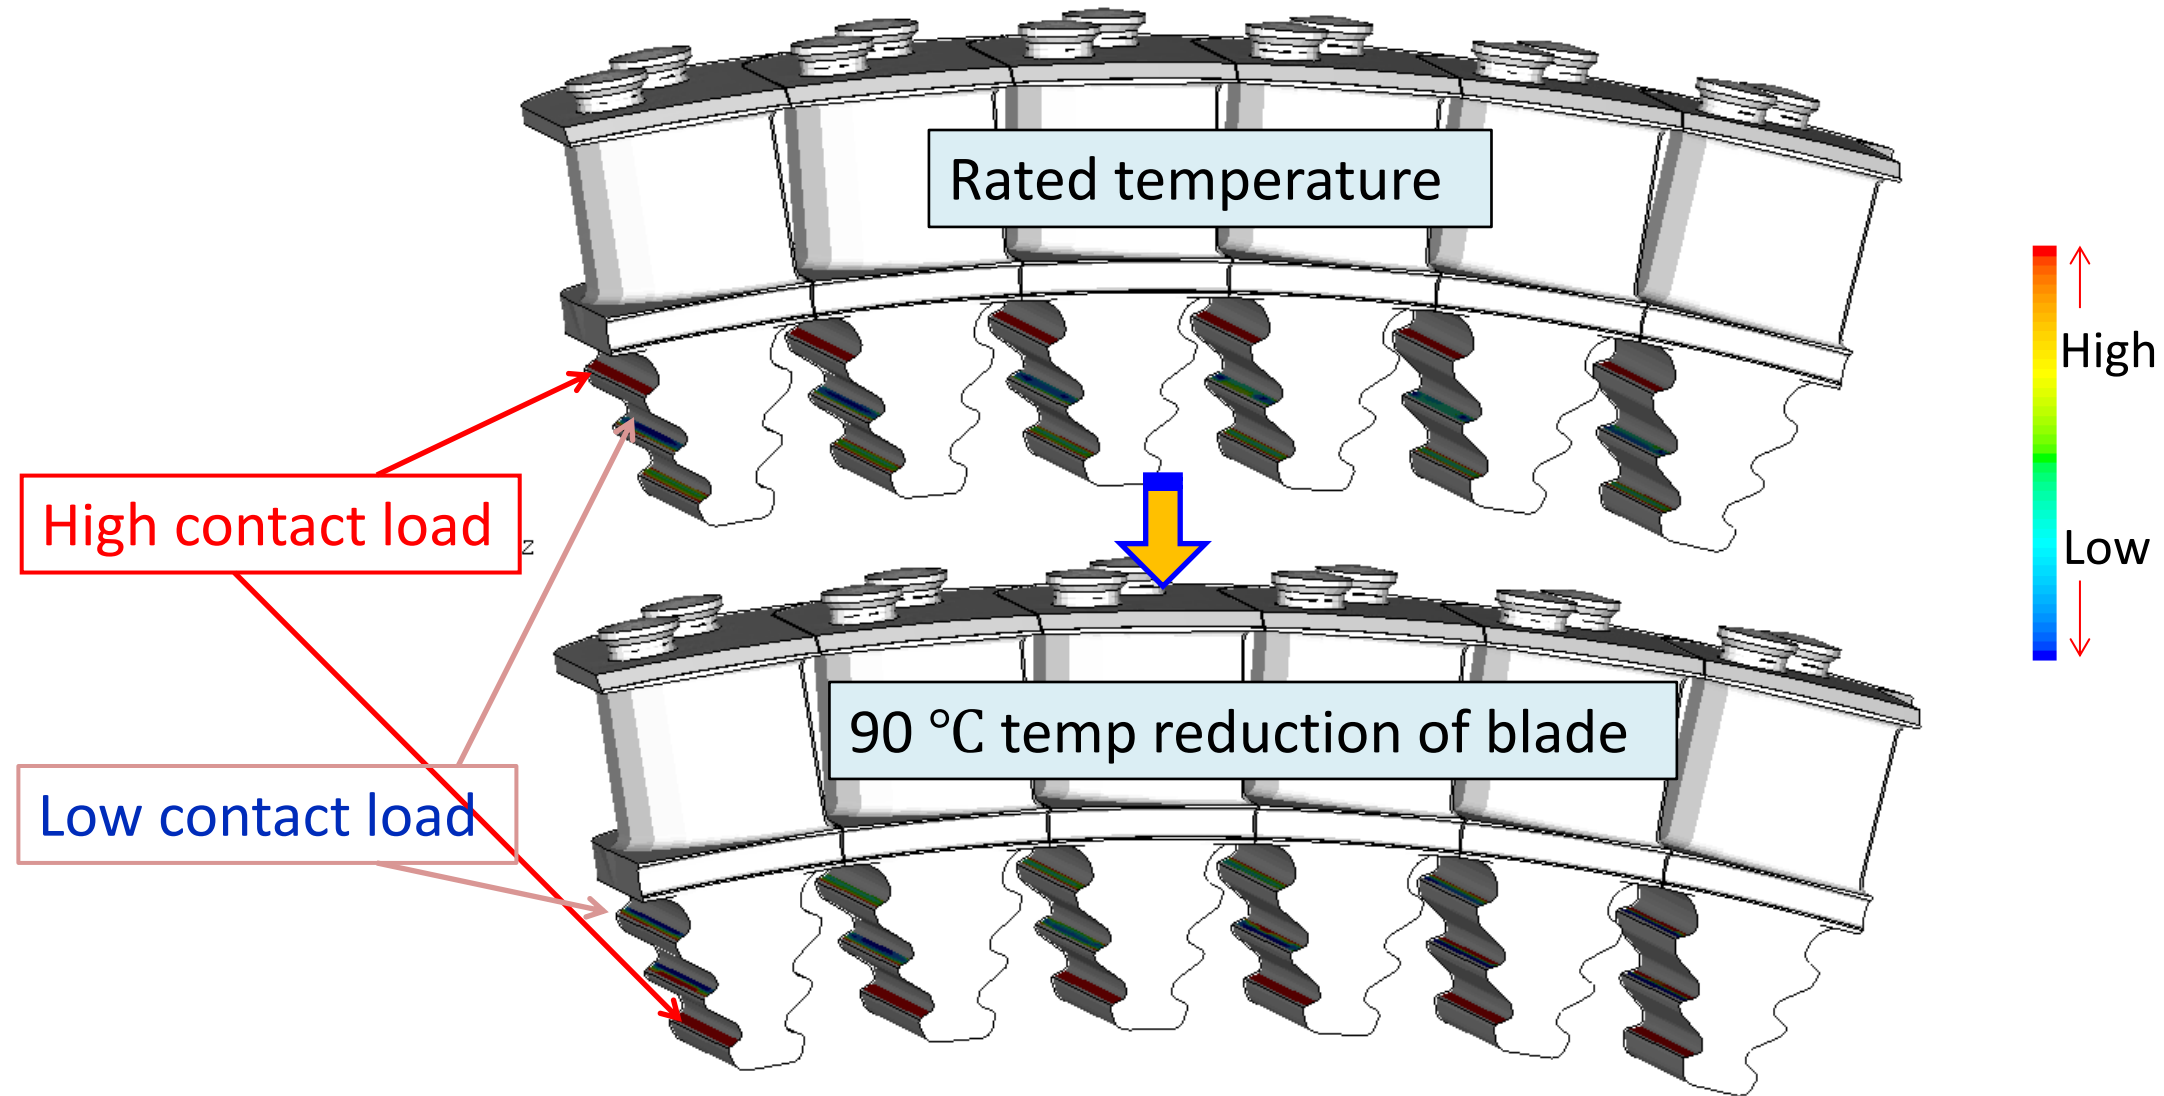
The contact area shifts from 1st bearing surface to 3rd bearing surface on end blades as temperature is reduced. Makes the end blades susceptible to vibrations.

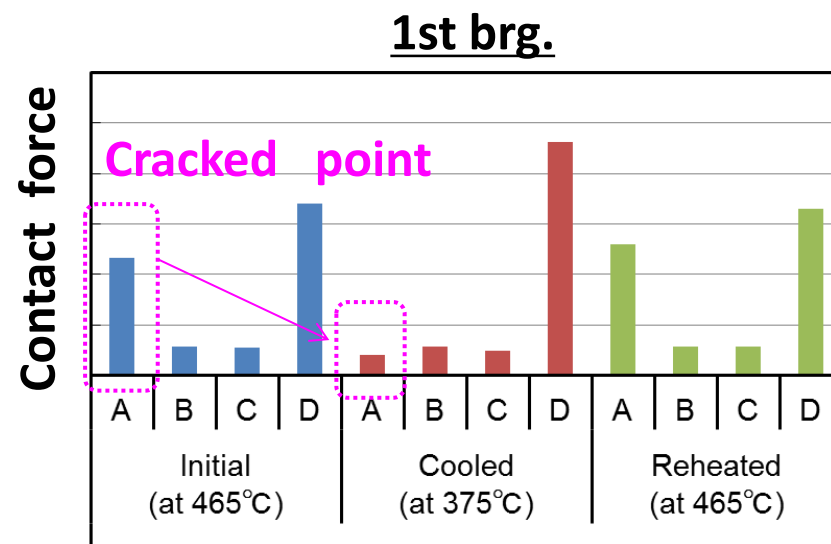
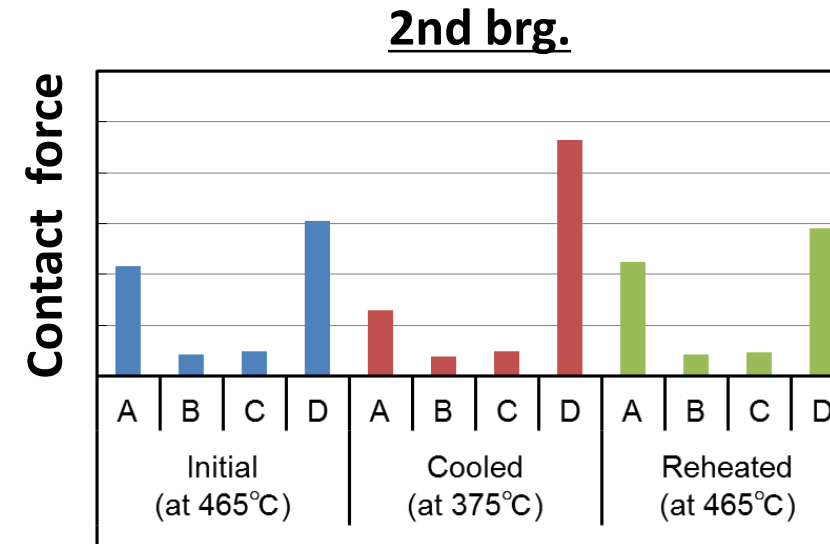
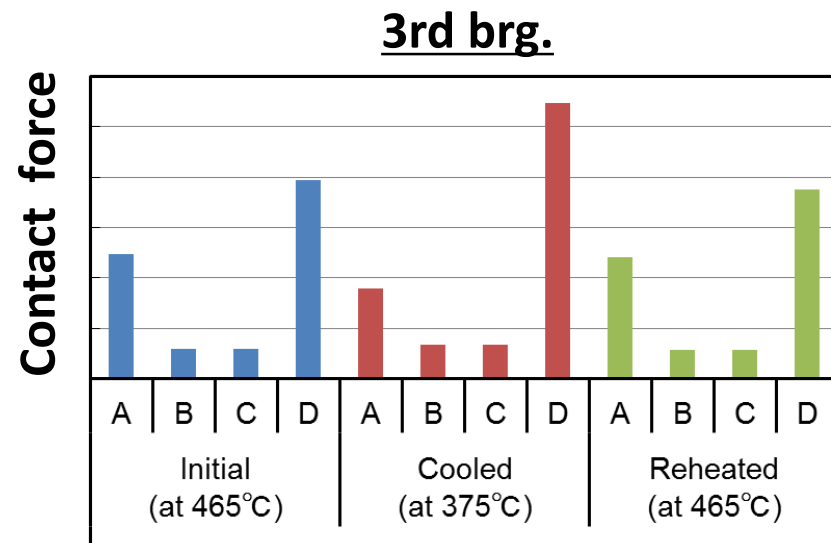
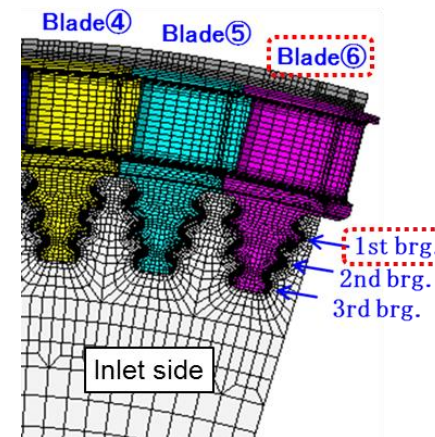
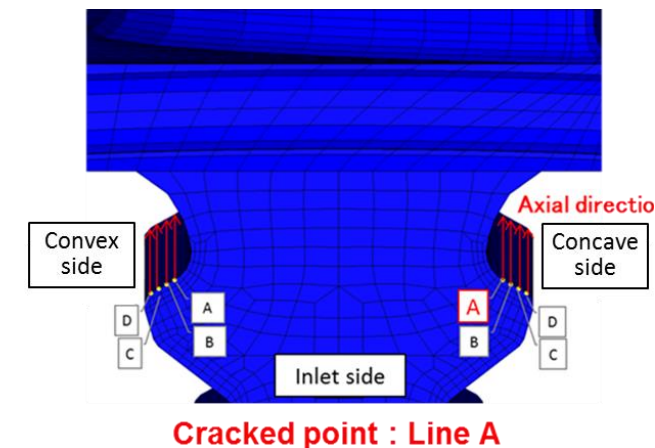
Average of contact pressure (at Blade⑥ / Concave side)

- ✓ At the 1st brg. Line A (cracked point), the contact pressure significantly reduce after steam cooled.
- ✓ After steam reheated, the contact pressure become nearly equal to initial condition again.

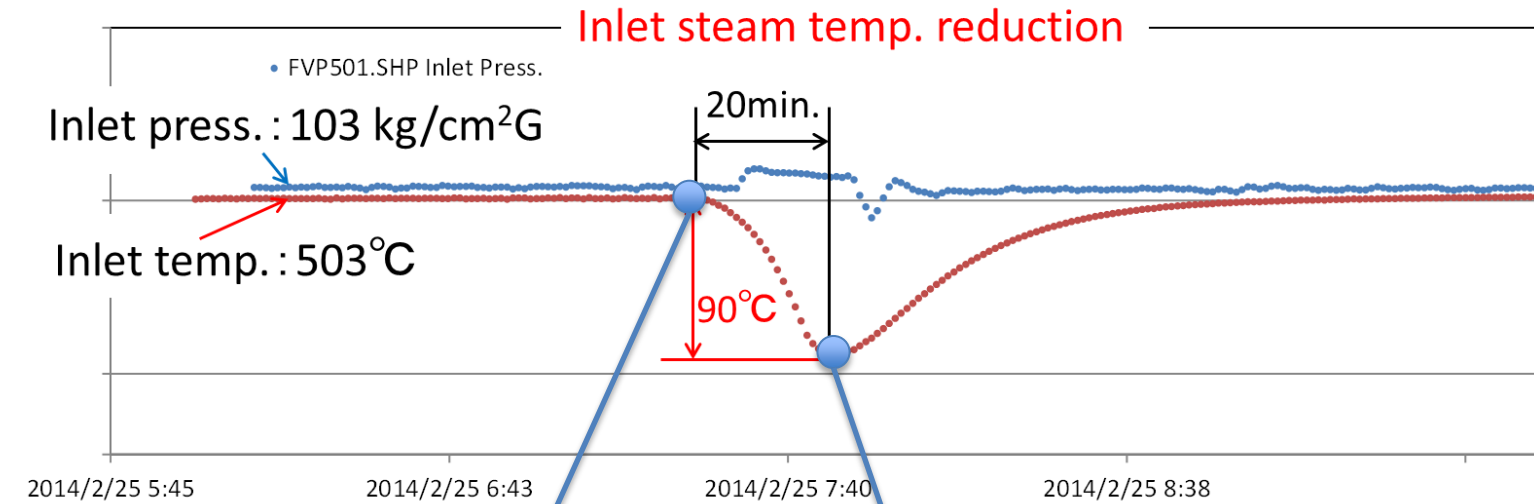
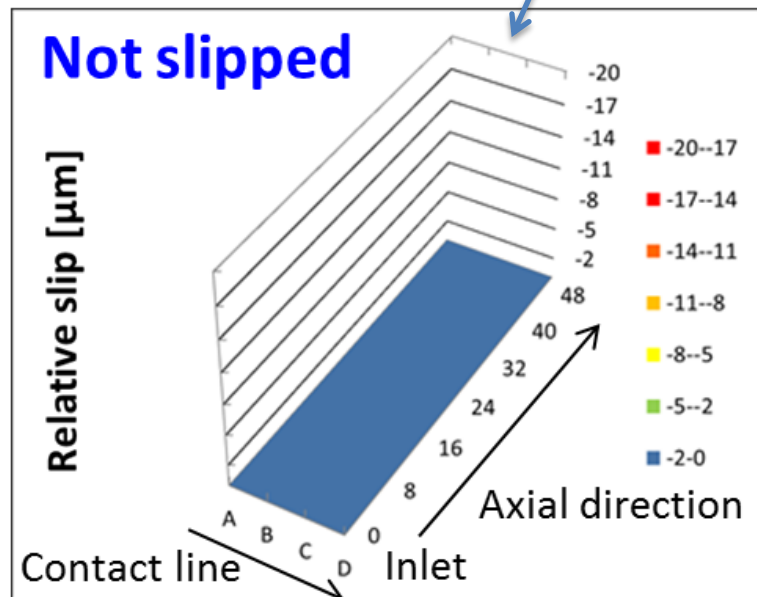
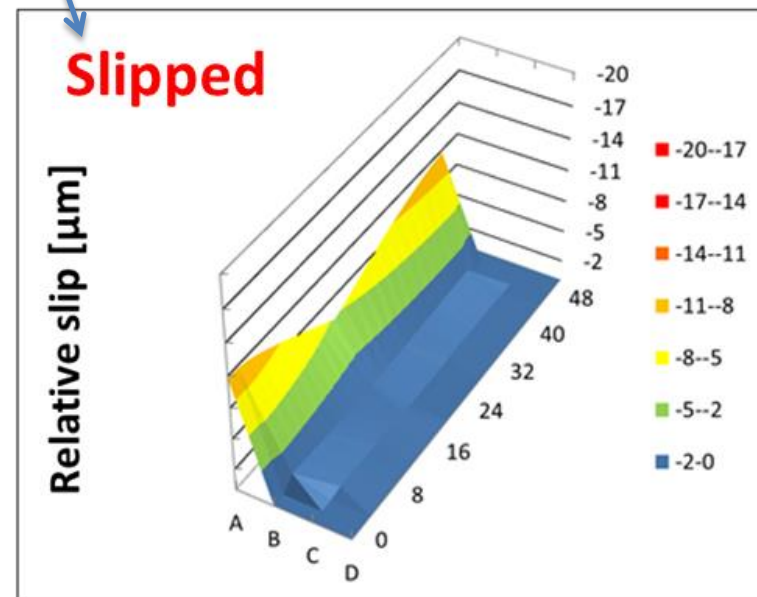
- ✓ Slip between rotor groove and blade was possible as the vibratory forces exceeded contact force on blade root during temperature excursion event

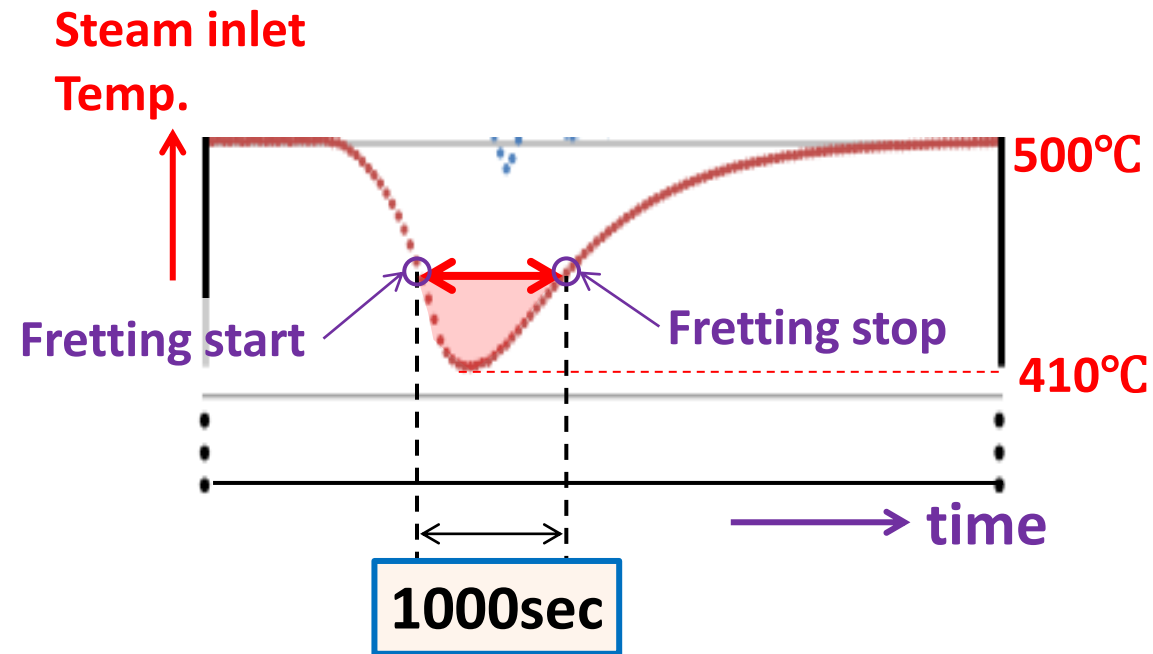
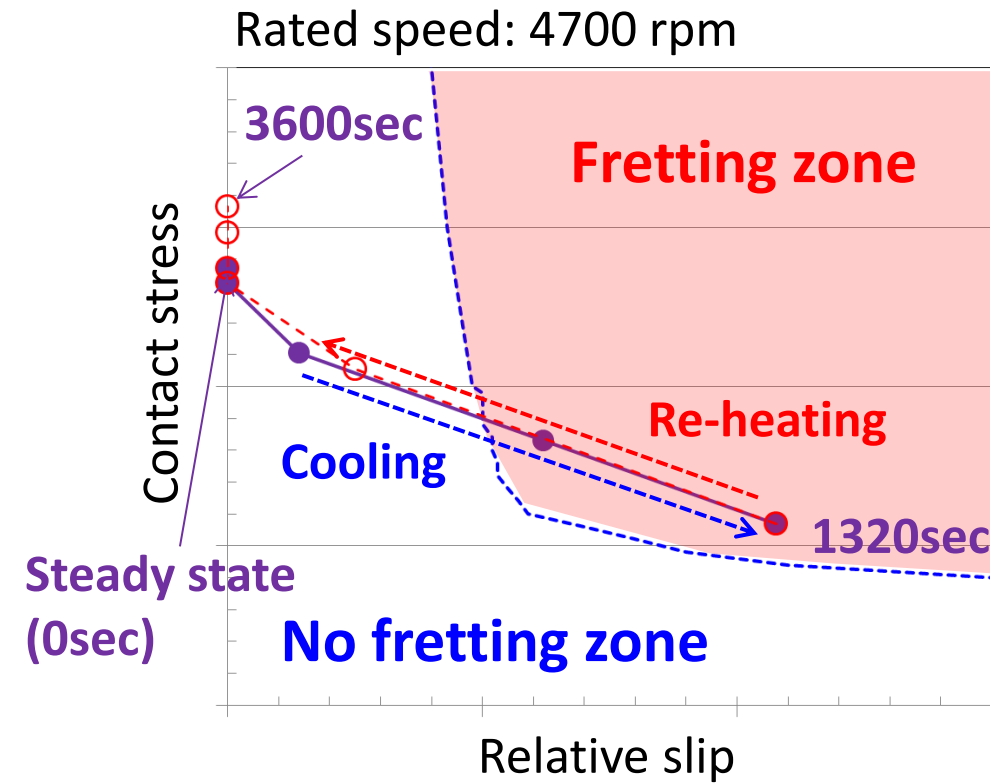
Fretting estimated time : 1000sec

Dominant cycle : $157\text{Hz} = 4700\text{rpm}/60 \times 2\text{shock/round}$

⇒ Cyclic number : $1.6 \times 10^5 \text{ cycles} = 157\text{Hz} \times 1000\text{sec}$

Commonly, cyclic number for fretting fatigue crack initiation is $10^4 \sim 10^5$ cycle.

➔ Enough time to initiate fretting crack

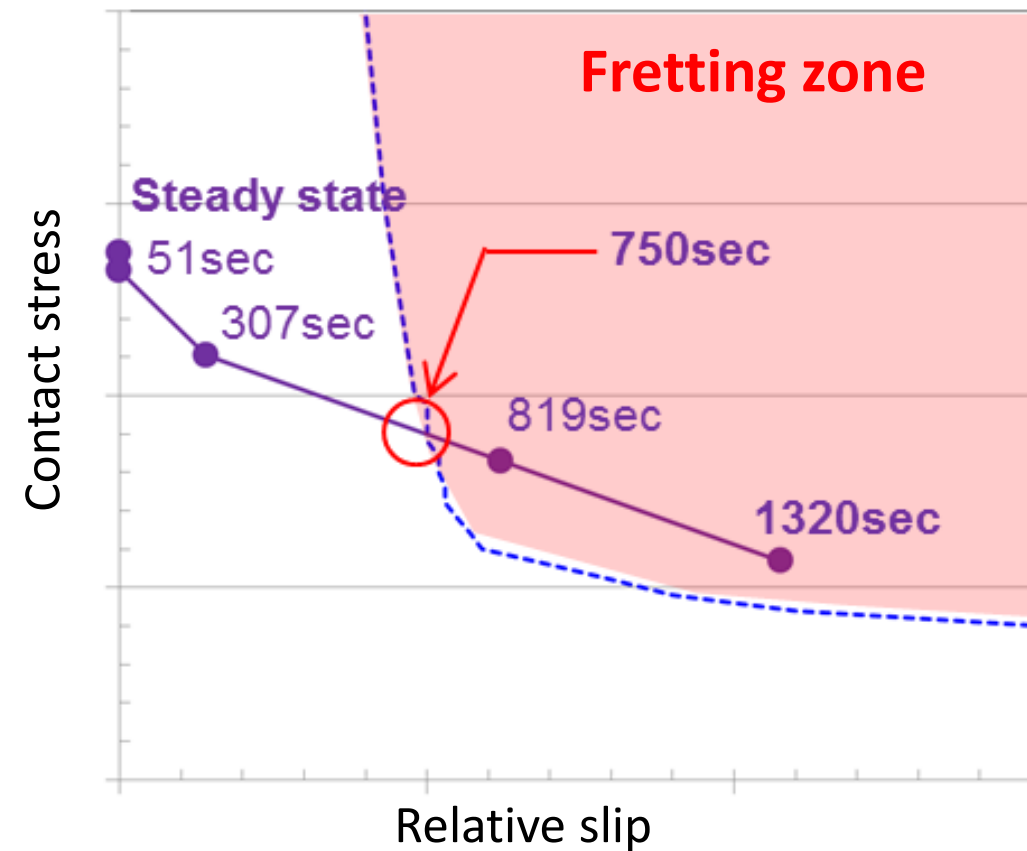
Original case

Fretting occurs from 750sec

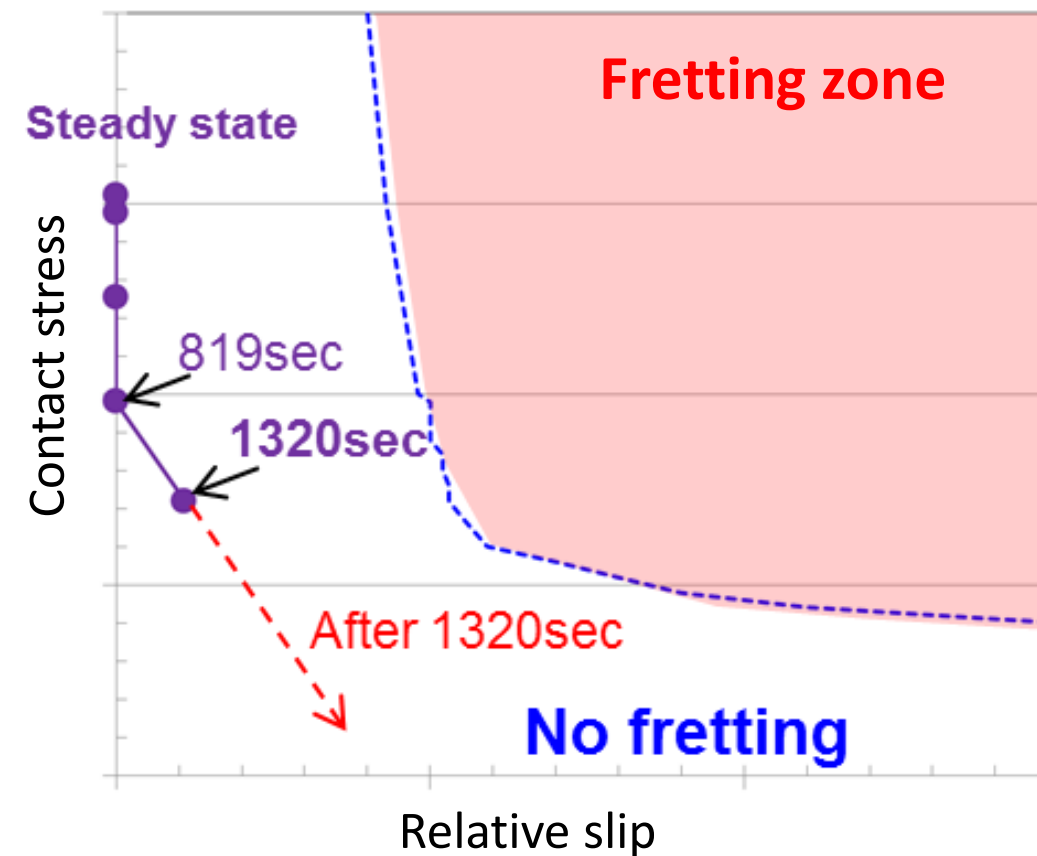
Improvement case

Fretting does not occur.

5. Vibratory stresses have to be reduced to be lower than contact pressure as a solution to avoid fretting. This was possible by modification of governing valve sequence in case of this turbine. Effect of change has been studied and model results show that fretting can be avoided even in case of temperature excursions by reducing vibratory stresses.
