45TH **TURBOMACHINERY** & 32ND **PUMP SYMPOSIA**
HOUSTON, TEXAS | SEPTEMBER 12 – 15, 2016
GEORGE R. BROWN CONVENTION CENTER

High Vibration Analysis of Eddy Current Drum Coupled Motor to a Vertical Centrifugal Pump – Solution Based on EMA, ODS and FEA

Problem Statement

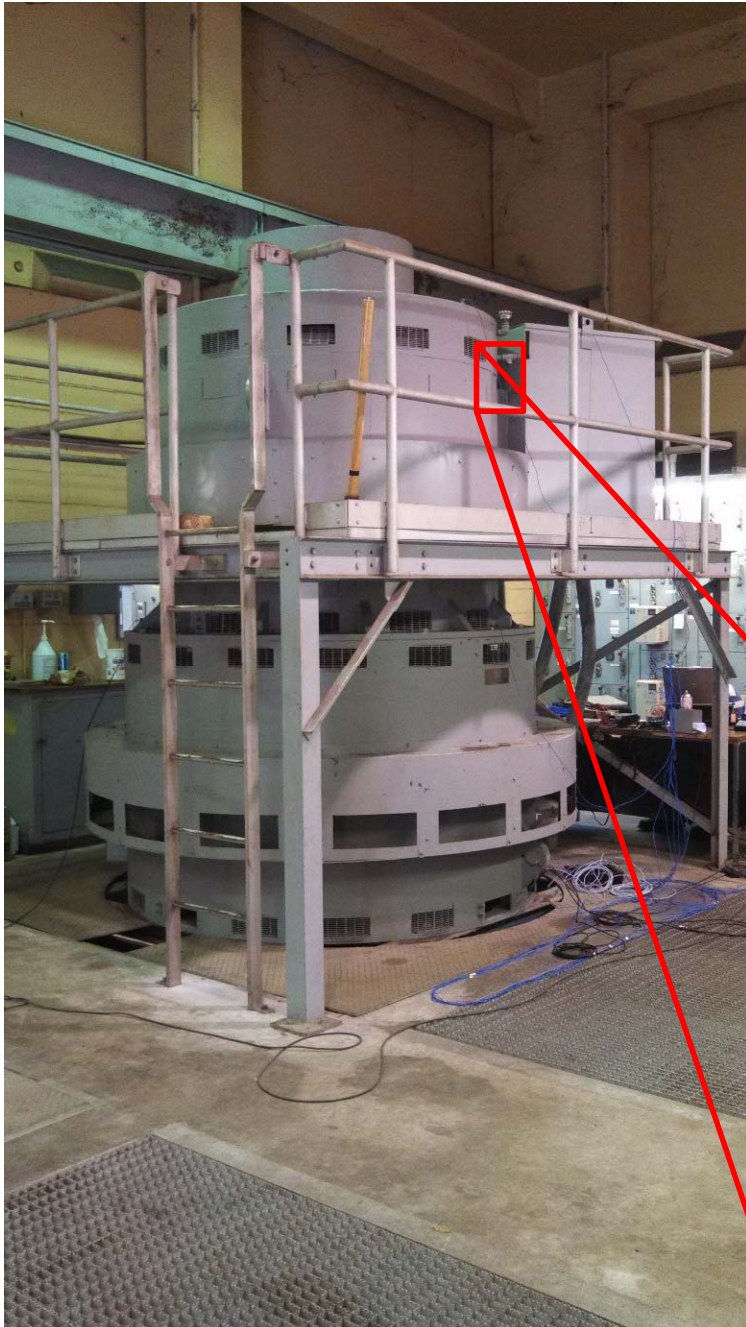
Top: Support added at motor base

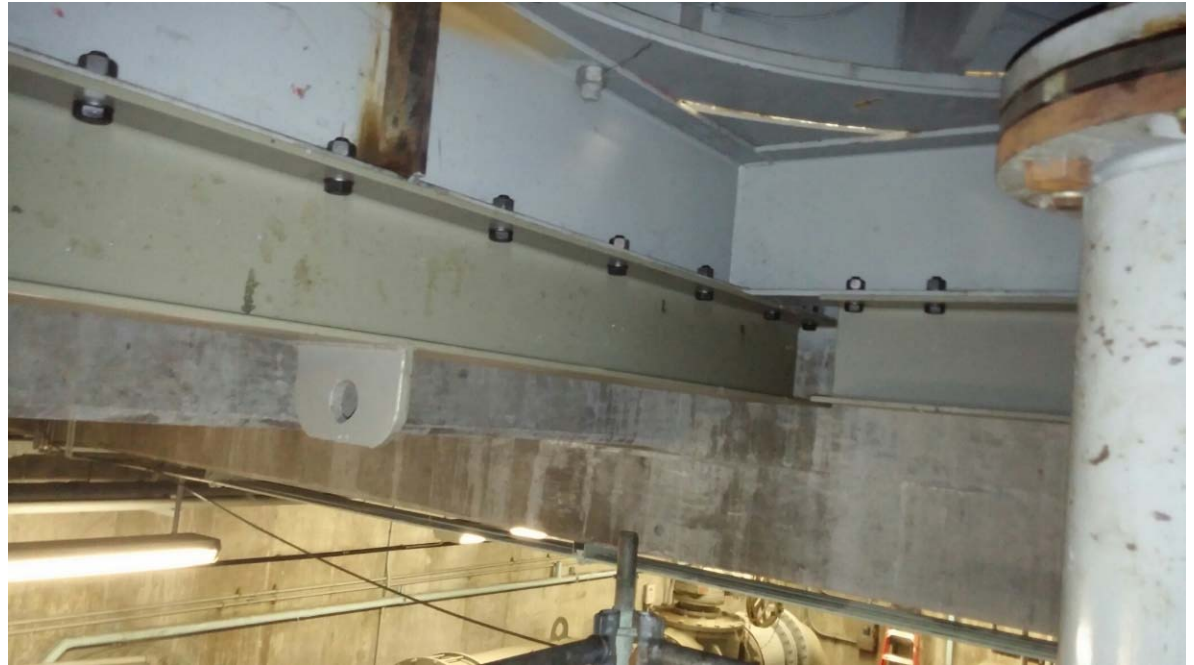
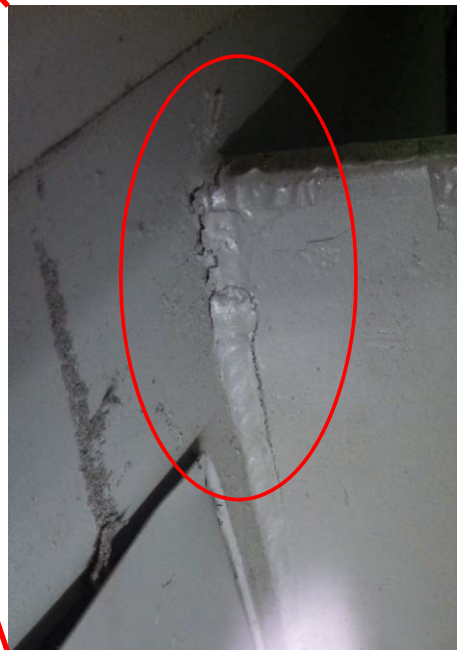
Left: Motor to Junction Box Connection Weld Crack

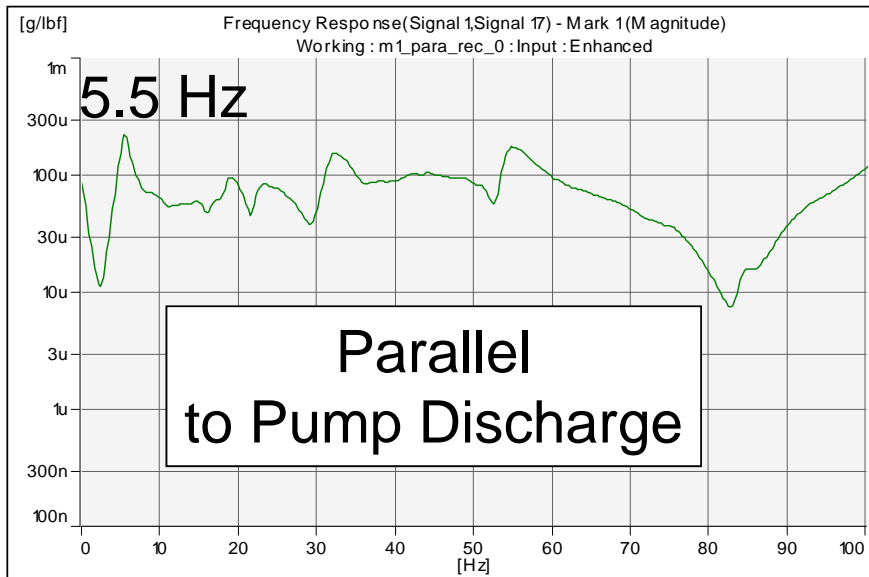
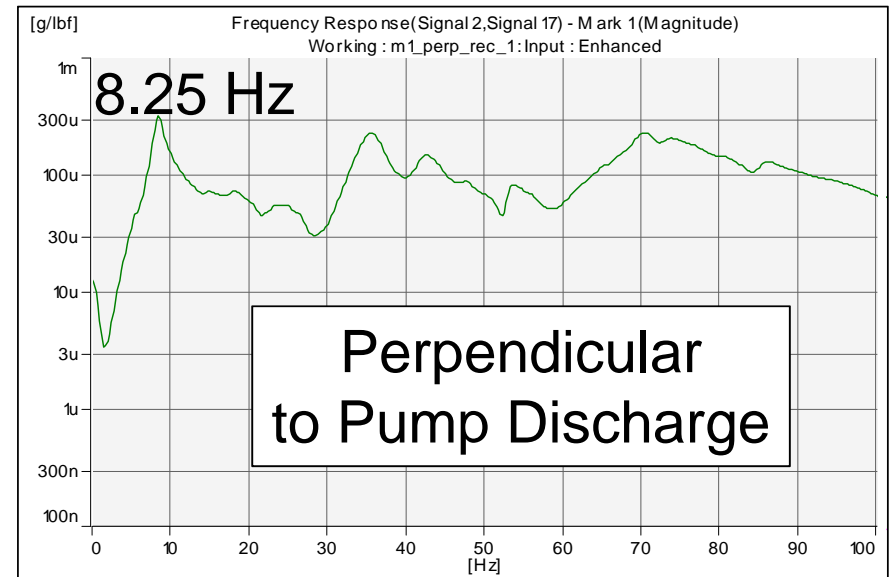
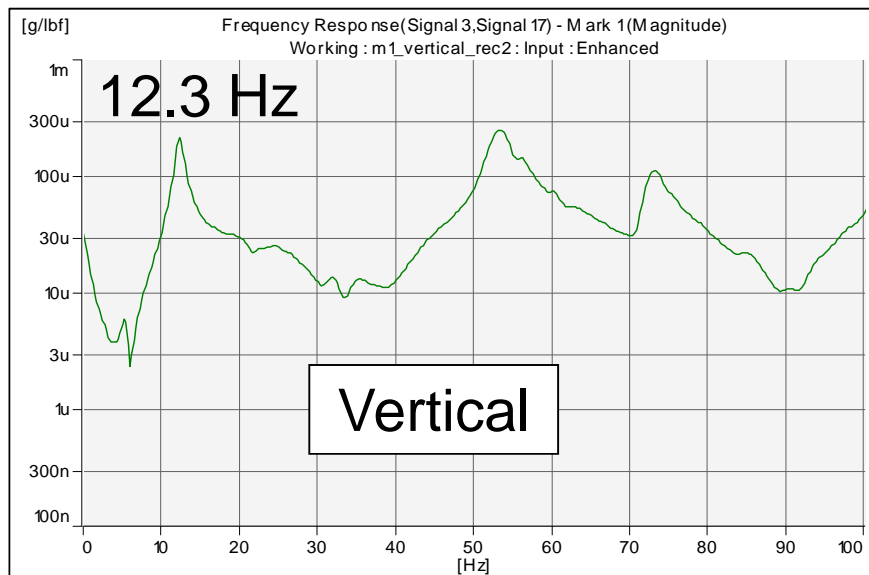
Experimental Modal Analysis (EMA)

*Directions struck at the top of the motor with a modally tuned impact hammer. FRFs are of accelerometers located near and inline with impacts.

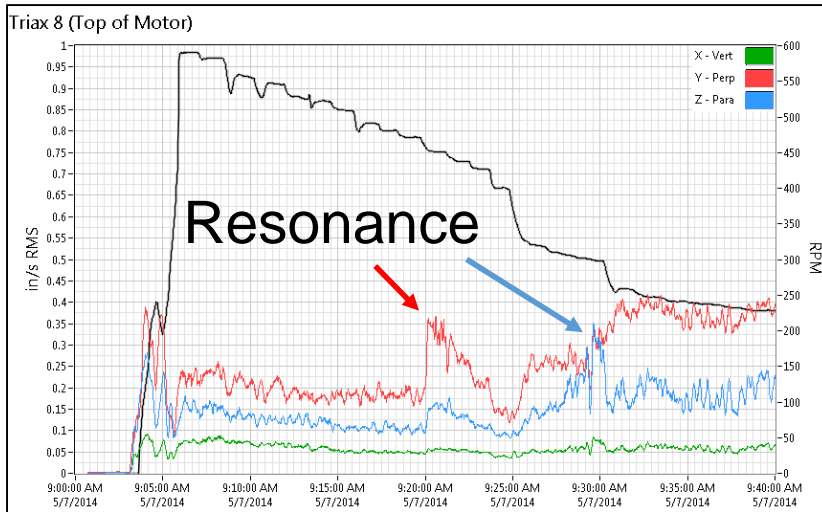
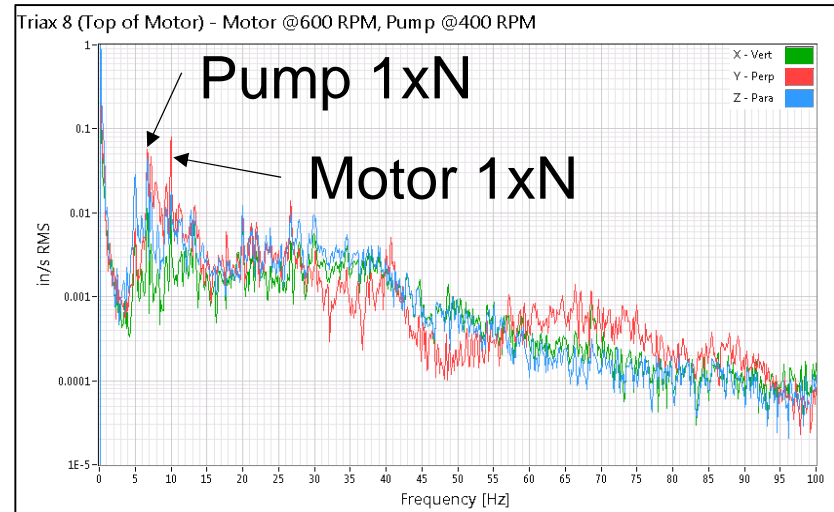
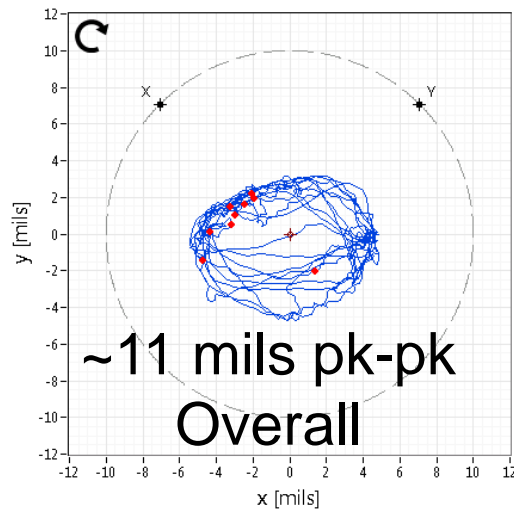
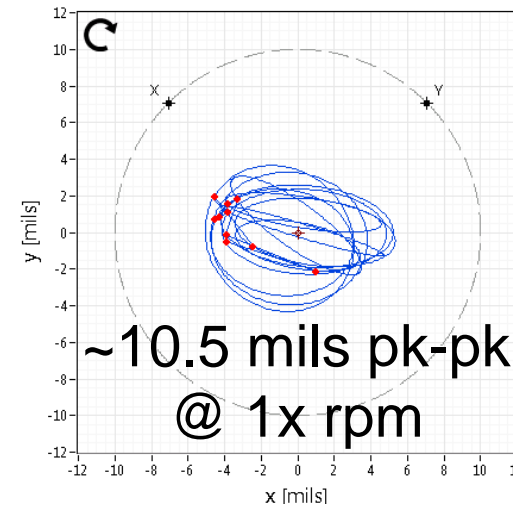
Condition Monitoring Plots

305 RPM (5.1 Hz)
450 RPM (7.5 Hz)

The radial proximity probes were located at the motor output shaft near the coupling.

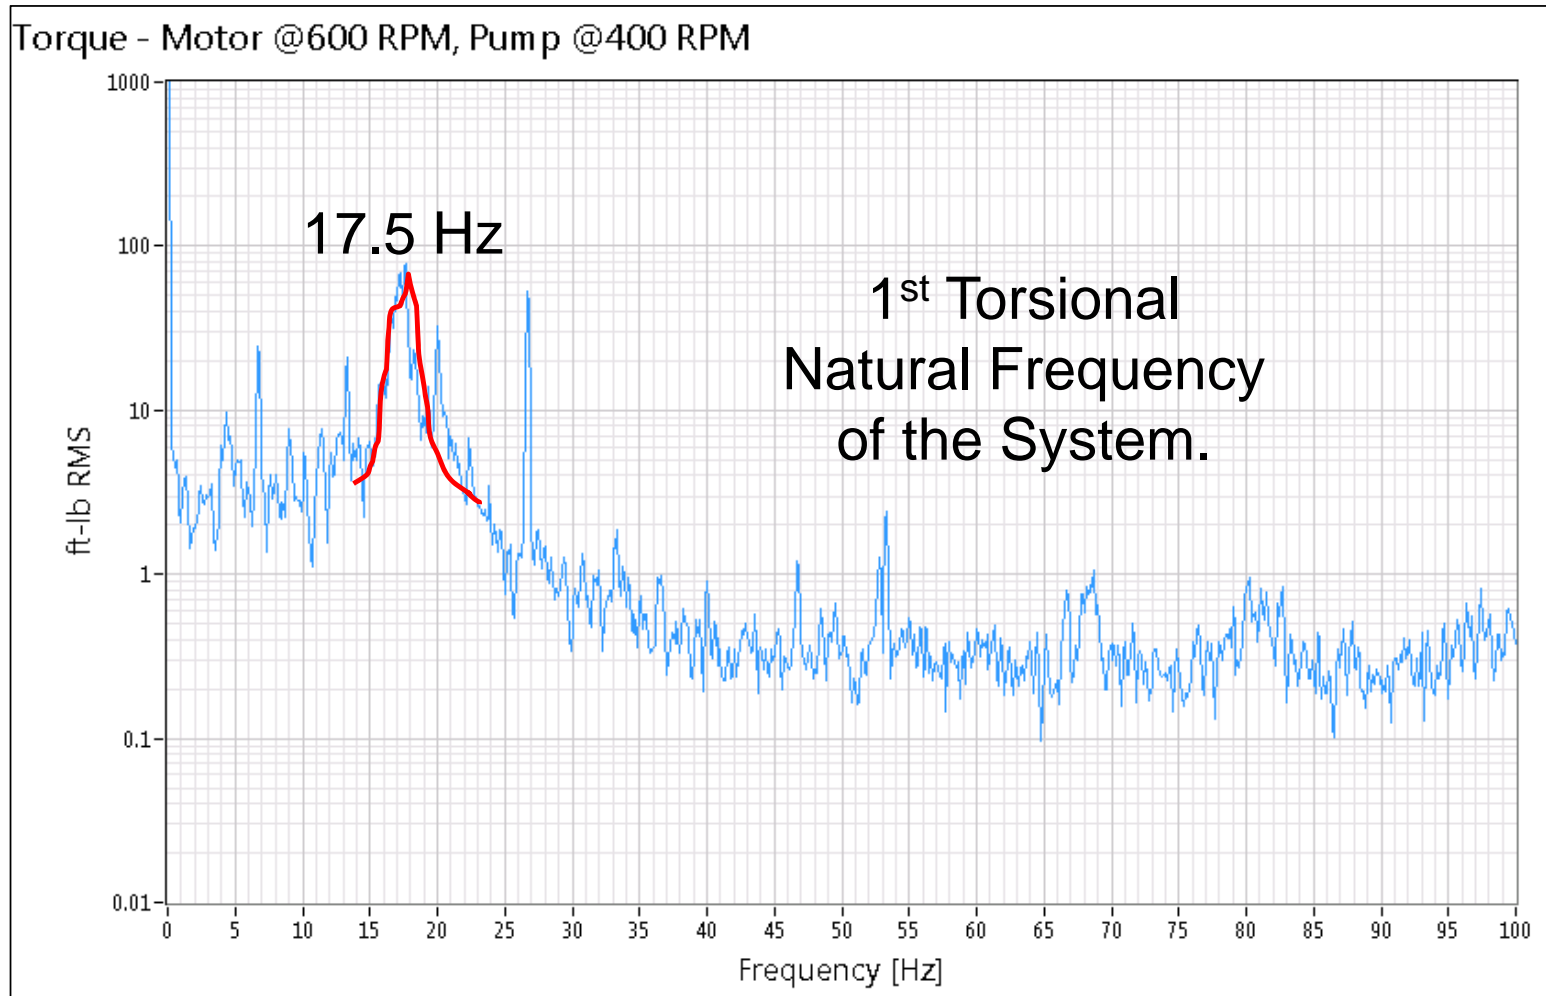
FFT Spectra of Torque Strain Gauge

Since the torsional natural frequency was calculated to be 17.5 Hz, it was ruled out as a possible source of the elevated vibration.

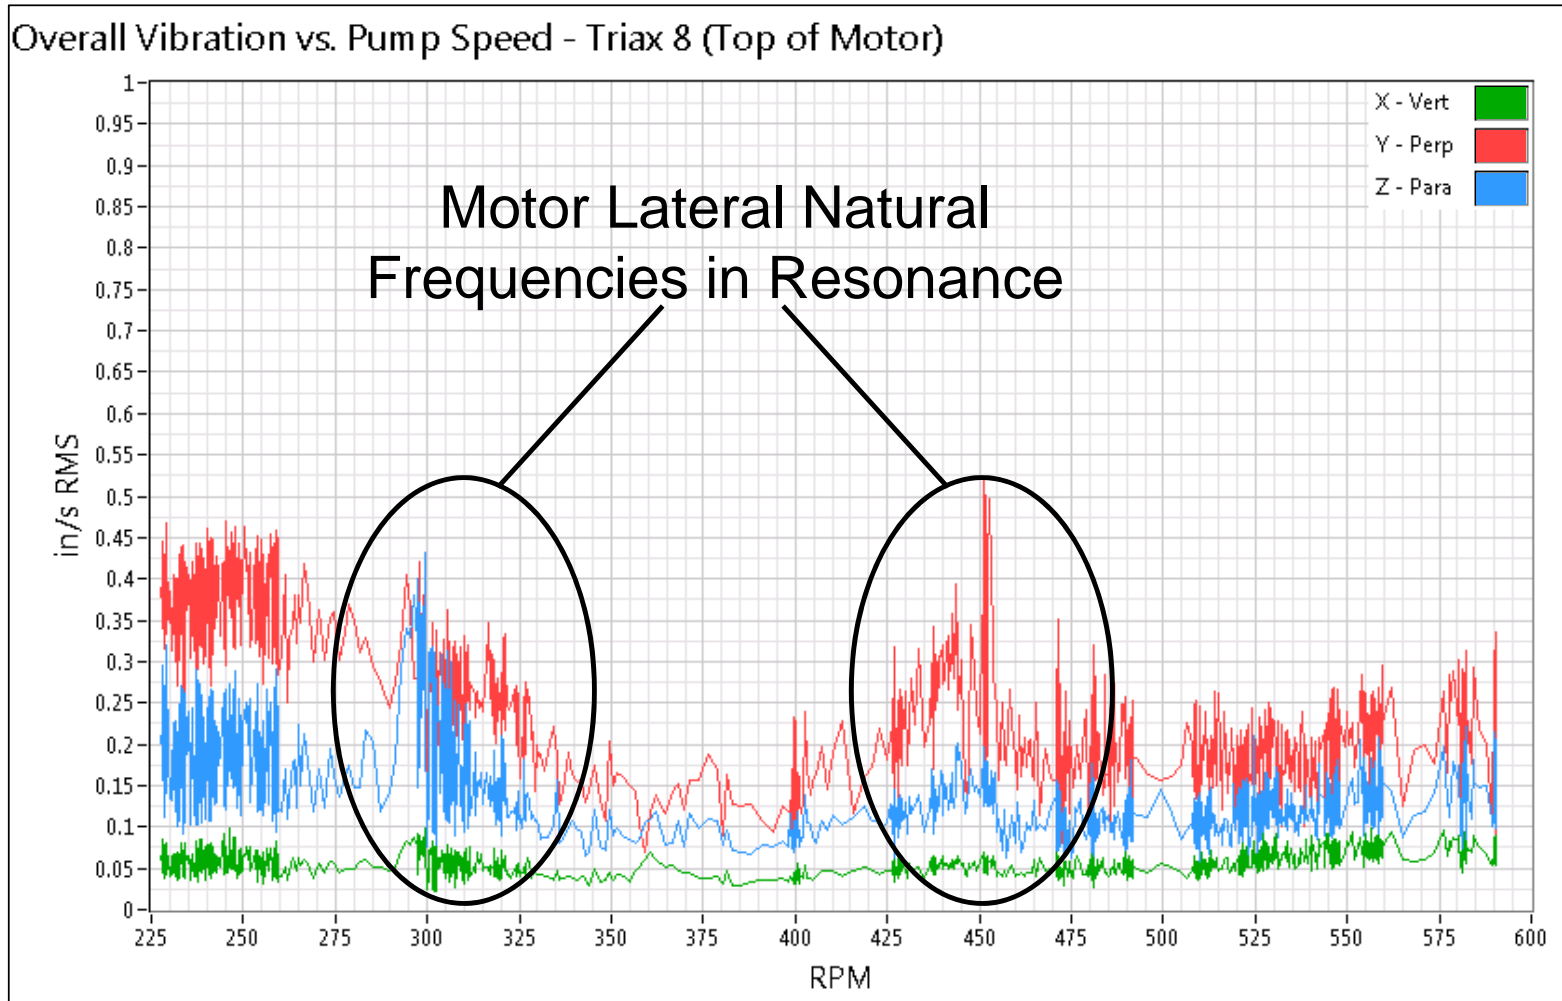
Top of the Motor Vibration vs. Speed

This speed vs. vibration trend plot shows that as the speed approaches the natural frequencies, the vibration gradually increases and vice versa.

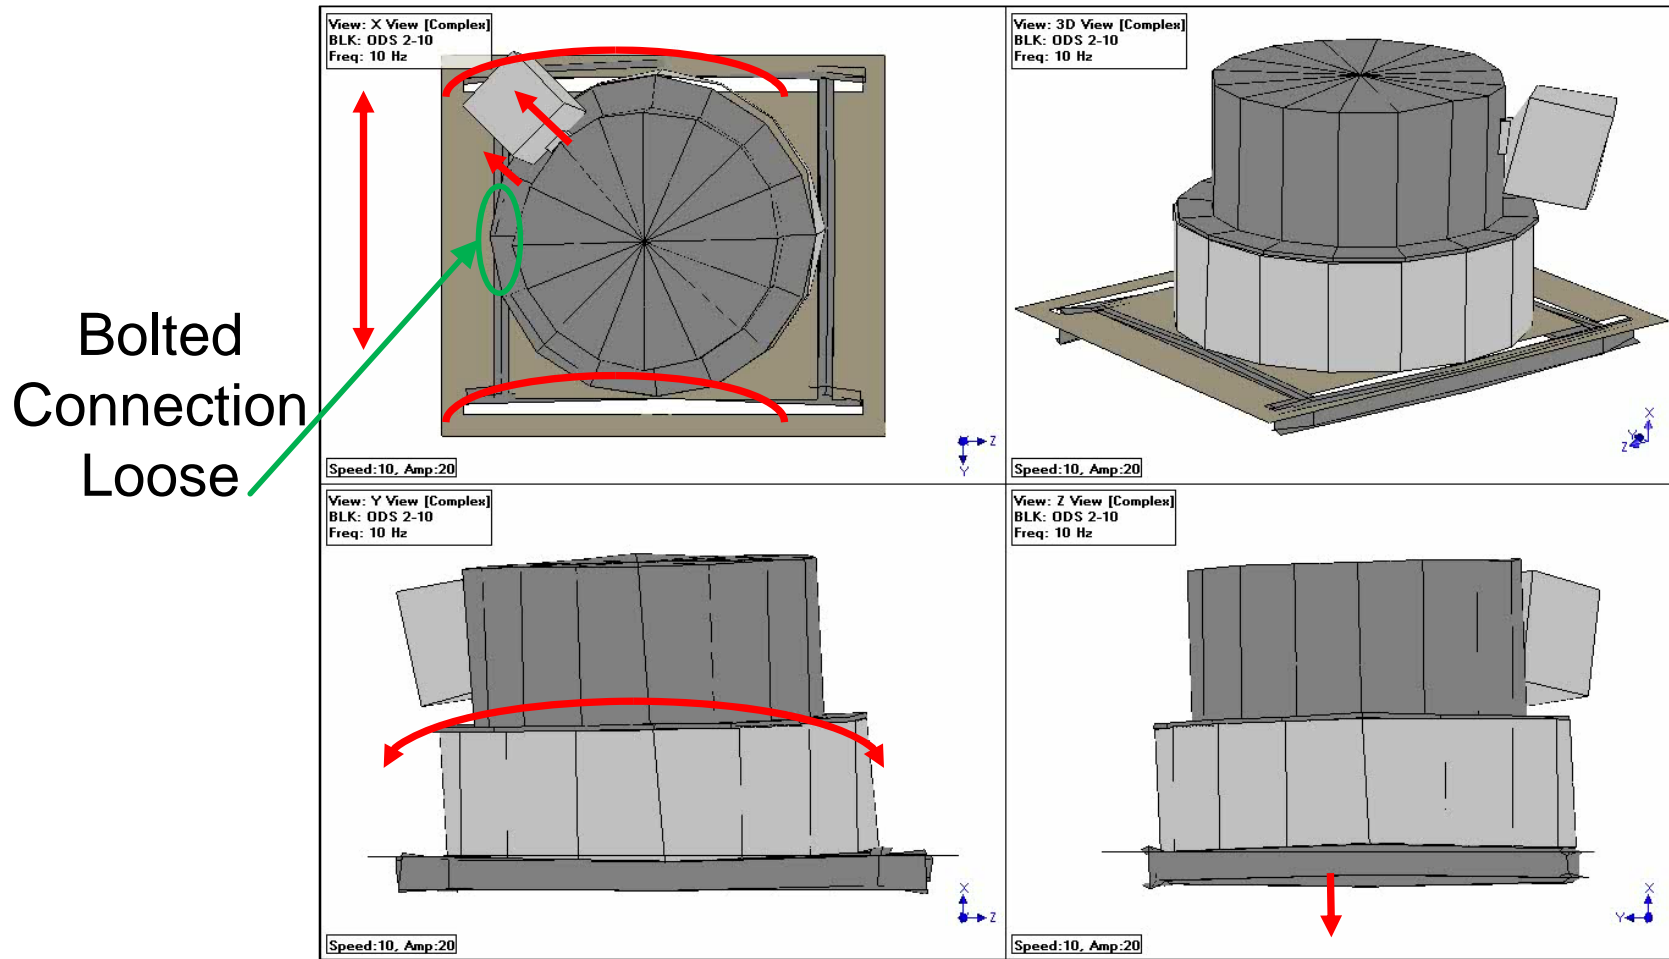
Computer Model Using ME'scopeVES Software Plotting ODS Test Results

The ODS animation at 10 Hz indicated a strong motion of the motor swaying and jumping. It also indicated a loose connection between the junction box and motor.

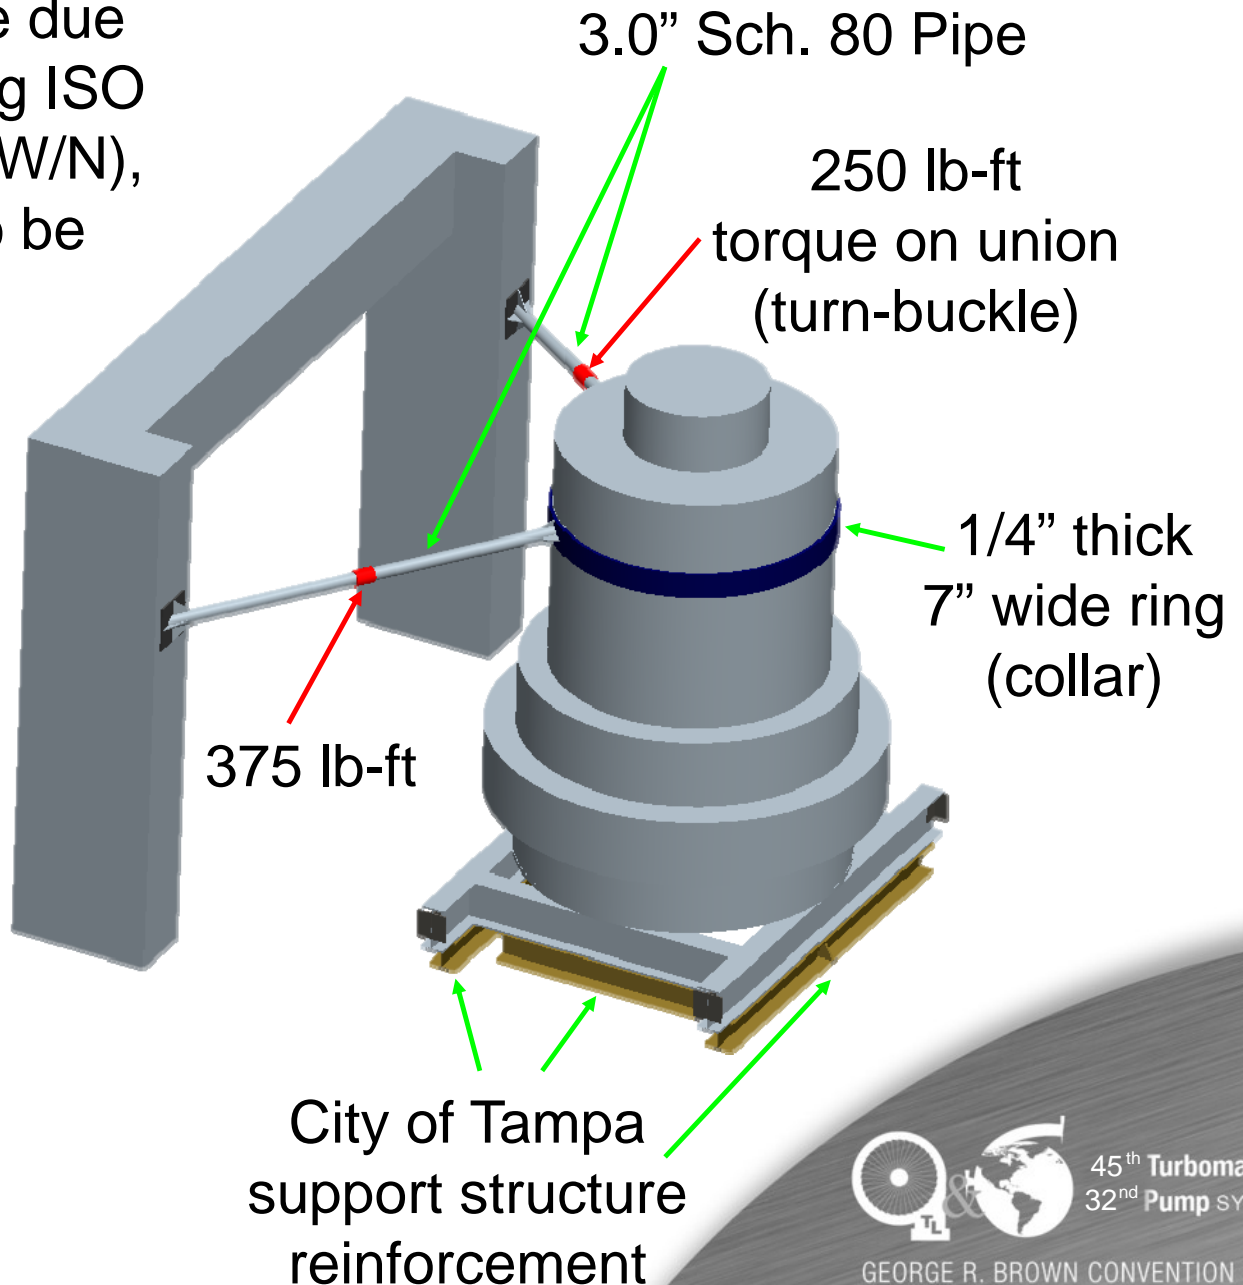
Modifications

Based on the motor rotor weight and speed, the radial force due to residual imbalance using ISO G2.5 or four times API (16W/N), the radial dynamic force to be supported was calculated.

The struts were to be anchored at the existing concrete supports and welded to a fabricated ring around the motor. Turn-buckle pre-load “in compression” (pushing the bracket and the ring outwards) was produced by the torque applied at the coupling.

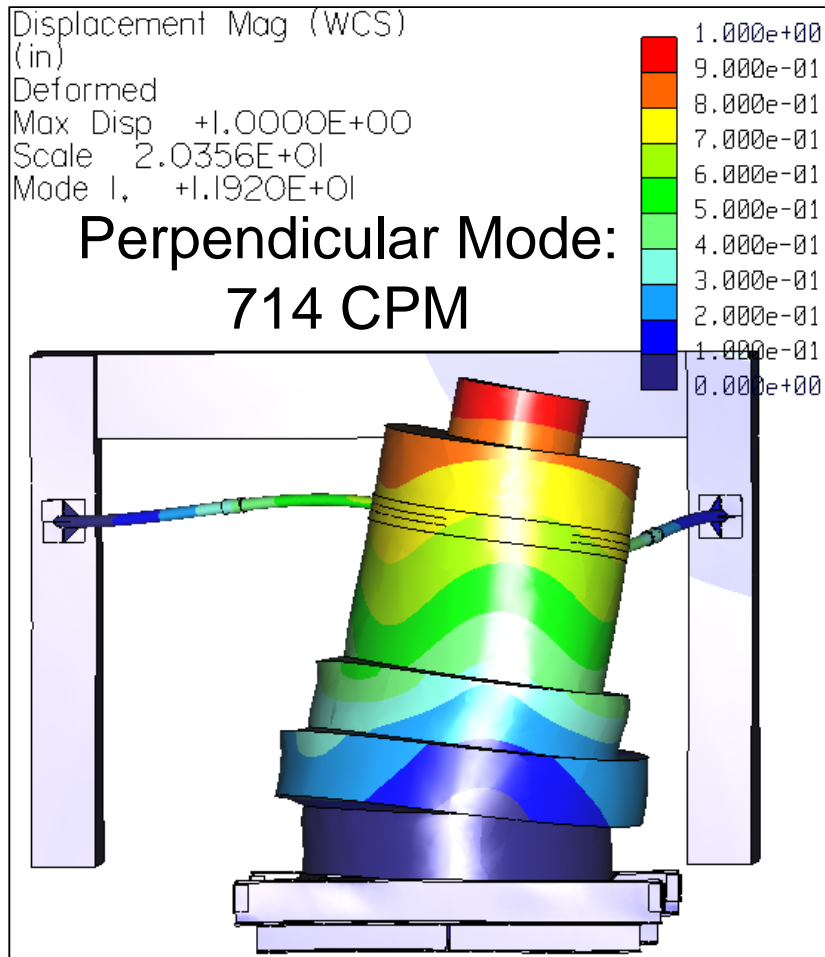
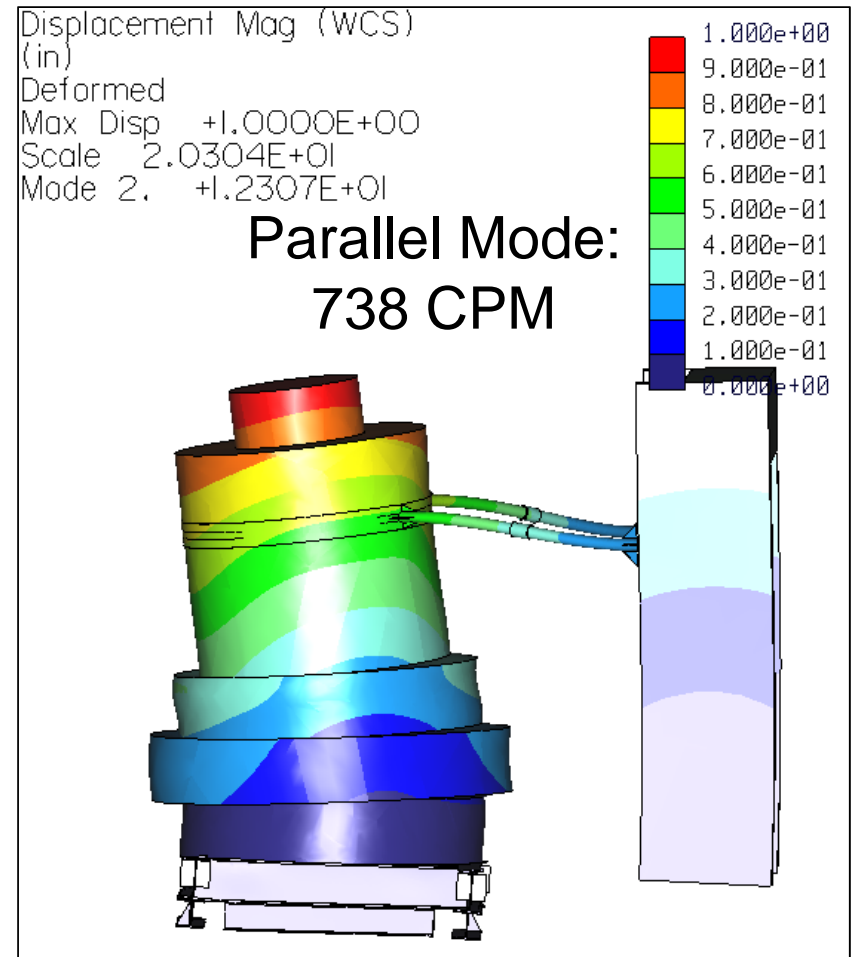
Finite Element Analysis

The lowest predicted FEA separation margin from the full motor speed of 600 rpm (10 Hz) was approximately 19%. This indicated the suggested modifications would increase the motor natural frequencies enough to prevent resonance.

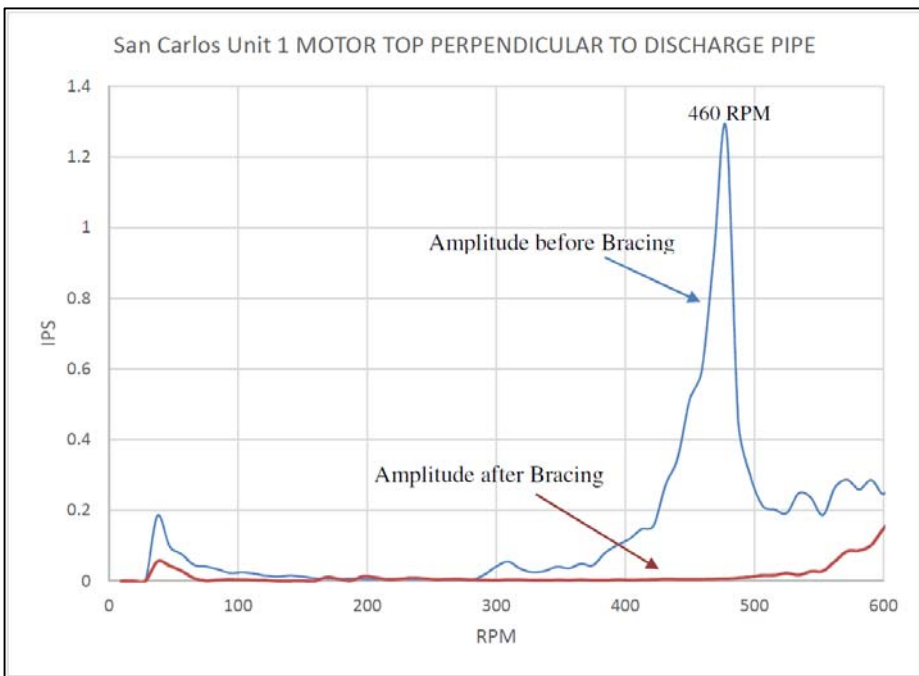
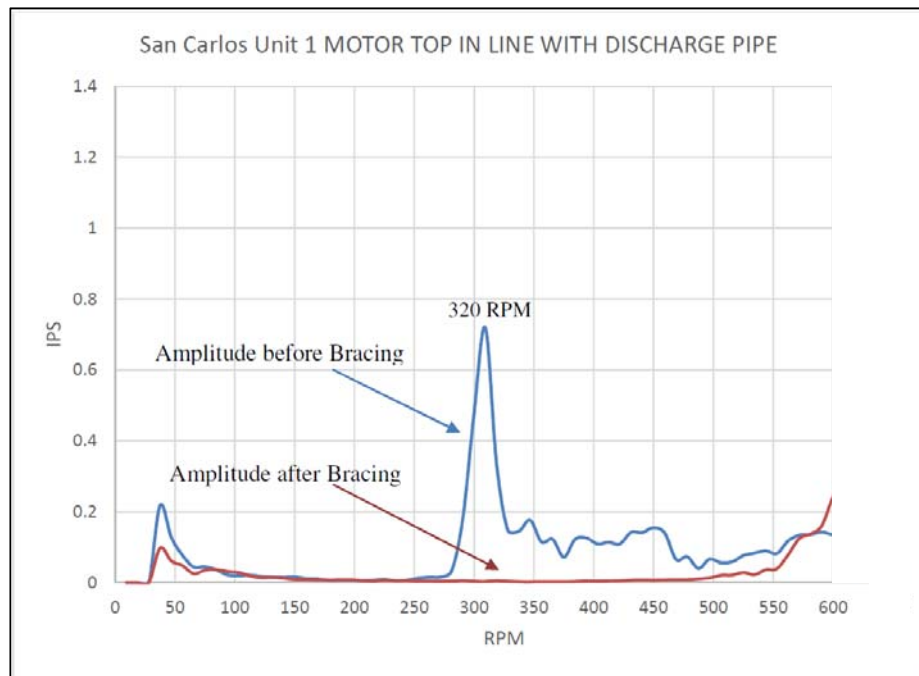
Vibration Response Before and After Modifications

Blue: Before
Red: After
