ASIA TURBOMACHINERY AND PUMP SYMPOSIUM

Investigation of Steam Turbine blade failure

Blade failure was observed on a backpressure steam turbine (driving a centrifugal compressor) after it was in service for more than one year.

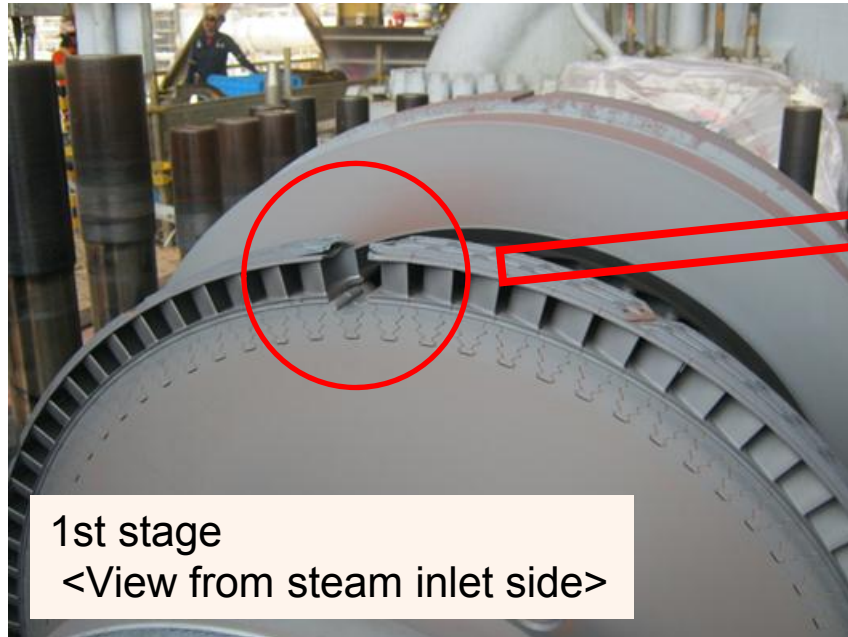
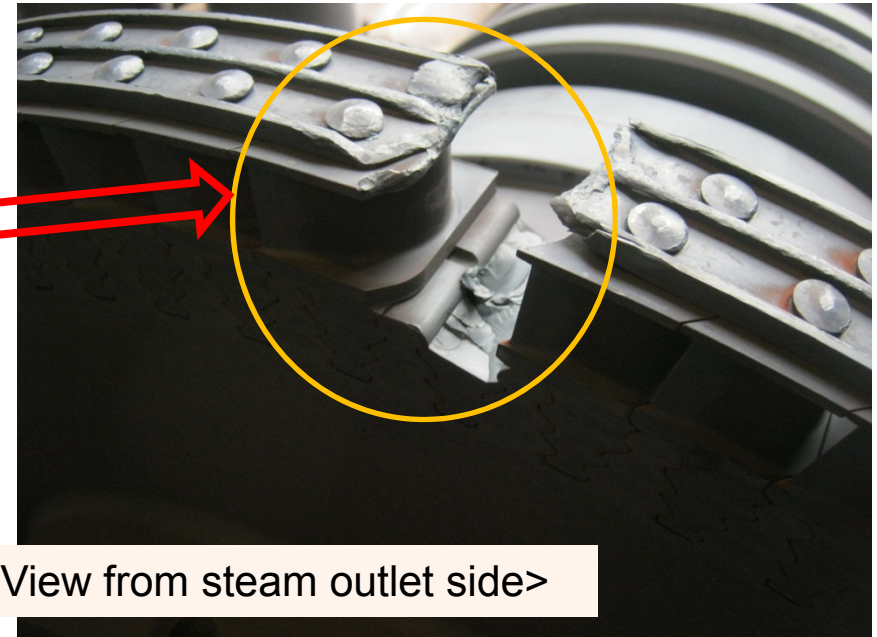
First stage wheel : Broken blade at one location. No damage on other components.

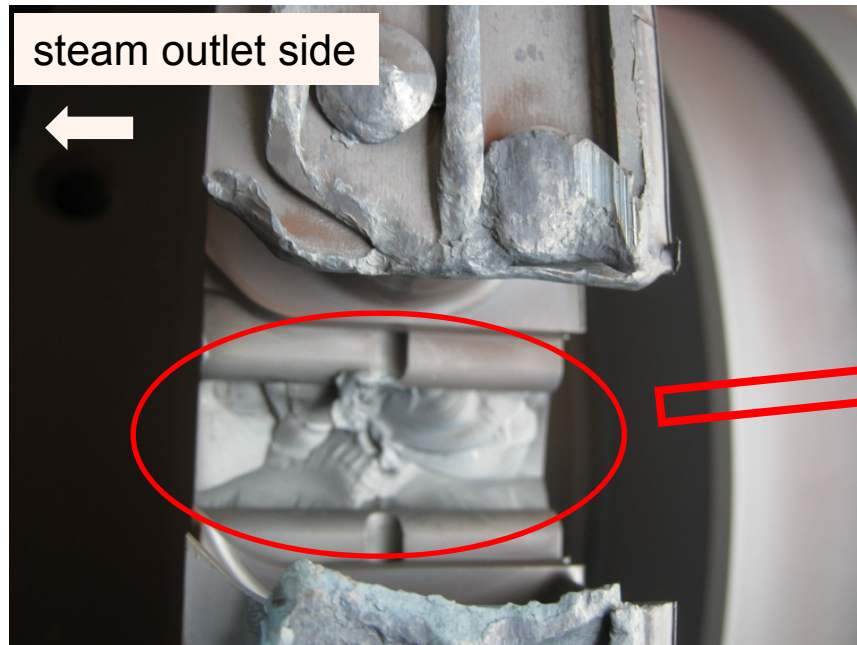
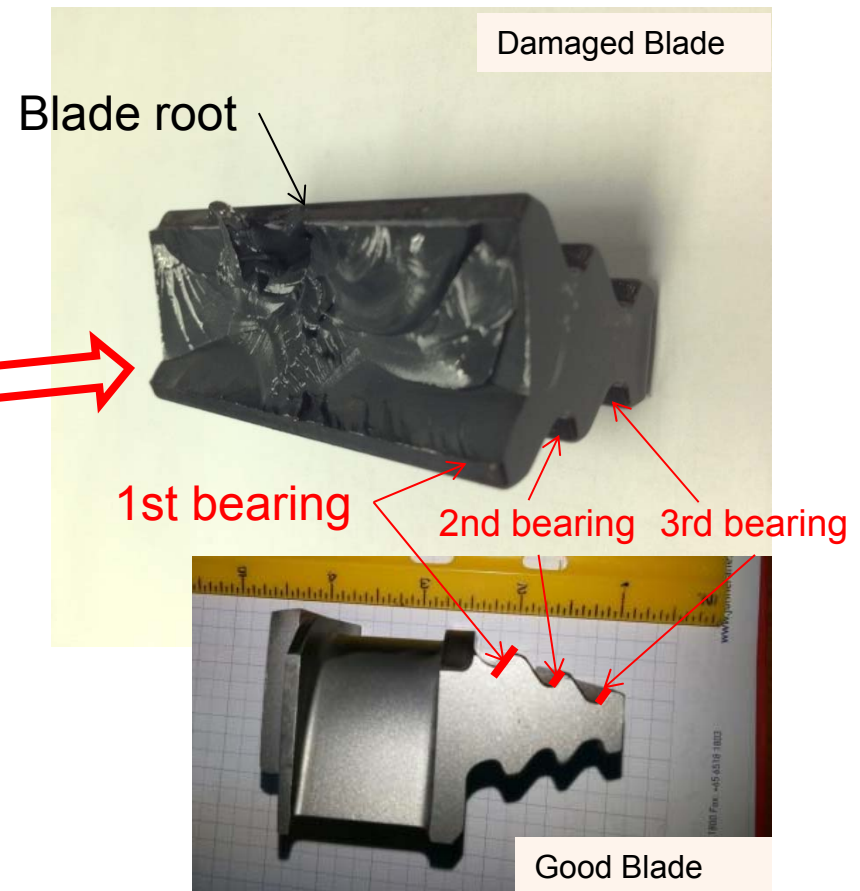
One blade damaged out of 78 blades, and fracture was located at the 1st bearing portion of blade root. Other components (2nd and 3rd stage) not damaged

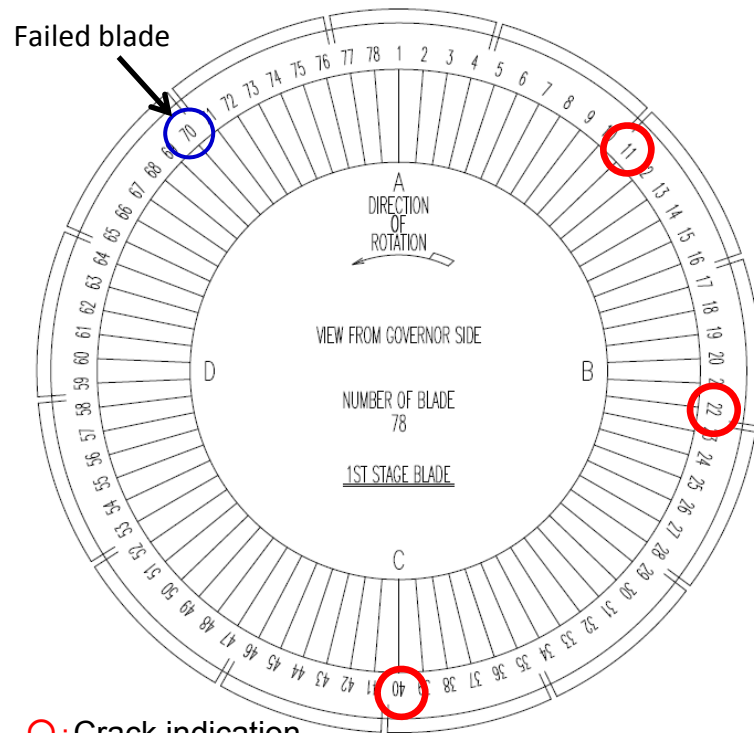
○: Crack indication

Failed blade and crack indicated blades were located on the first/last of shroud.

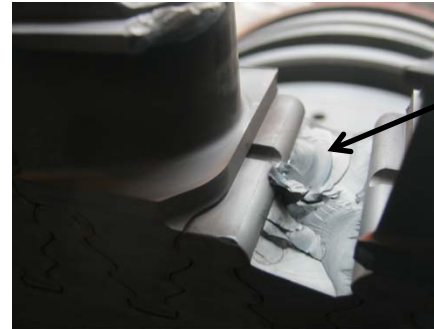
No.70 blade root

Failed blade was No.70 on blue colored circle part.

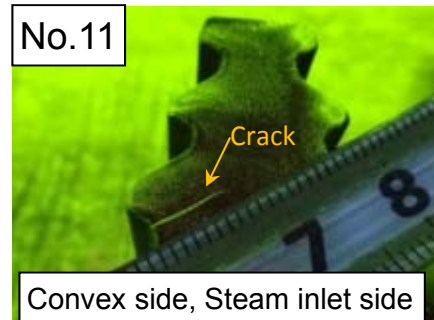
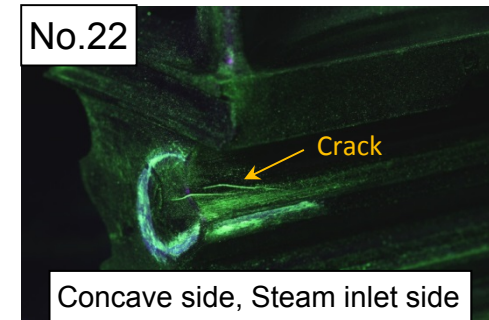
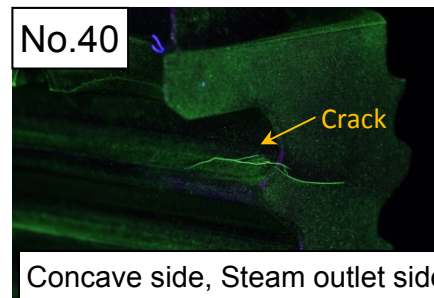
Crack indication was detected on No.11, No.22 and No.40 blade root in MT inspection.

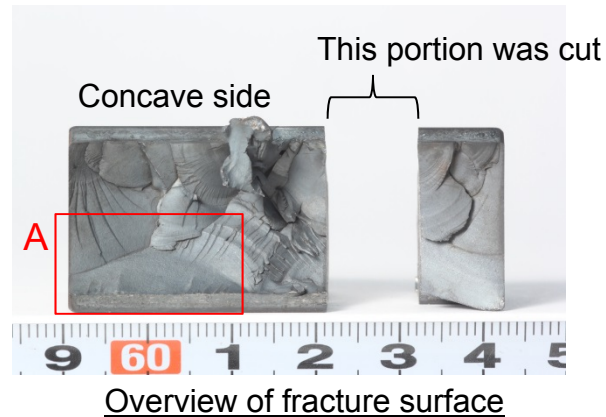
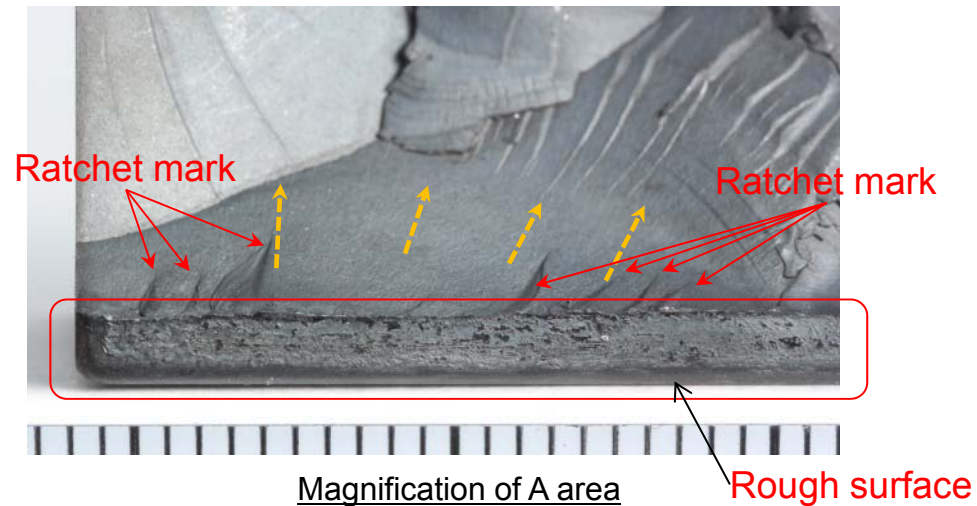
- Ratchet mark was observed on fracture surface, so the crack has multiple origin.
- Rough surface was observed around crack origin.
- Crack was started from rough surface.
- No corrosion pit was observed.
- Chemical components and hardness were satisfied the required specification.

Initial crack was initiated by fretting fatigue, and blade failed from high cycle low stress fatigue.

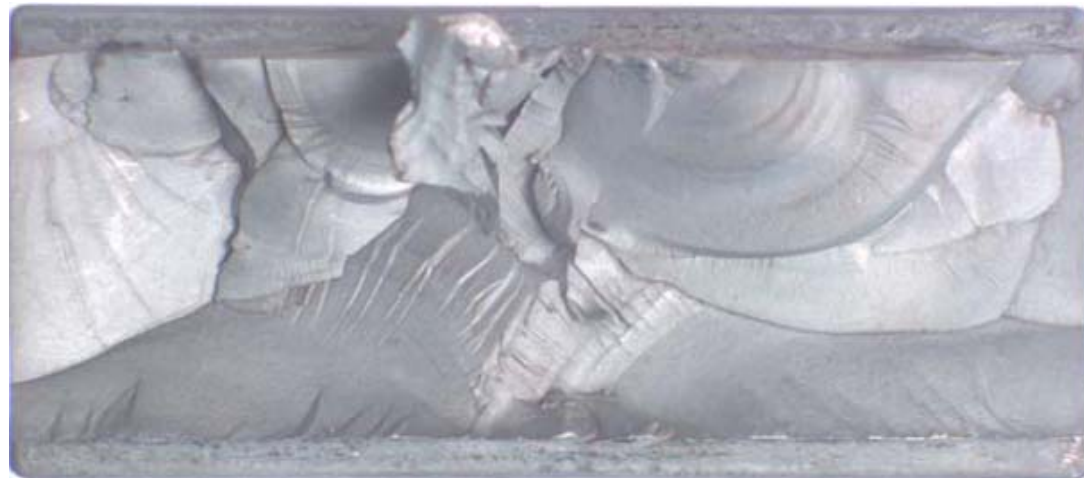
Fig.1 Fracture surface of No.70 blade

1)The blade failed from high cycle fatigue.

2)Fatigue cracks start in 4 areas on both sides of the blade root.

This and the presence of ratchet marks support a high cycle low stress fatigue mode.

3)In the fatigue crack initiation locations multiple fretting marks are present.

Fretting fatigue cracks start from these locations.

4)The failed blade steel is made of good quality.

5)No evidence of an external factor related to steam quality was found.

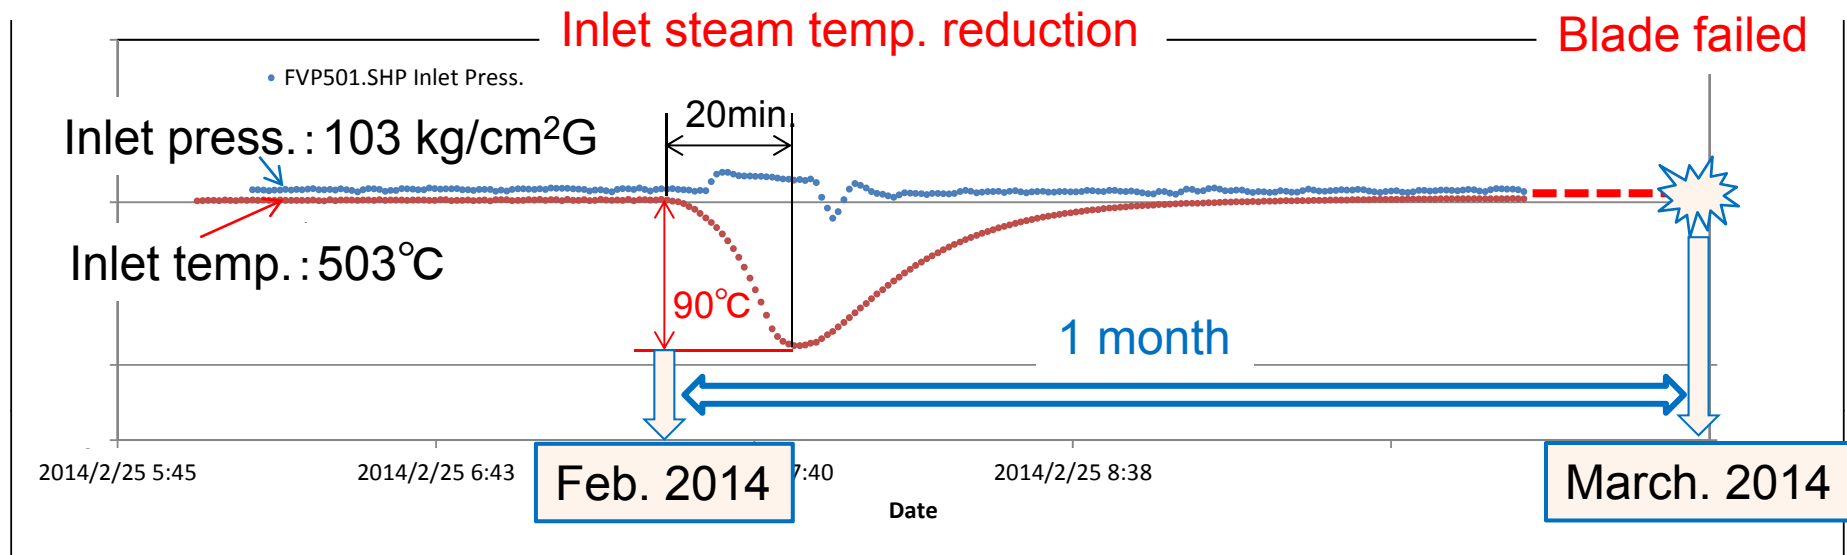
The temperature changed from approximately from 500 degree C to 410 degree C in roughly 20 minutes and then recovered to rated temperatures in approximately 30 minutes. This event had occurred approximately 1 month before the failure of the turbine blade.

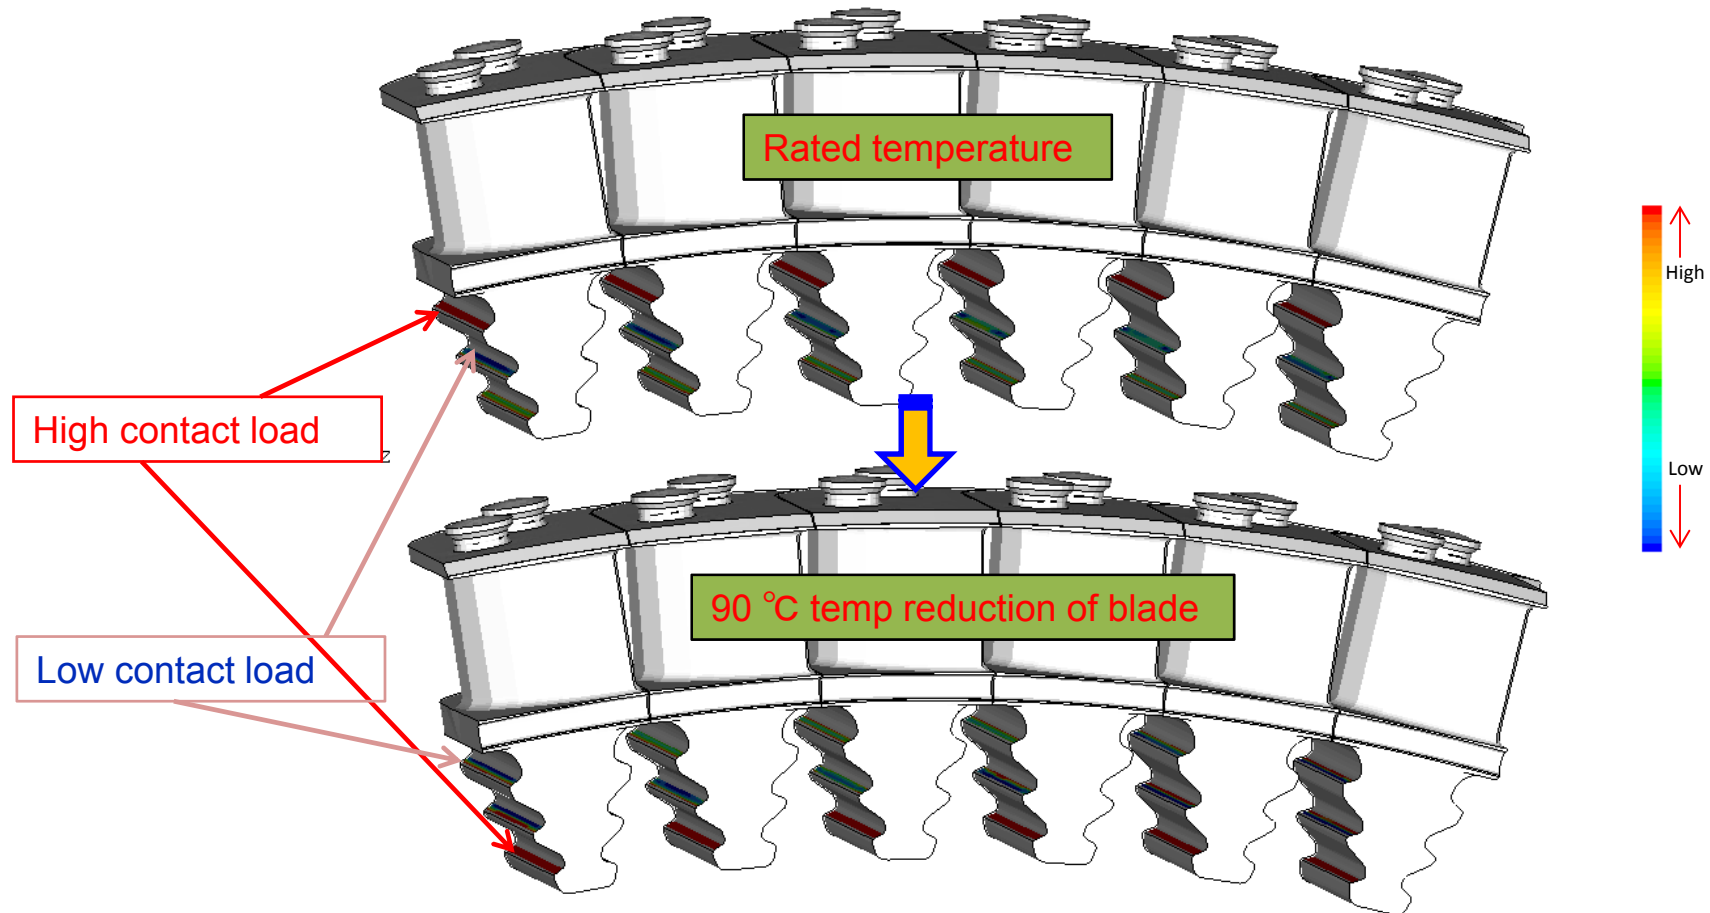
The contact area shifts from 1st bearing surface to 3rd bearing surface on end blades as temperature is reduced. Makes the end blades susceptible to vibrations.

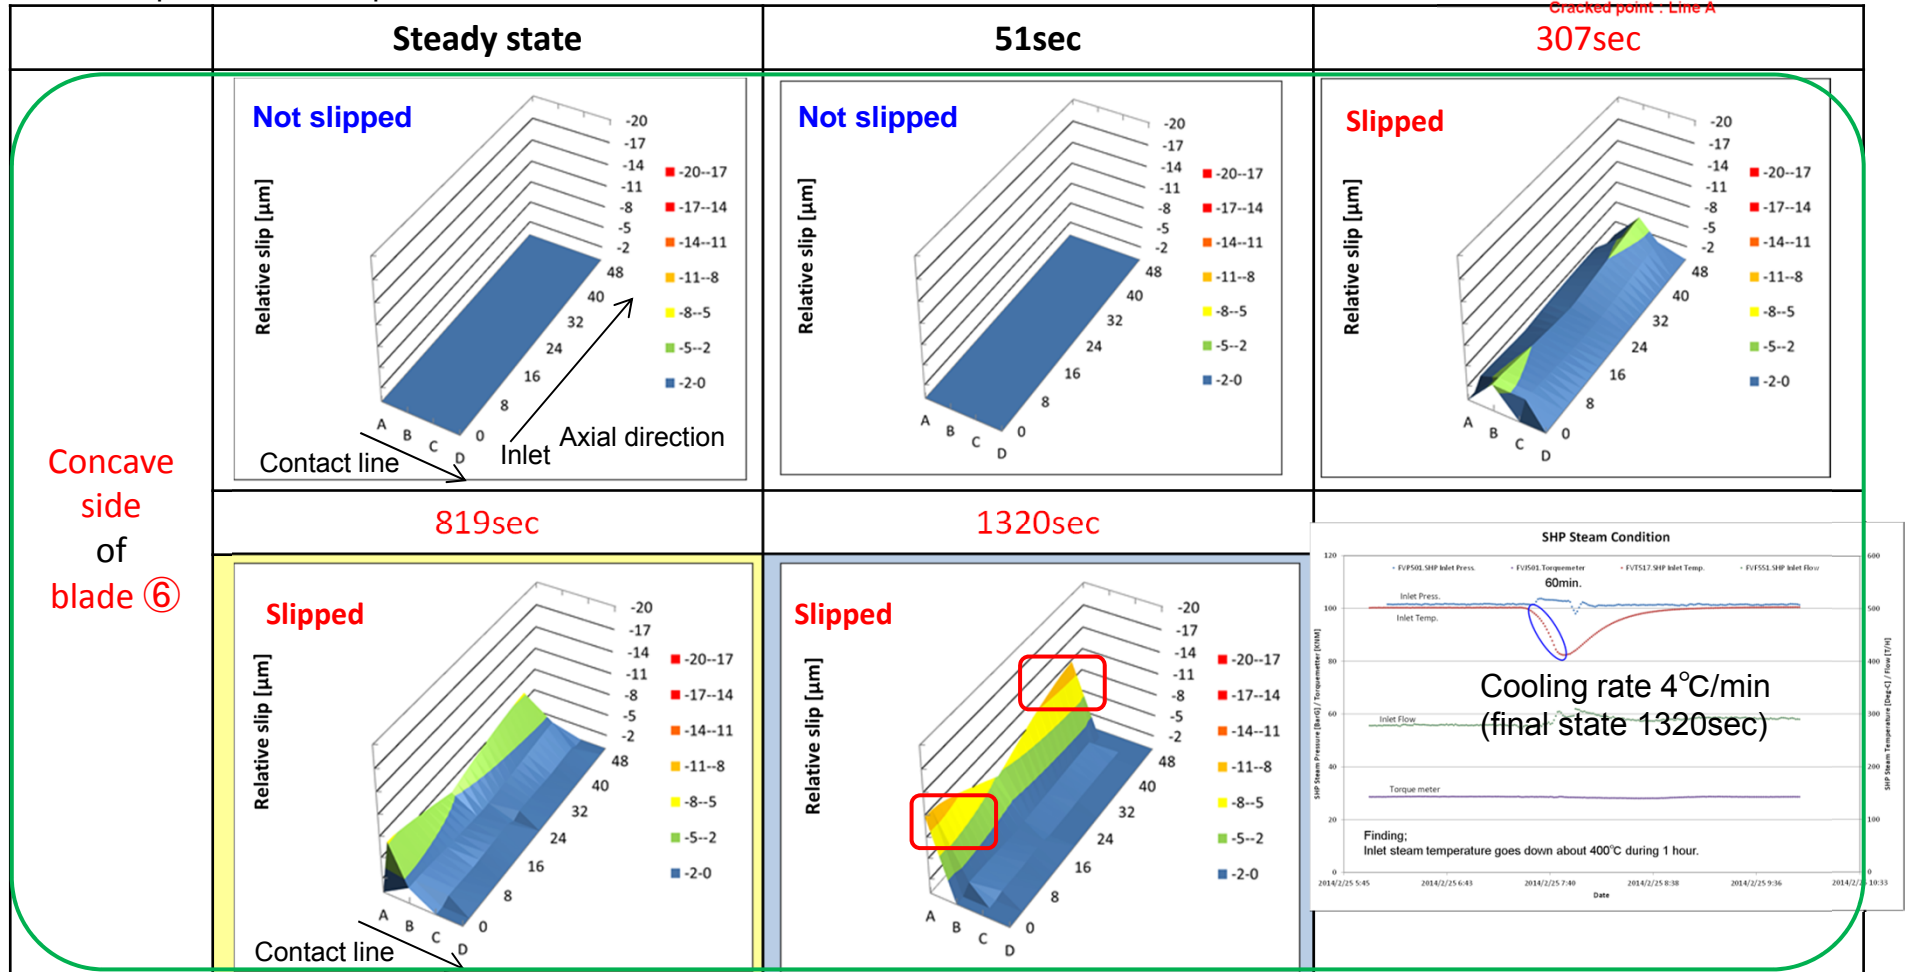
Contact force reduction (Focused on first/last blade of shroud group)

- ✓ At the 1st brg. Line A (cracked point), the contact pressure significantly reduce after steam cooled.
- ✓ After steam reheated, the contact pressure become nearly equal to initial condition again.

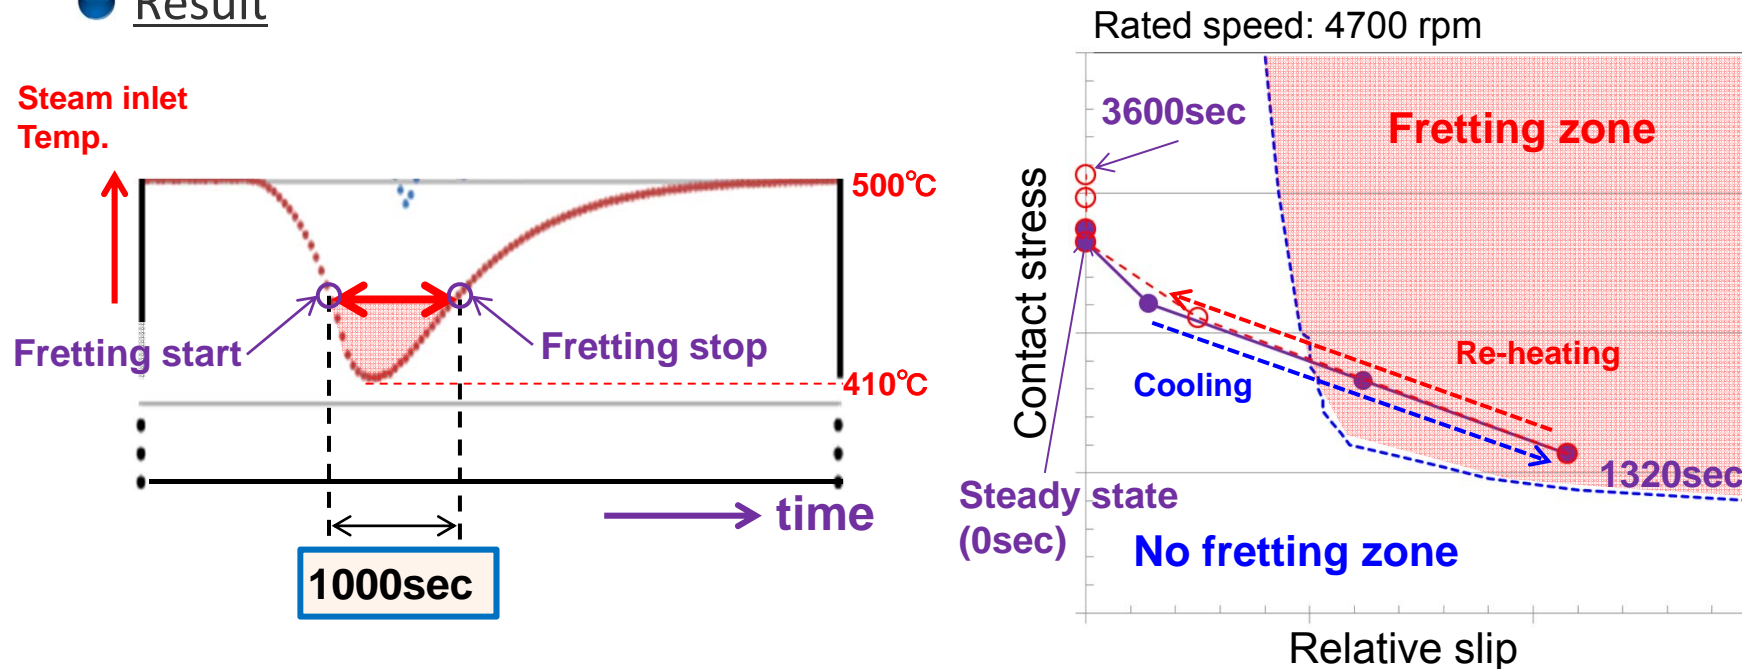
Fretting estimated time : 1000sec

Dominant cycle : 157Hz = 4700rpm/60 × 2shock/round

⇒ Cyclic number : 1.6×10^5 cycles = 157Hz × 1000sec

Commonly, cyclic number for fretting fatigue crack initiation is $10^4 \sim 10^5$ cycle.

Enough time to initiate fretting crack

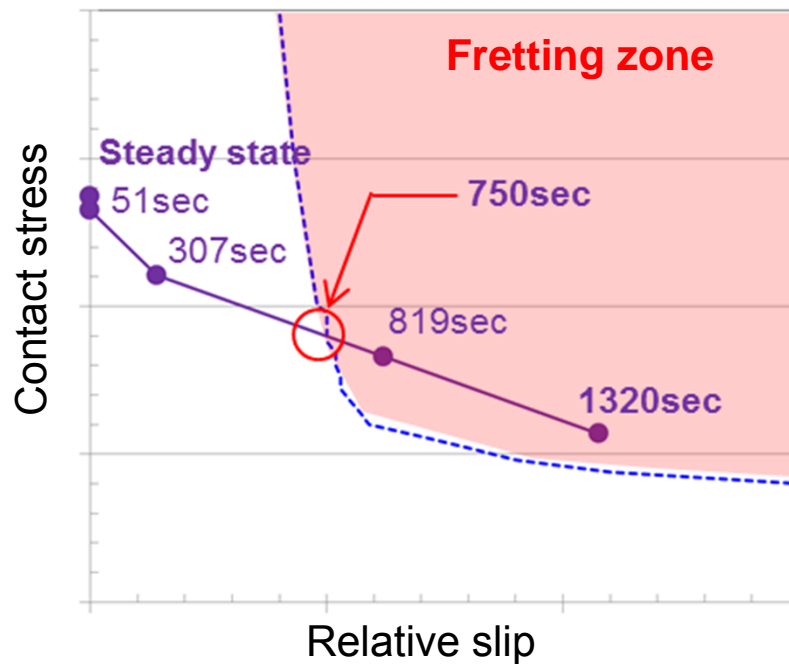
Original case

Fretting occurs from 750sec

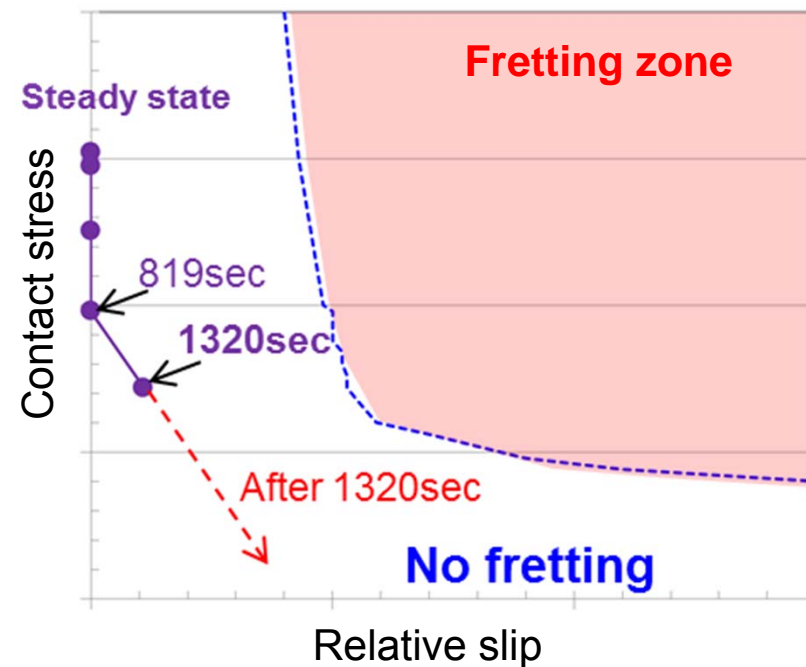
Improvement case

Fretting does not occur.

5. [Vibratory stresses have to be reduced](#) to be lower than contact pressure as a solution to avoid fretting. This was possible by modification of governing valve sequence in case of this turbine. Effect of change has been studied and model results show that [fretting can be avoided even in case of temperature excursions by reducing vibratory stresses](#).
