ASIA TURBOMACHINERY & PUMP SYMPOSIUM
SINGAPORE | 22 - 25 FEBRUARY 2016
M A R I N A B A Y S A N D S

PTT Public Company Limited

SULZER PUMPS

Hydraulic Power Recovery Turbine Operational Failure and Design Enhancements

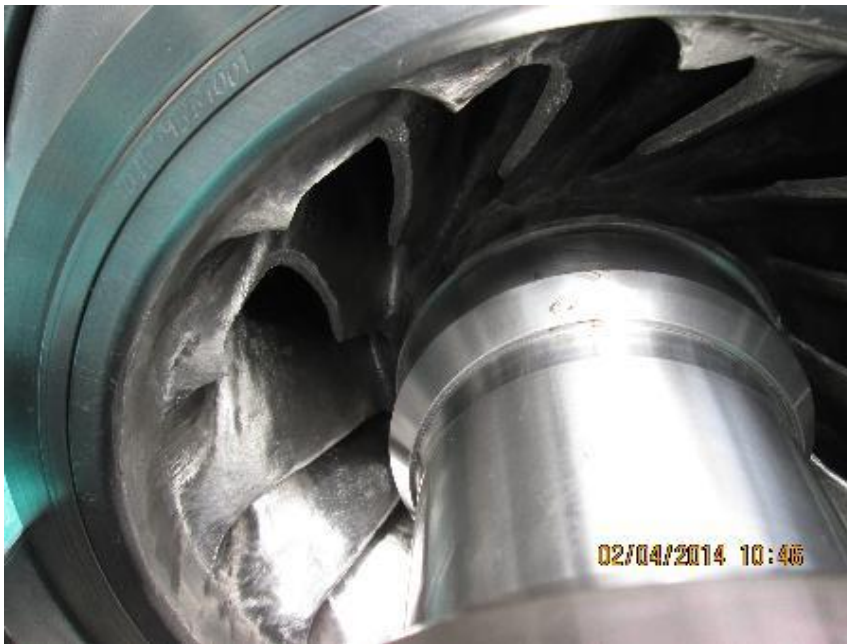
- Runner Exit Vane Failure
 - 3-5 Adjacent Runner Vanes on DE

- HPRT runner failures typically occurred after 2-3 months of operation.
 - All runner vane failures were isolated to 3 – 5 adjacent vanes on DE side of HPRT runner.
- Runner vane steady stresses due to steady torque transmission is very low (approx. 5% of material YS).
- Possibility that a runner structural mode was excited, however, amplitude of the stress cycles are expected to be very low due to low amplitude pressure transients at runner exit.
- Unlikely that dynamic loading from rotor-stator interaction during normal operation caused fatigue failure of HPRT runner vanes.
 - Consider a 2 kHz mode:
 - 10^7 stress cycles are accumulate in less than 1.5 hours of operation.
 - If a 2 kHz. runner structural mode was excited during normal operation and the stress amplitude were high, the runner vanes should have failed due to fatigue in approximately 2 hours.

- High amplitude system pressure transient (water hammer or surge) provided impulsive excitation with sufficient energy to excite runner vane mode(s) and lead to high cycle fatigue failure.
- Reduced material strength resulting from sigma phase embrittlement resulting from improper post weld heat treatment on affected vanes.

- Change Runner MOC (material of construction) from Duplex SS, ASTM A995 Gr 1B CD4MCu, to precipitation hardened SS, ASTM A747 Gr CB7 Cu1.
- 35% increase in yield strength (larger strength margin against system upset conditions).
- Less risky heat treatment process to easily facilitate weld repair.

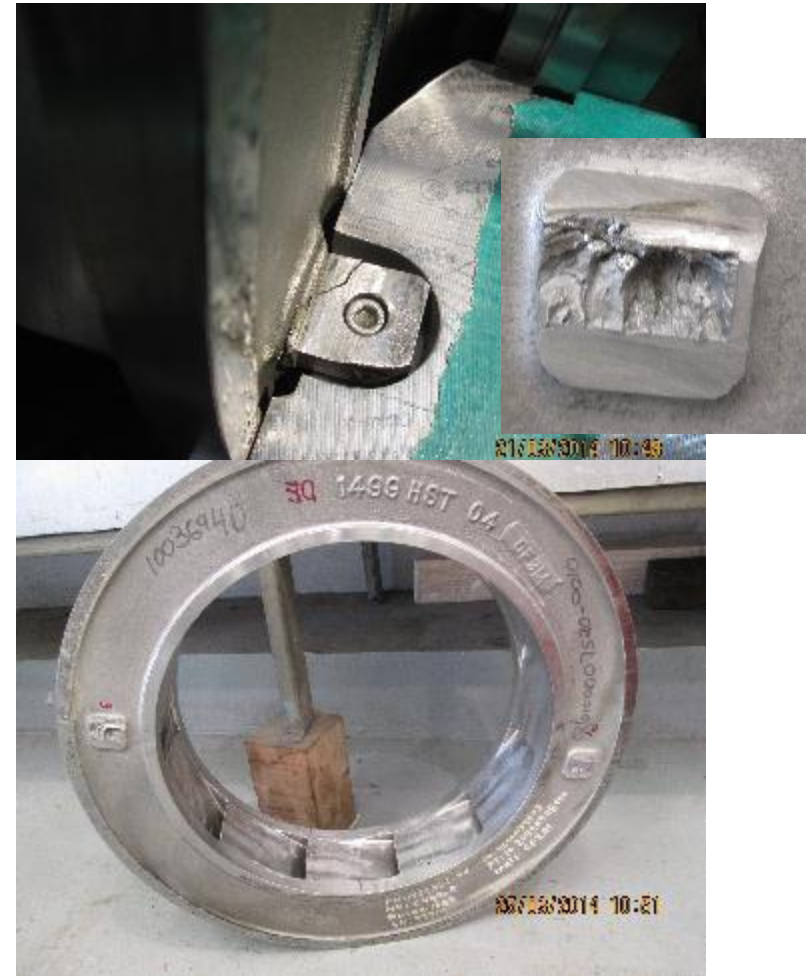
- IGV Assembly Retention Tab Failure

- High amplitude system pressure transient (water hammer or surge) leading to over stress/fatigue of IGV retention tabs.
- Loosing of retention screws – IGV free to vibrate/move
- Improper shimming resulting in high assembly stresses

- Change guide vane MOC (Material of construction) from ASTM A351 Gr CF3M, to Precipitation hardened SS, ASTM A747 Gr CB7 Cu1.
 - >50% increase in yield strength for increased strength margin against possible system upset conditions.
- Increase retention tab sectional area (x4) and retention bolt size (x4) and increase fillet radii at juncture to side plates
 - for increased mechanical design robustness against possible system upset conditions.

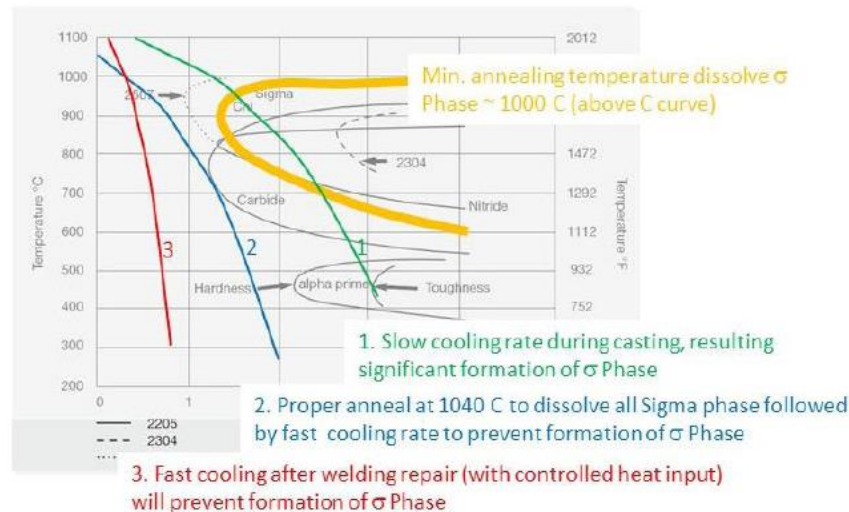
- Inter granular crack(s) originating from Sigma Phase Embrittlement compromised runner mechanical properties and resulted in fatigue failure
- Source of Sigma Phase:
 - Improper heat treat after Foundry weld repair on runner vanes (gates/risers location ??) lead to formation of Sigma Phase in heat affected zone.
 - Required Heat Treatment for ASTM A995 Gr. 1B (CD4MCU – Duplex SS)
 - Heat soak to minimum 1040 °C followed by rapid cool down to avoid precipitation of sigma phase at grain boundary.

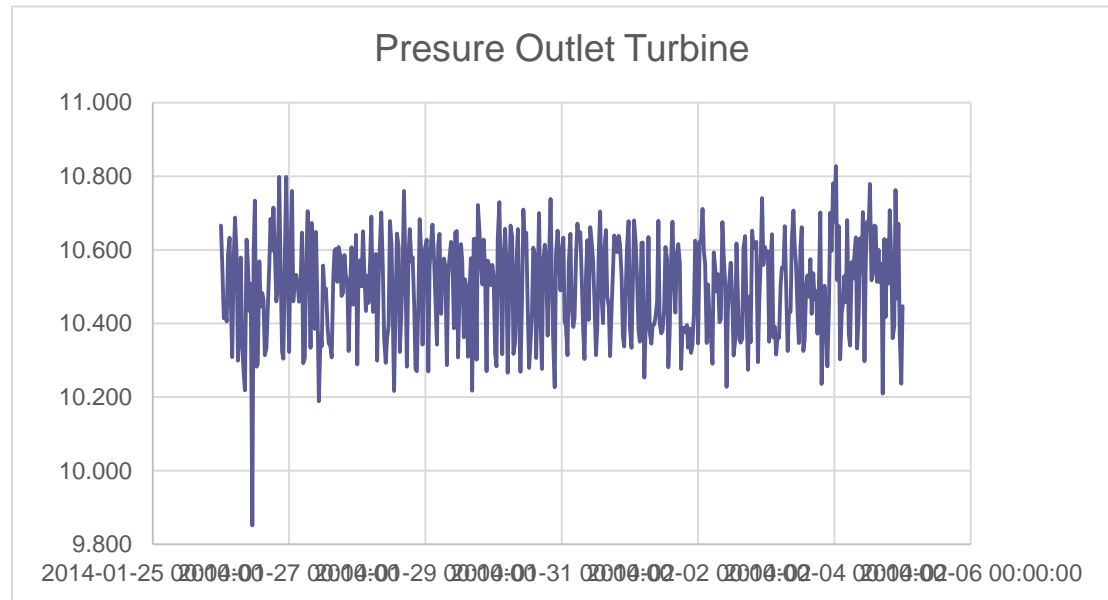
- Measured (PTT) HPRT outlet pressure trend.
 - peak-to-peak pressure variations in range of 0.3 – 0.4 bar (4.5 – 6 psi)
 - i.e. 17,250 – 20,700 Pa (2.5 psi to 3 psi) amplitude.

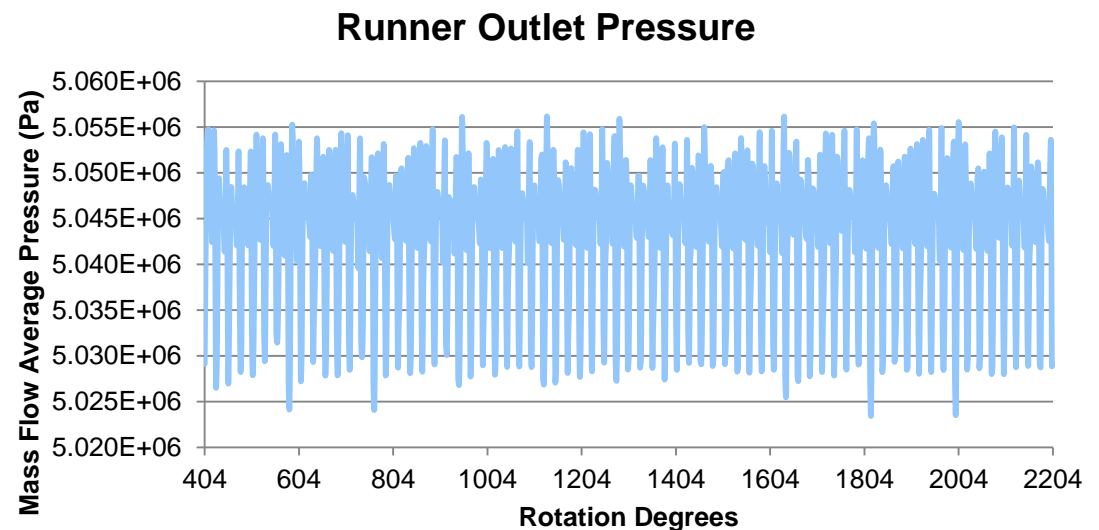
- CFD estimated HPRT outlet pressure trend.
 - peak-to-peak pressure variation in the range of 30,000 Pa (4.4 psi)
 - i.e. 15,000 Pa (2.2 psi) amplitude.

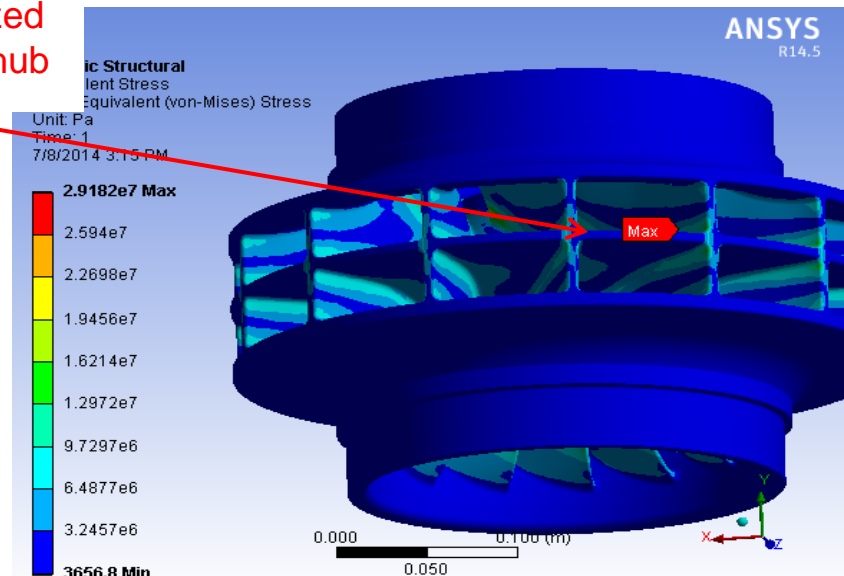
- Max von-Mises Stress Approx. 29 MPa
 - < 6% of Yield Stress for CD4MCu (Duplex SS)
 - < 4.5% of Yield Stress for CB7Cu-1 (17-4 pH H1150)

Max stress localized to vane fillets on hub
