ASIA TURBOMACHINERY & PUMP SYMPOSIUM
SINGAPORE | 22 - 25 FEBRUARY 2016
M A R I N A B A Y S A N D S

Polytropic Efficiency Improvements and Sustenance on Centrifugal Compressor: Corrosion Erosion and Impact of Fouling

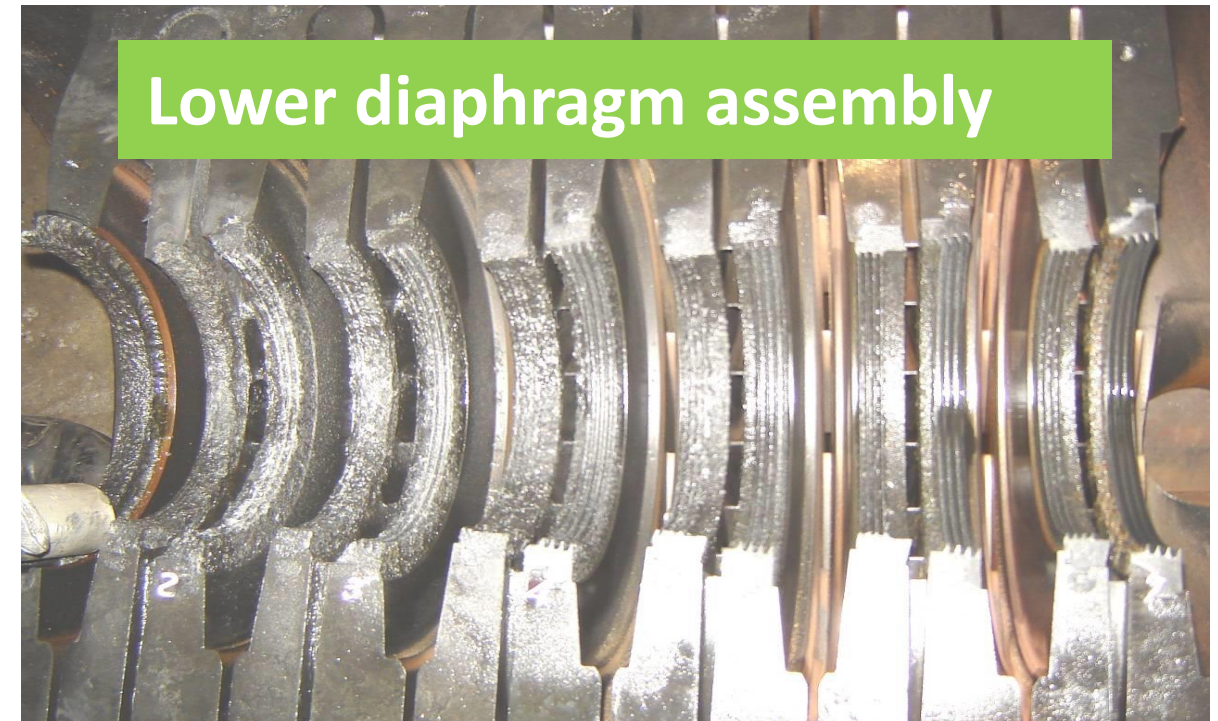
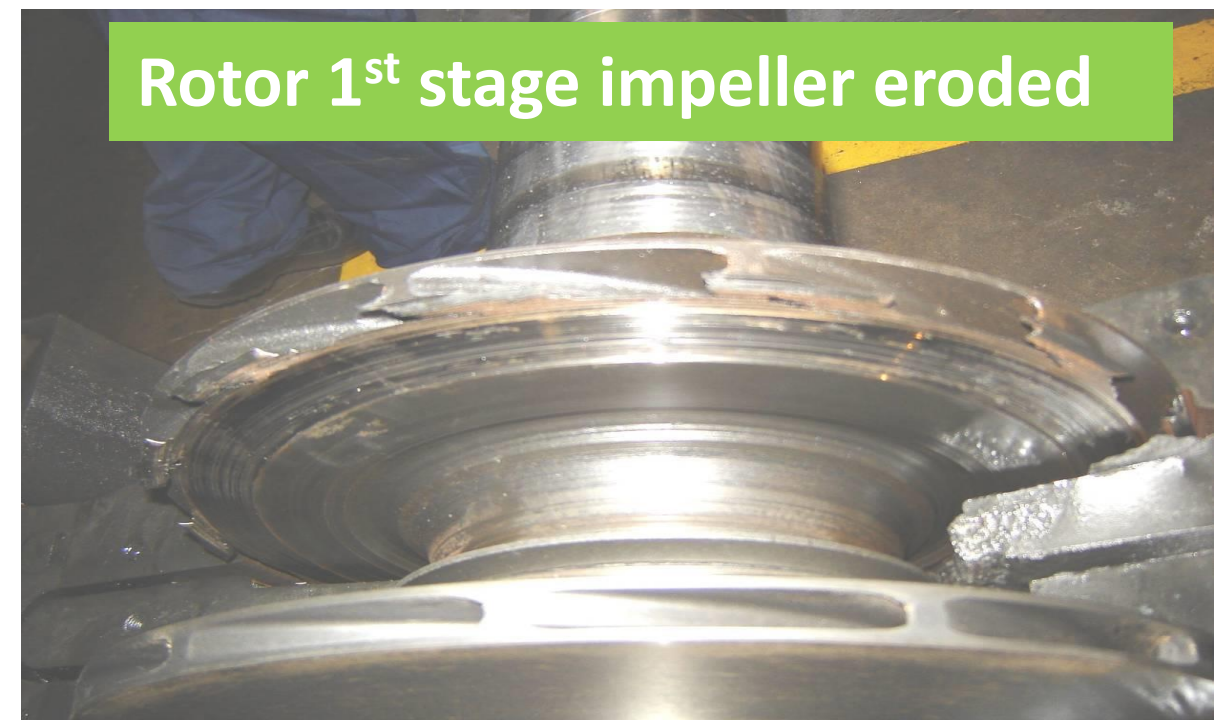
First Overhaul Observation

- Compressor efficiency downtrend detected
- Heavy deposit of black muddy scales in the compressor diaphragm
- Severe erosion in 1st stage rear impeller shroud
- Severe erosion of impeller labyrinths from 1st stage to 3rd stage
- Pitting marks found in the compressor 1st and 2nd stage impeller
- 3rd to 7th stage impellers found in good condition

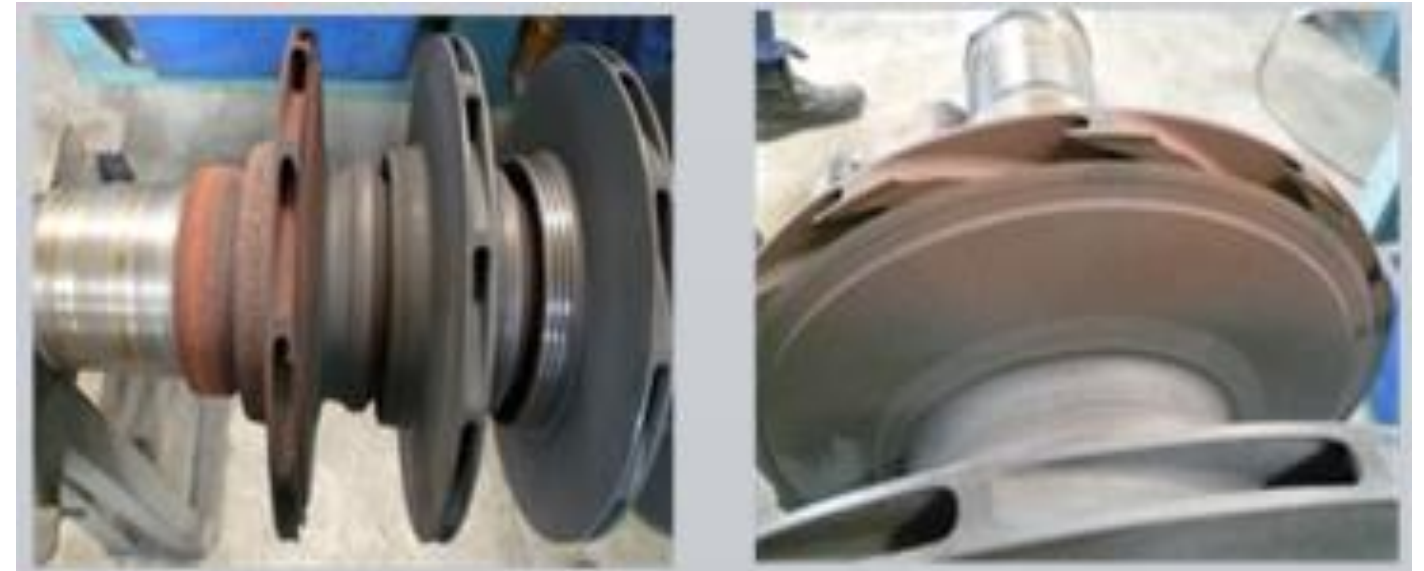
- Compressor efficiency downtrend detected
- Radial vibration was increasing prior to overhaul
- Severe erosion in 1st stage rear impeller shroud
- 2nd & 3rd stage rear impeller observed rubbed
- Severe erosion for all impeller labyrinths
- Pitting marks found in the compressor 1st to 6th stage impeller. (1st to 6th stage impeller replaced)

1st Stage Impeller damages

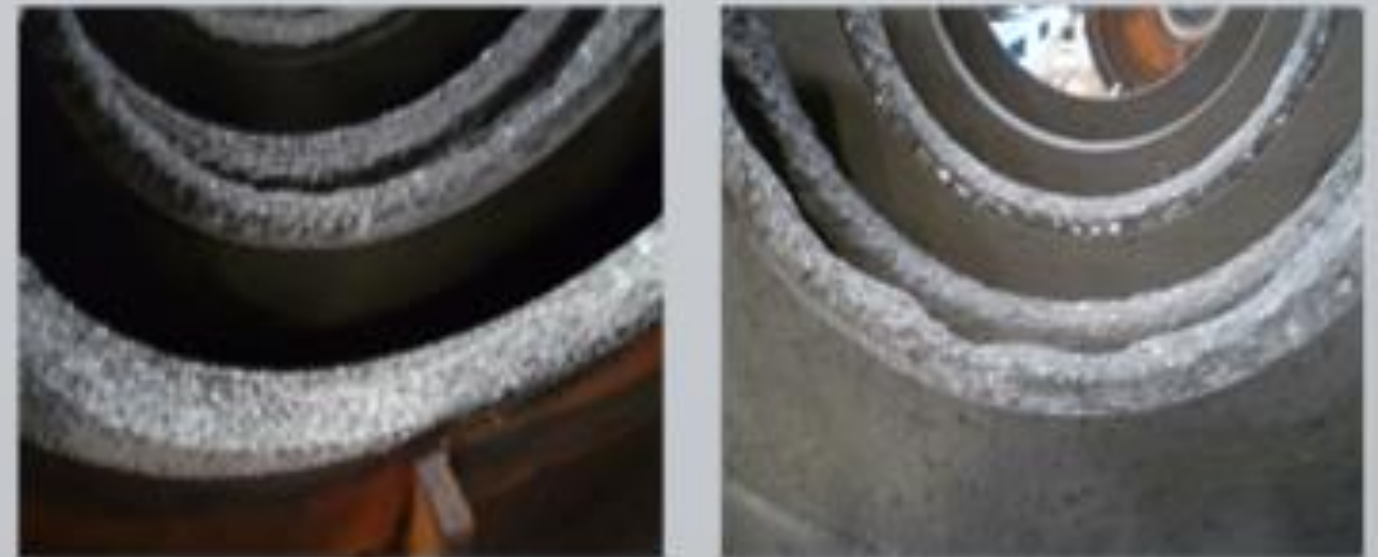
Impeller labyrinth corroded

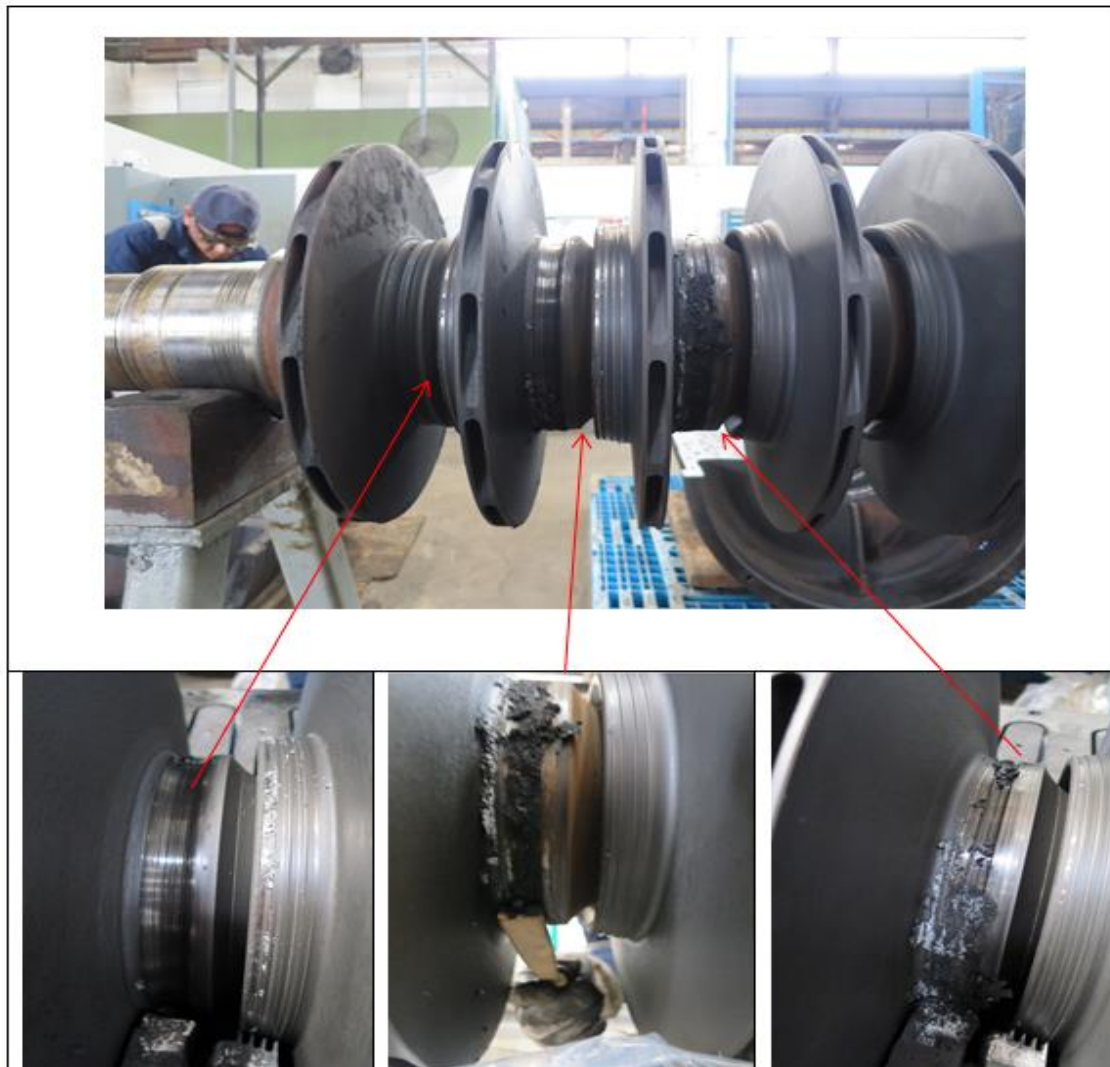
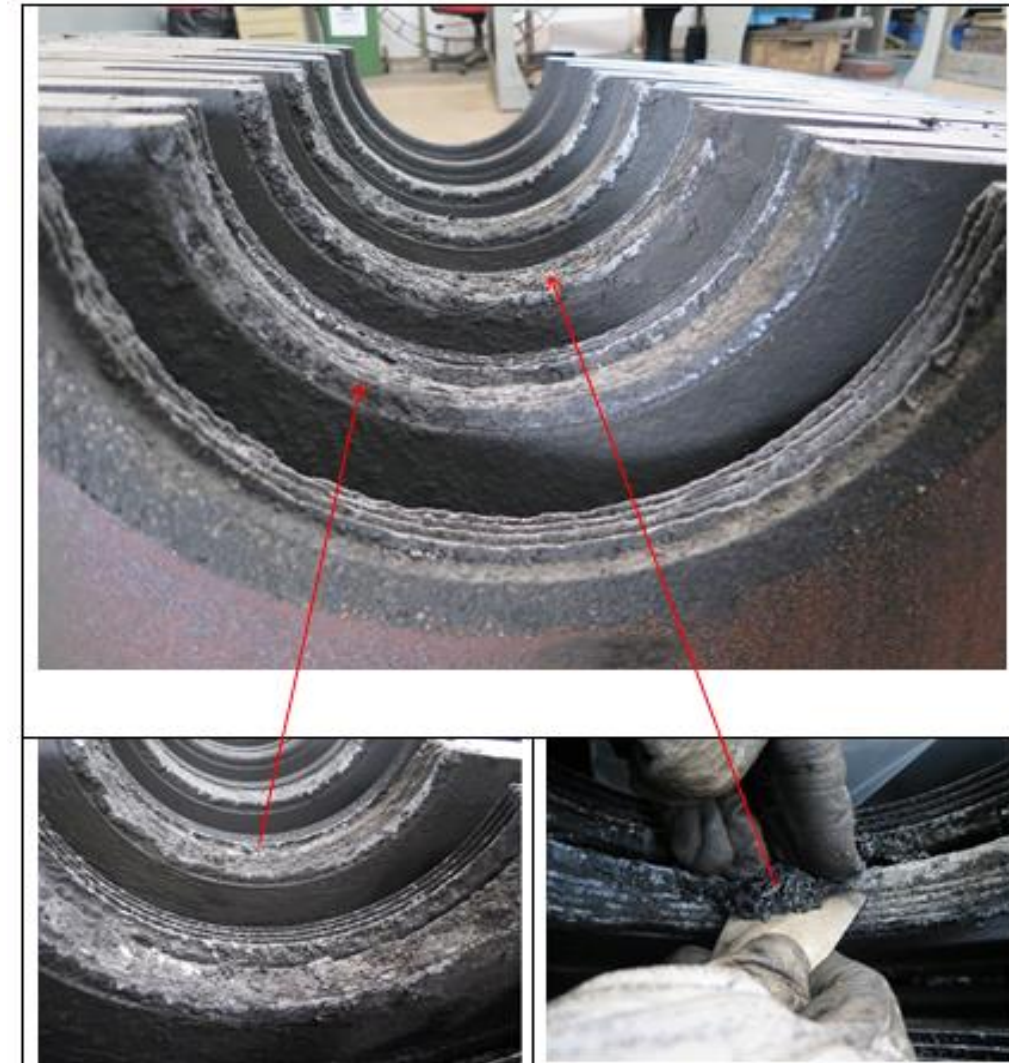
Third Overhaul Observation

- Deep grooving mark and severe material loss observed on 1st, 2nd and 3rd inter stage labyrinth.
- Severe erosion on all impeller labyrinths.

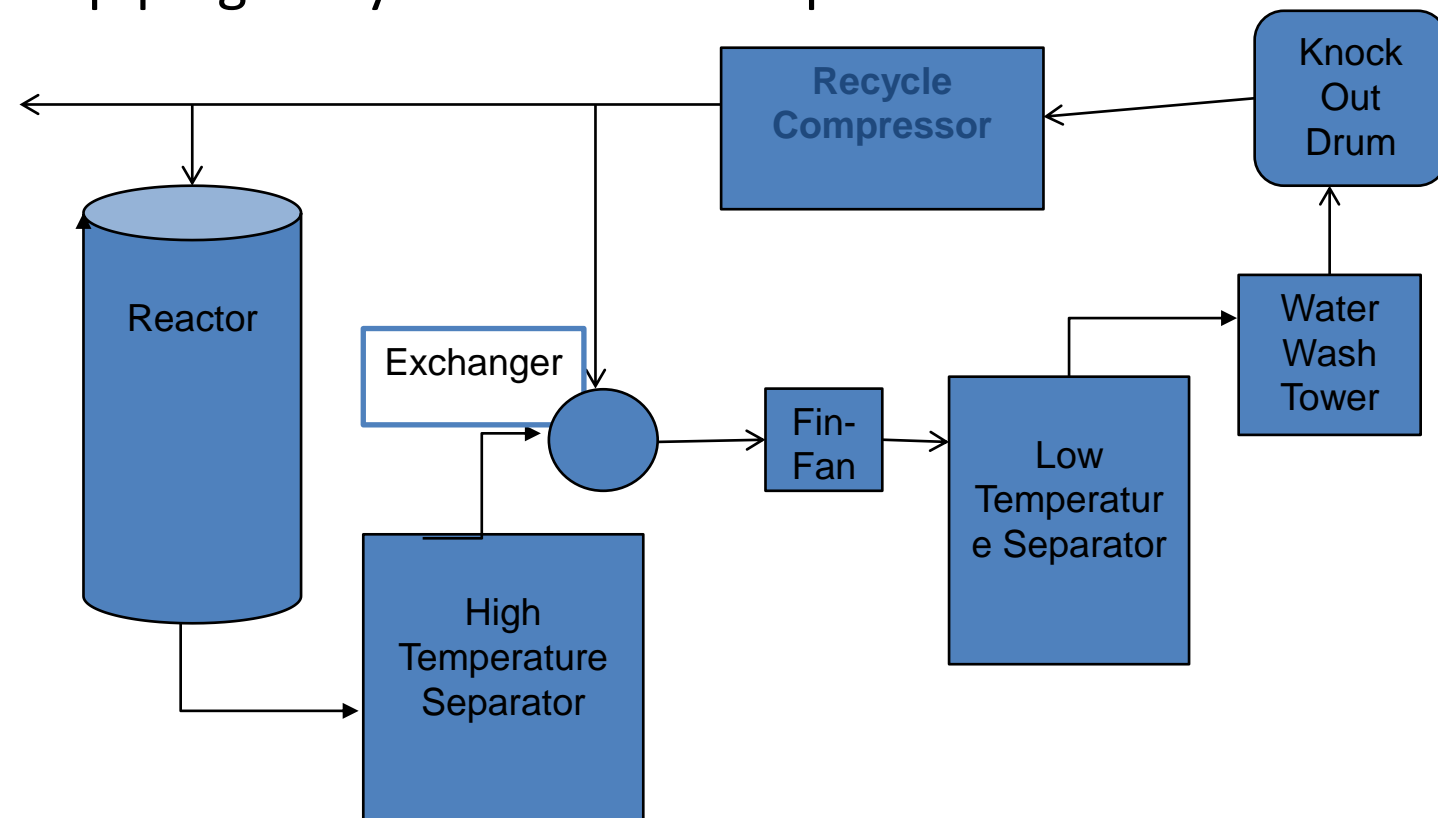
- Sulfur (S), Nitrogen (N) and Chloride (Cl) elements were tested on the samples taken from compressor rotor and labyrinth, indicates ammonium salts (NH_3HS and NH_4HCl) presence.
- Presence of ammonium salts was largely due to ineffective washing of the salts in the water wash tower.
- Liquid distributor orifices were heavily fouled with solid fouling, causing water to overflow vapor risers during operation, causing mal-distribution and loss of packing efficiency.

Water condensation in compressor suction piping carryover to the compressor.

Impact of ammonium salts :-

- Severe erosion on labyrinth
- Corrosion and erosion on impeller

- 1 To maintain compressor suction temperature by insulating suction piping (from Knock-Out-Drum to compressor suction flange) to prevent water condensation
- 2 Suction line from knock-out-drum to compressor suction flange was chemically cleaned
- 3 Water wash tower liquid modifications
- 4 Chloride mitigation project on High Temperature Separator overhead circuit for removing ammonium salts.
- 5 Knock-out-Drum modifications for better liquid knock-out. Installation of slotted pipe distributor, 2 layers of Crinkle Wire Mesh and horizontal perforated plate

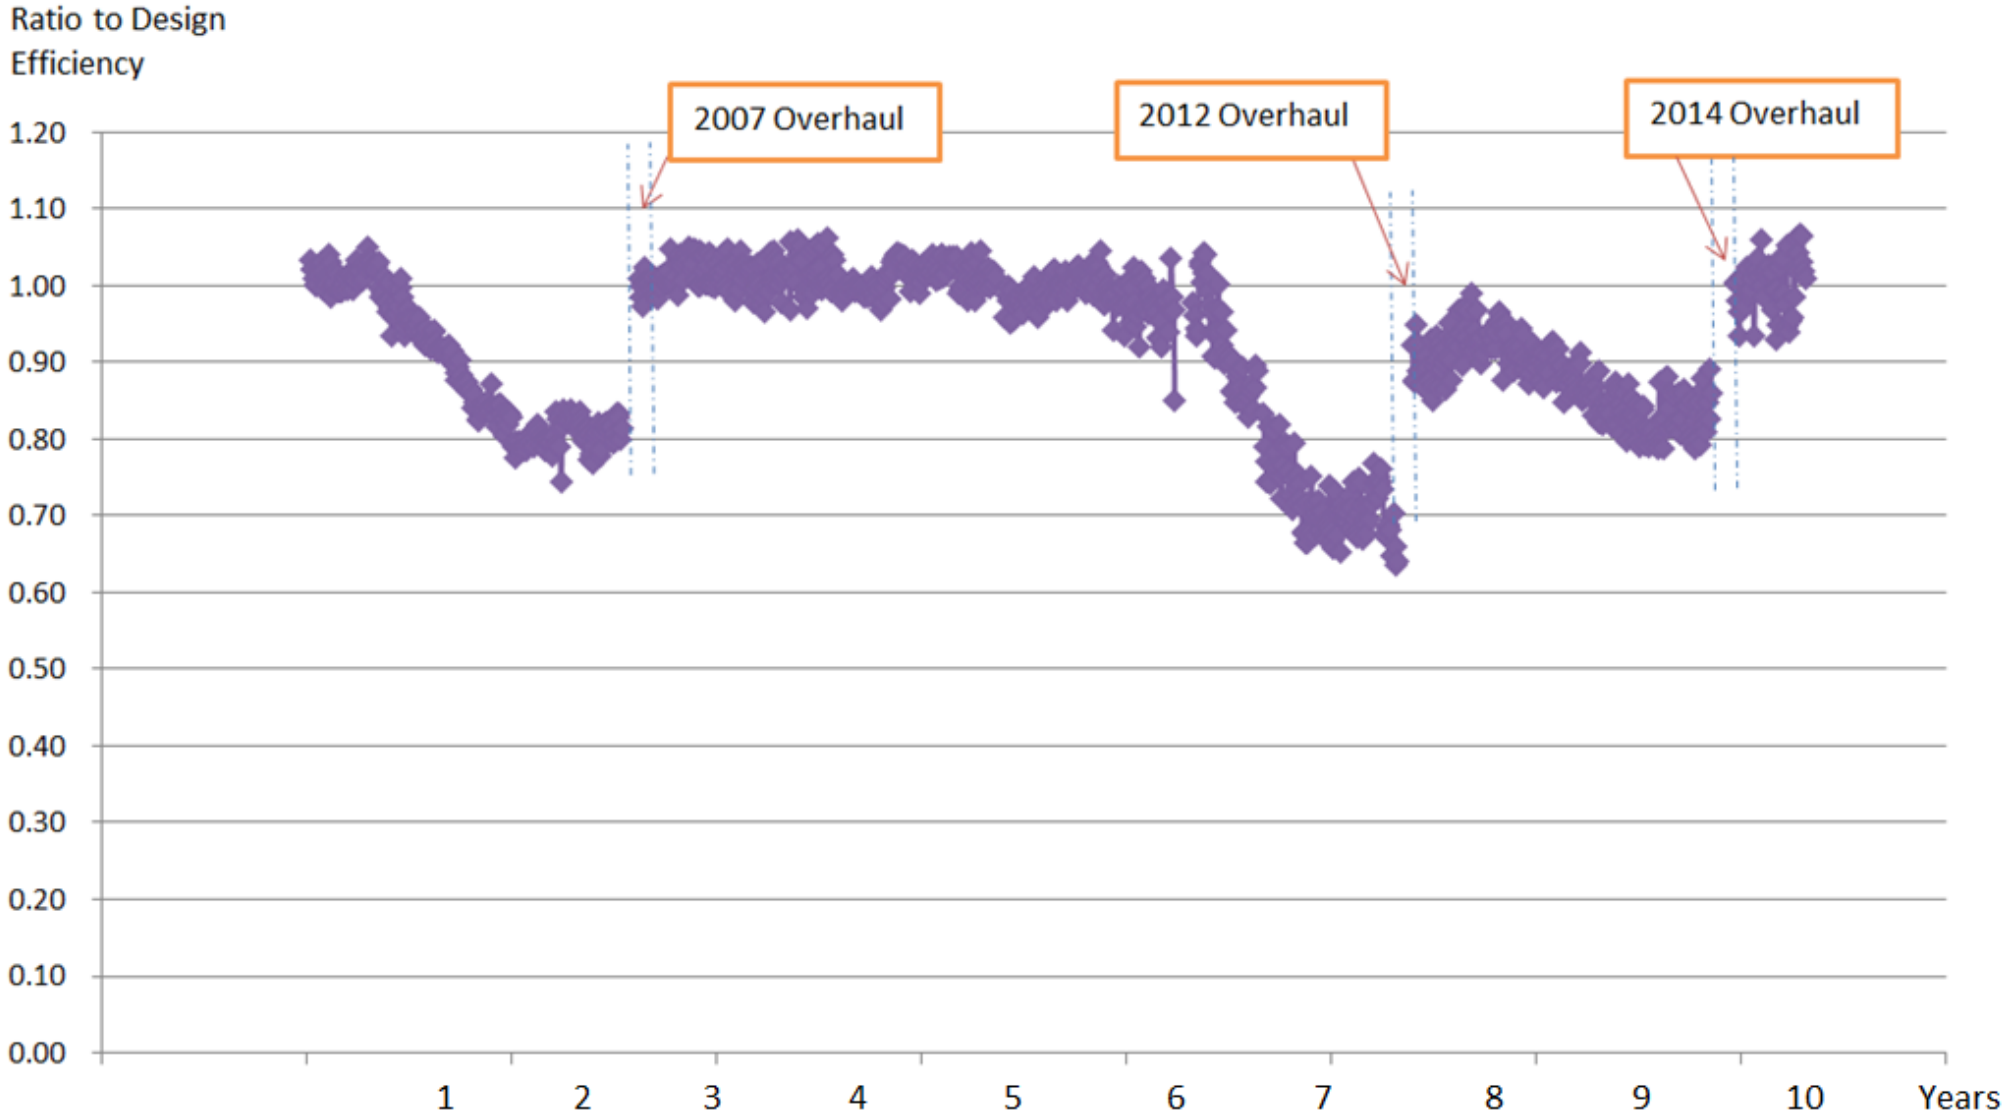
Polytrophic Efficiency Trend from 2005 till 2015

After 3rd overhaul, compressor able to achieve design poly efficiency
