ASIA TURBOMACHINERY & PUMP SYMPOSIUM
SINGAPORE | 22 - 25 FEBRUARY 2016
M A R I N A B A Y S A N D S

ExxonMobil

Investigation & Resolution on Oxidation Feed Pump Pulsation Related fatigue failures

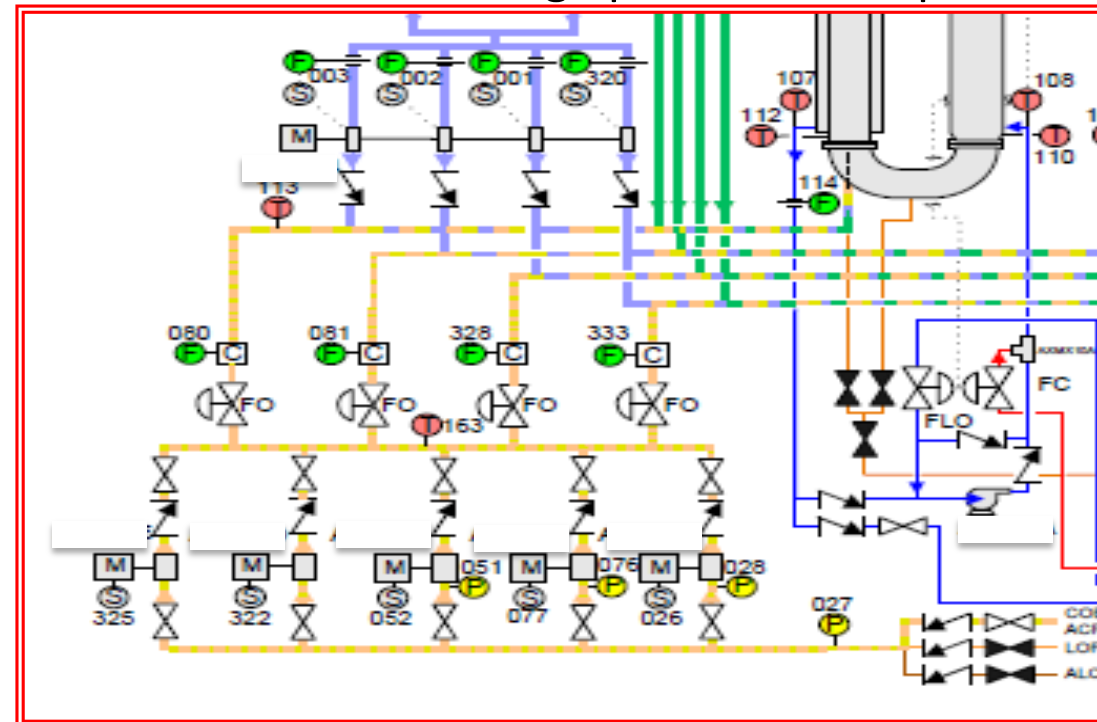
Two additional pumps were installed subsequently to meet increased process demand. By Design all 5 Pumps are operated in parallel. After a few operating hours very high vibrations were observed on the cylinder nozzles, between pump cylinder and discharge pulsation dampener, resulting in a fatigue failure of butt welds of these nozzles. This failure only occurred on the new installed pumps. The differences between the initially and new installed pumps were the layout and length of the cylinder nozzles of the discharge pulsation damper.

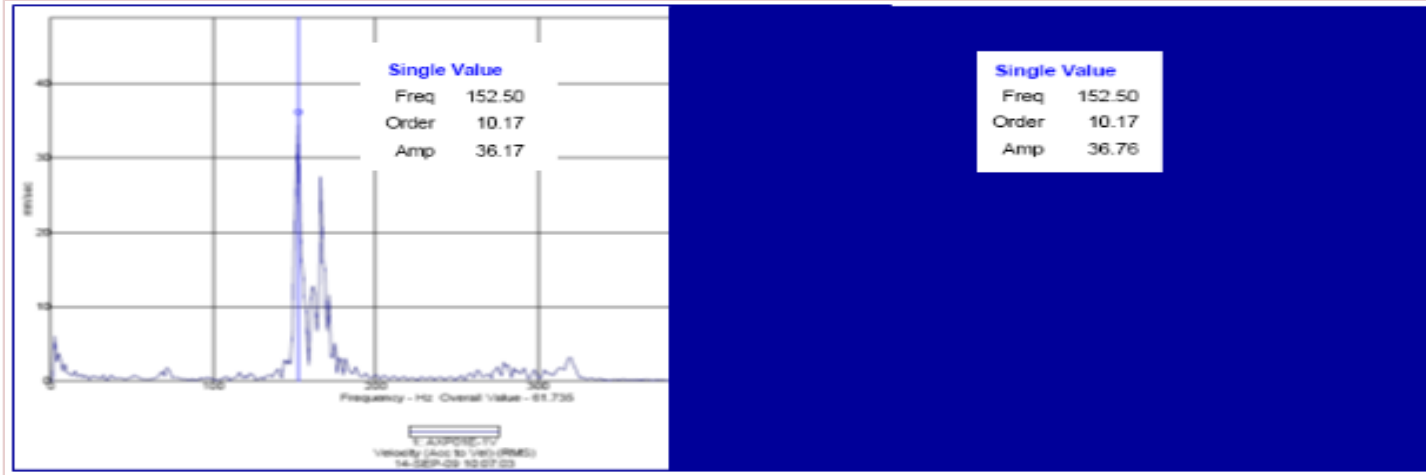
Vibration spectrum of AXP01E (Head #1 at J-bend - Vertical)

- Multiples of harmonics and raised noise floor in spectrum at J-bend piping was evident
- Peaks of 152.5 Hz and 175 Hz likely to be associated with acoustic and mechanic resonant frequencies
- These are not 1X,2X or 3X dominant spikes associated with rotary component deficiencies

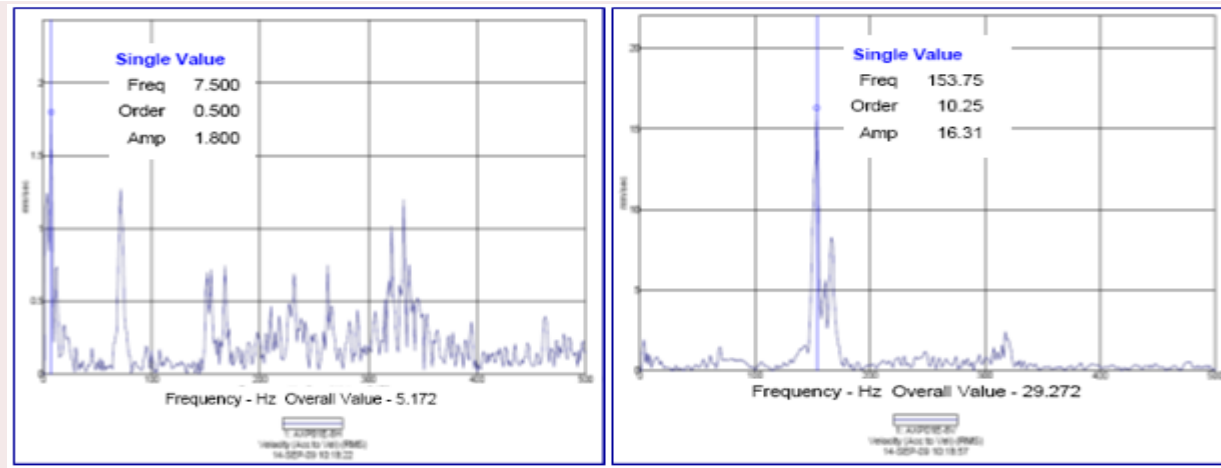
Vibration spectrum at pos 8. (Head #2 at J-bend – Horizontal & Vertical)

- Higher vibration response of J-bend frequency at 153.75 Hz (suspected this harmonic contains more energy) in vertical direction as compared to horizontal direction which is deemed acceptable
- Acceptable overall vibration velocity level: 19 mm/s r.m.s

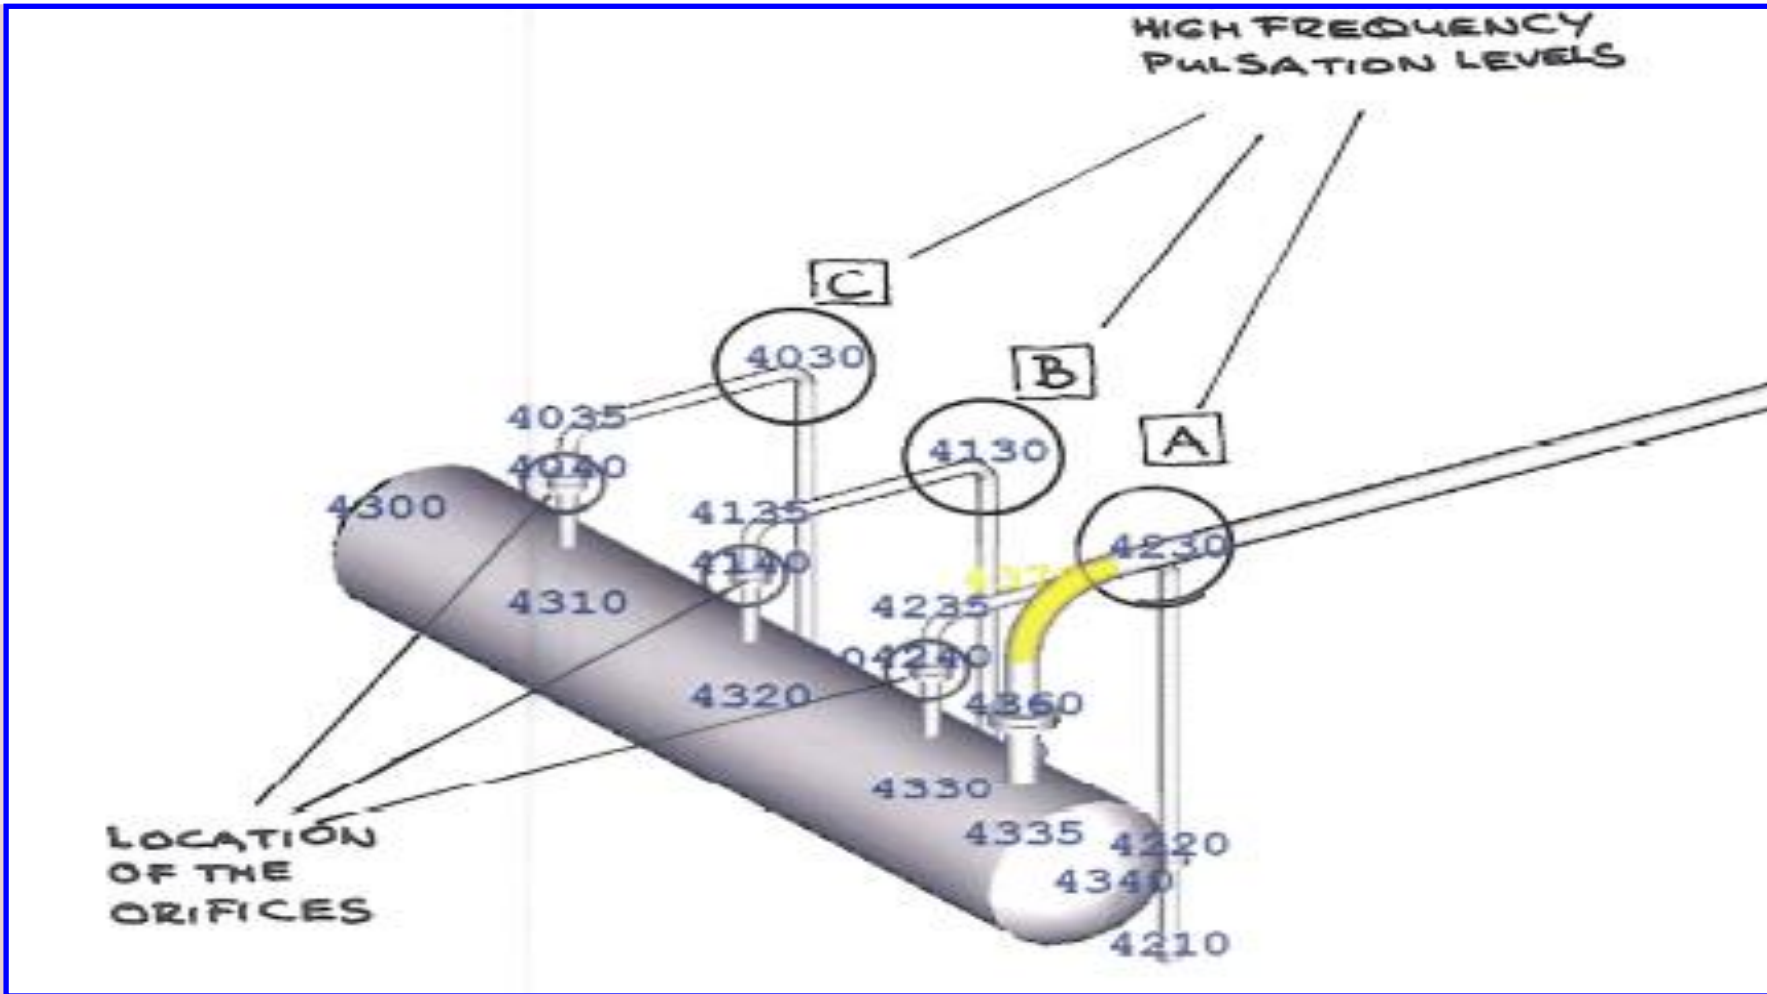
Orifice Sizing & Installation : Standing Waves Attenuation

- Pulsation analysis conducted on the J-bends only inferred that standing waves in the J-bends are responsible for the high vibration amplitudes
- Outcome of this technical evaluation called for orifice installation on the discharge resonator take off section to dampen and mitigate the effects of standing wave issue

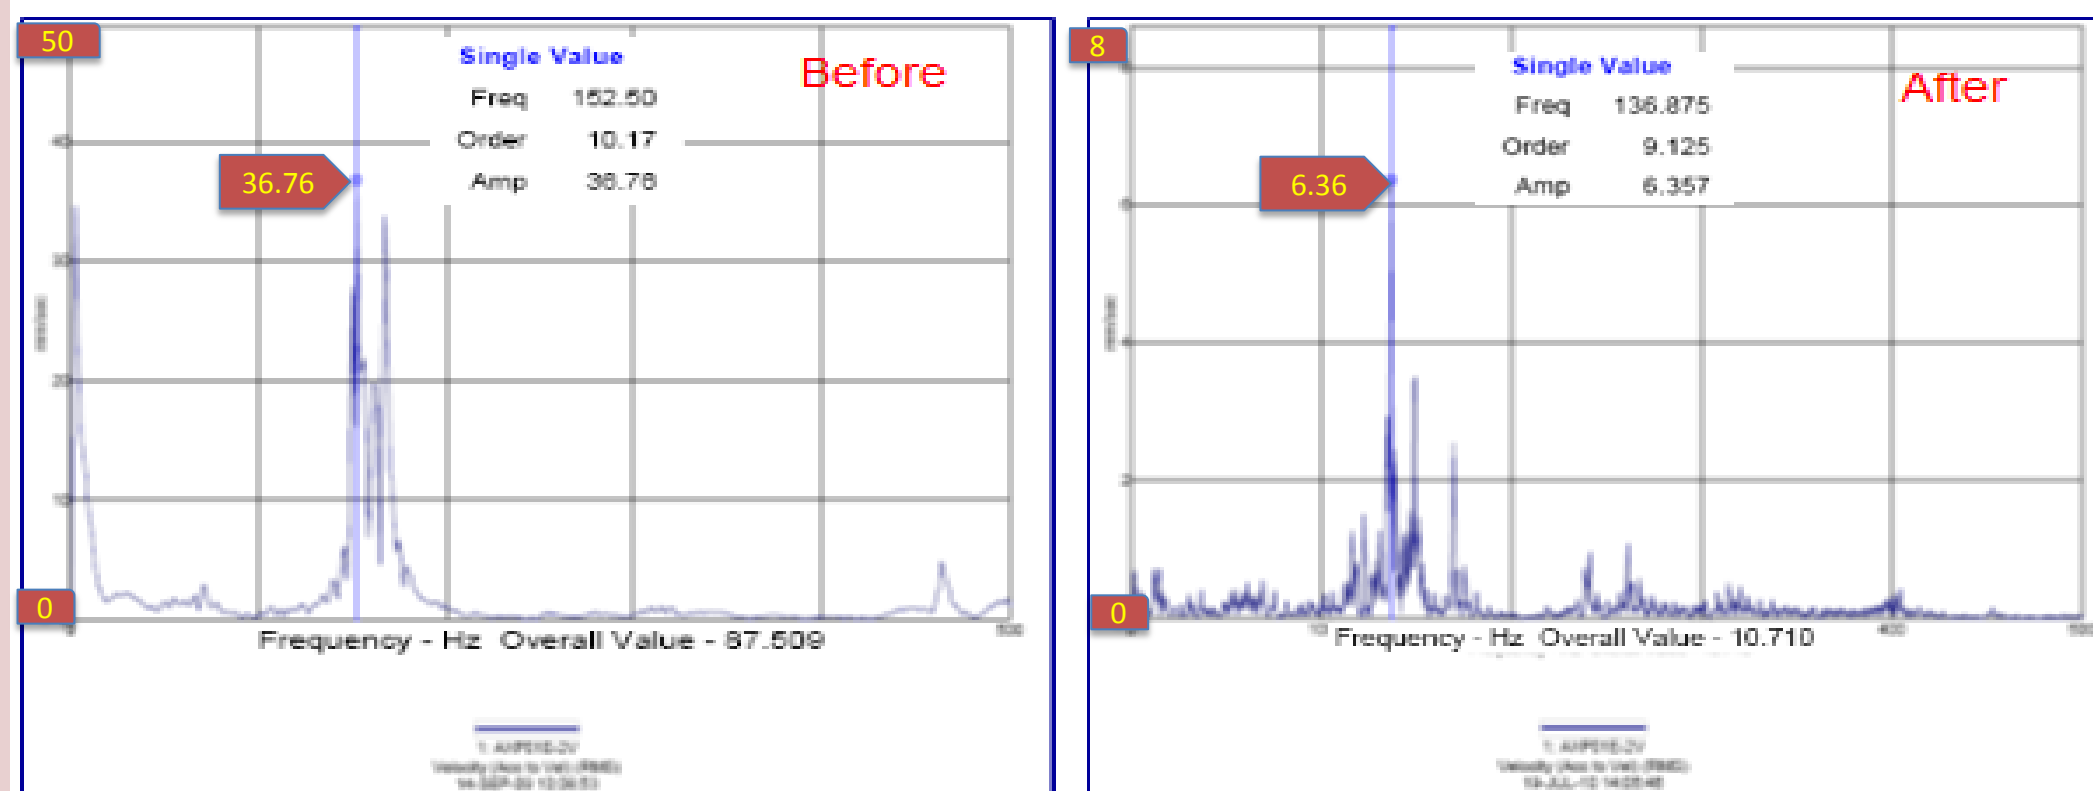
Vibration spectrum at pos 2 (Head #1 at J-bend - Vertical).

Vibration response of J-bend piping was reduced significantly by 95% from 87.5 mm/s r.m.s. to 10.7mm/s r.m.s. in vertical direction after the modification with the installation of Orifice

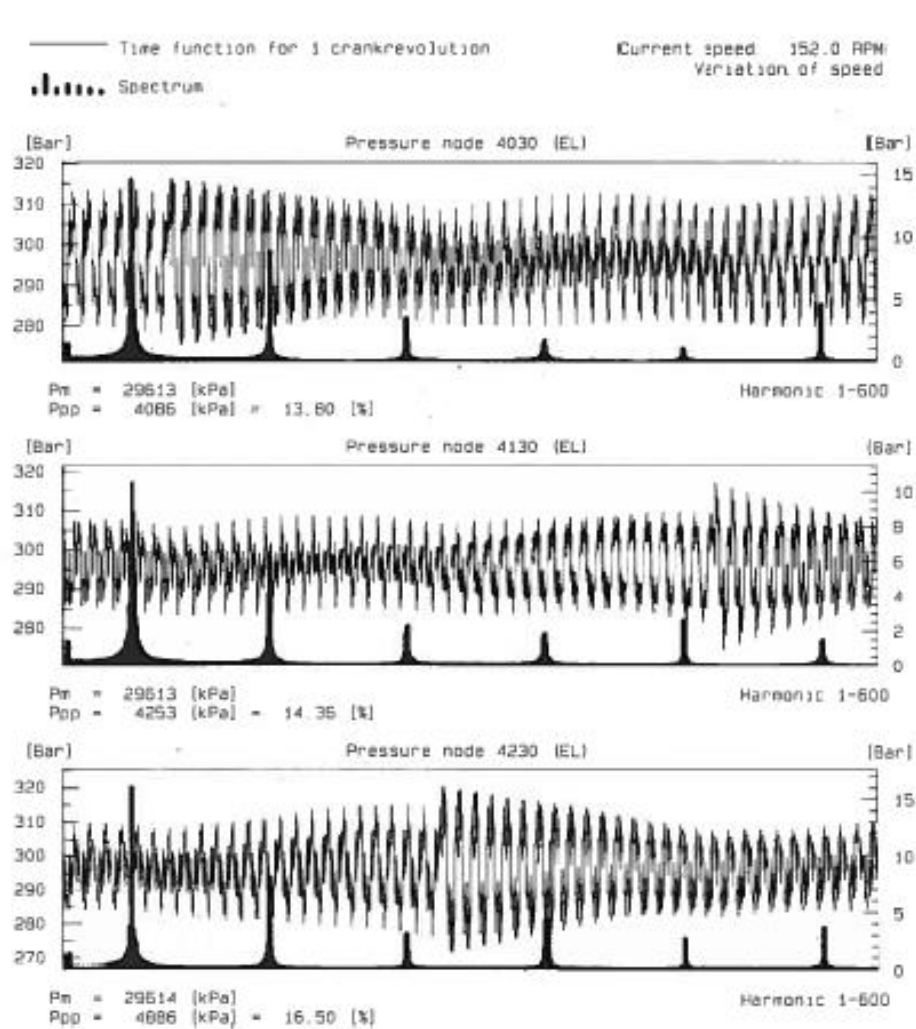
Pulsation level at bends before installation of the orifice plates

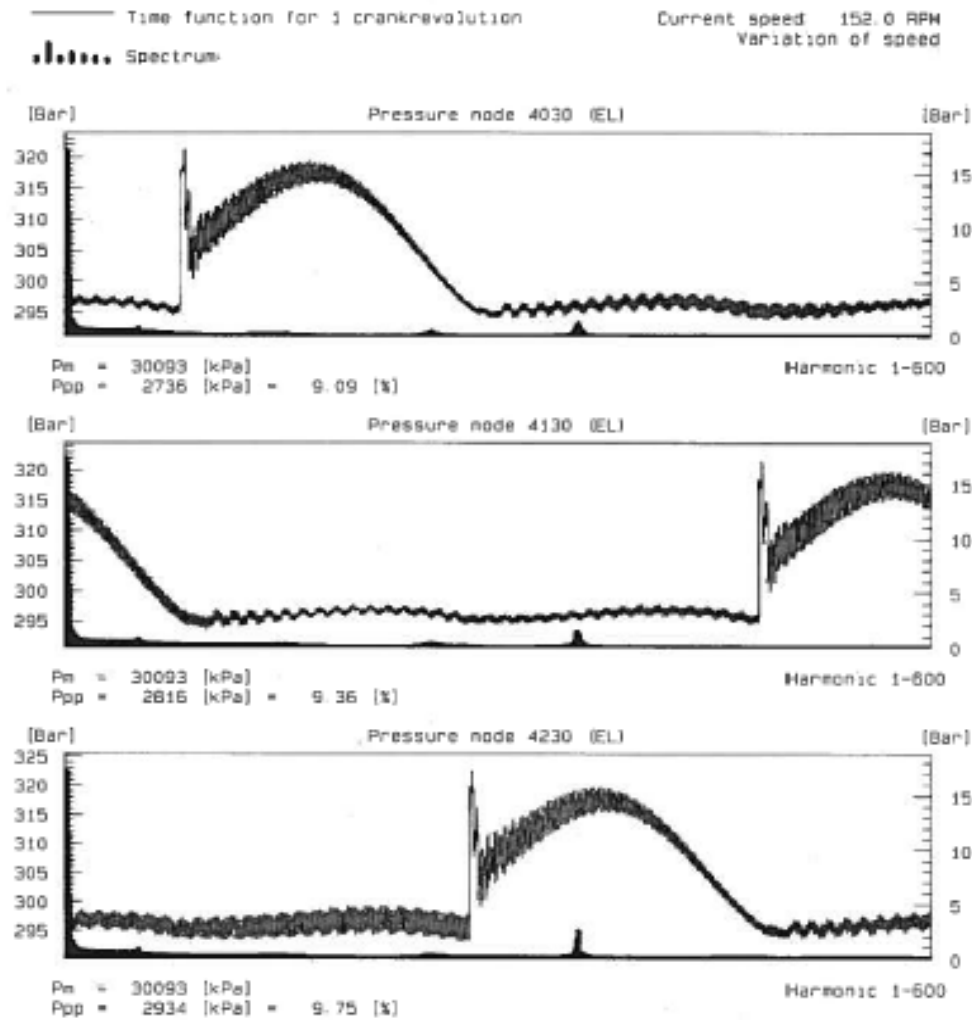
Pulsation level at bends after installation of the orifice plates

Conclusion: pulsation levels were reduced significantly after the installation of the orifice plate

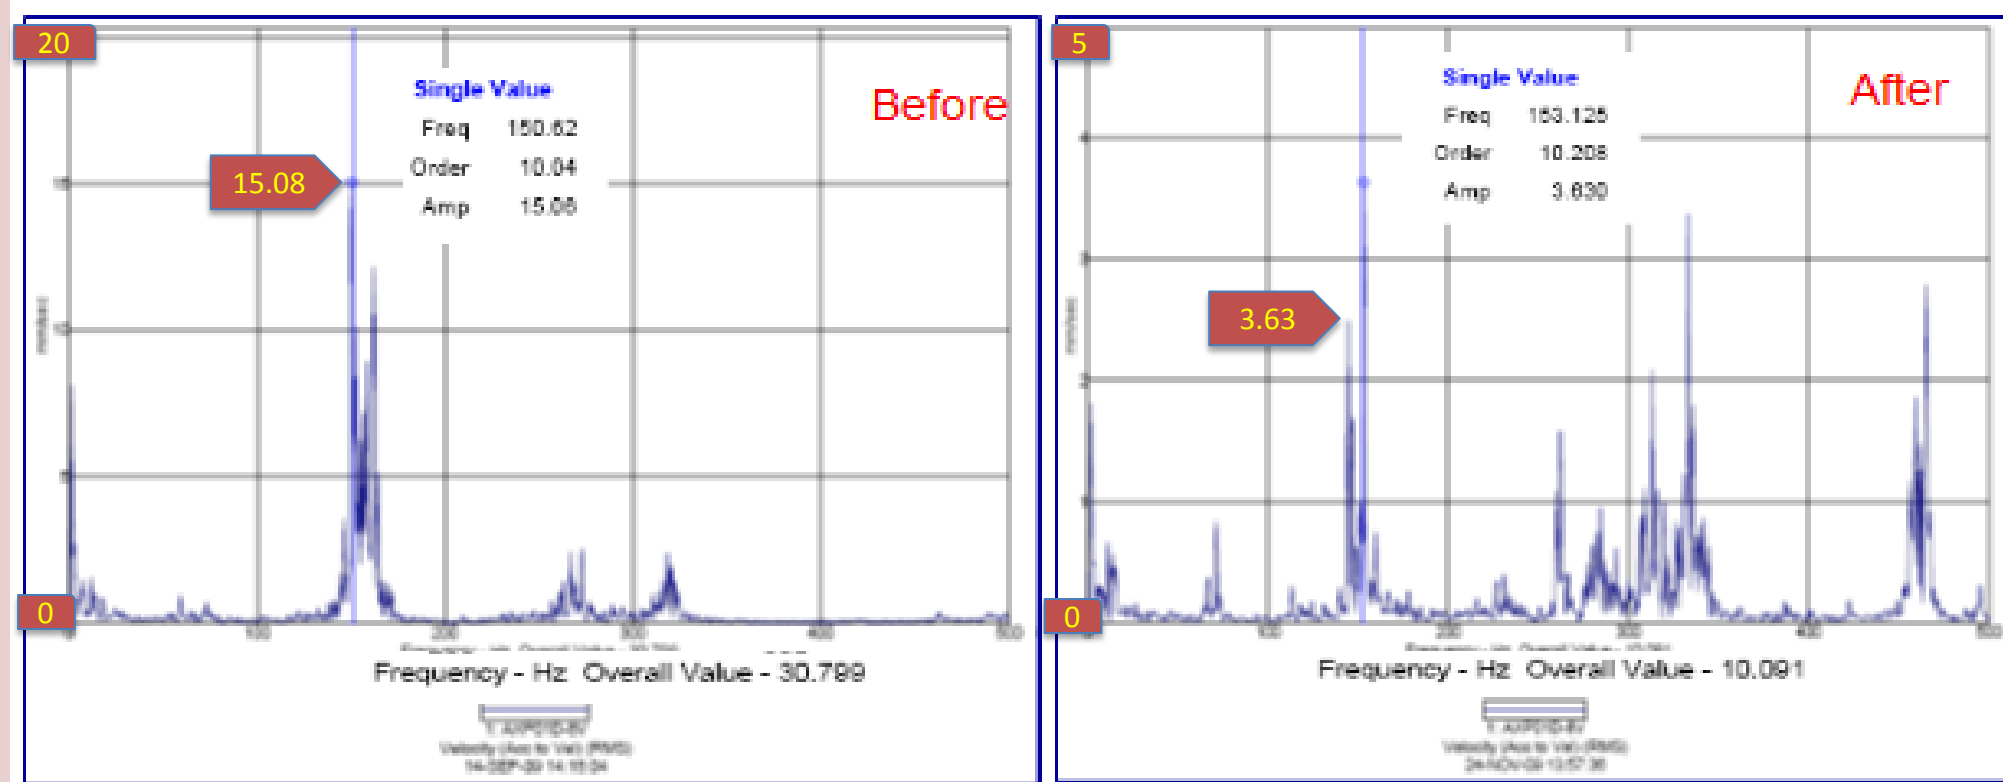
Vibration spectrum at pos 2 (Head #1 at J-bend - Horizontal)

Vibration response of J-bend piping in horizontal direction was also significantly reduced from 30.8 mm/s r.m.s. to 10 mm/s r.m.s. after the modification
