Effects of shaft geometric unconformities on the rotor-dynamic behavior in hard coupled equipment

This case study deals with a 25MW turbo-generator train with a semi-rigid connection between generator and gearbox.

The rotor-dynamics of the train in subject was negatively influenced by a geometrical out-of-tolerance on the generator flange, causing a distortion in the shaft line which introduces a pre-stress on the rotor system.

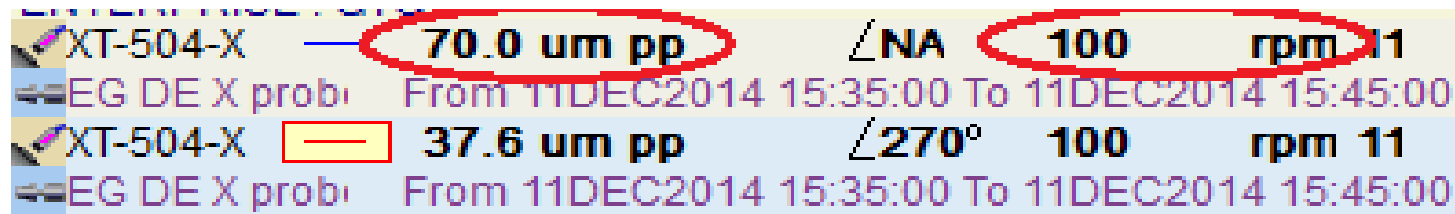
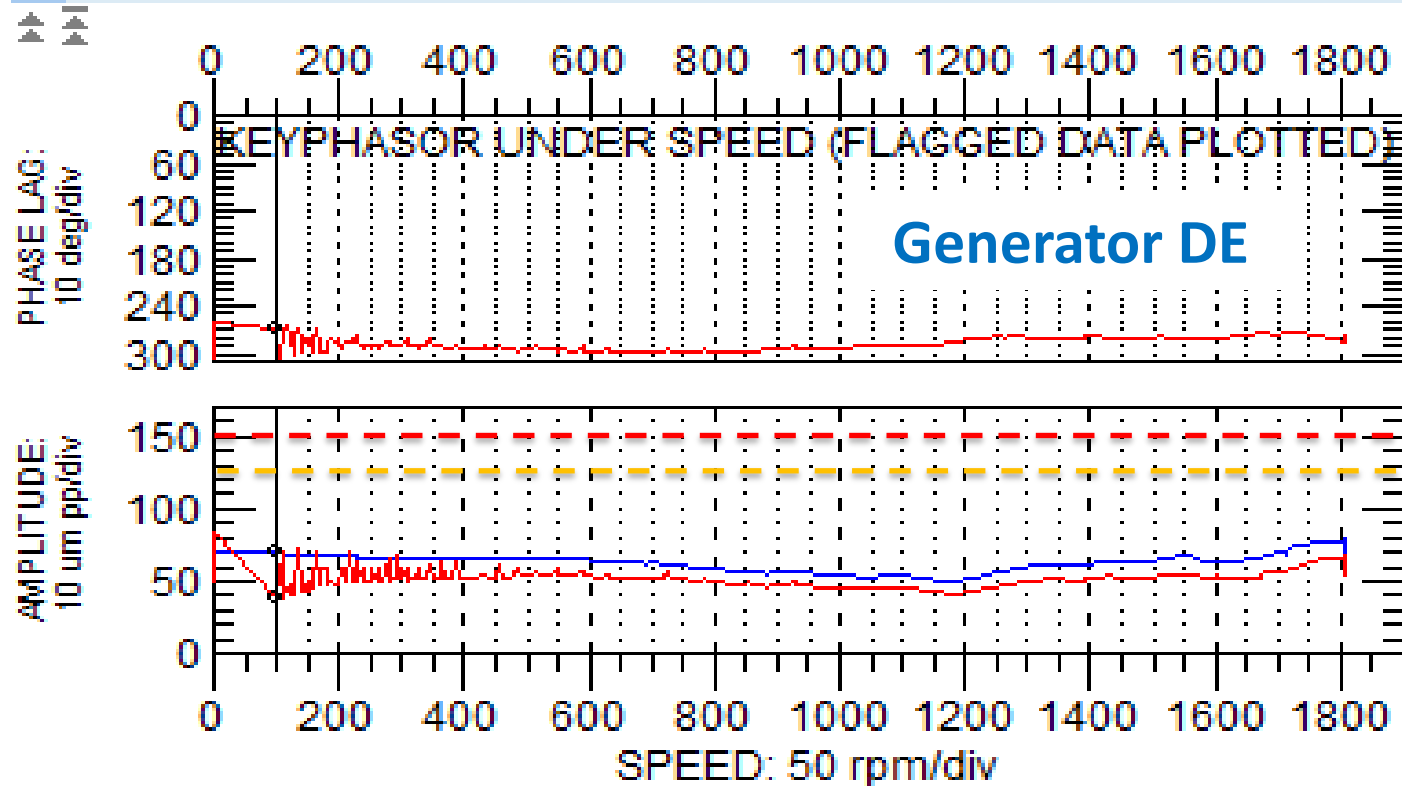
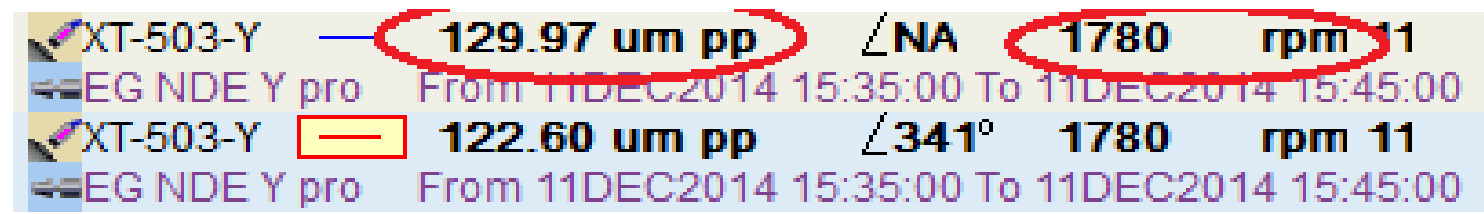
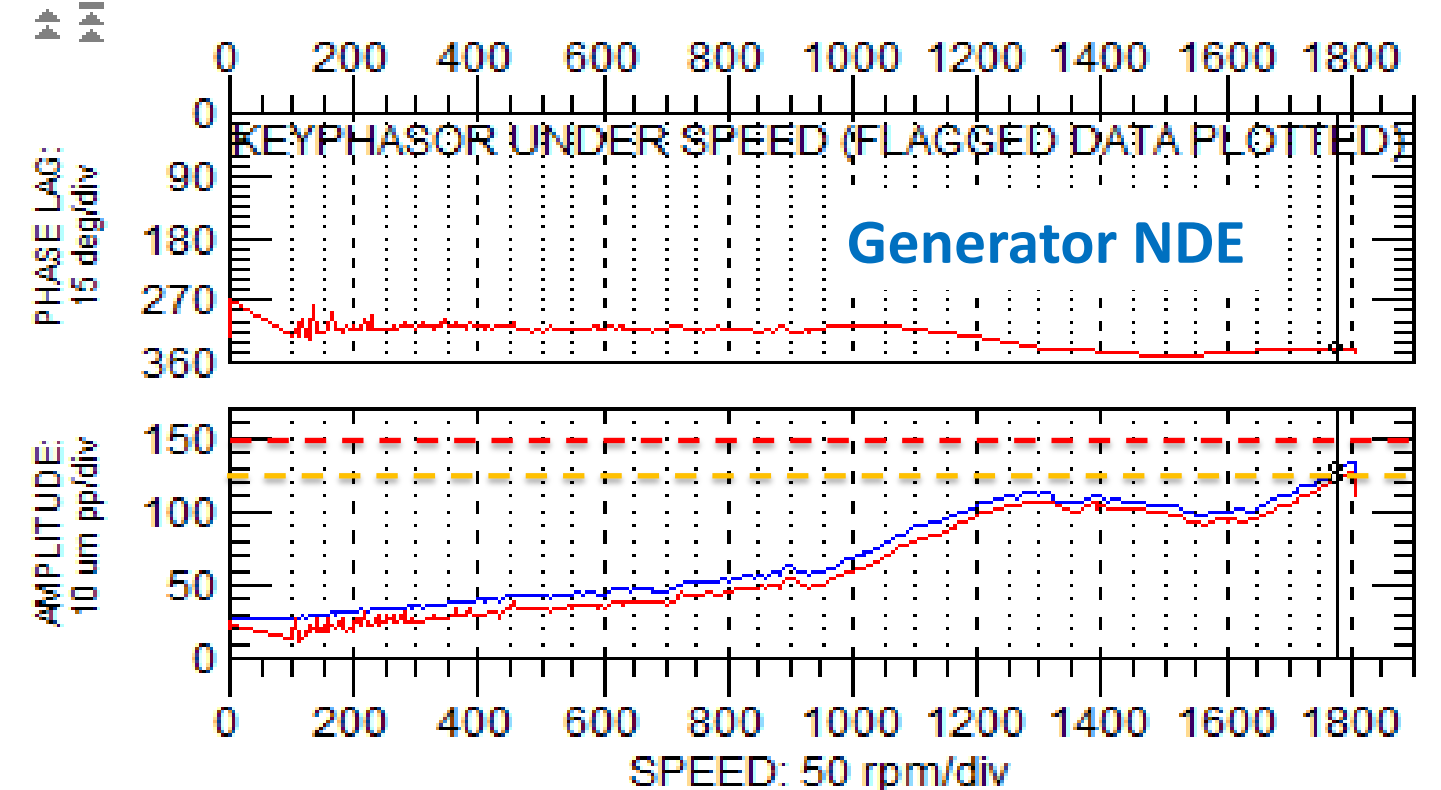
Observed vibration

- Generator shaft run-out ~60micron p-p during slow roll (expected below 30micron) at DE side
- Main component: 1X REV

- Generator high vibrations (~130micron p-p) at NDE side during ramp-up at MCS
- Main component: 1X REV

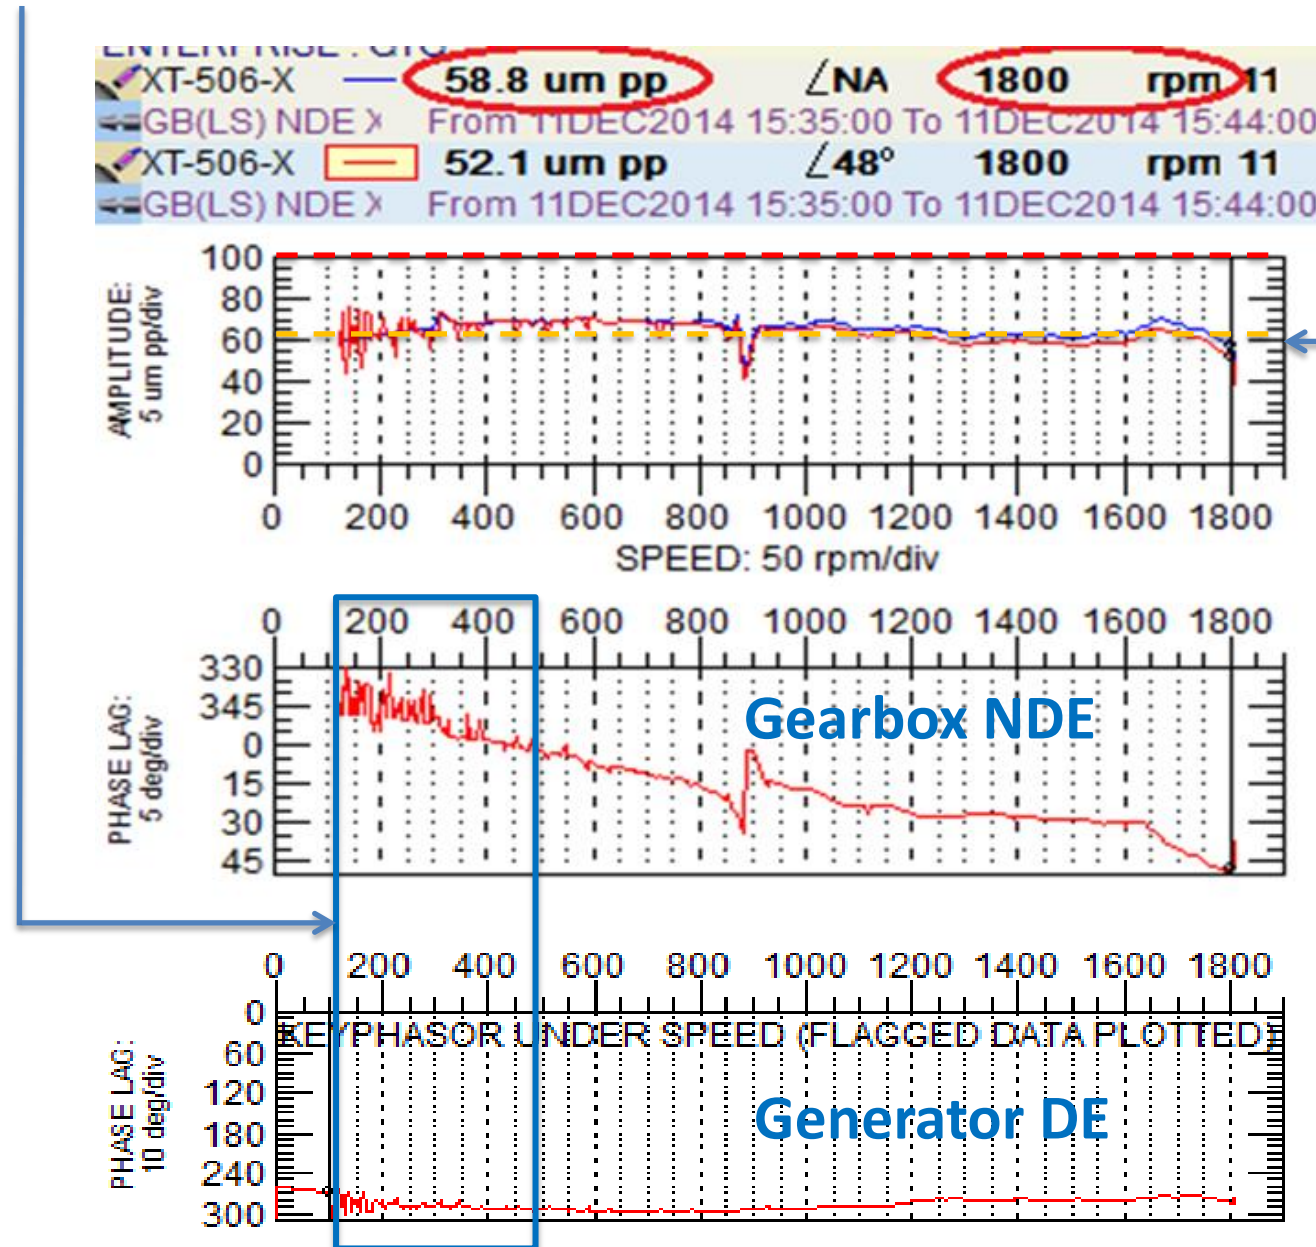
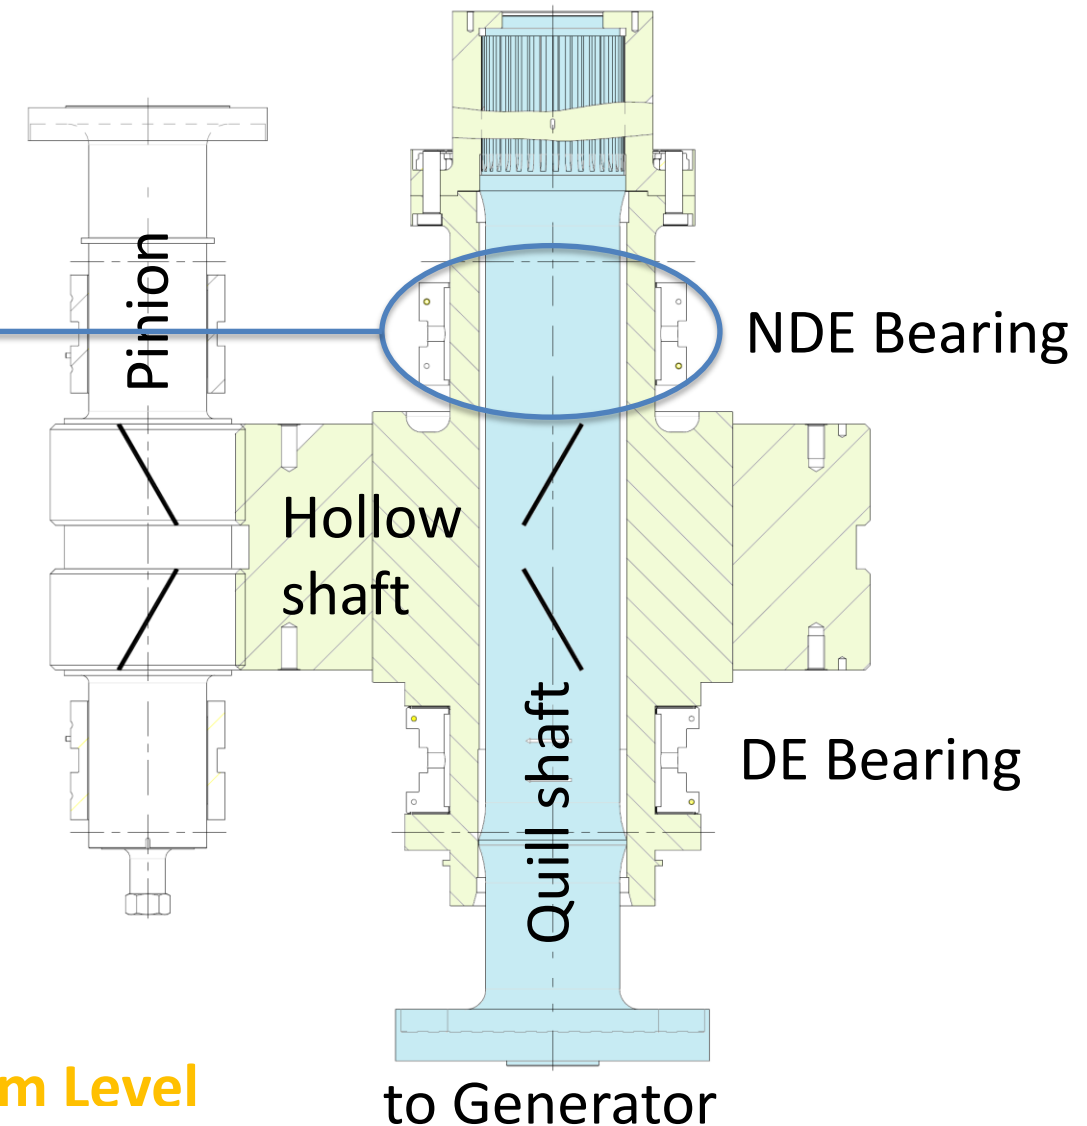
Observed vibration

- Abnormal radial vibrations detected on Gearbox LS shaft NDE side
- Gearbox phase lag at low speed is higher than Generator vibration probes (i.e. Generator peak anticipates Gearbox peak)

This suggests that the issue comes from Generator side

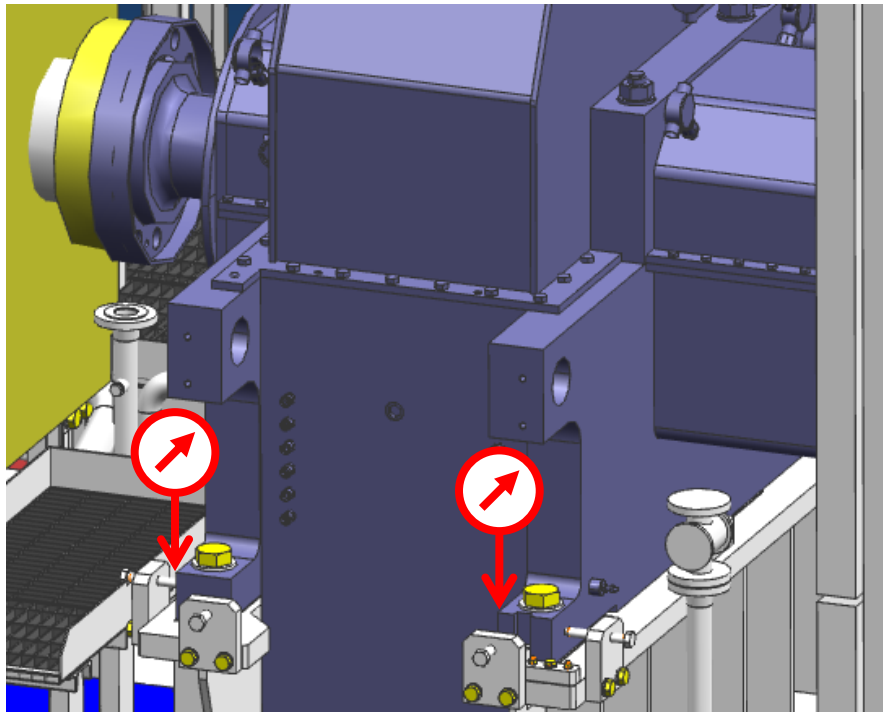
Soft Foot check acting on
Gearbox & Generator
anchorage bolts

Negligible dial gauge variations
when tightening/untightening bolts

OK

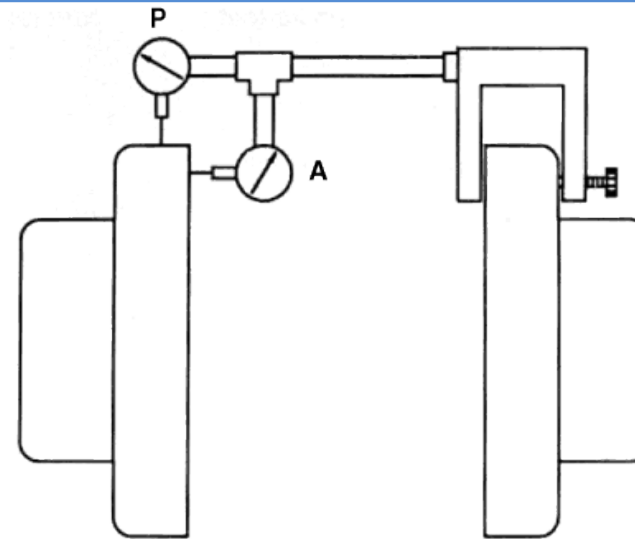
Machines
alignment
check

Alignment records depended
on Generator/Gear flanges
relative clocking

Alignment not repeatable

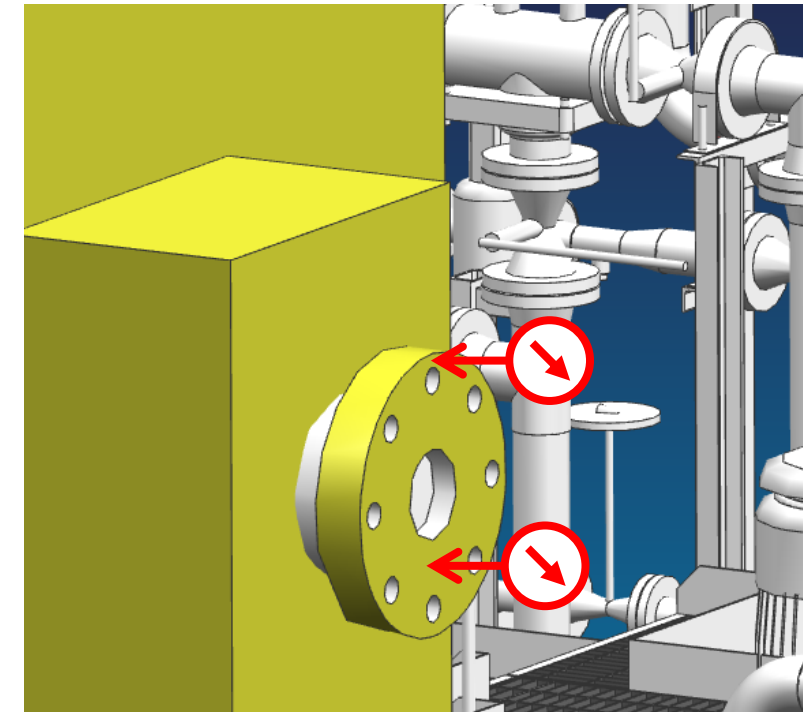
Flange
Planarity
Measurement

**Generator flange planarity
out of tolerance**

Max axial run-out tolerance:

Required = 2/100 mm

Measured = 8/100 mm

Resolution: flange re-machining in situ

The flange deviation was corrected on the field, by the grinding process performed on the generator flange face

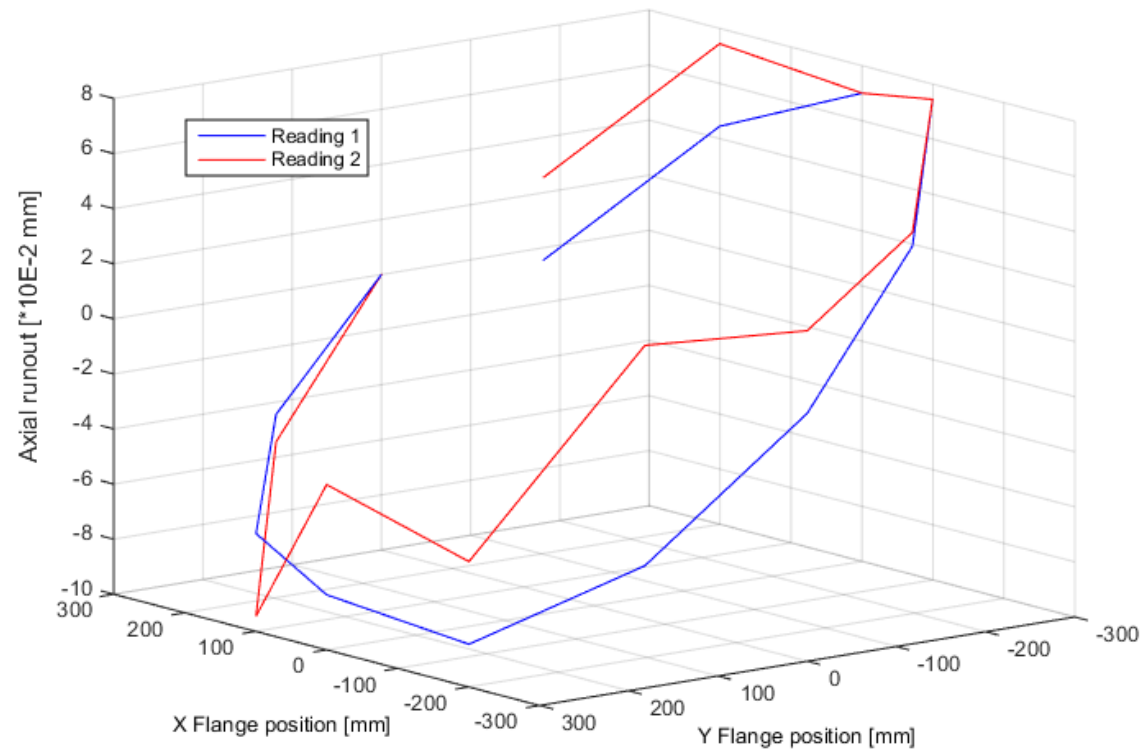
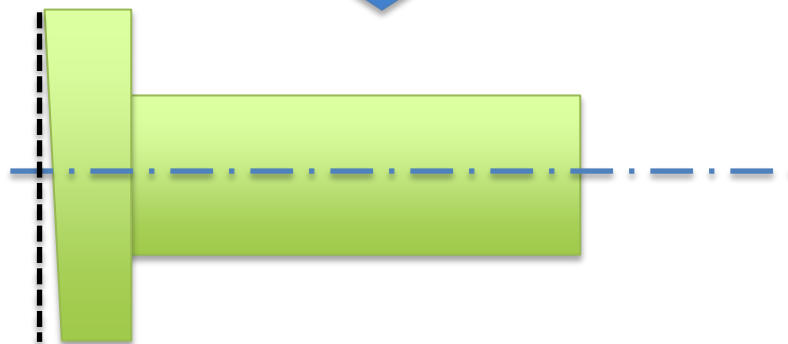
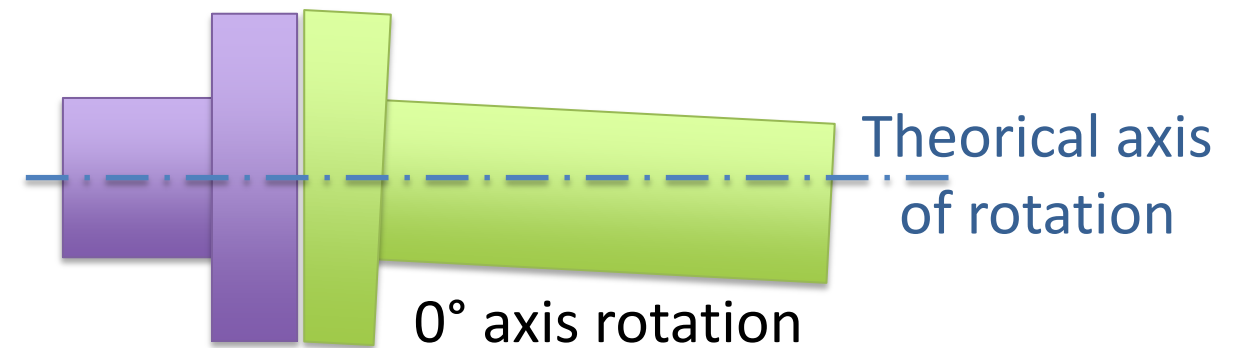
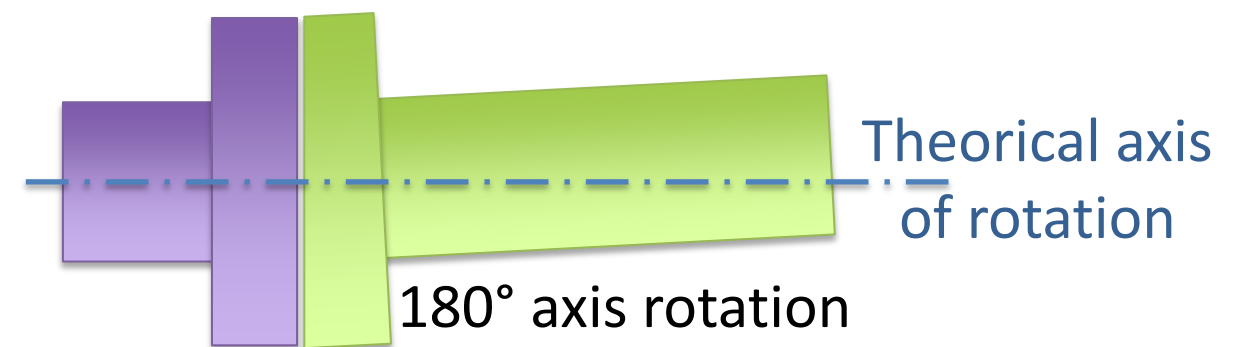
How non-planar flange influences vibration

Especially in semi-rigid connections, flange non-planarity induces a permanent deformation in the shaft line that produces a force status able to alter the predicted rotor-dynamic equilibrium

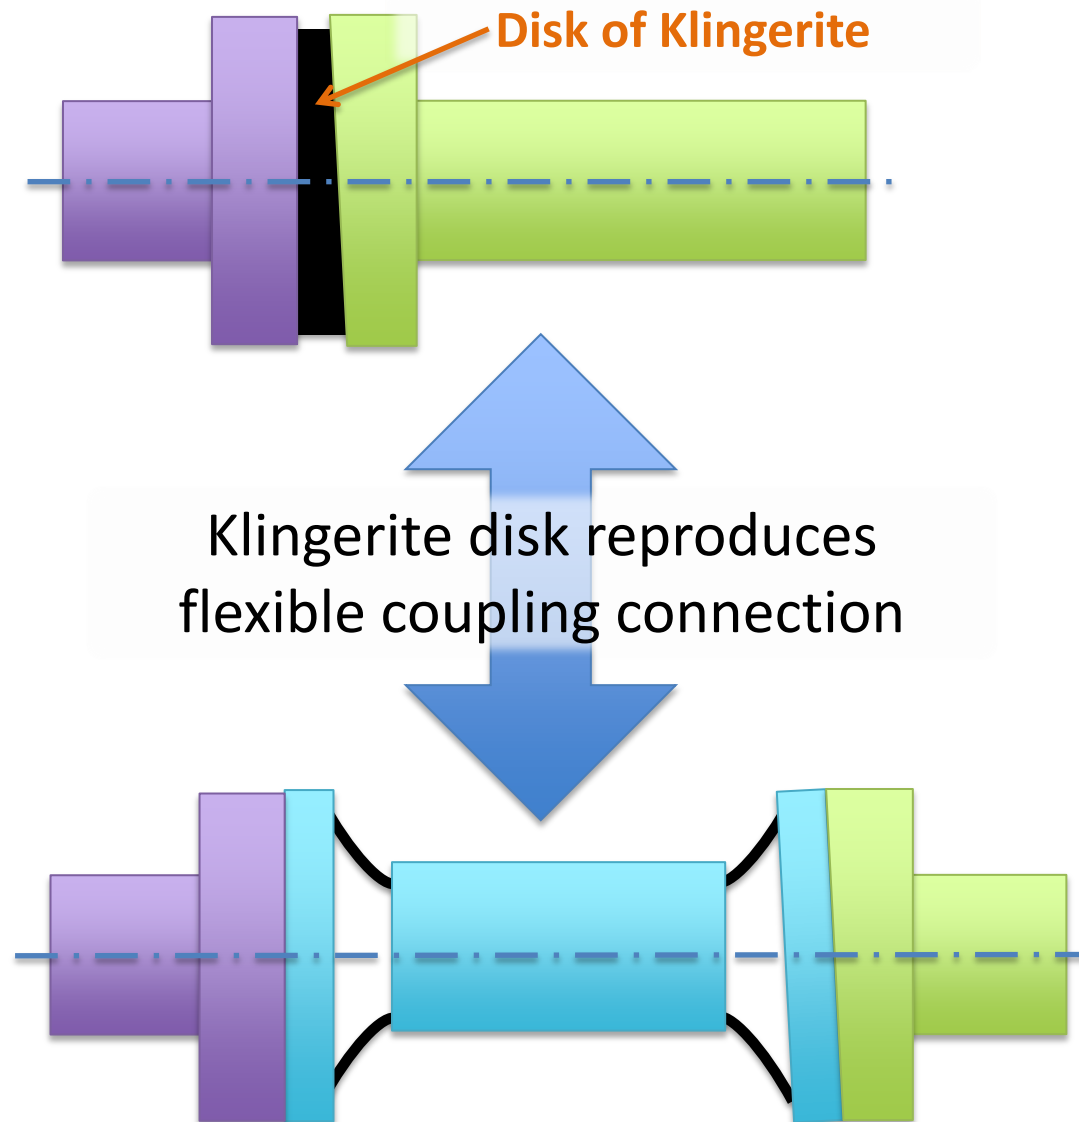
Additional test performed inserting a soft joint (disk of Klingerite ≈ 3 mm-thick; Klingerite is typically used for gaskets) between gearbox and generator flanges to prove that the issue is caused by the connection between the two machines

- 1) Lateral rotor-dynamic disconnection (i.e. lateral disturbances are not transmitted between different machines)
- 2) Rotor-dynamics is less affected by connection errors (misalignments, flanges manufacturing errors, etc.)

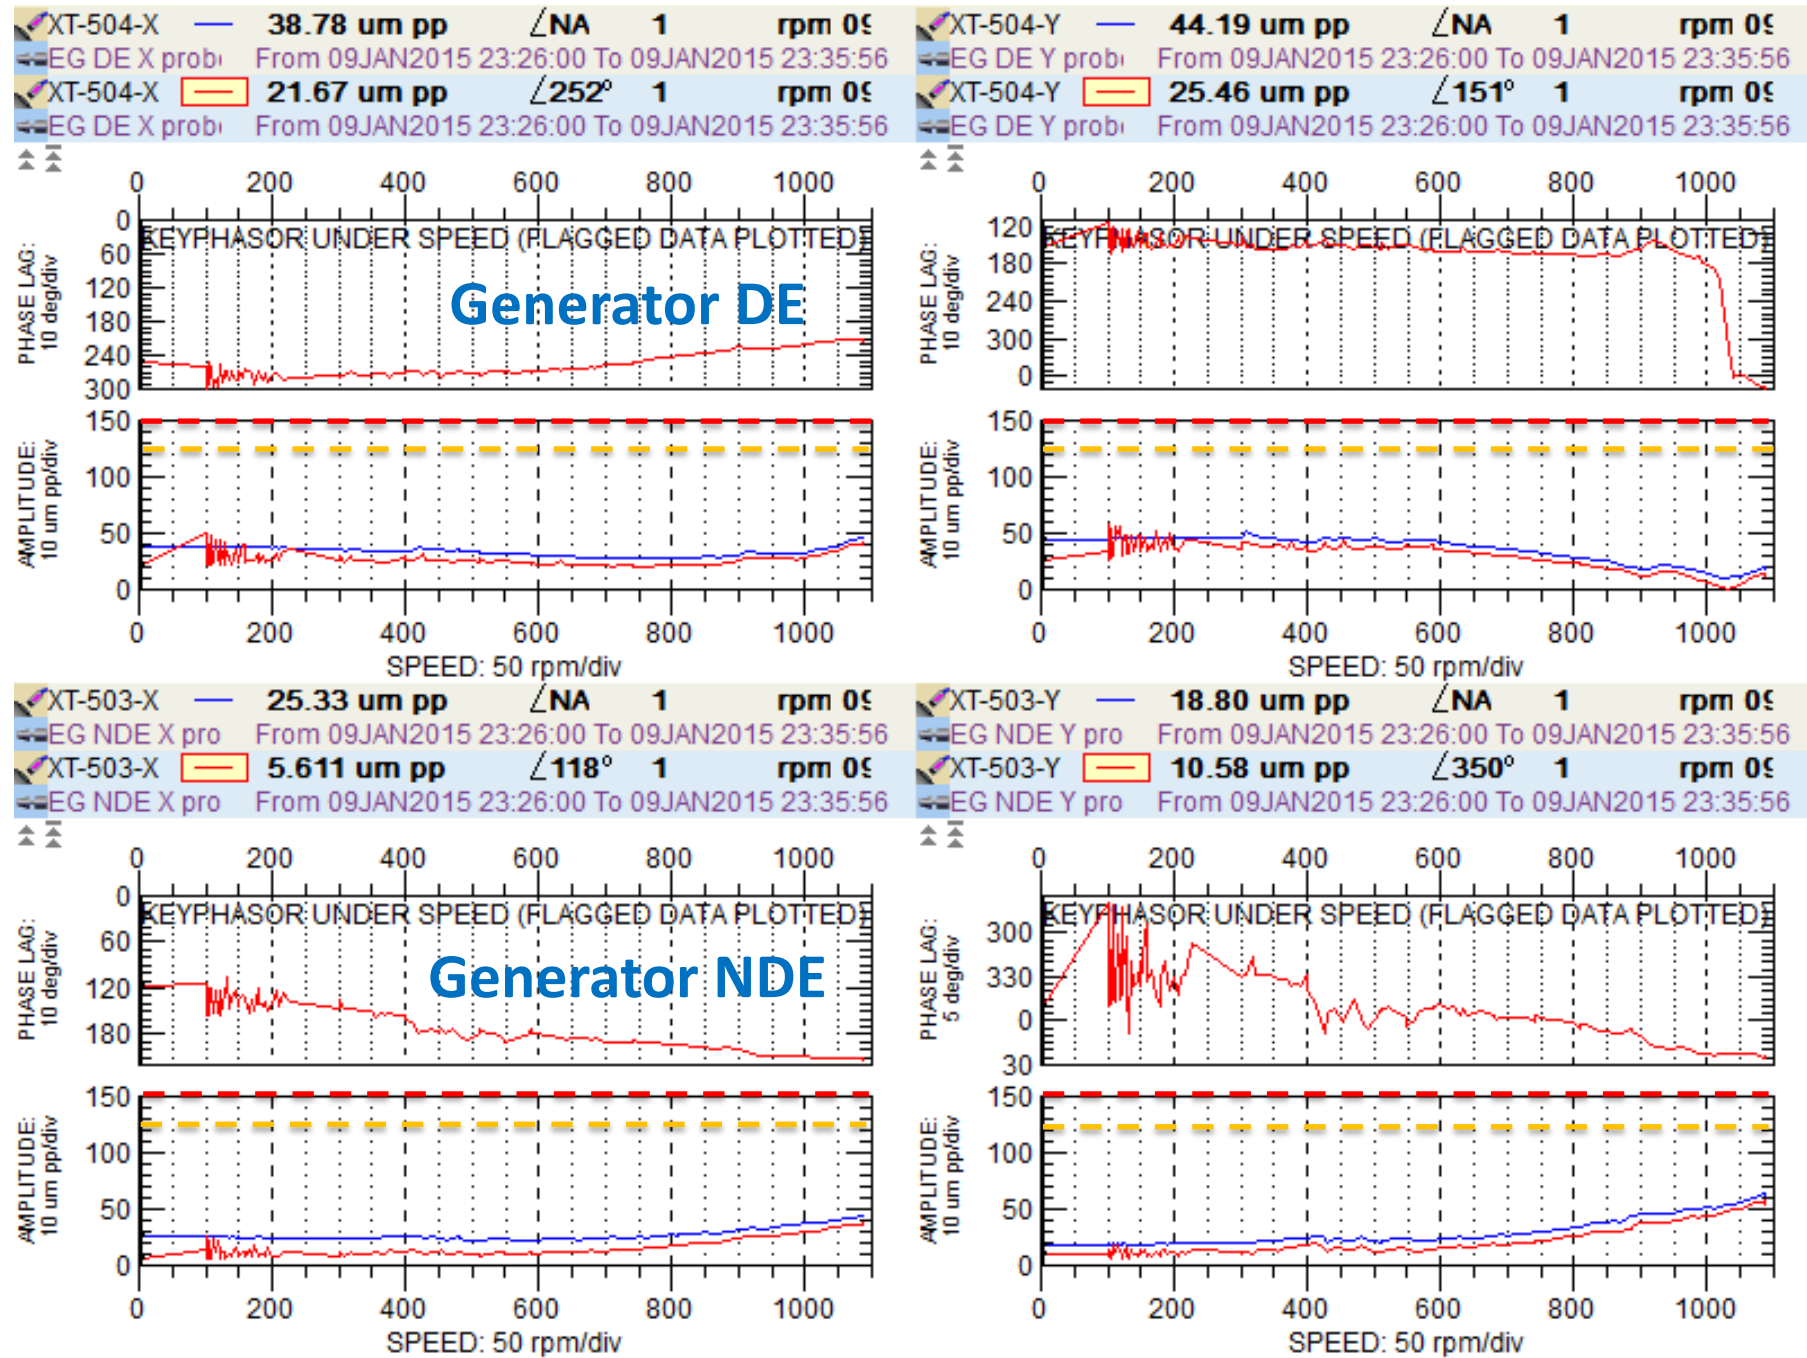
Bode plot of Generator vibration probes with soft joint installed

In presence of soft joint, radial vibration is dramatically reduced

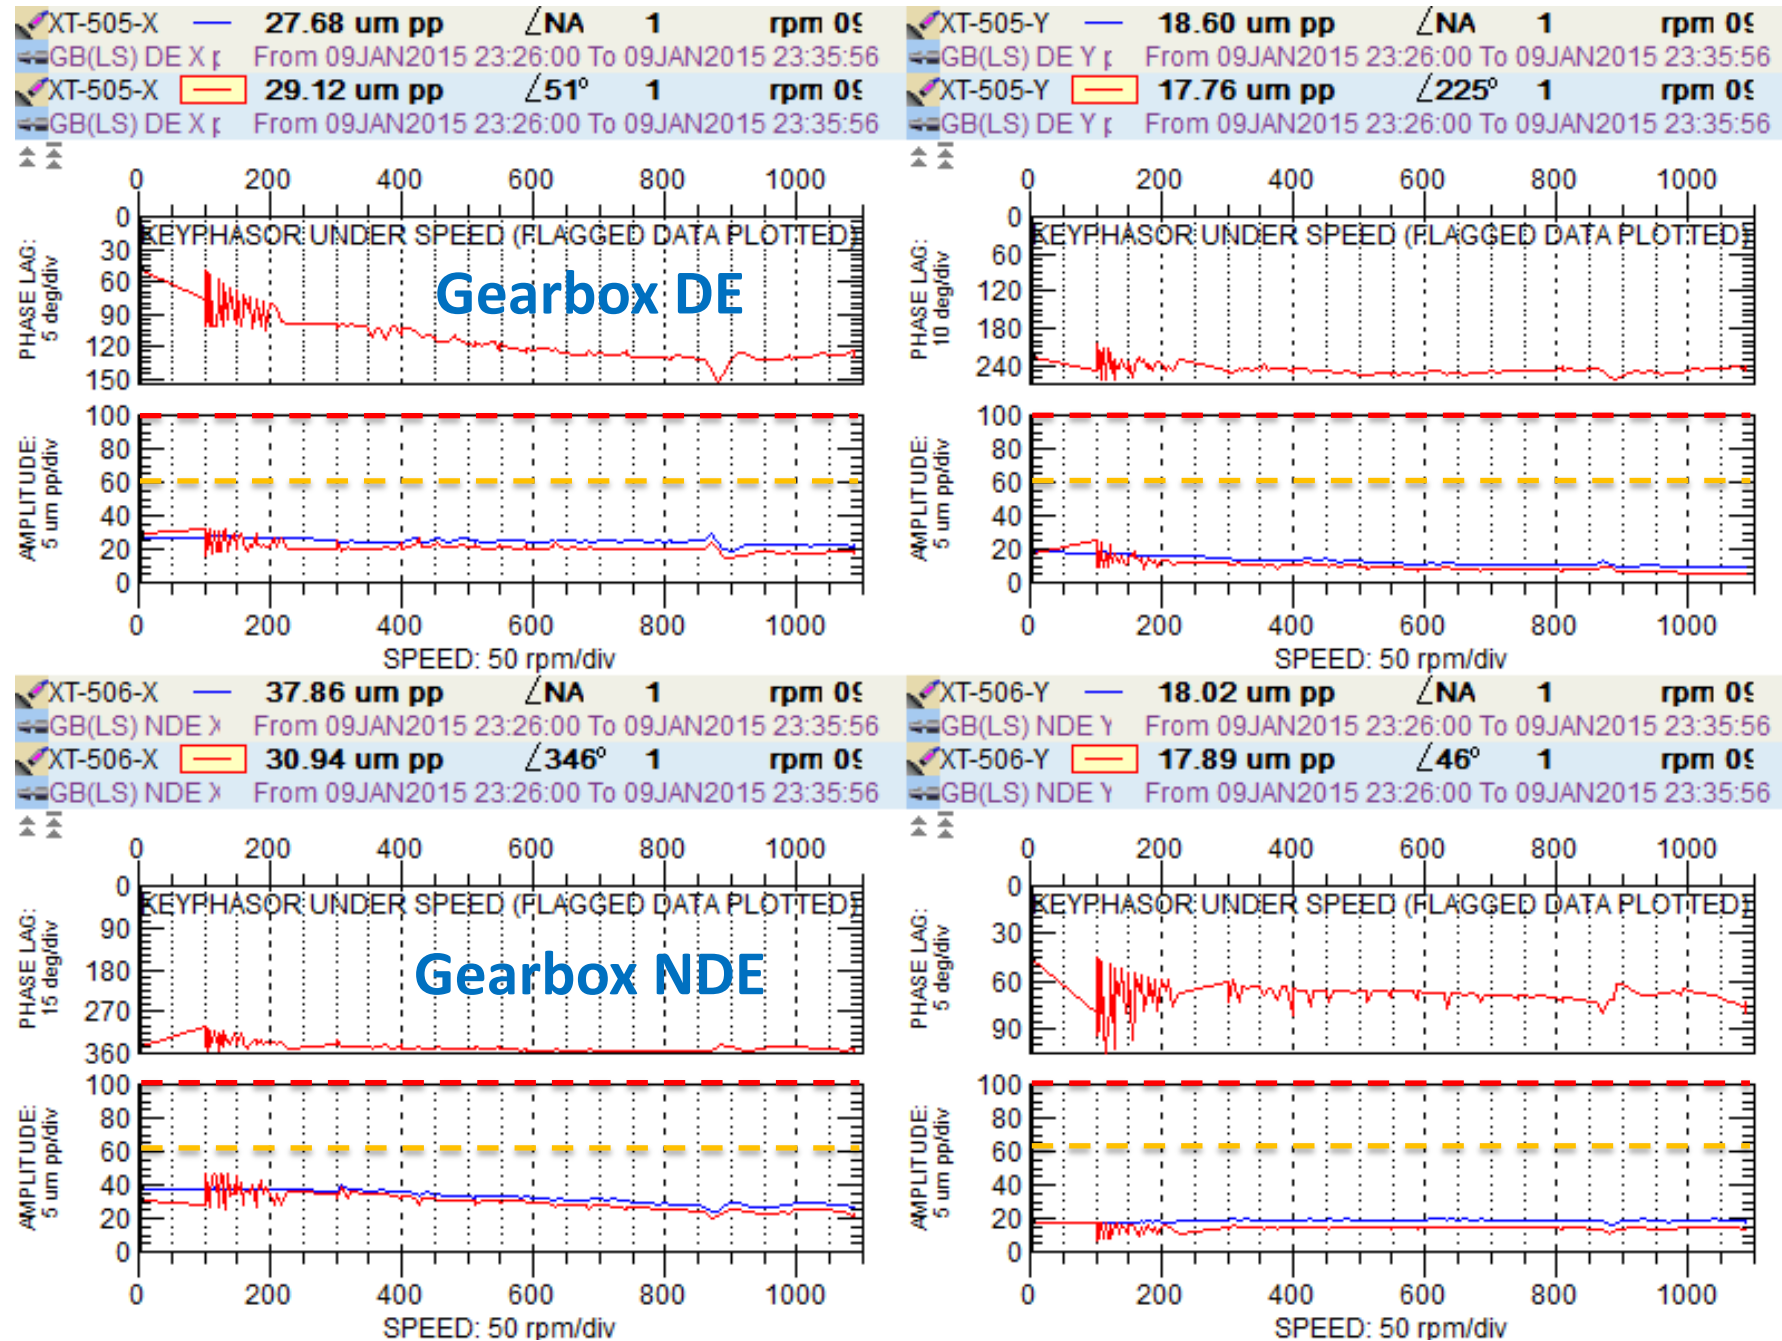
Bode plot of Gearbox vibration probes with soft joint installed

The root-cause is the Generator flange non-conformity

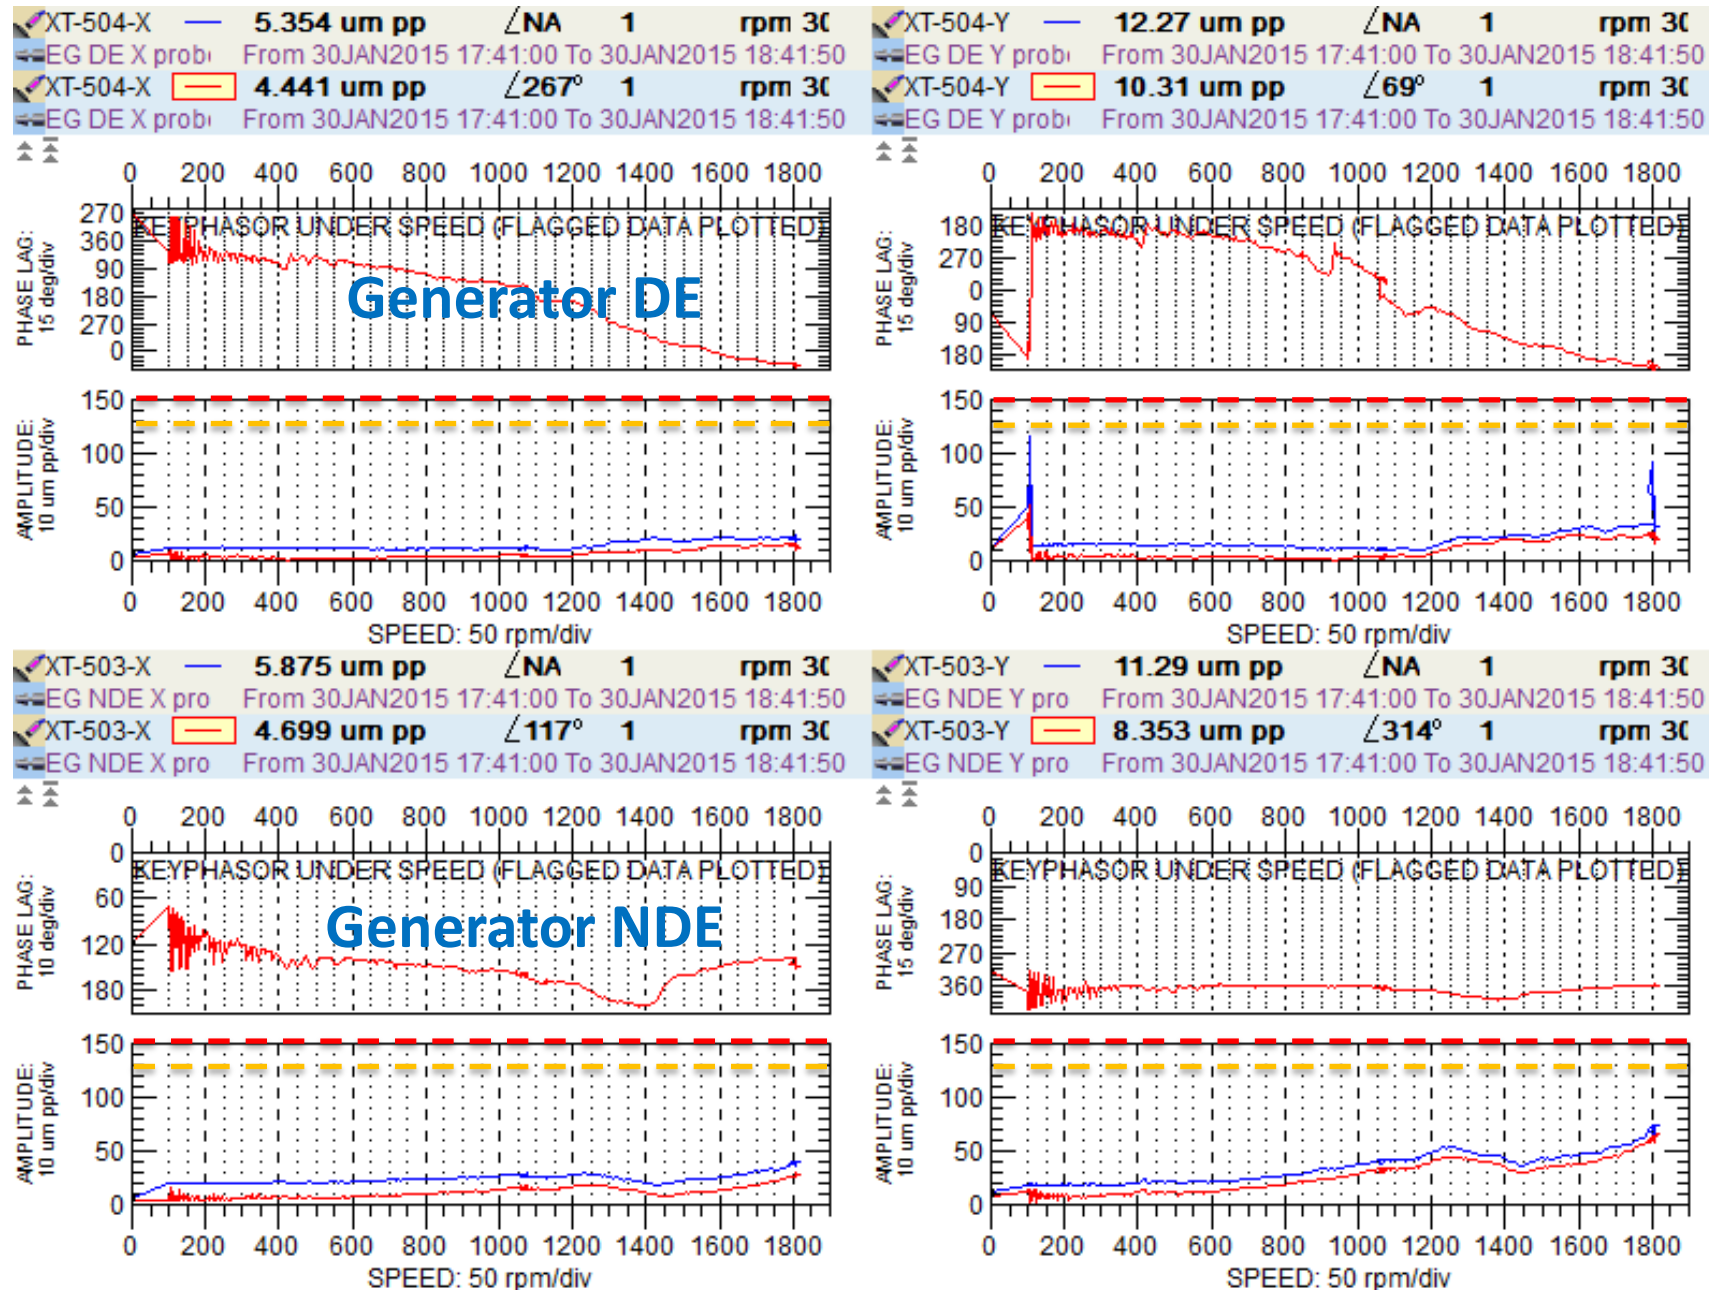
Bode plot of Generator vibration probes

Vibration analysis after flange machining confirms the correctness of the corrective action.

Rotor-dynamic of the shaft line at both FSNL and FSFL condition meets the expected behavior.
