SEPARATION SEAL UPGRADE TO OVERCOME REPETITIVE FAILURES

Author : Rasgas

42nd Turbomachinery
29th Pump SYMPOSIA

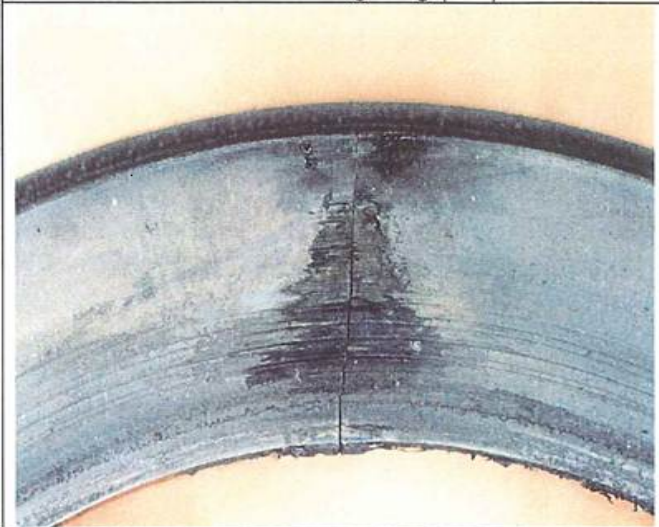
Outboard Mating Ring (#12)

Surface condition : Heavy contacting mark at the all surface
Liquid migration : Wetted overall with oil contamination

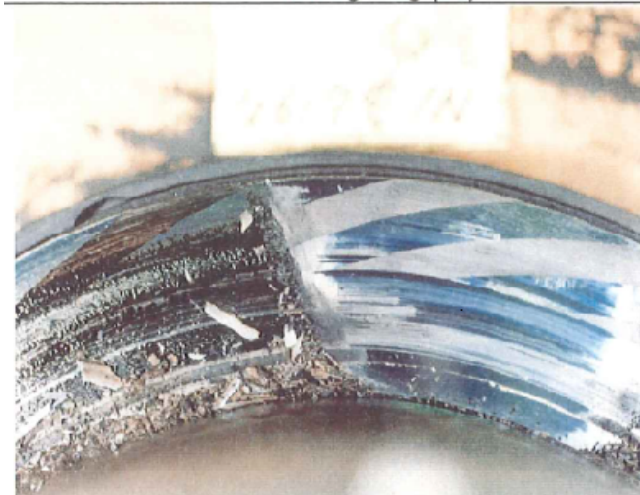
Inboard Mating Ring (#1)

Surface condition : Heavy contacting mark at the all surface
Liquid migration : Wetted overall with oil contamination

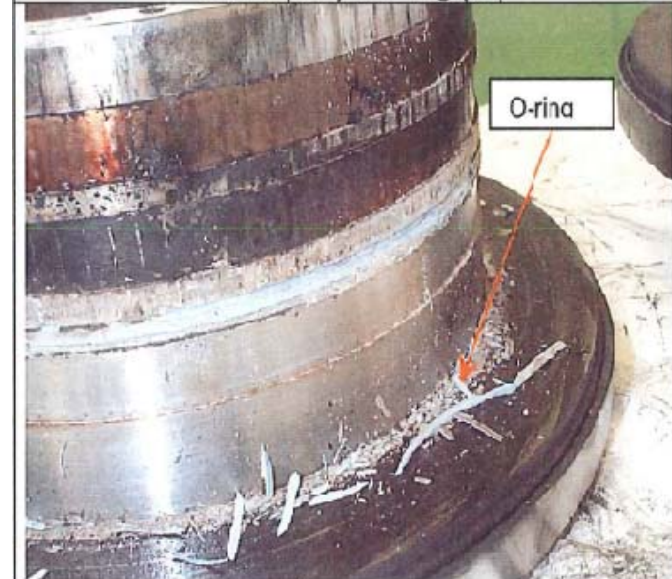
Sleeve (#11) & O-ring (#9)

O-ring (#9) overheated and smashed into fragments

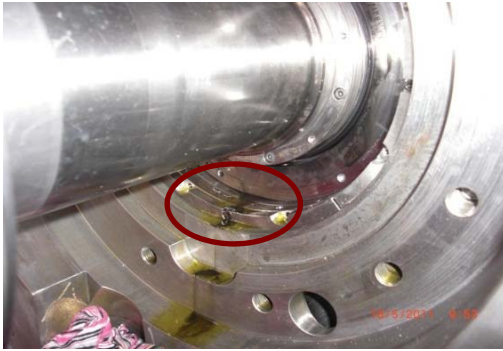
- Lube oil accumulation inside seal bore

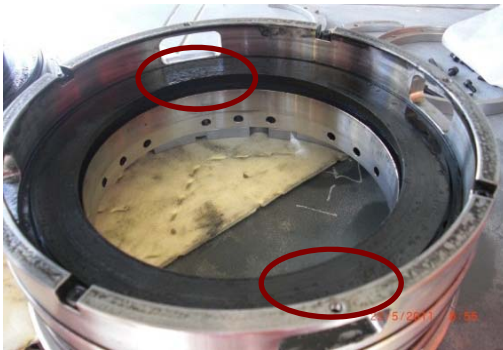
- High/hard spots
- Sharp edge / Irregularities

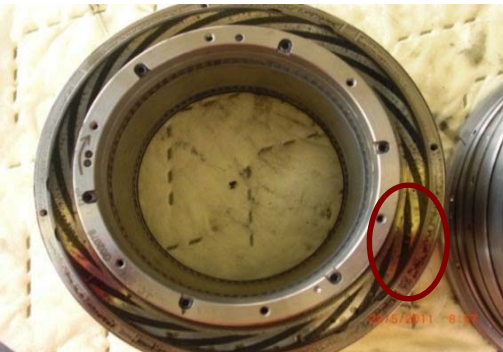
- Oil film on Secondary seal ring faces

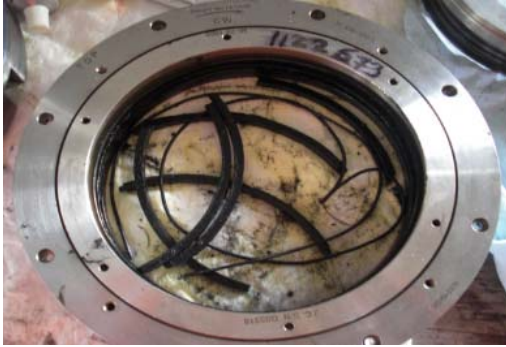
- Separation seal carbon segments in damaged and dislocated condition

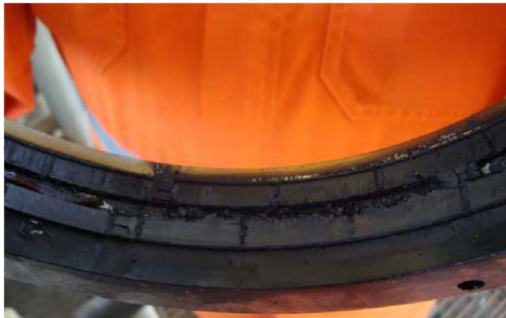
- Worn out seal rings

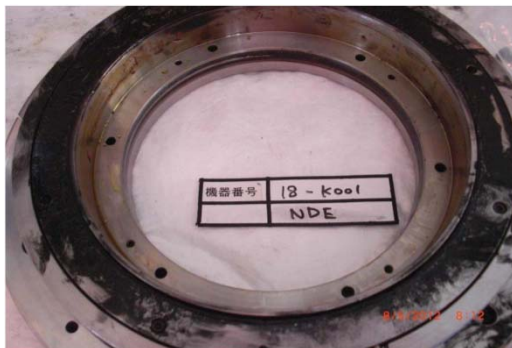
- Carbon deposit

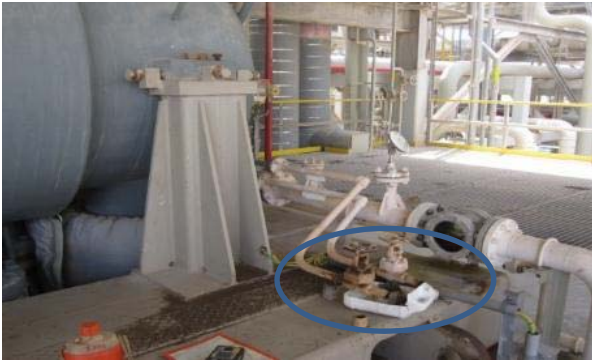
- Excess oil collected from both Primary & Secondary drain line

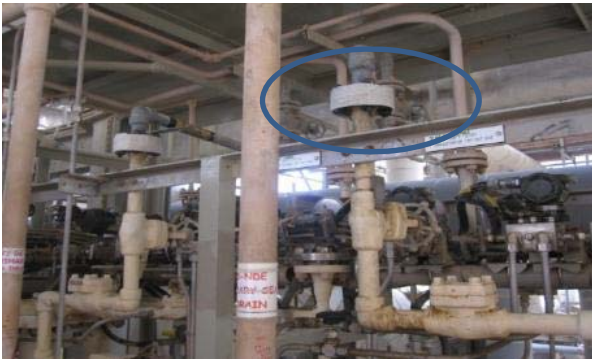
- Oil reached up to primary vent line

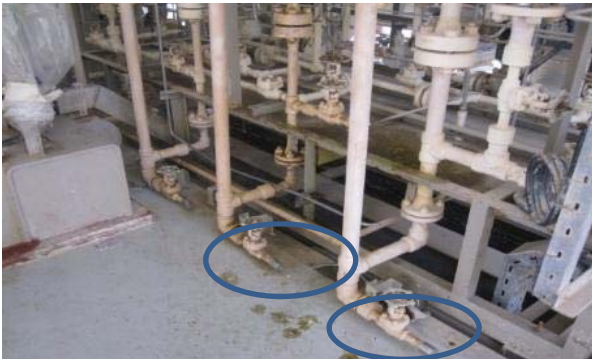
- Oil collected from vent line drain points

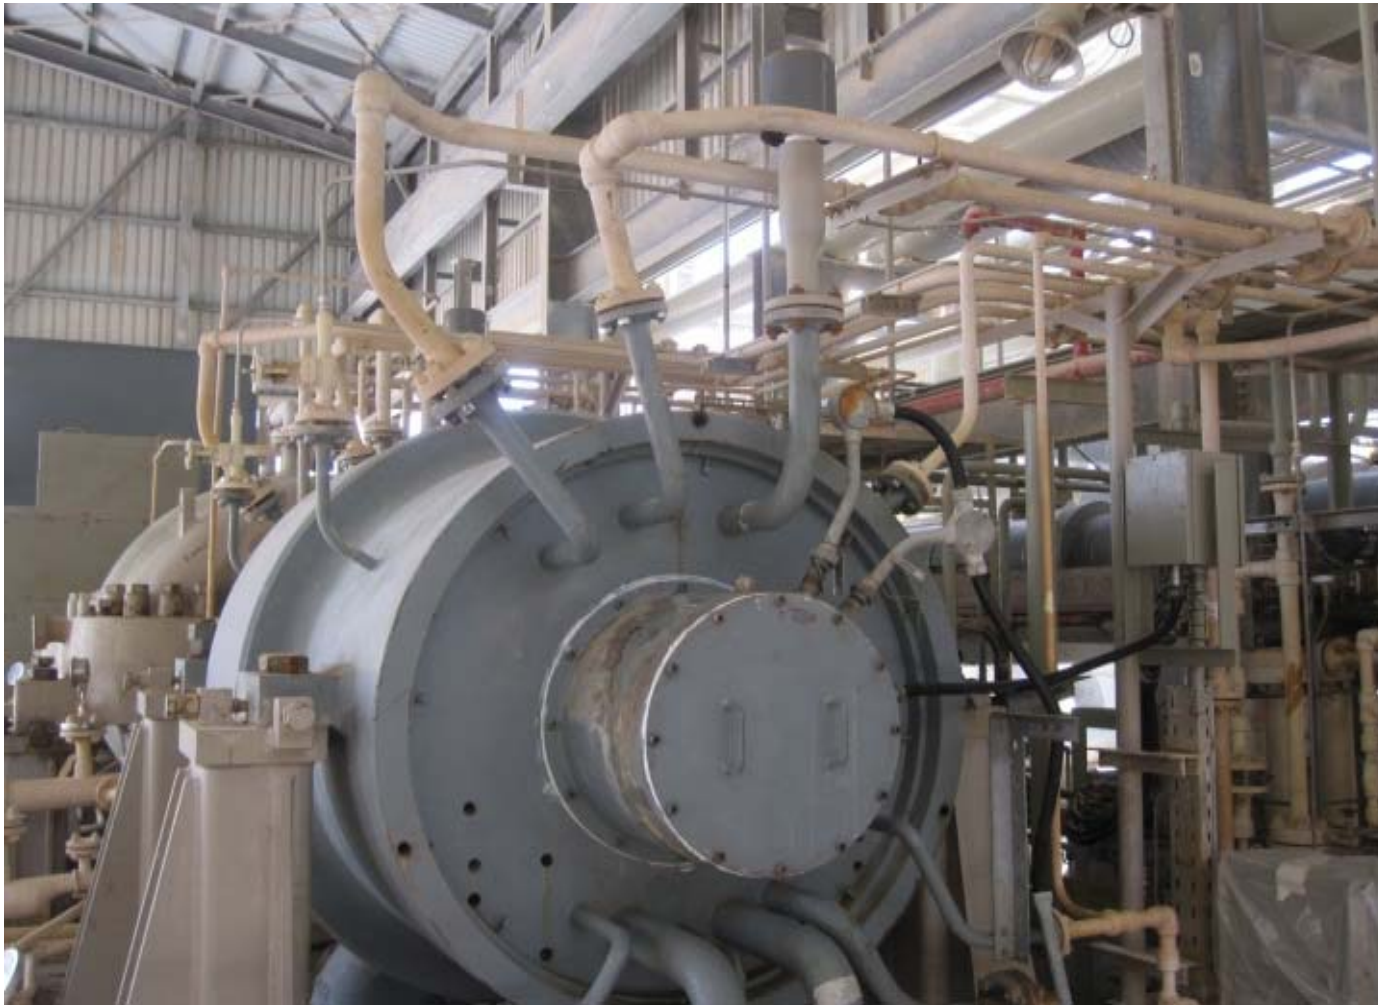
- Lube Oil migration issue found more severe at NDE (Thrust Bearing) relative to DE (Non Thrust) DGS assembly.

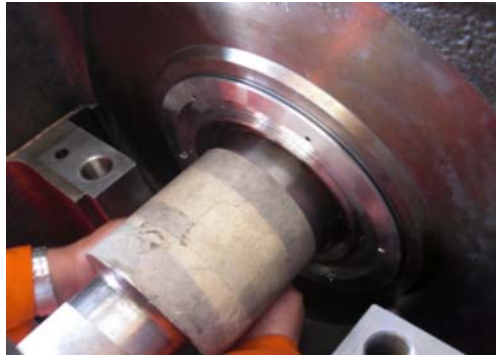
- Oil slinger (deflector)

“Upgrade existing DGSs to available technology of Non contacting type Separation Seal (T-93FR) with Oil Slinger / Deflector provision followed by related modifications in Main Gas Sea”
