# ANALYSIS OF ROTOR RUB IN A LARGE CENTRIFUGAL REFRIGERATION COMPRESSOR CASE STUDY

NEETIN GHASAS (FLUOR CANADA LTD.)

42<sup>nd</sup> Turbomachinery  
29<sup>th</sup> Pump SYMPOSIA

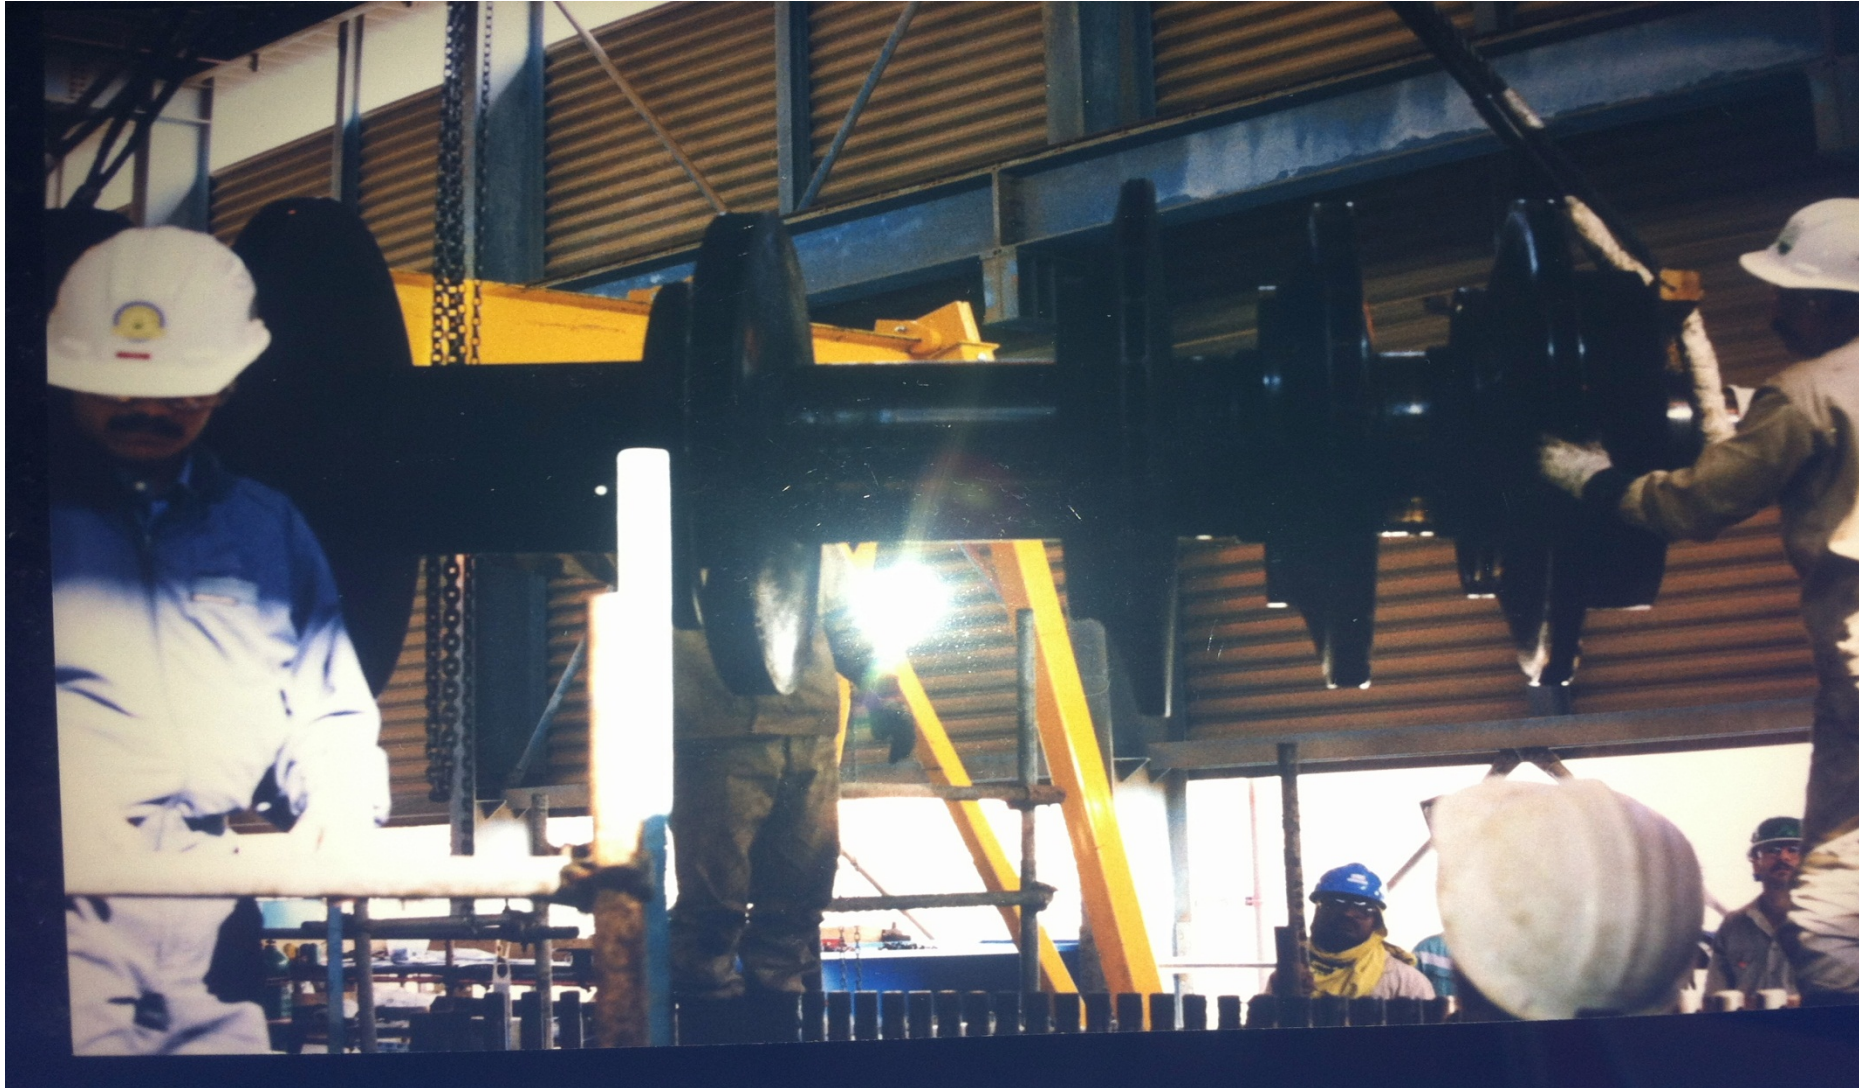
- a. Severe heat indications (heat marks) were noticed on the balance piston and the balance piston seal was found to be destroyed. This was the only region of the rotor affected by friction induced thermal distress.
- b. The rotor was seized in the casing at the balance piston location.
- c. Shaft runout was found to be 2.5 mil (63.5  $\mu\text{m}$ ), much more than the manufacturer's allowable limit of 1.0 mil (25.4  $\mu\text{m}$ ). The shaft had bent at the drive end.

Compressor rotor being removed from the lower half casing.

- Damage to the compressor's rotor and balance piston static seal required a complete overhaul of the machine. The replaced components included the spare rotor, new mechanical contact shaft end seals, interstage labyrinth seals and lead lined seal for the balance piston.
- After verifying the clearances and completing dimensional and visual checks, radial bearings and thrust bearing were re-installed in the compressor.
- The machine was assembled, coupled and restored into service after this overhaul. It is since operating normal, with steady-state overall vibration amplitude of 0.63 mil (16 microns p-p). Compressor rotor's thrust position is 8 mil in normal direction (0.20 mm) and bearing metal temperatures are at pre-shutdown level, 162 °F (72 °C).

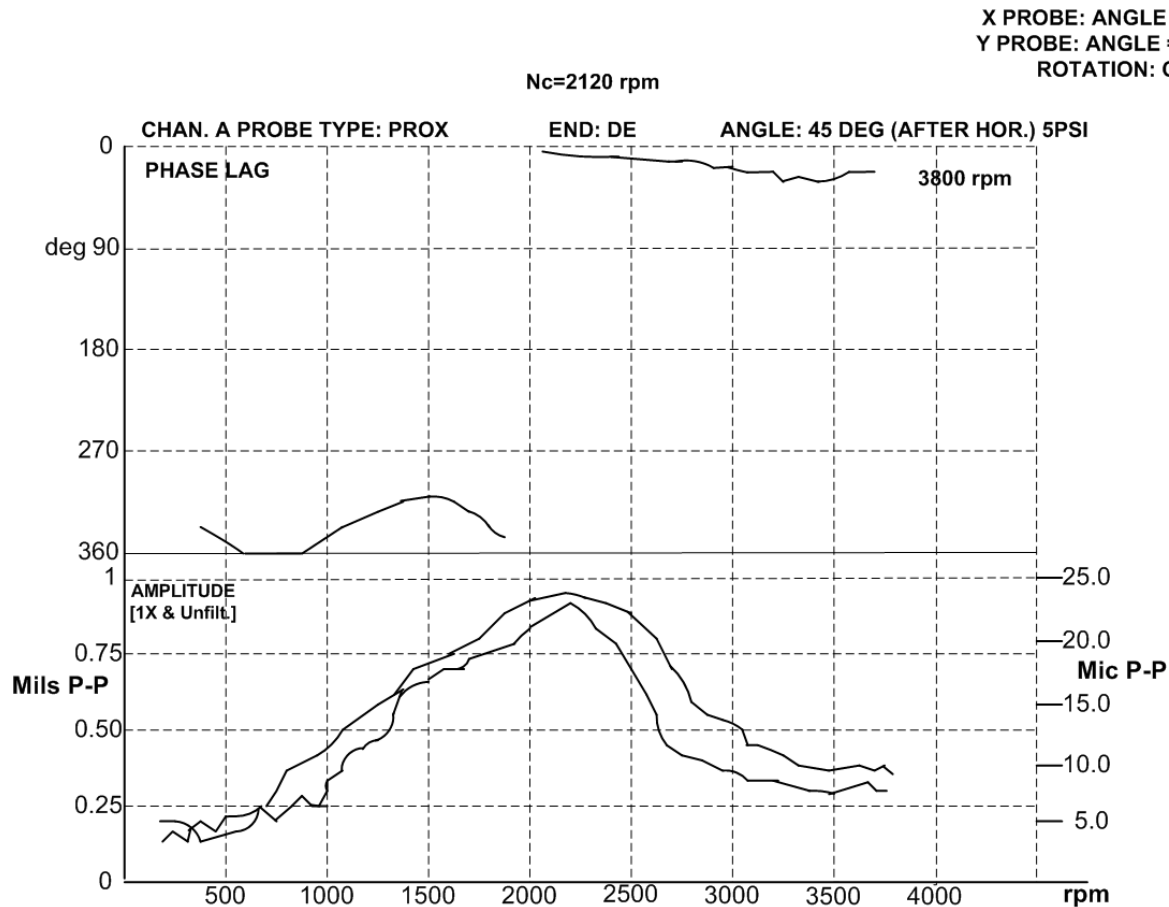
## Bode Plot during Compressor's deceleration

- The compressor rotor's calculated first critical speed is 2120 rpm. As the operating speed was reduced to below the critical speed, the radial vibrations became more prominent, both in p-p amplitude and phase.

- The change in radial vibrations was 35%, from normal 0.67 mil (17  $\mu\text{m}$  p-p) to 0.90 mil (23  $\mu\text{m}$  p-p). High vibration alarm is set at 0.98 mil (25  $\mu\text{m}$  p-p).
- The panel operators had ignored increasing vibration amplitude at both radial bearings and also the shift from normal thrust.
- With elevated vibration level, clearance at the balance piston seal was eventually exceeded and its rotating labyrinths rubbed with the stationery lead seal lining, causing friction that negatively impacted the rotor's stiffness.
- Rub at the balance piston seal caused localized heating and expansion.

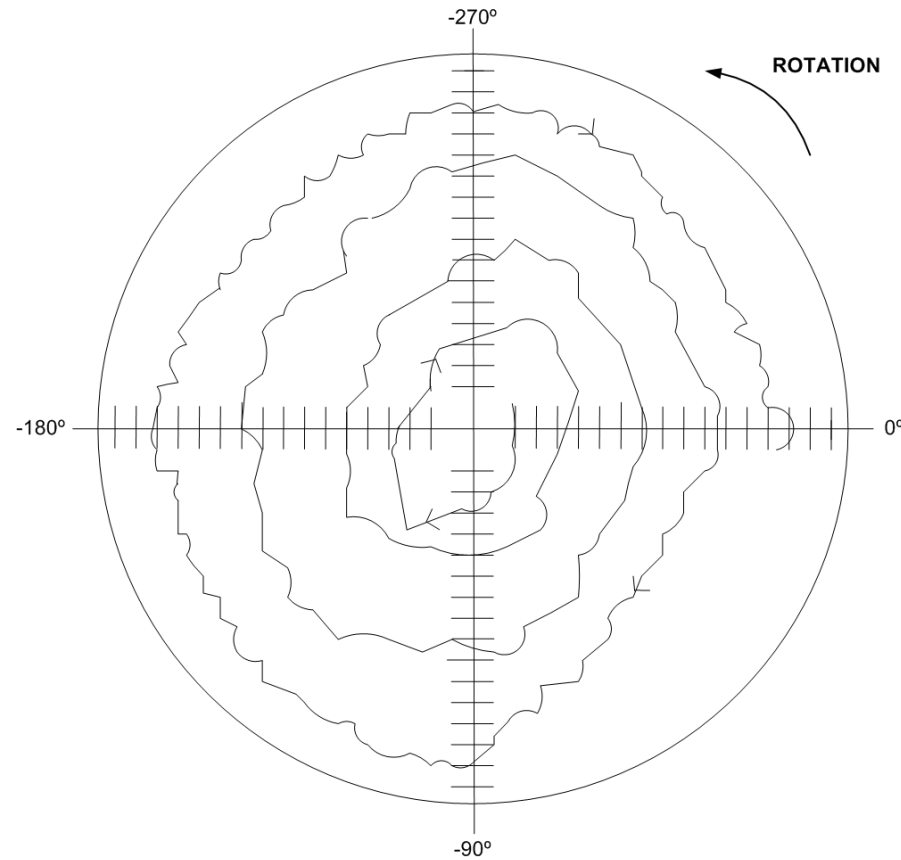
## Polar Plot at Compressor Non-Drive End Radial Bearing

- It is mentioned earlier in this case study that the temperature limit of the lead seal installed in this compressor is 350 °F (~177 °C). The investigators concluded that the rub induced heat was severe enough to destroy the lead seal and the localized expansion caused the shaft to bend, thus adding to unbalance.
- In addition to frequency-amplitude spectrum, the polar plot data generated by the online data acquisition software also showed 1X signal's orbital motion within the radial bearings in the 15-minutes time period prior to full stop. This is a distinctive characteristic of thermal rub phenomenon.

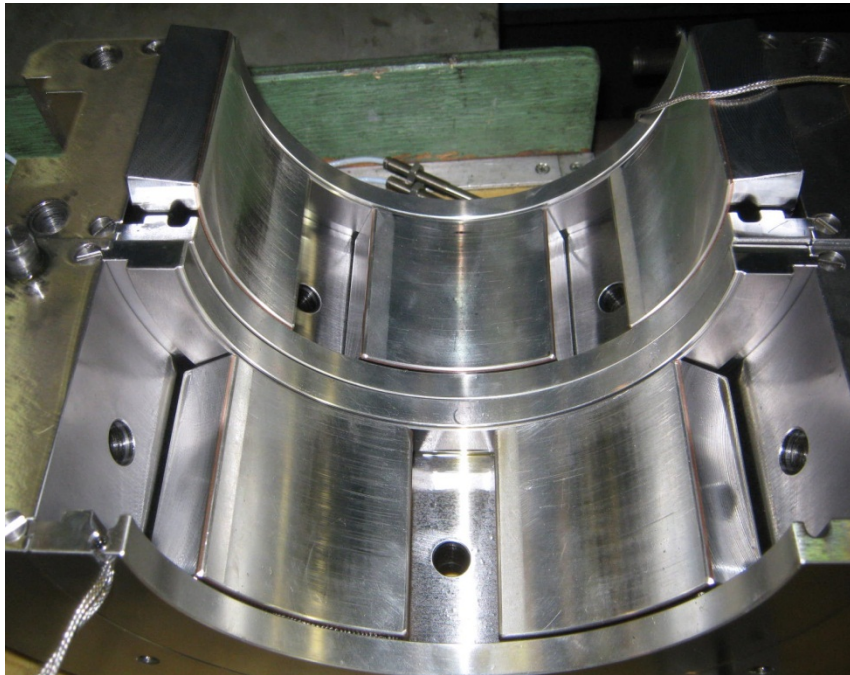
New Drive End Radial Bearing

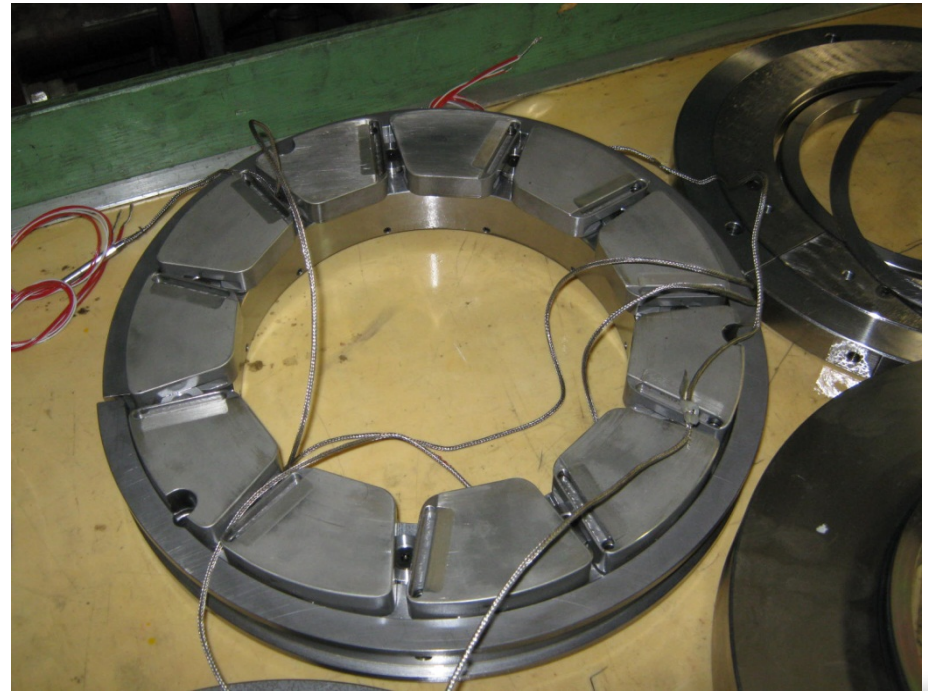
New Active Side Thrust Bearing

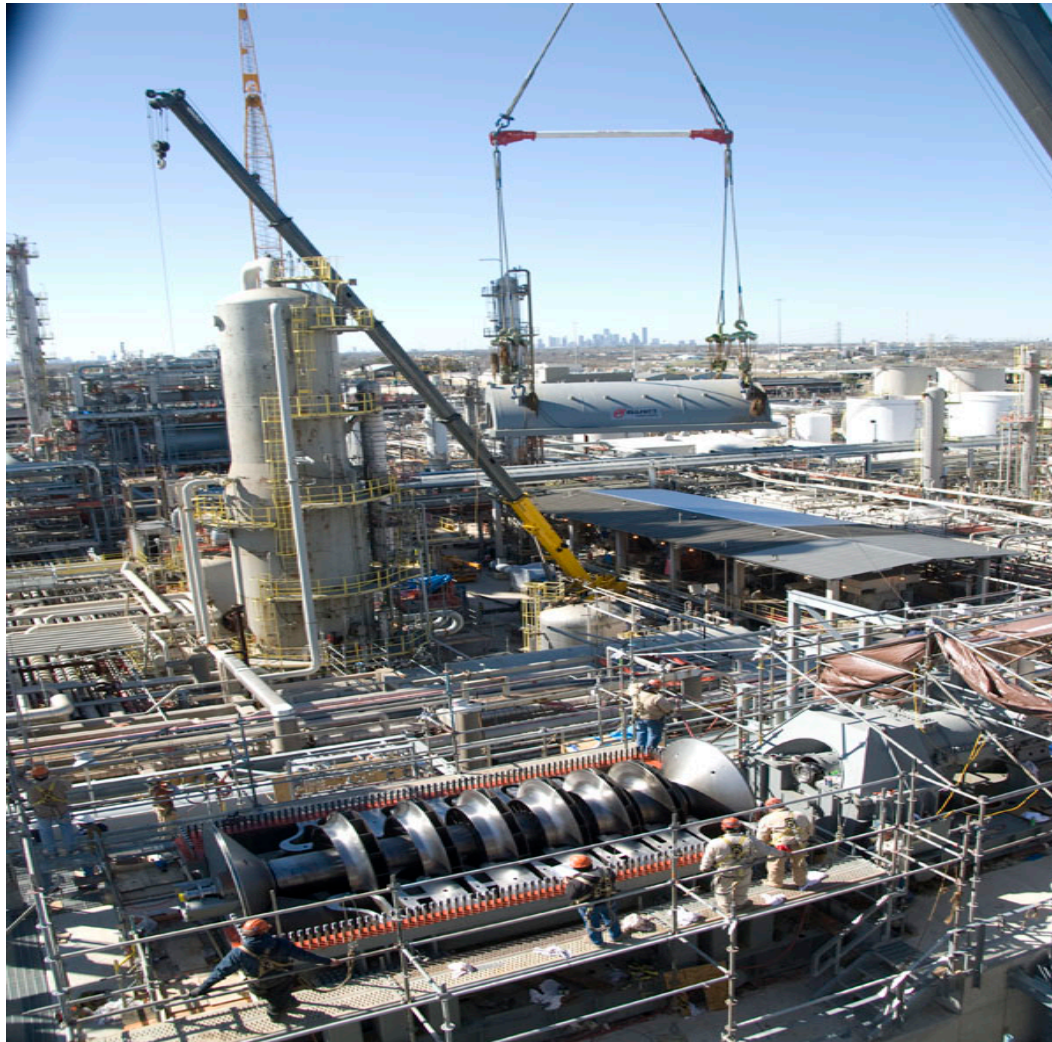
Spare Rotor installed in the casing
