RESOLVING INTERMITTENT VIBRATION SPIKES ON STEAM TURBINES

Rajakumar Thiagarajan
Rotating Equipment Engineer

42nd Turbomachinery
29th Pump SYMPOSIA

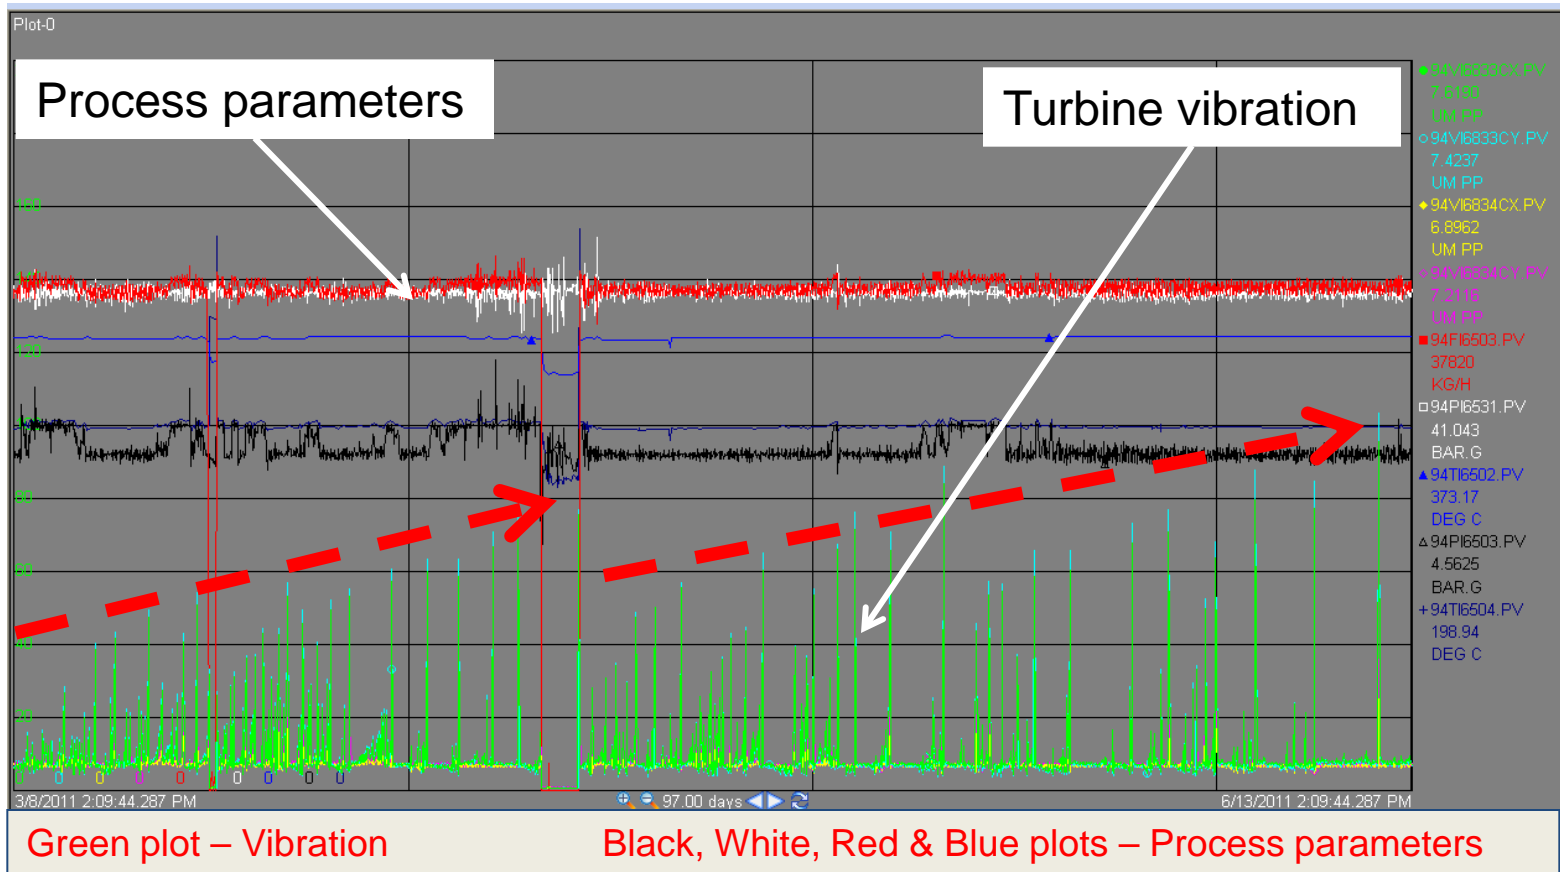
Overall Vibration vs. Process data

- Increasing Vibration Trend & High vibration Trip
- No correlation with the process parameters

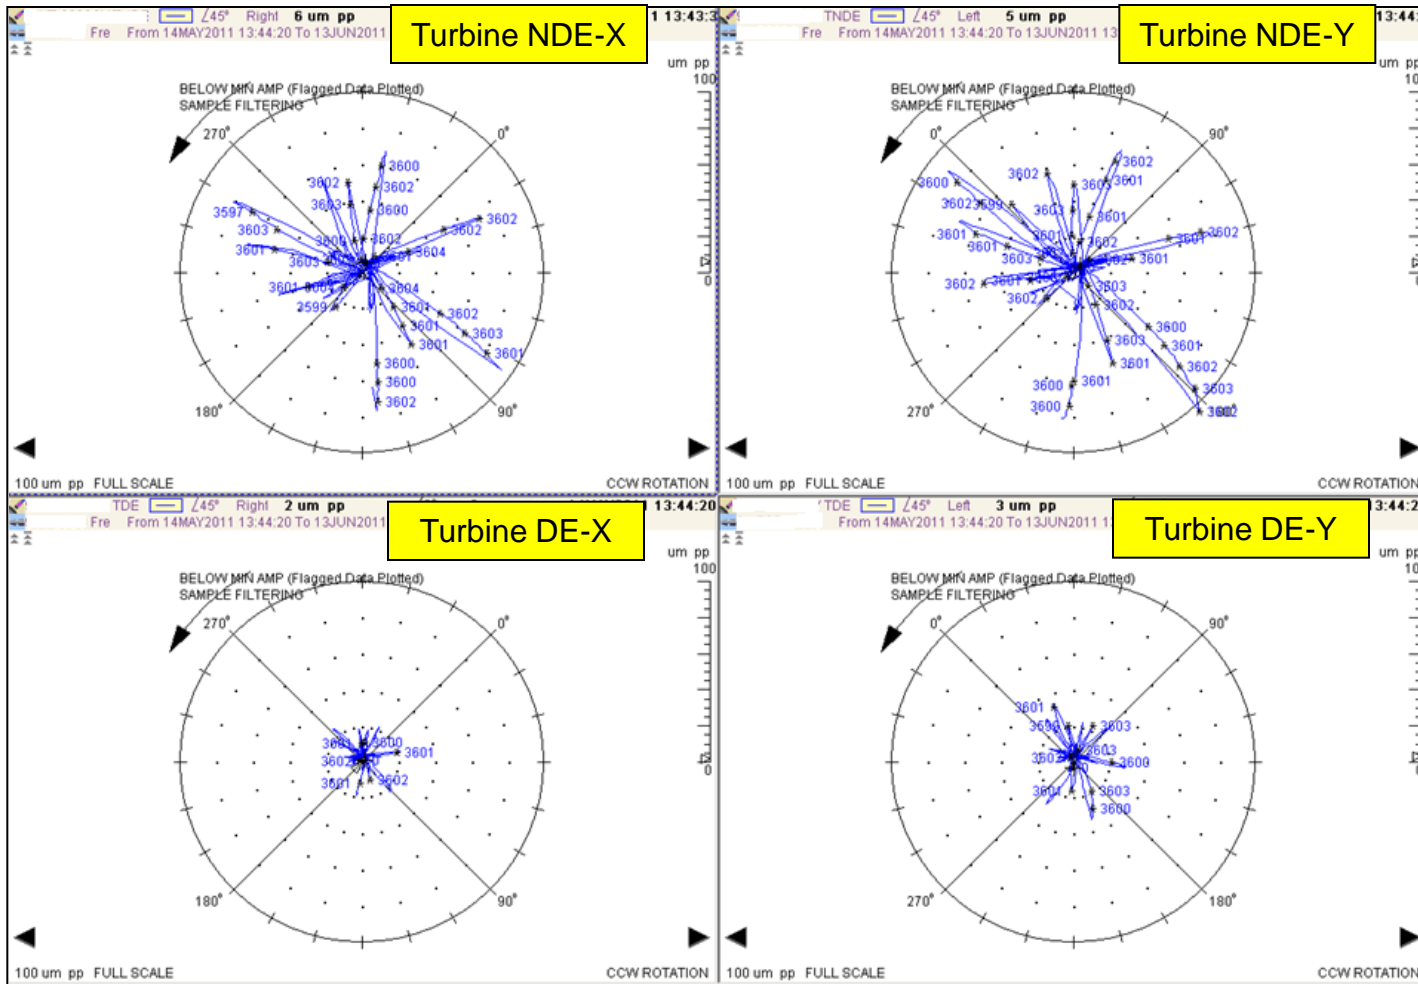
Polar Plot – 1X Amplitude & Phase Angle

Abnormal Behavior – Significant Phase Angle Change During Steady State (All Over 360°)

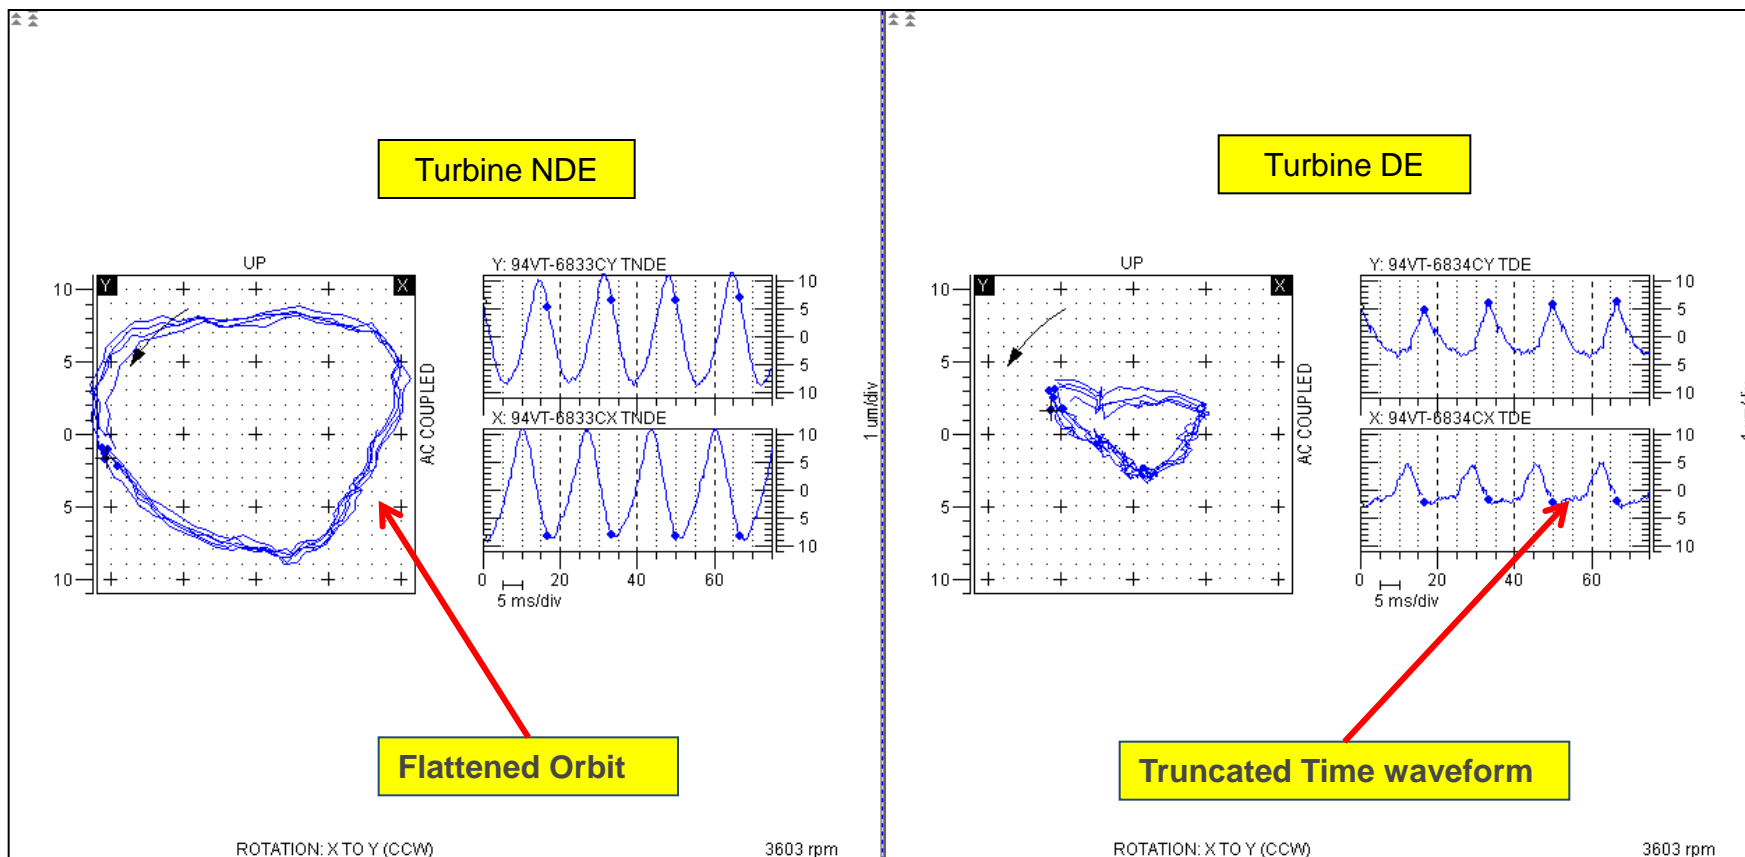
Direct Orbit Review During Vibration Excursion

Flat Orbit & Truncated Time Waveform due to Rub

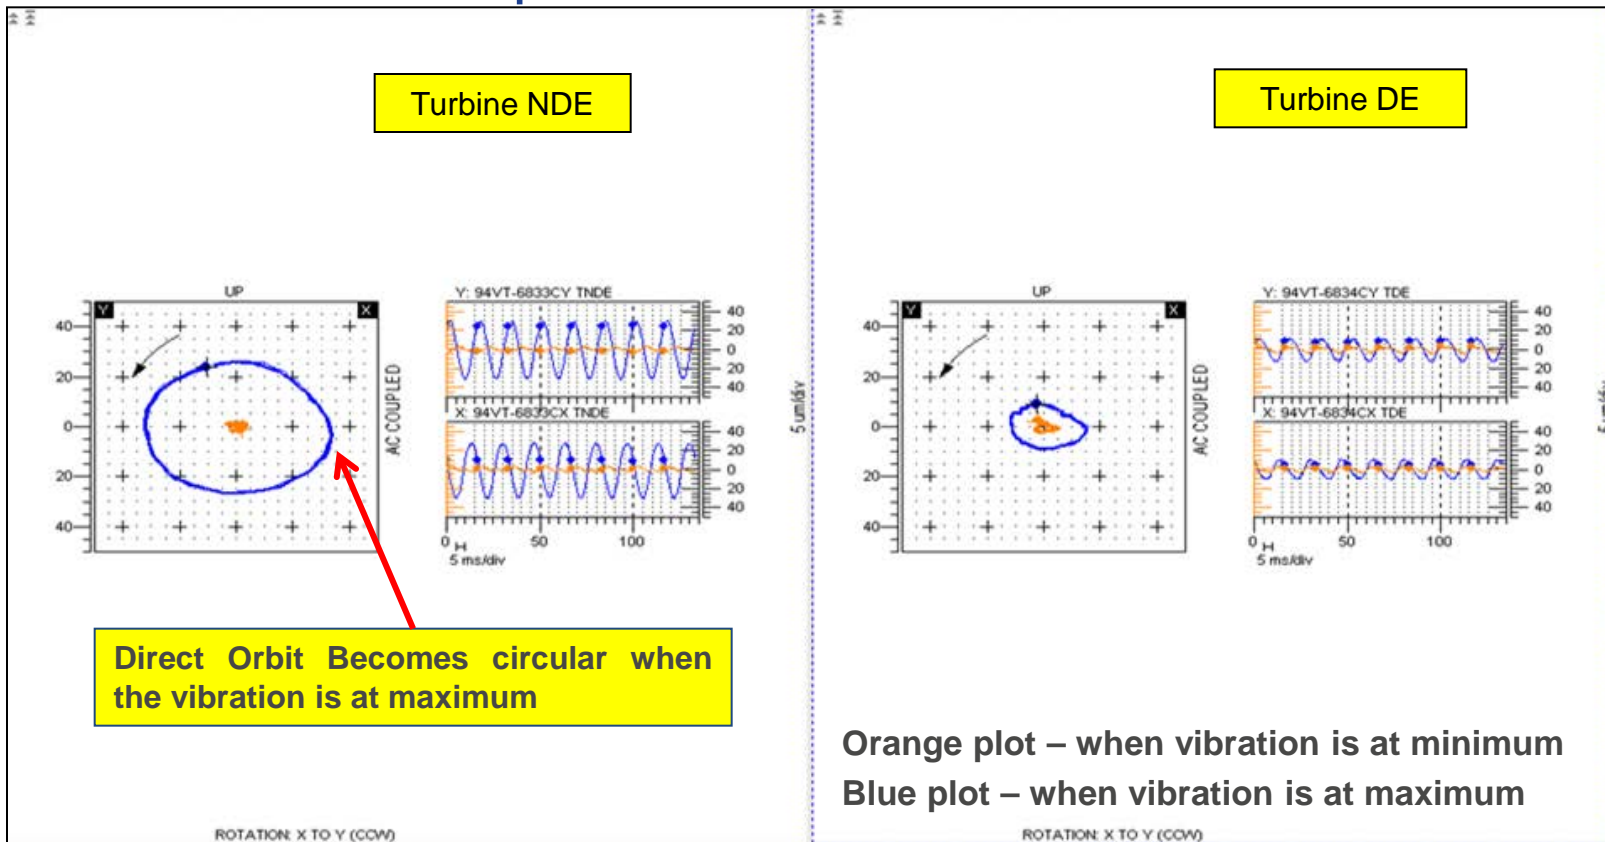
Direct Orbit Overlay – Comparison of Low & High Vibration Amplitudes

Significant change in the Orbit Shape & Amplitude (Change in Balance Condition Due to Thermal Bow)

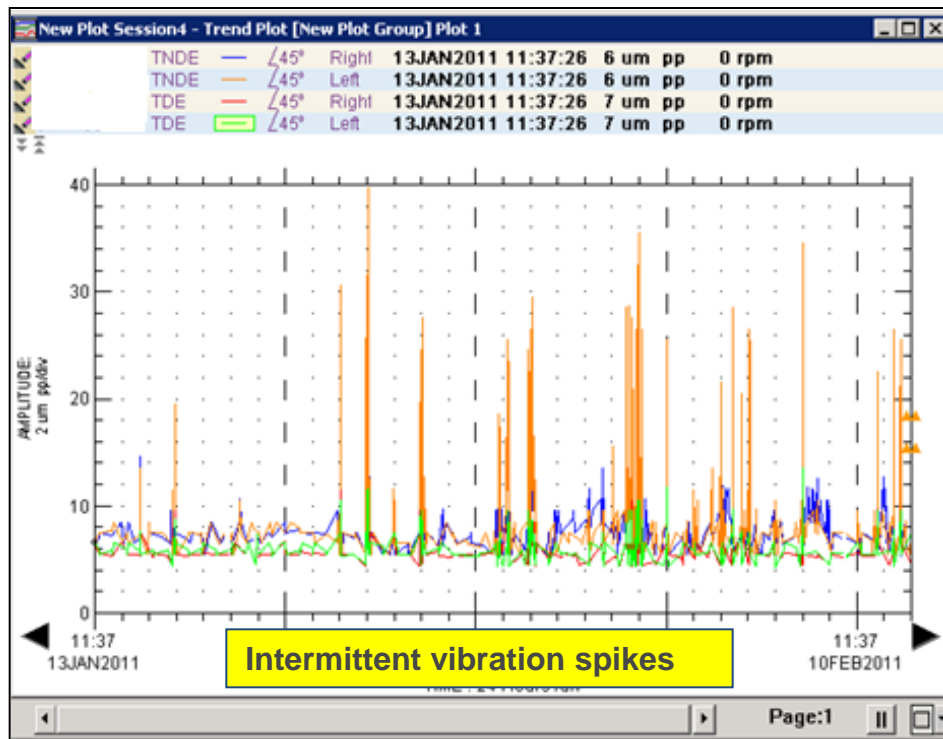
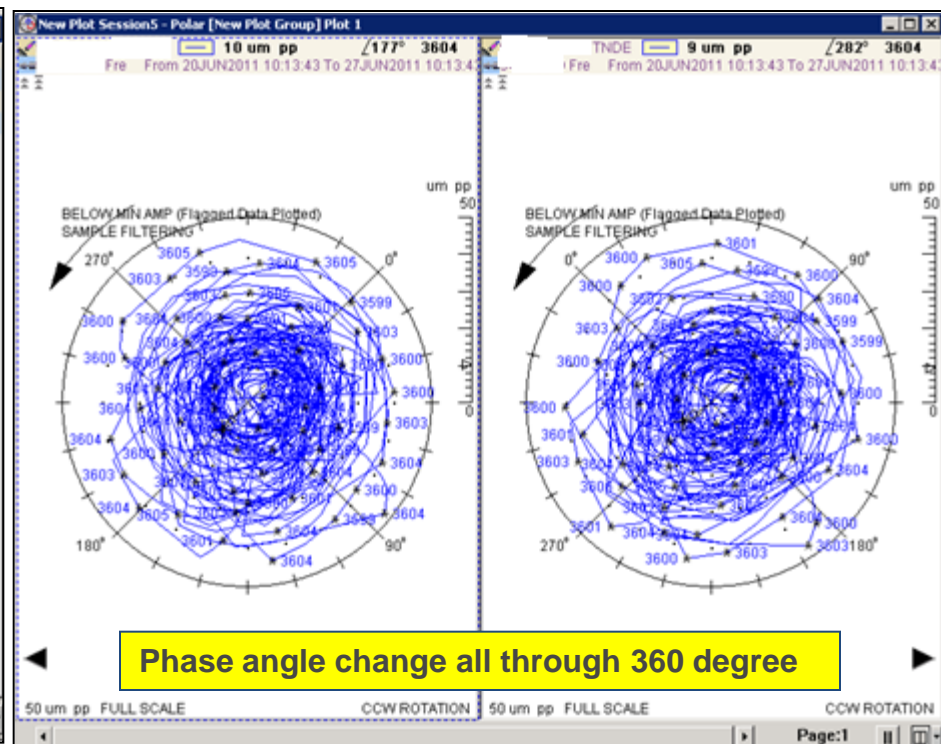
Vibration Trend and Polar Plot – Reviewed for 2nd Steam Turbine

Similar Behavior - Intermittent vibration
Amplitude & Change in Phase Angle

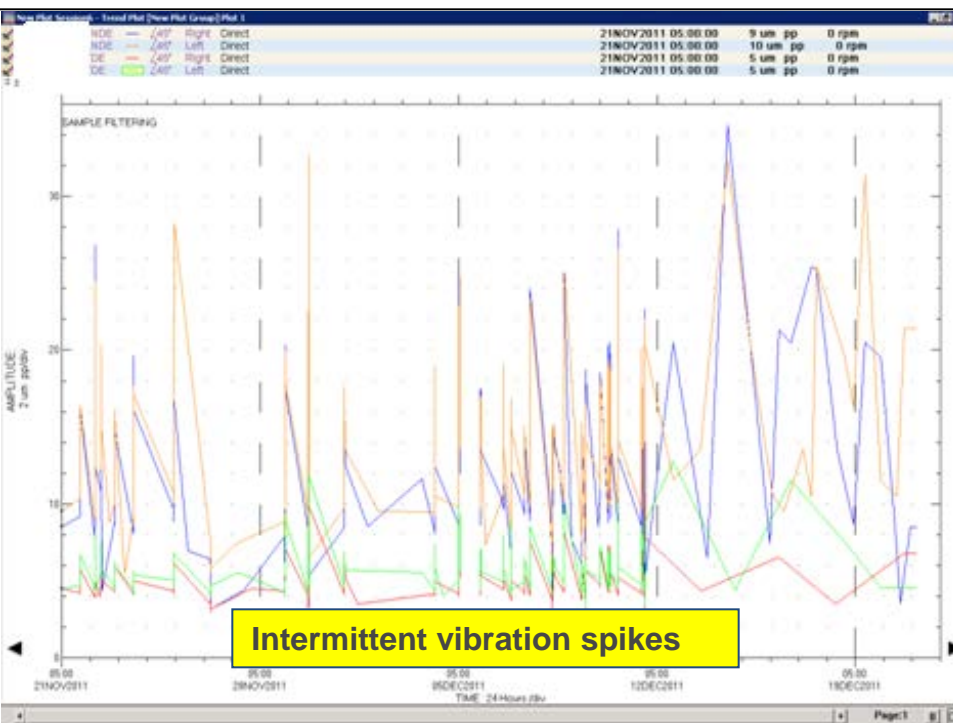
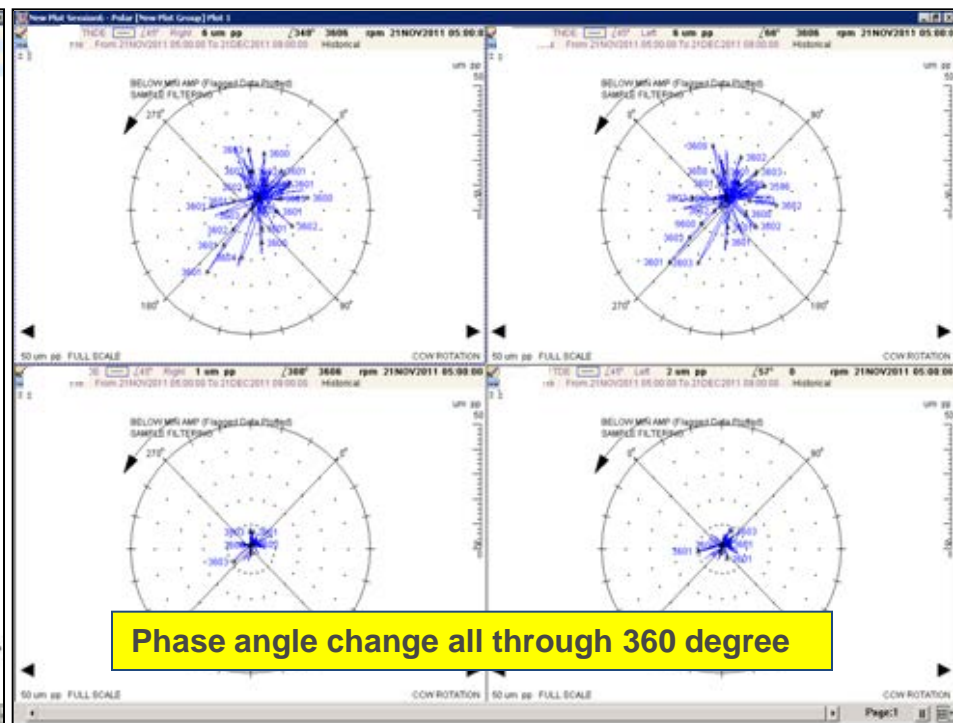
Vibration Trend and Polar Plot – Reviewed for 3rd Steam Turbine

Similar Behavior But Less Severity - Intermittent vibration Amplitude & Change in Phase Angle

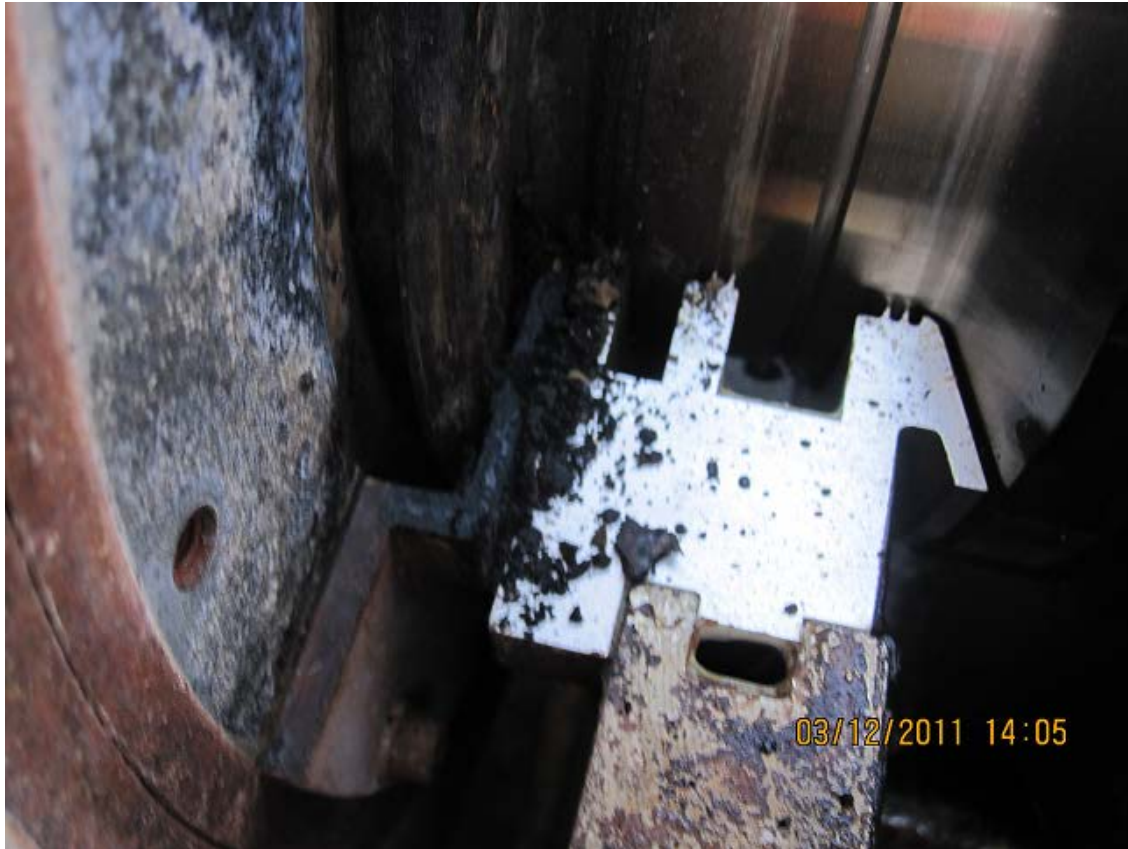
Oil Seal Area at Non Drive End Bearing of 1st Turbine

- *Carbonized oil buildup in the oil deflector / seal area.*

Carbonized deposits at NDE seal area

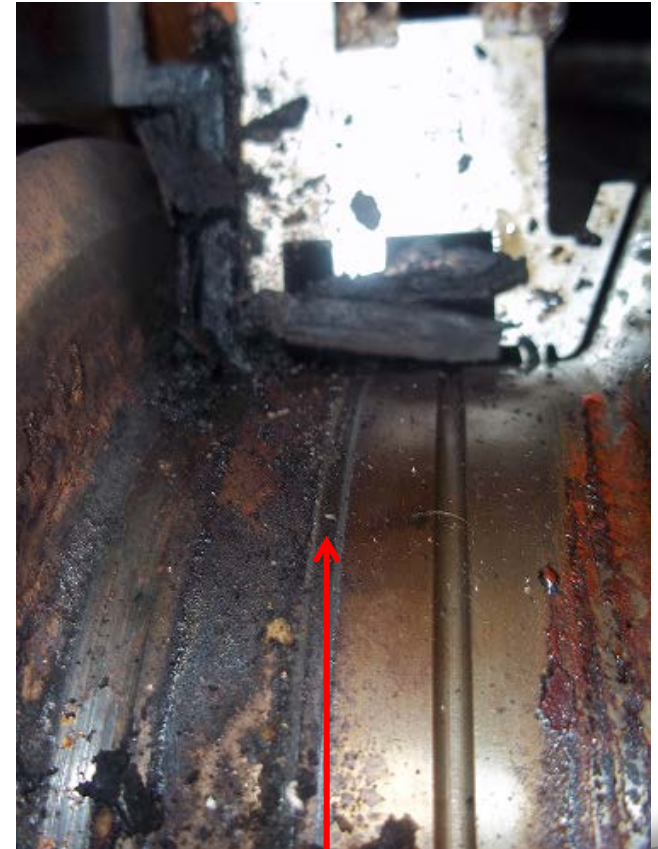
Rubbing Marks on the shaft

Rubbing Marks at the seal area due to oil carbonization is evidenced.

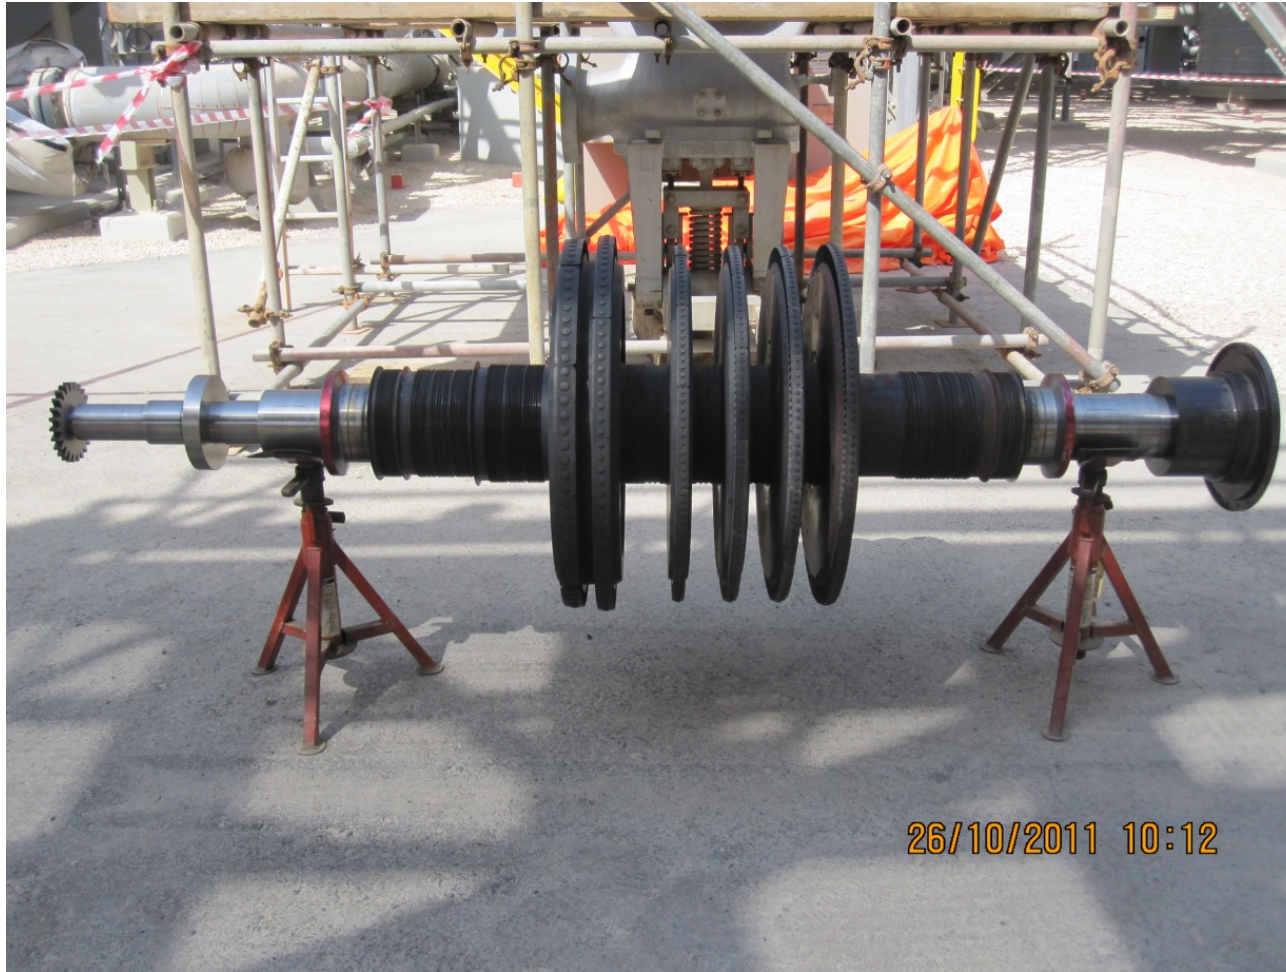
Rotor Internals of 1st Turbine

No abnormalities noticed on the Rotor internal components.

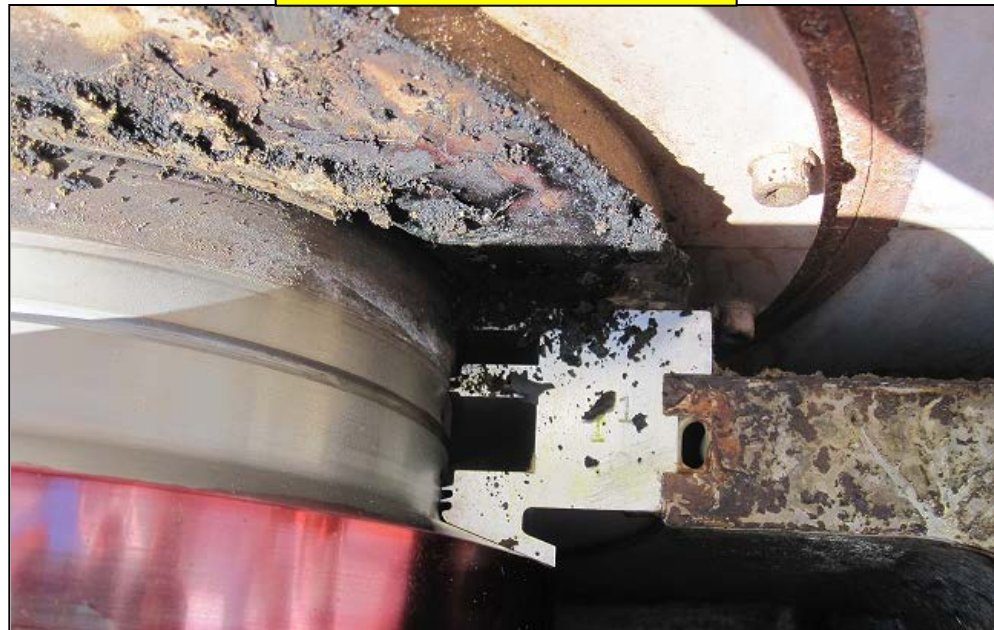
Seal Area of 2nd Turbine

- Oil Carbonization deposits and Rubbing Marks at the seal area
- Based on the inspection results of 1st Turbine, no internal checks carried out for the 2nd & 3rd Machines
