HOW AN ON-LINE MONITORING SYSTEM SUCCESSFULLY  
TRIPPED A 4-THROW RECIPROCATING COMPRESSOR ON  
THREE SEPARATE EVENTS PREVENTING MAJOR  
EQUIPMENT DAMAGE AND DOWNTIME

Eric Miller  
DuPont

Skip Morrison  
Prognost Systems, Inc

42<sup>nd</sup> Turbomachinery  
29<sup>th</sup> Pump SYMPOSIA

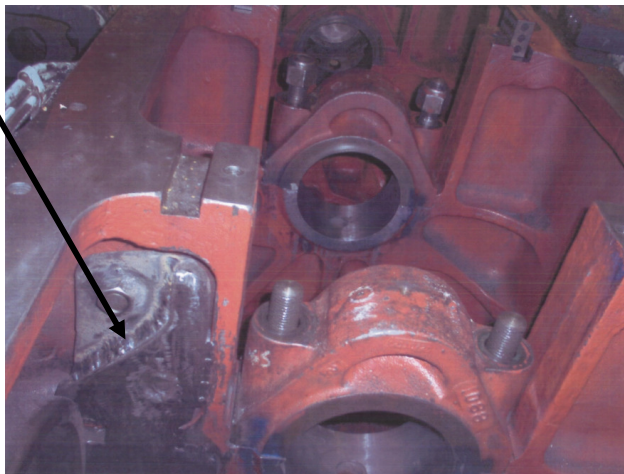
Metal-Stitch Repairs

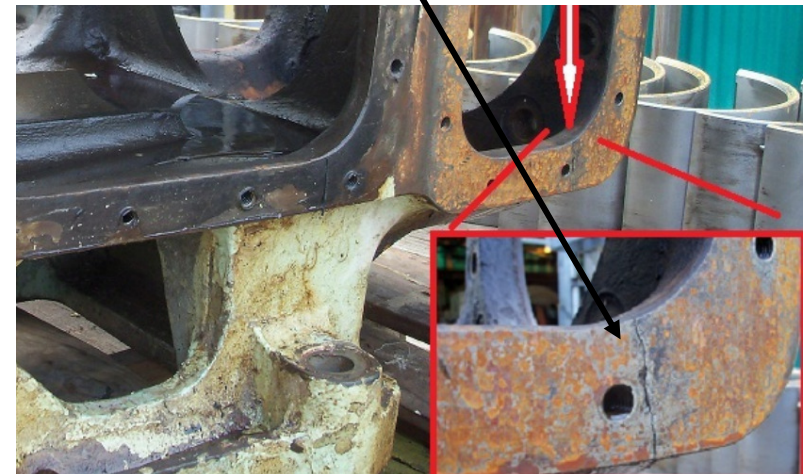
Crack in distance piece

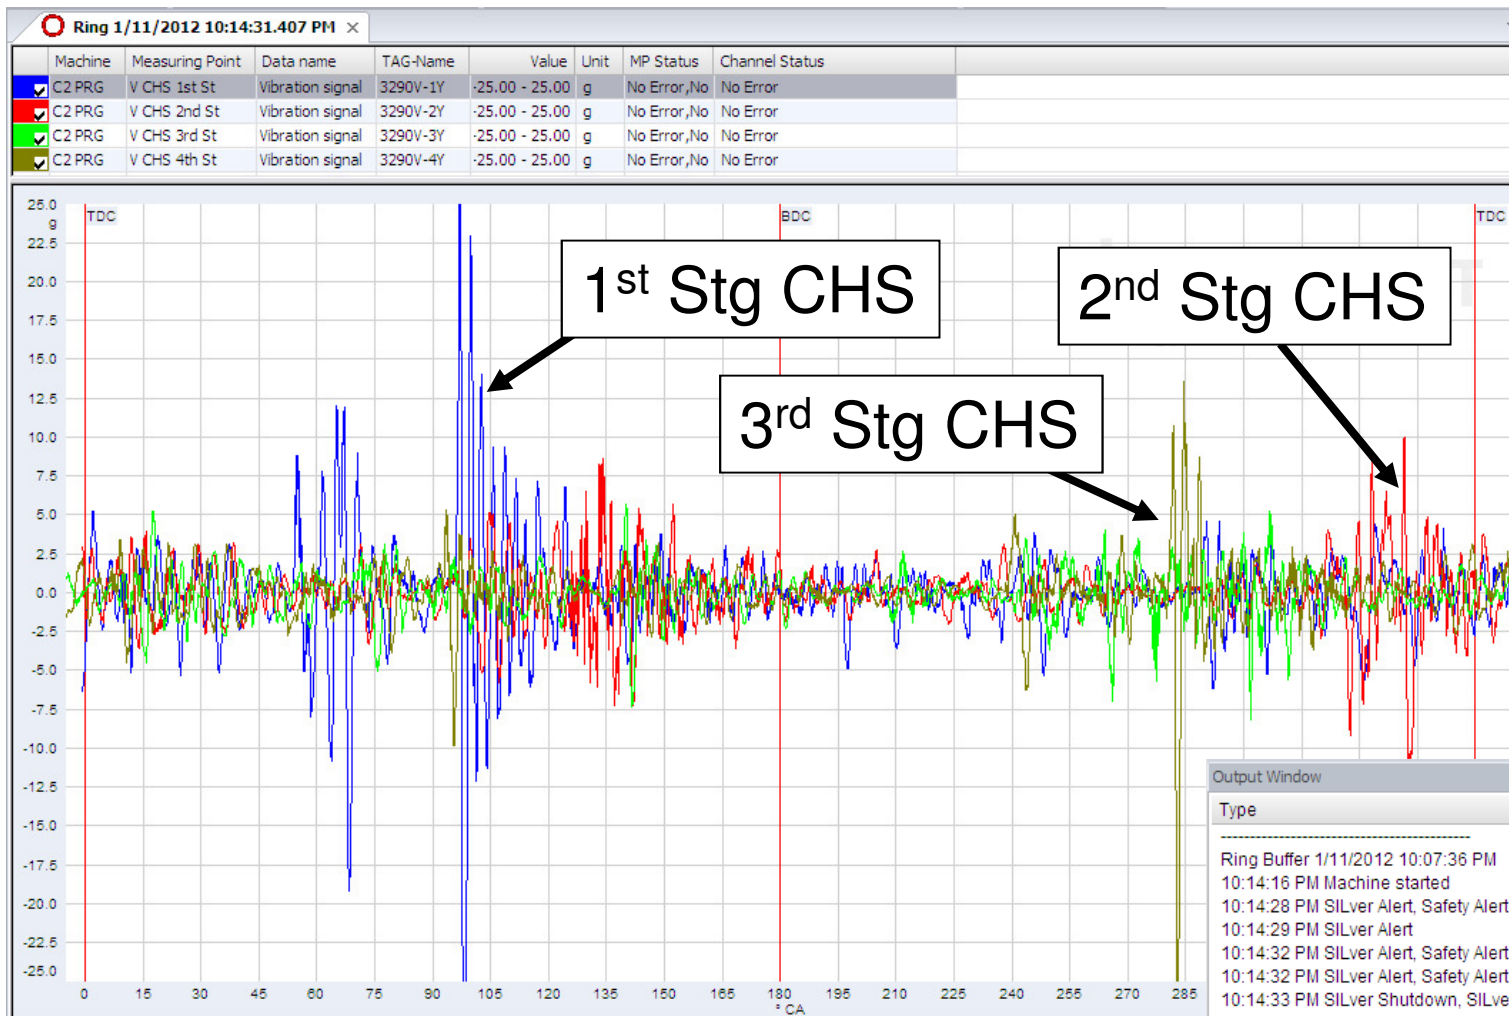
- 1/11/12 10:14 pm Interlock 17 seconds after started compressor due to being full of liquid
- 1/12/12 – 1/17/12 Repairs made – New valves on all stages, pushed pin on 1<sup>st</sup> and 2<sup>nd</sup> stage – no wear and clearances OK. Drained liquid from low points.
- 1/17/12 11:30 pm Machine started after repairs
- 2/3/12 10:28 pm Alert on 2<sup>nd</sup> Stg CHS RMS Vibration – Segment 34

# Interlock 17 seconds after started due to liquid

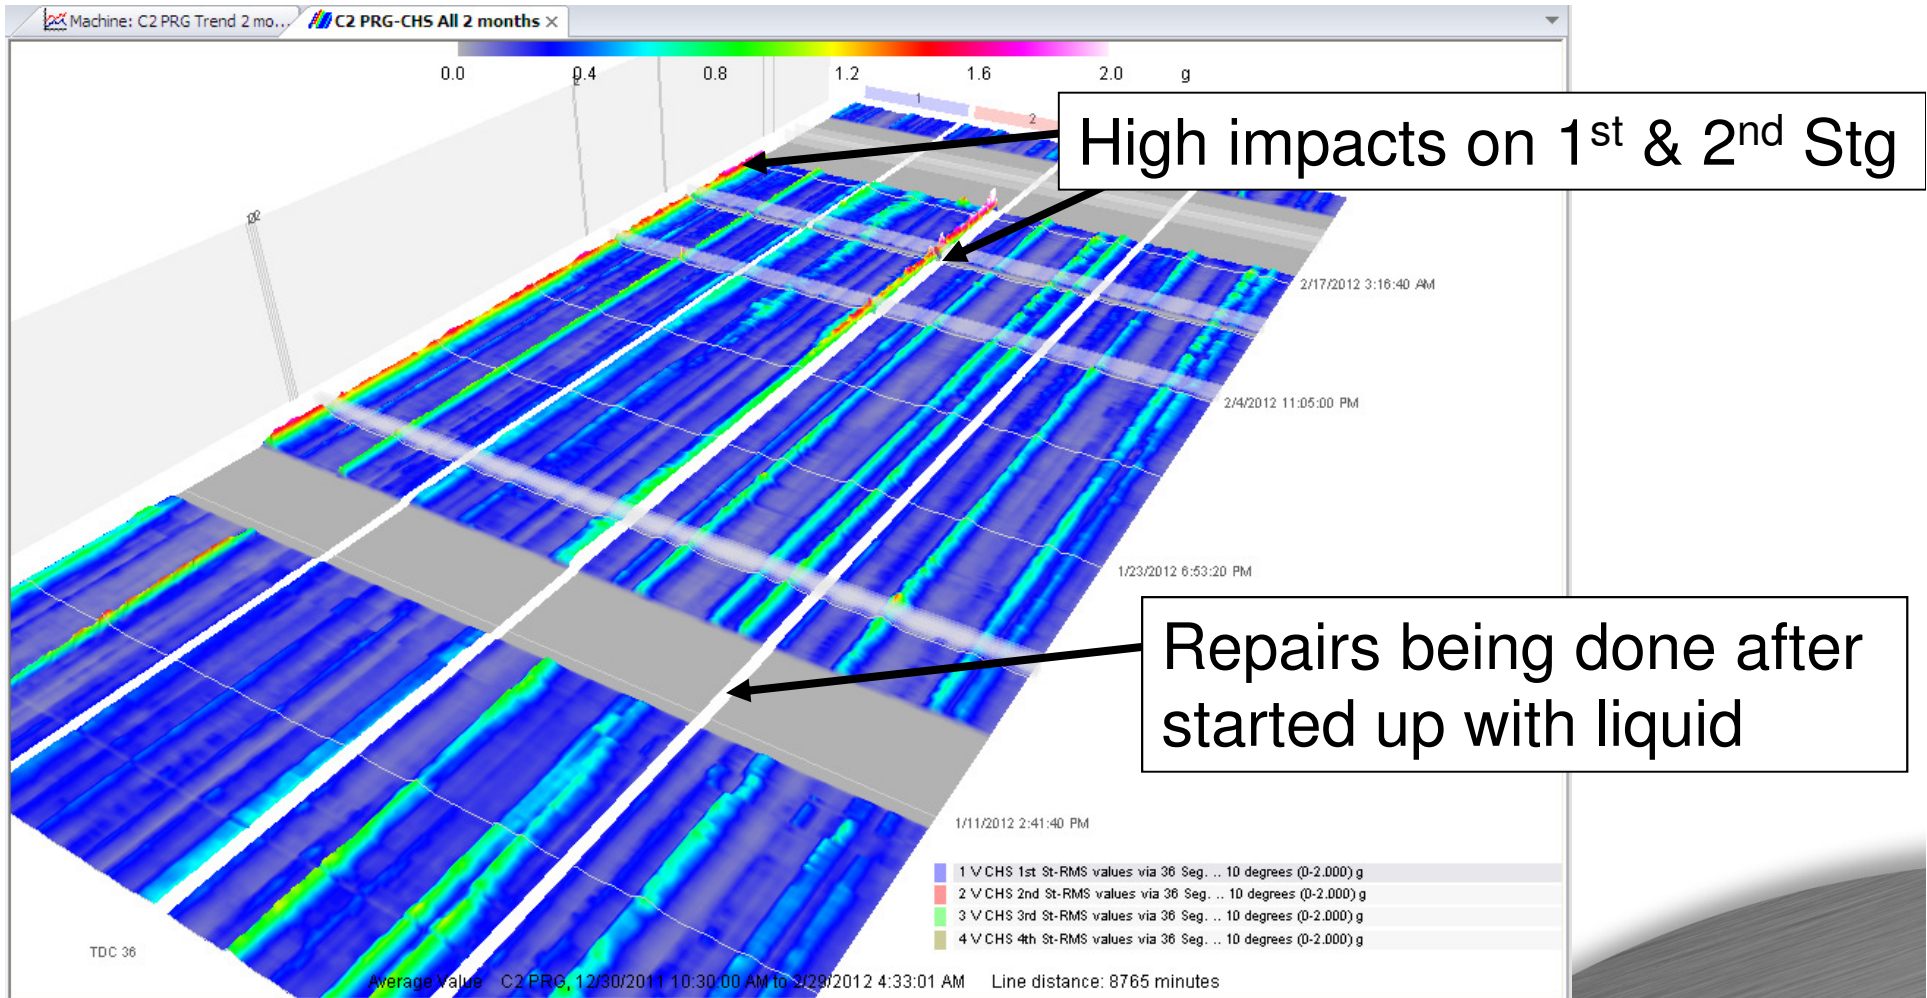
# Suspected problems with 1<sup>st</sup> & 2<sup>nd</sup> Stages

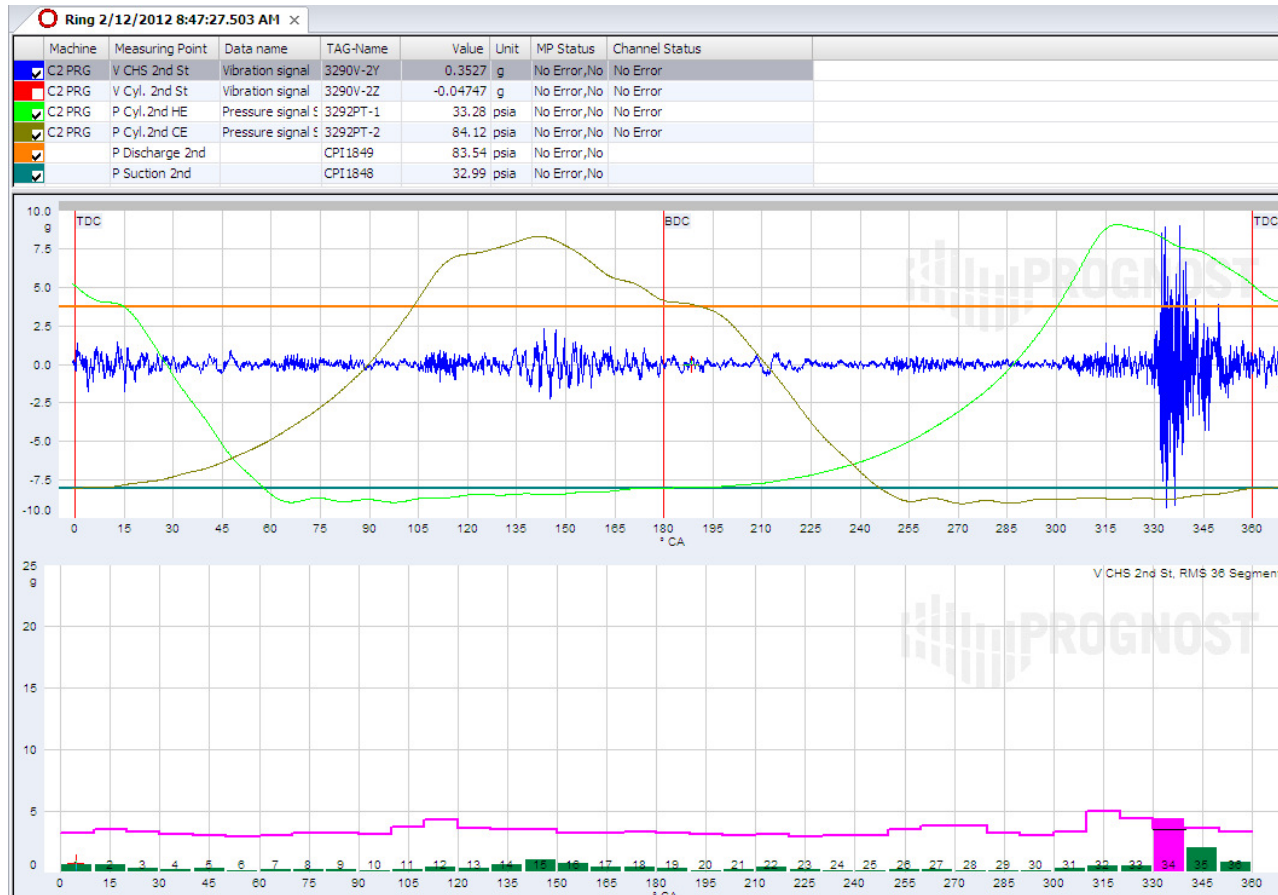
# 2<sup>nd</sup> Stg CHS ALERT (2/3/12 until 2/18/12)

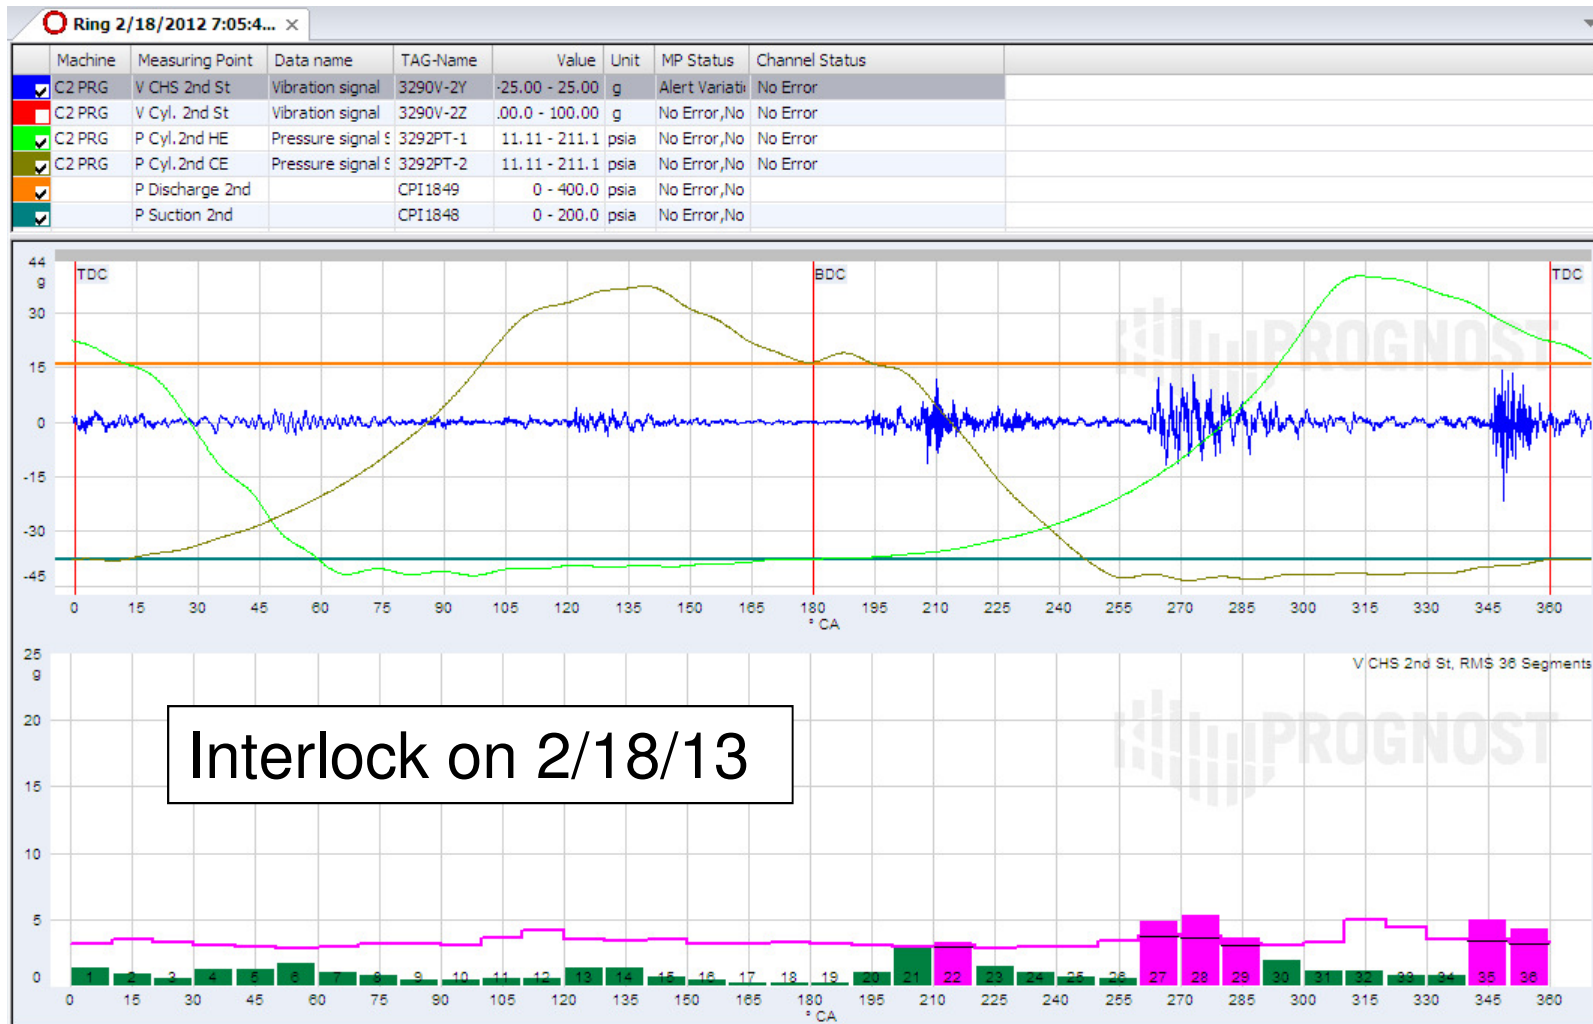
- 2/18/12 6:05 am Interlock on 2<sup>nd</sup> Stg CHS RMS Vibration
- 2/18/12 6:14 am Started 9 minutes after Interlock (Ooops!) Interlock on 2<sup>nd</sup> Stg CHS RMS Vibration (ran 8 minutes with many segment violations)
- 2/18/12 – 2/22/12 Repairs made – Found loose 2<sup>nd</sup> stage piston nut. Changed 1<sup>st</sup> and 2<sup>nd</sup> stage pistons/rods, changed 2<sup>nd</sup> stage connecting rod and installed the RP sensors on 1<sup>st</sup> and 2<sup>nd</sup> stages

# 2<sup>nd</sup> Stg CHS – Found loose piston nut

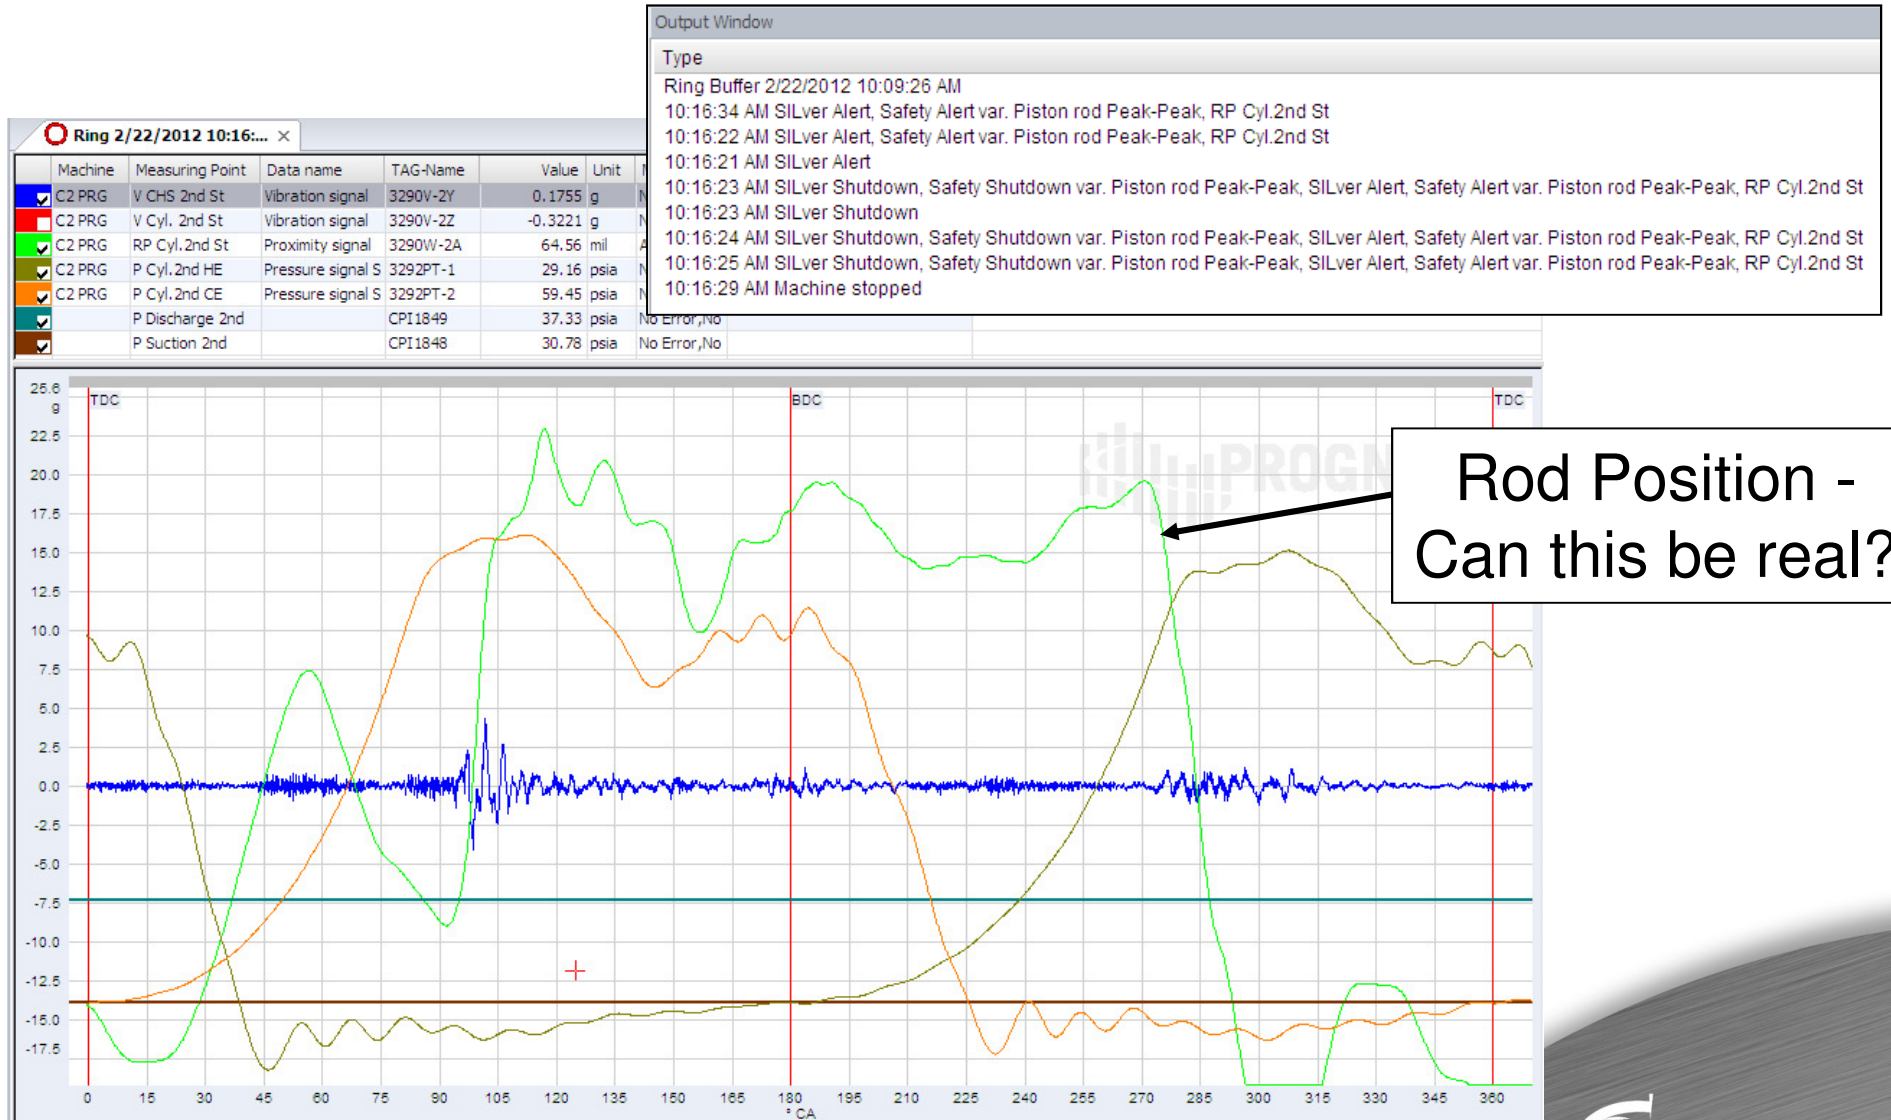
- 2/22/12 10:14 am Machine started after repairs. Interlock 82 seconds after machine started due to 2<sup>nd</sup> Stg Pk-Pk Variation Rod Run Out over 8 segments (suspected liquid)
- 2/22/12 10:41 am Machine started a 2<sup>nd</sup> time after blowing down snubbers. Interlock 63 seconds after machine started due to 2<sup>nd</sup> Stg Pk-Pk Variation Rod Run Out over 8 Segments

# Start-up after new 2<sup>nd</sup> Stg Rod installed

Rod Position -  
Can this be real?

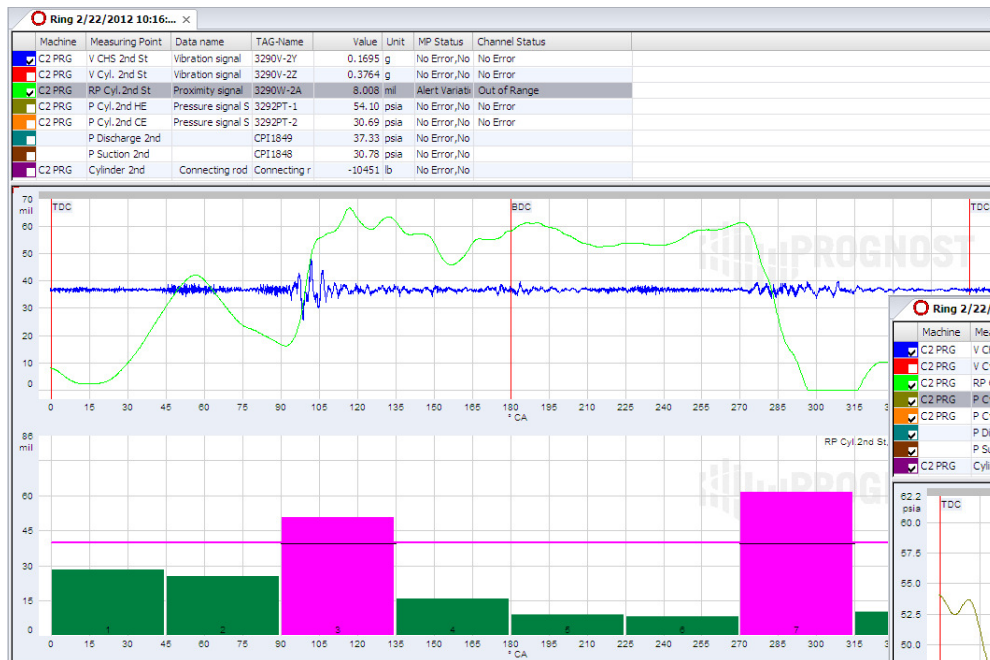
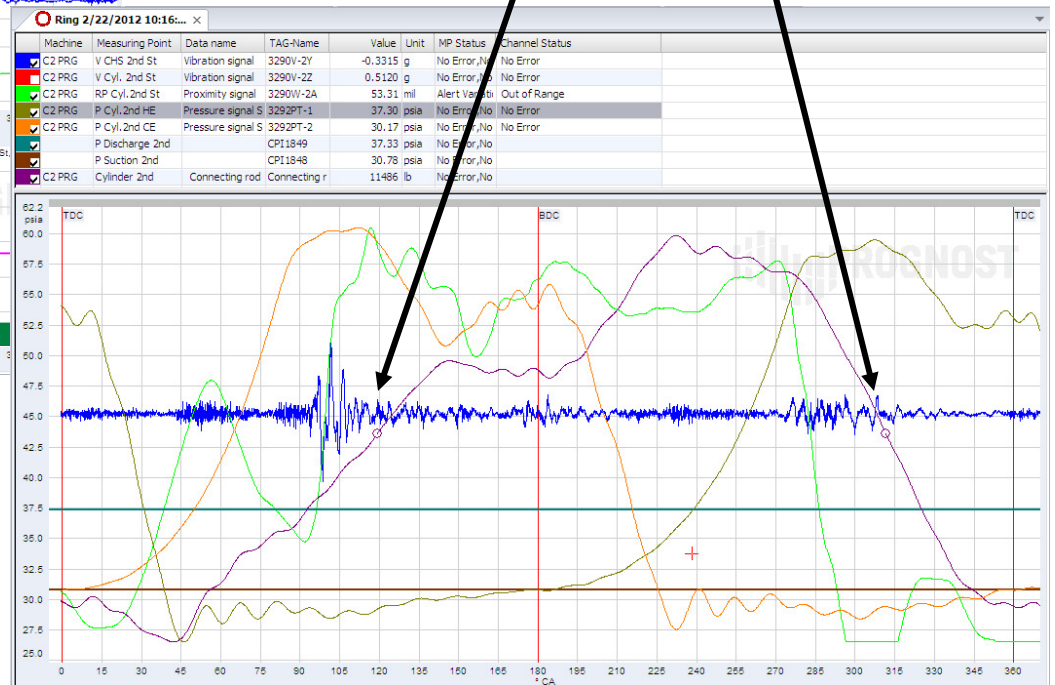
# 2<sup>nd</sup> Stage Reversal points

Reversal Points

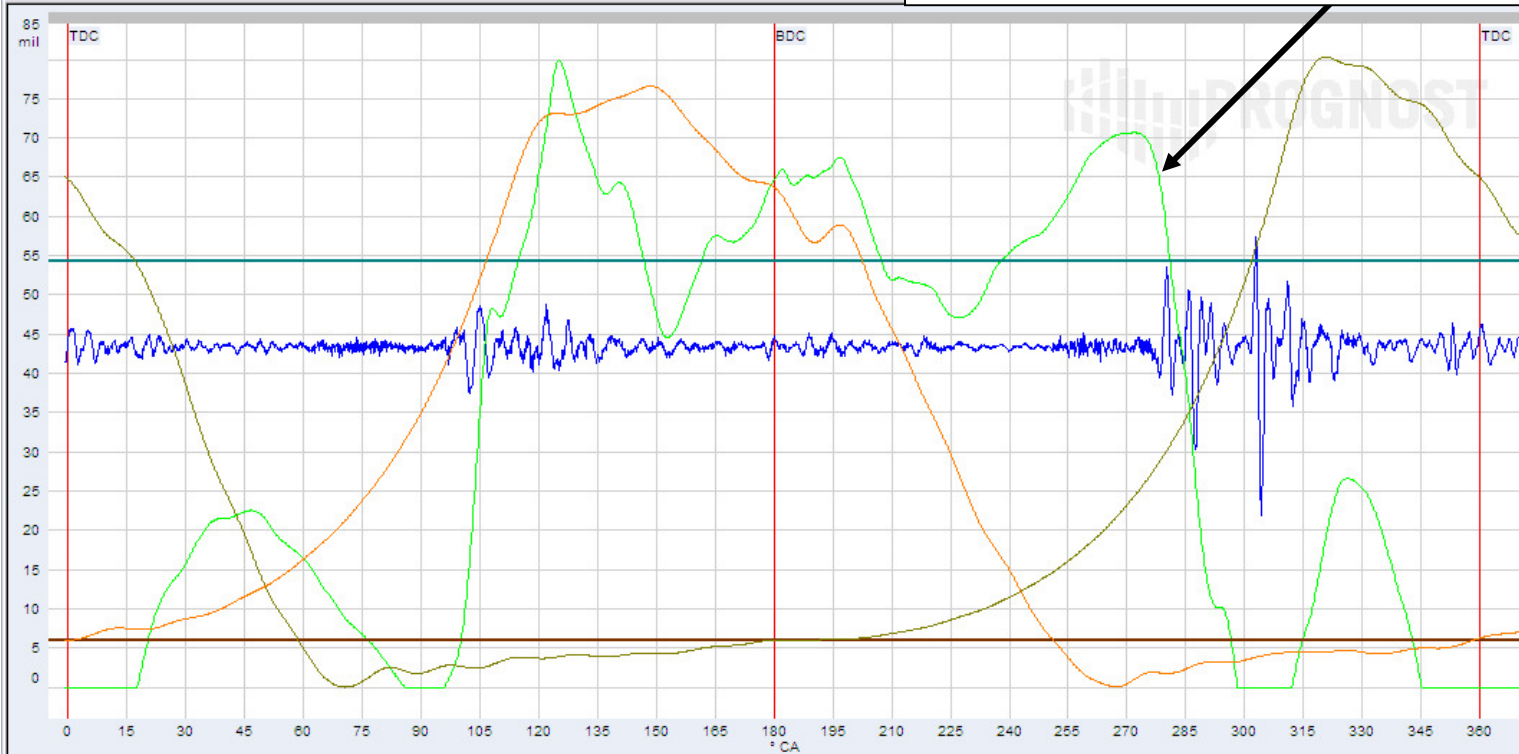
# After increasing RP Intlk to 80 mils

Almost 80 mils displacement –  
Would have interlocked if left  
At 40 mils Interlock level

- 2/22/12 11:00 am Raised Pk-Pk Rod Run Out Interlock level from 40 mils to 80 mils
- 2/22/12 12:52 pm Machine started but had interlock 25 seconds later due to 2<sup>nd</sup> Stg CHS RMS Vibration
- 2/22/12 – 2/26/12 Found crosshead pin to crosshead bushing had almost zero clearance. Changed connecting rod, crosshead, crosshead slippers, pin and bushing.
- 2/26/12 9:32 am Machine started and has been running well since

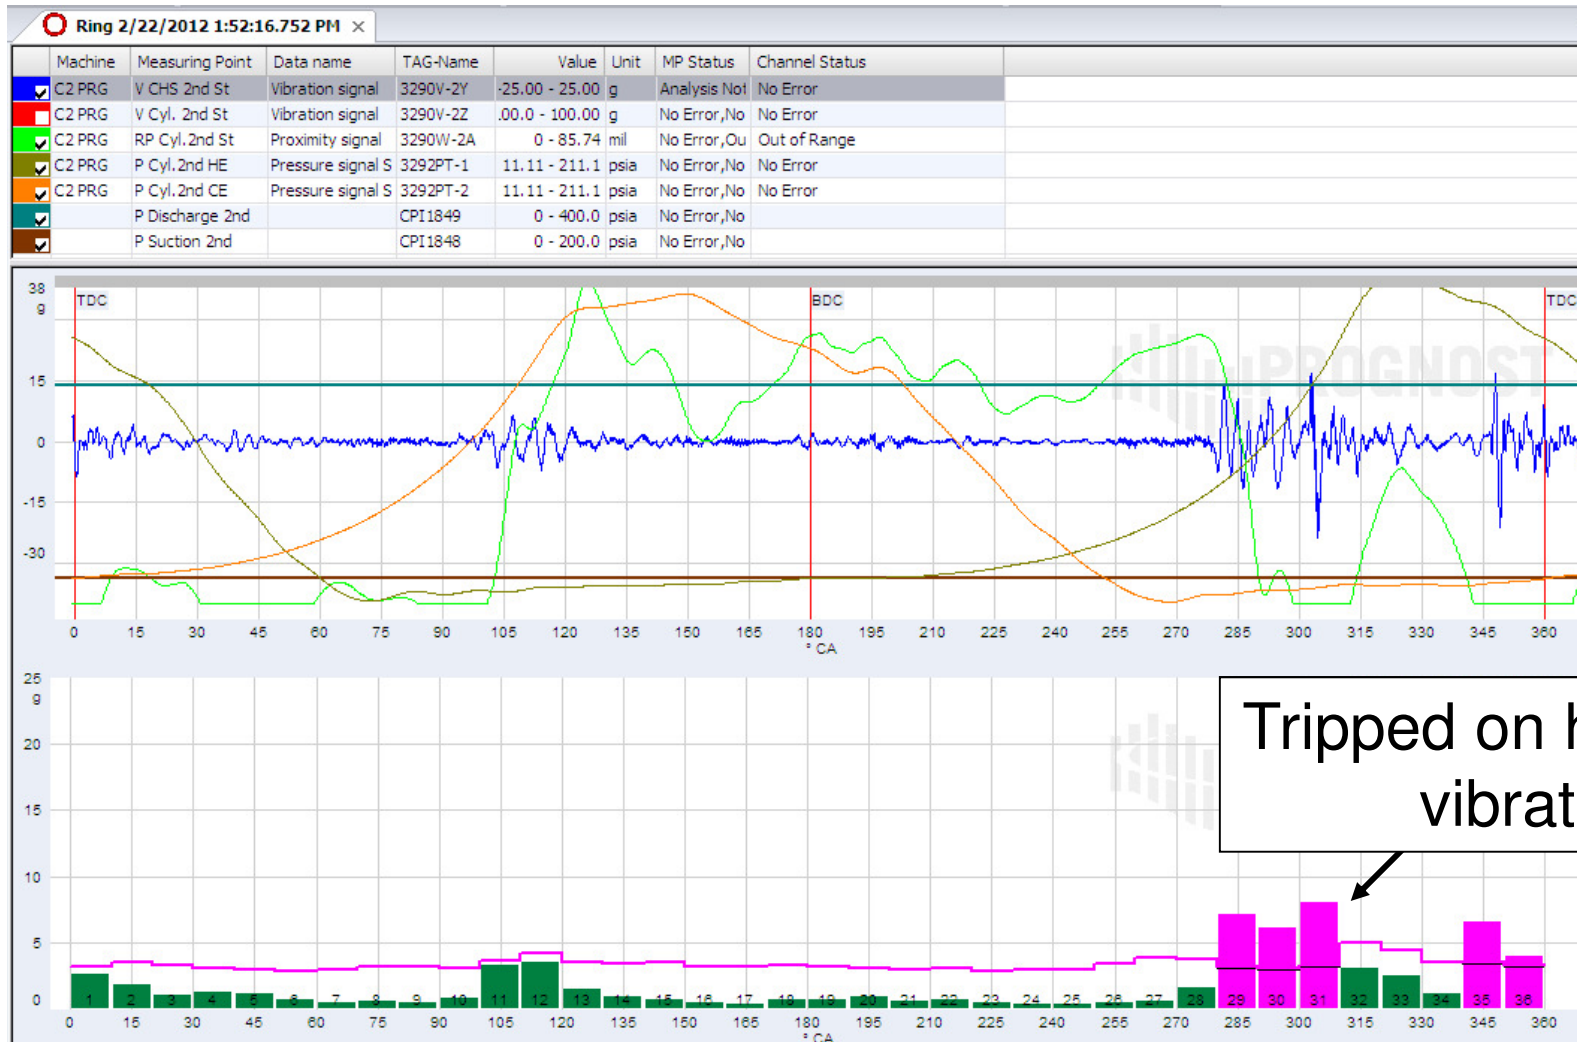
# 2<sup>nd</sup> Stg Pin to Bushing clearance inadequate

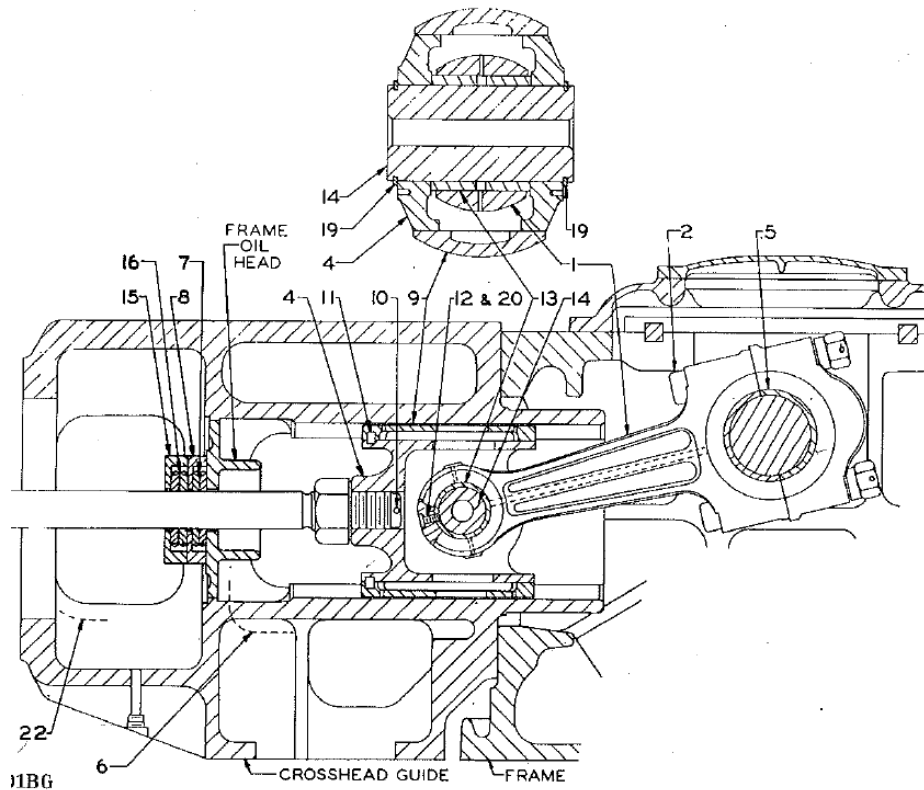
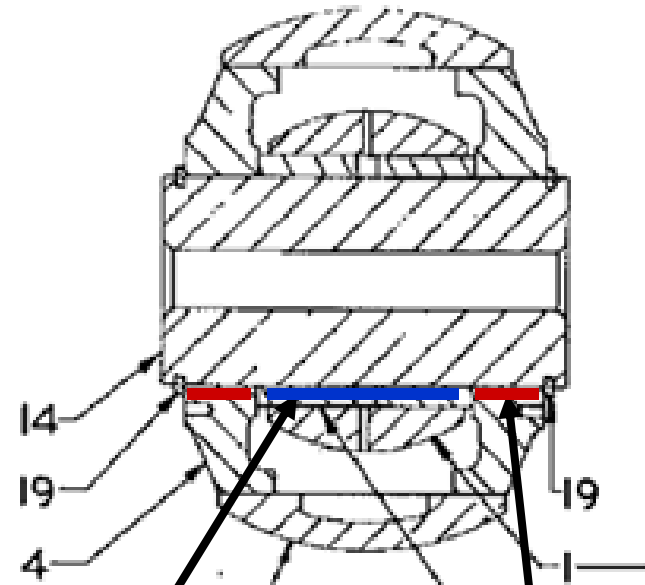
CROSSHEAD & CONNECTING ROD ASSEMBLY

## Floating Style Pin

0.0015" – 0.0045"  
clearance

0.0005" - 0.002"  
clearance

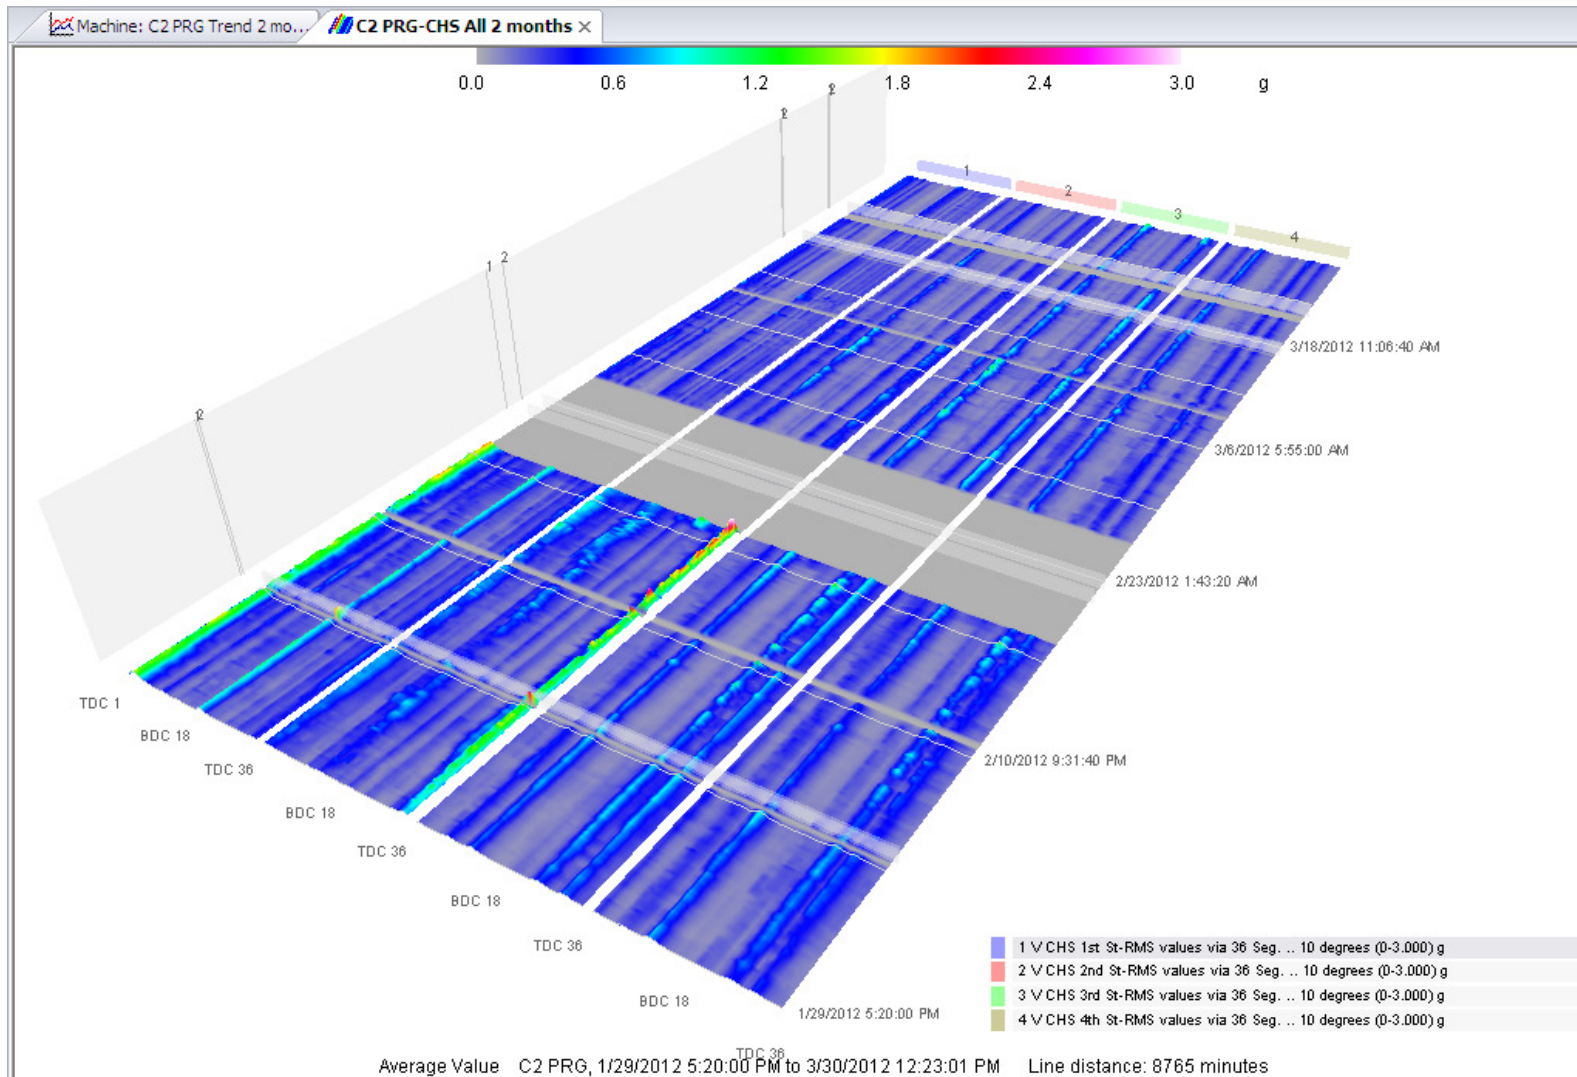
# Smooth operation after final repairs
