IMPROVING RELIABILITY ON A
CENTRIFUGAL COMPRESSOR
EXPERIENCING FREQUENT BEARING
FAILURES.

Julia Postill, PE

Dan Hunt

ABSTRACT

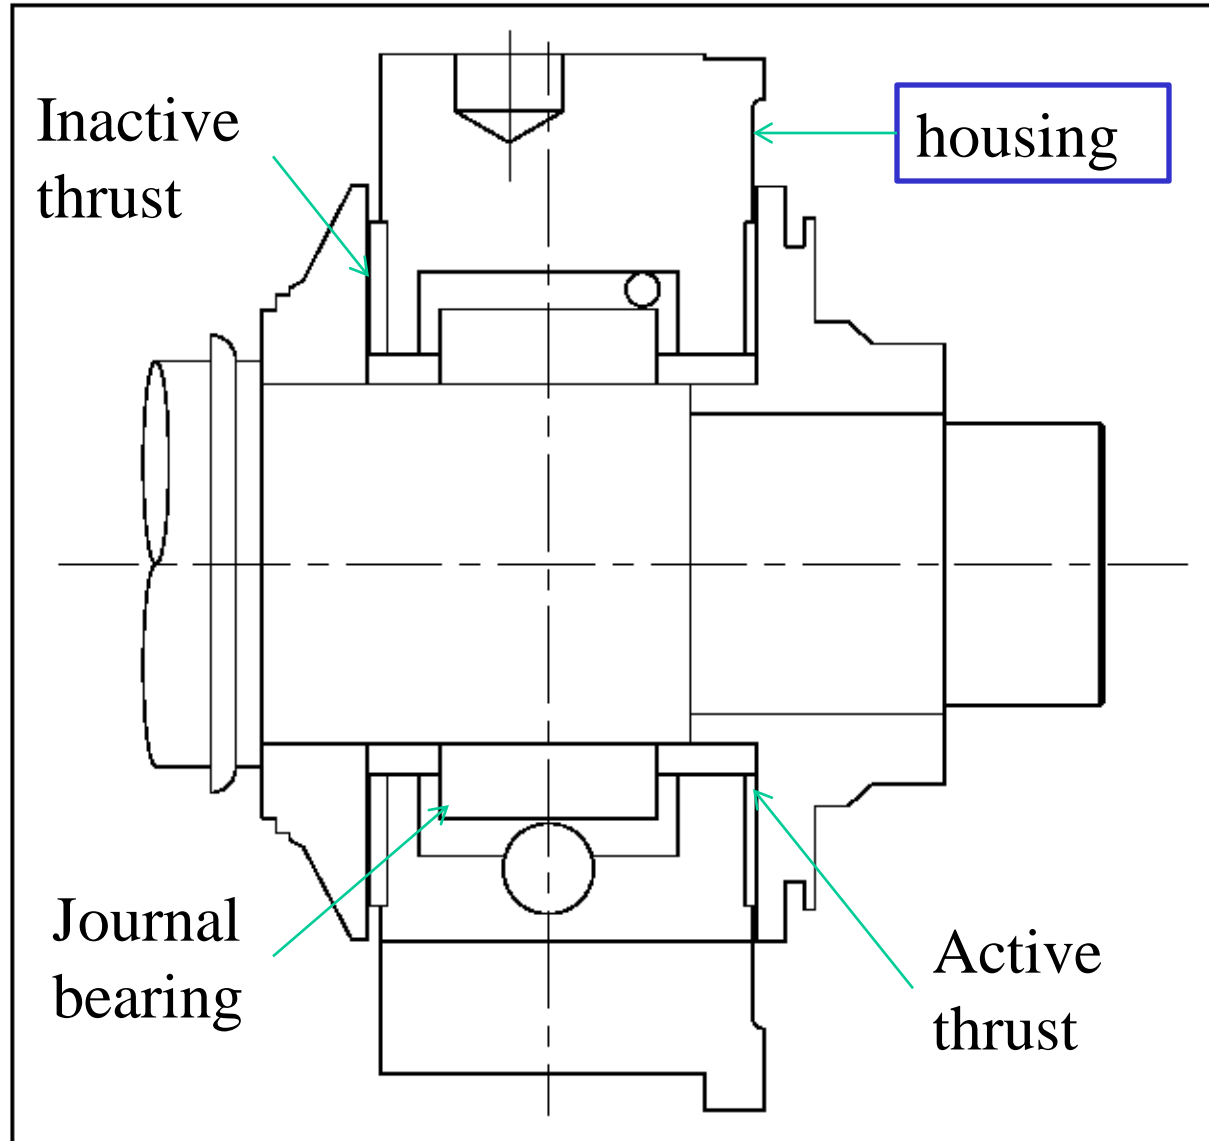
Original bearing

The original journal bearing is a lemon type sleeve, flooded, split, with each half bolted to the housing, at both ends of the shaft: 70 mm Drive End and 60 mm Non-Drive End.

The thrust bearings are each a taper land fixed plate, babbitted, on each side of the housing.

All original bearings have no capabilities to support misalignment.

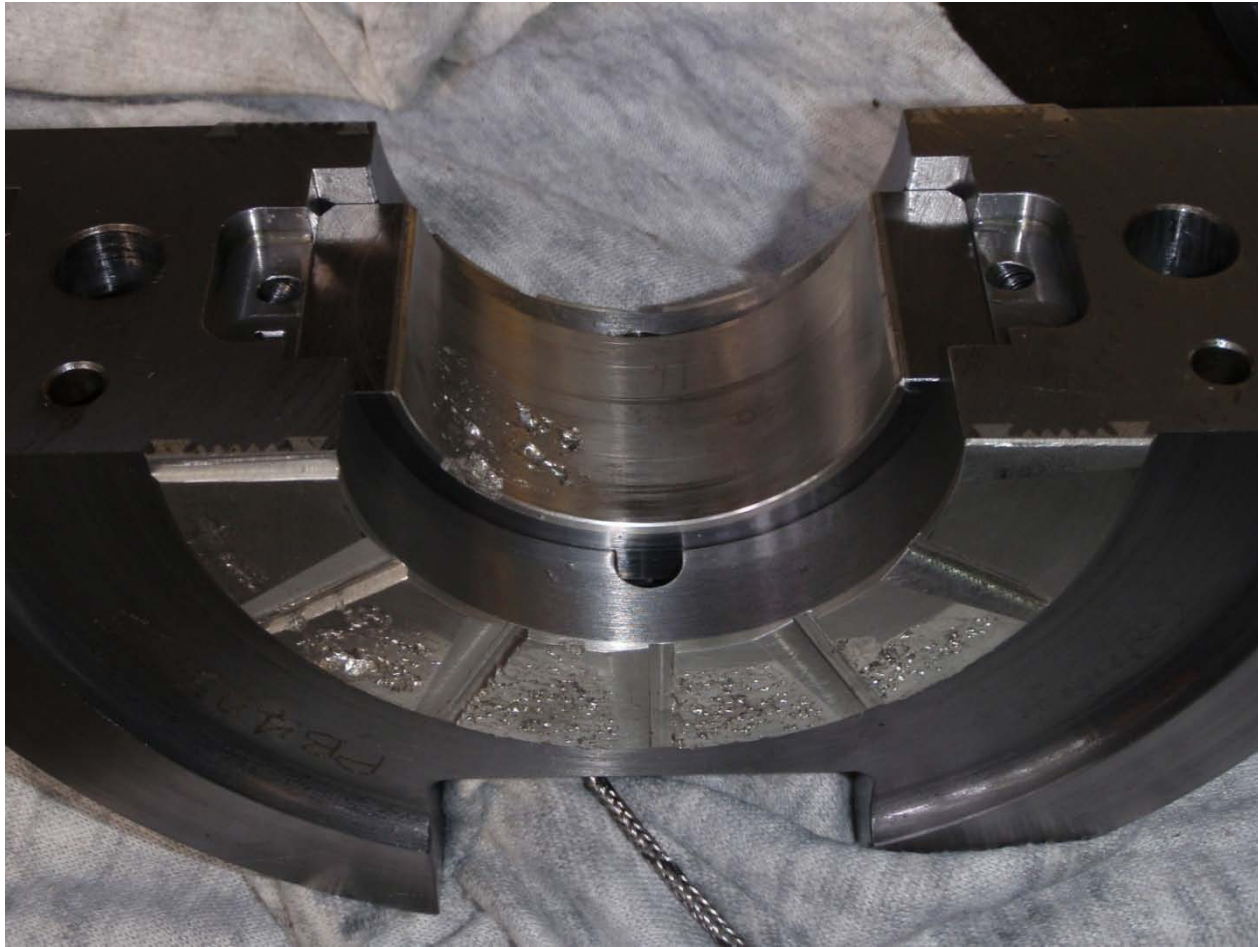
The Failed Original Bearings

A rotordynamic analysis revealed that the original bearing had significantly lower stiffness in the horizontal direction than the vertical.

If the compressor experienced high horizontal loading on the bearing, it would lower the second critical speed into the running range.

It was theorized that the new installed gear type coupling could have increased the horizontal loading on this LP compressor rotor. It was manufactured identical to the first gear coupling, but with much tighter tolerances. It was observed the tighter tooth clearances were contributing to the increase of the horizontal loading.

The analysis results were all consistent with the theory that the gear type coupling was more stiff and introduced horizontal loading in the journal bearings, thus reducing the second critical into the running range.

From these studies it was agreed to replace the coupling with a flexible type coupling and to replace the journal and thrust bearings with tilt pad bearings, both these changes of equal importance in solving this problem.

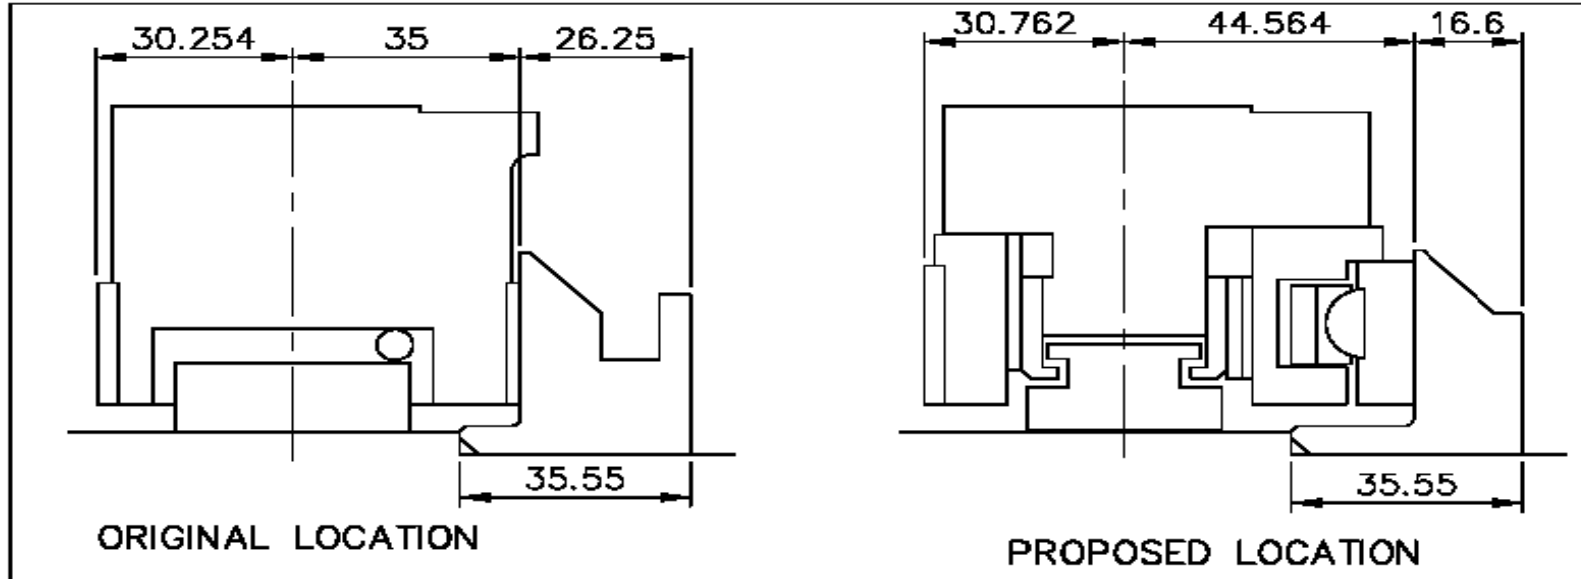
Available space for new design (dimensions in mm)

- The challenge was to implement the proposed bearing upgrade on the NDE within the available space limitations: with this very old compressor, there was only a small space available for the thrust and journal bearings.
- It was decided to make a new thrust collar to allow an extra 10 mm for the active thrust bearing width.
- The inactive thrust bearing was designed as an individual compound-taper thrust plate.

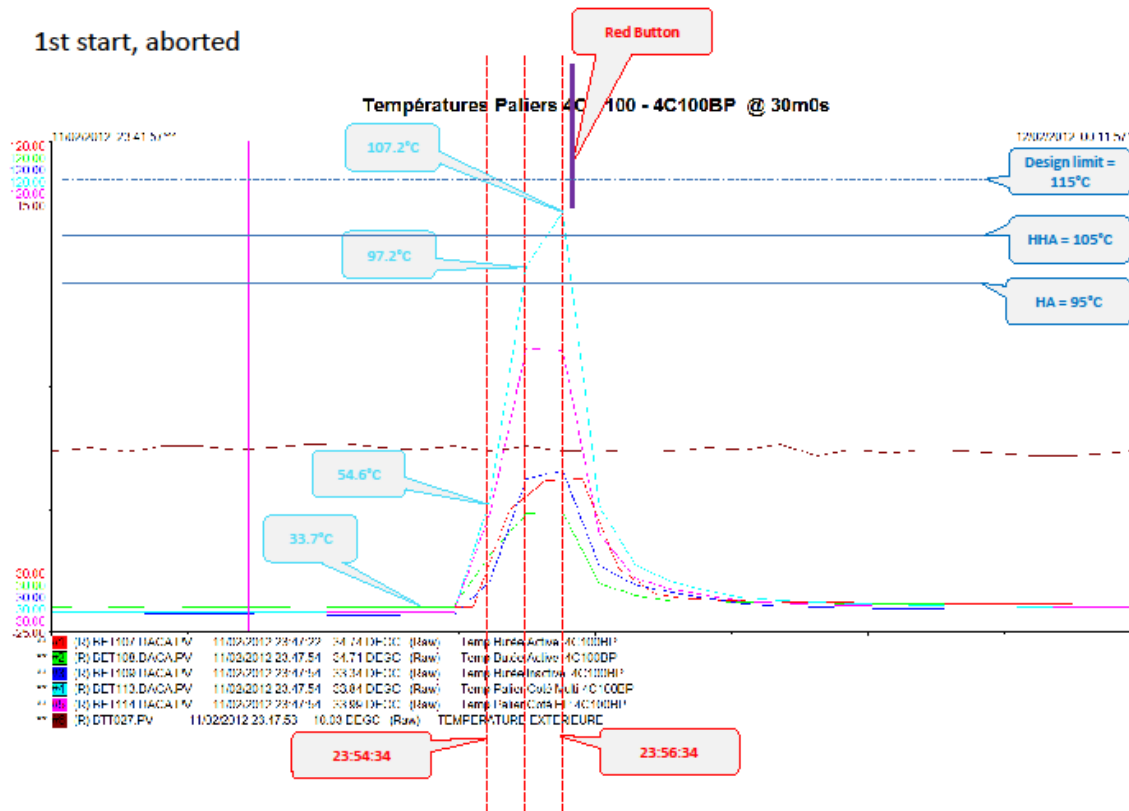
Bearing temperature with cold oil

- During the service of the newly designed bearings it was observed that the temperatures of the bearings are dependent of the ambient temperatures and the following graphs are presenting the situation.
- If the machine was stopped, in cold weather, when restarted with cold oil, the temperatures of the bearings spike. After trip and re-start with warmer oil and warmer machine, bearings are running normal temperatures.
- The start-up procedure included now the warm up of the machine and the oil, in cold weather.
- The bearings functionality was not affected by fluctuation in bearing metal temperatures.
