Turbo-Expander Compressor Active Magnetic Bearing Trips Reduction - A Case Study

RasGas

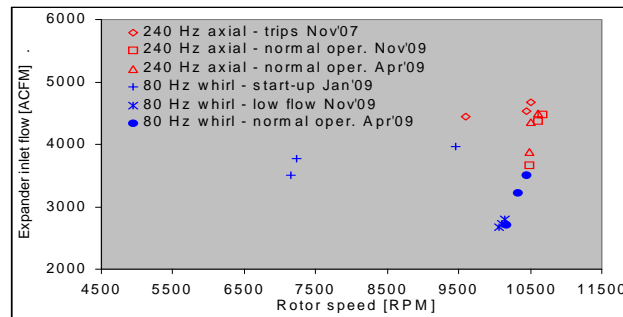
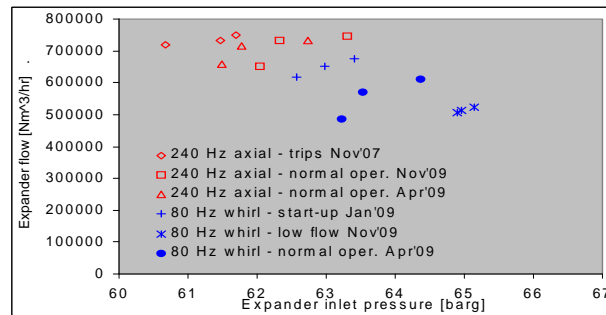
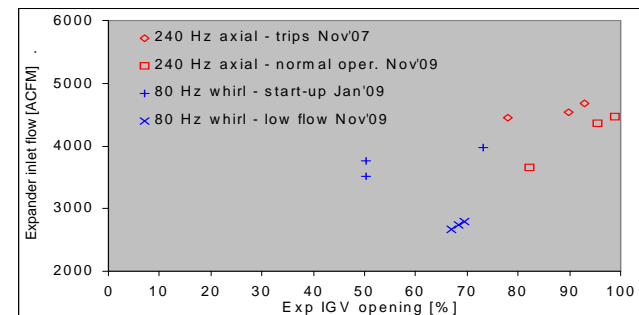
- RCFA Found Combination of Factors
 - ATB was initially not functioning correctly (logic, stroke & setting)
 - Off-design condition due to high rate operations creating low back wheel pressure (high axial thrust load)
 - Unknown high frequency (240Hz) vibration used up dynamic capability of AMB – only seen at specific low pressure/ high flow/ speed settings

- Automatic Thrust Balance logic, stroke & setting corrected
- Increased Thrust Bias Current (12A → 15A) to improve Dynamic Capability of AMB (by 60%)
- Better thrust balance after change of TEC Machine Center Section in Jan. 2009
- Stability check performed unloaded/ 50% neg. stiffness
- Extensive review confirmed ATB design (valve and piping), but measured pressure drop higher than expected
- Rotor dynamic analysis confirmed 80Hz natural frequency ... but could not detect any 240Hz cross-coupling

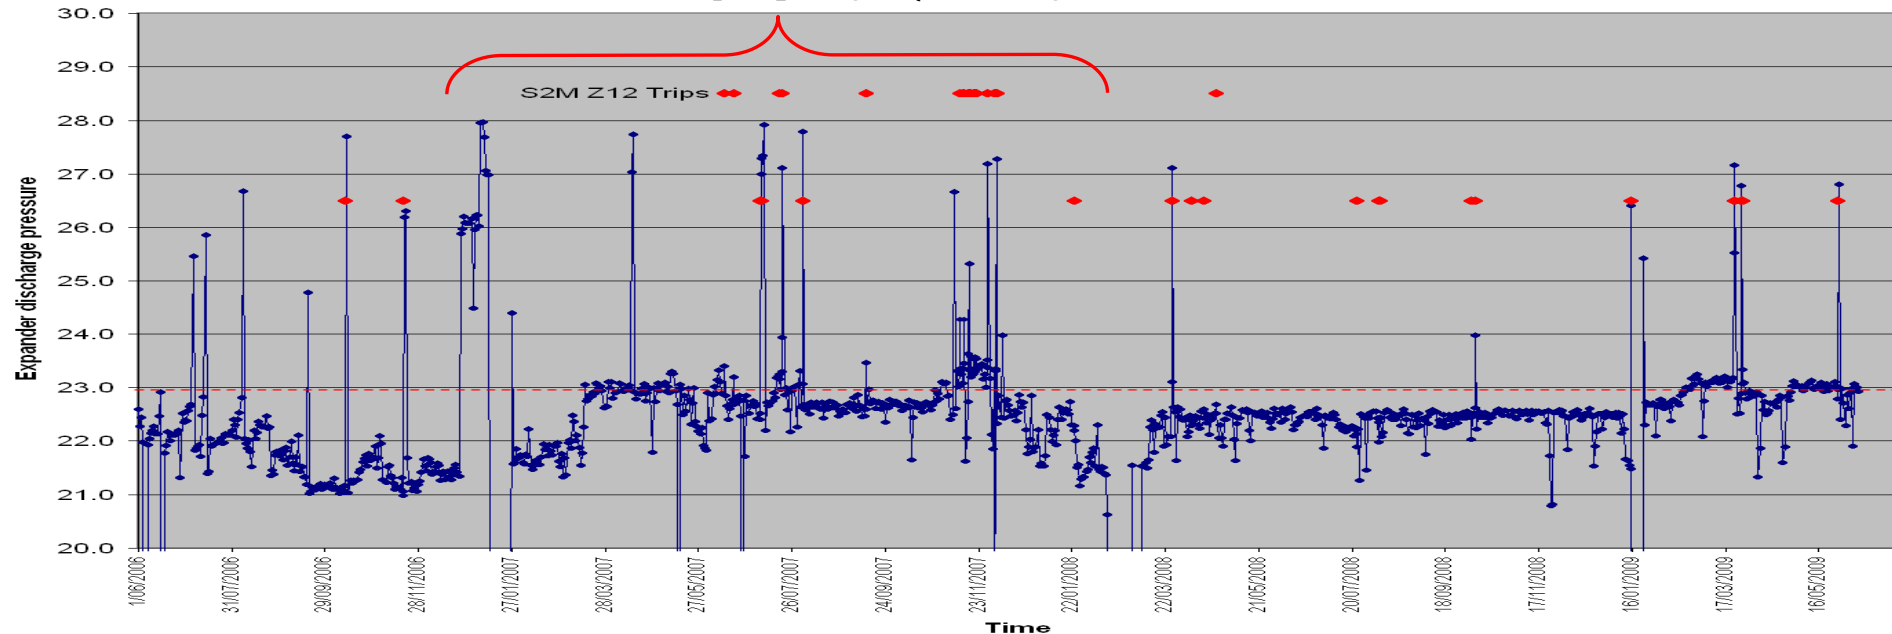
- **No AMB/ Z12 Trips since April 2008**

- Outstanding Works
 - Source of high frequency (240Hz) vibration is still to be determined, though
 - ATB valve and piping to be inspected and if necessary upgraded to reduce pressure drop

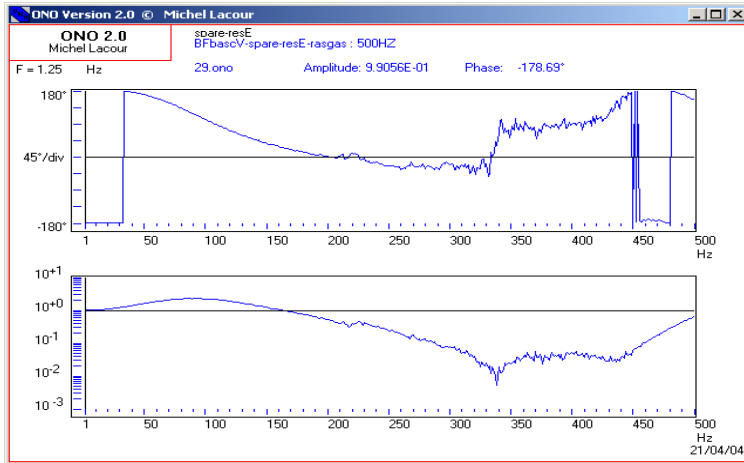
Translation Closed Loop TF

- Closed Loop TF on Translation and Tilting mode controllers (measured at standstill) appear to be very flat in the 70-120 Hz frequency range. This is a good indicator of system stability.

The standard S2M Amplification factor criteria on a close loop transfer function is < 2.5

- Closed Loop TF should be measured with machine in operation to have confirmation on stability margins.

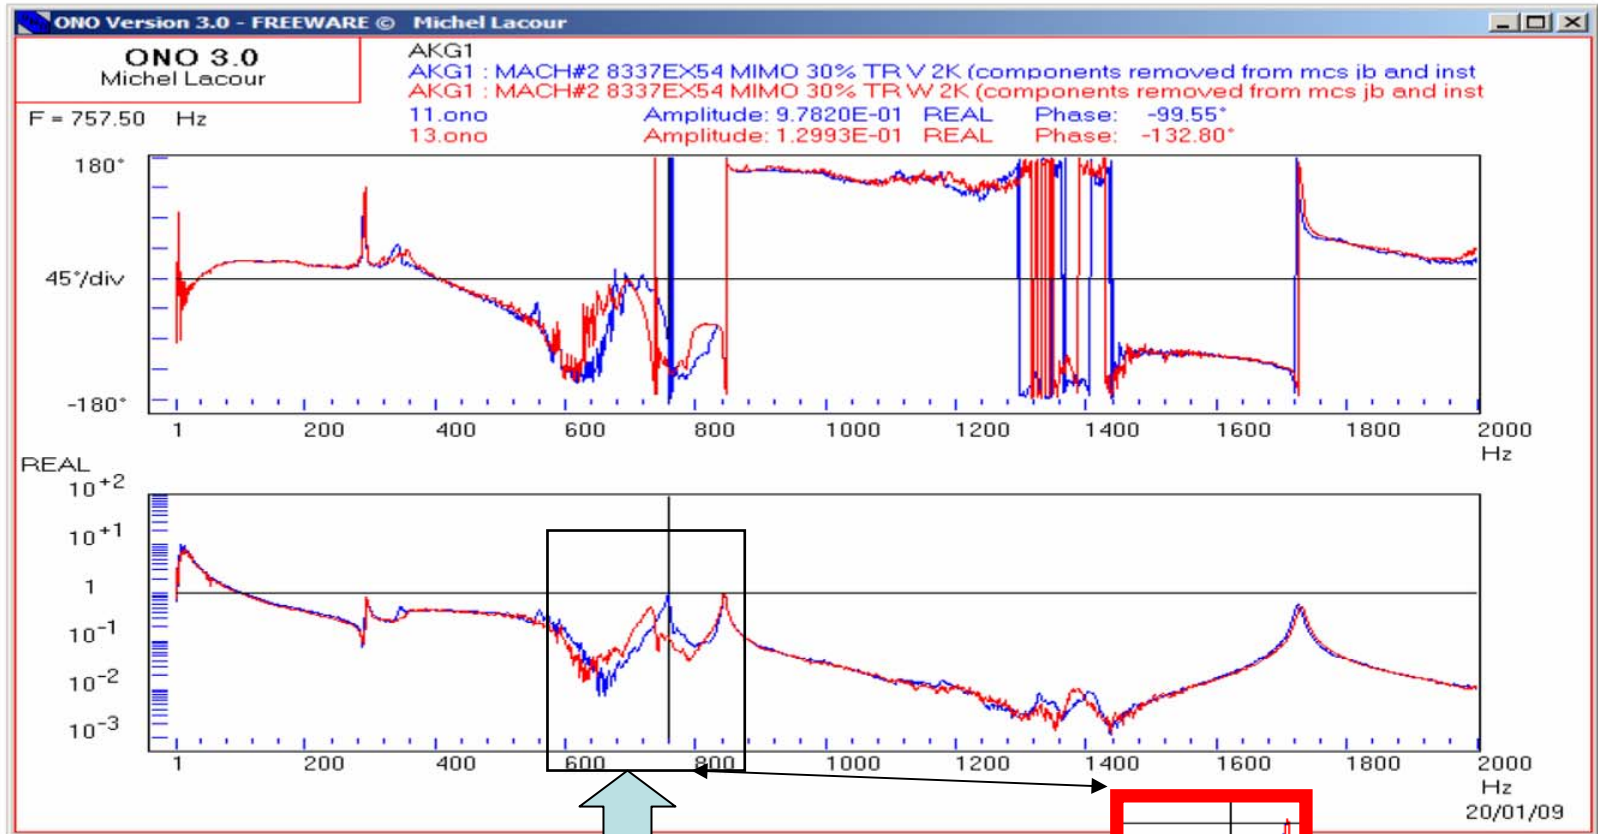
A2 – Unit #1 TF Change at High Frequency

High frequency TF change measured

TF curve before the replacement of the MCS (this is the expected curve).

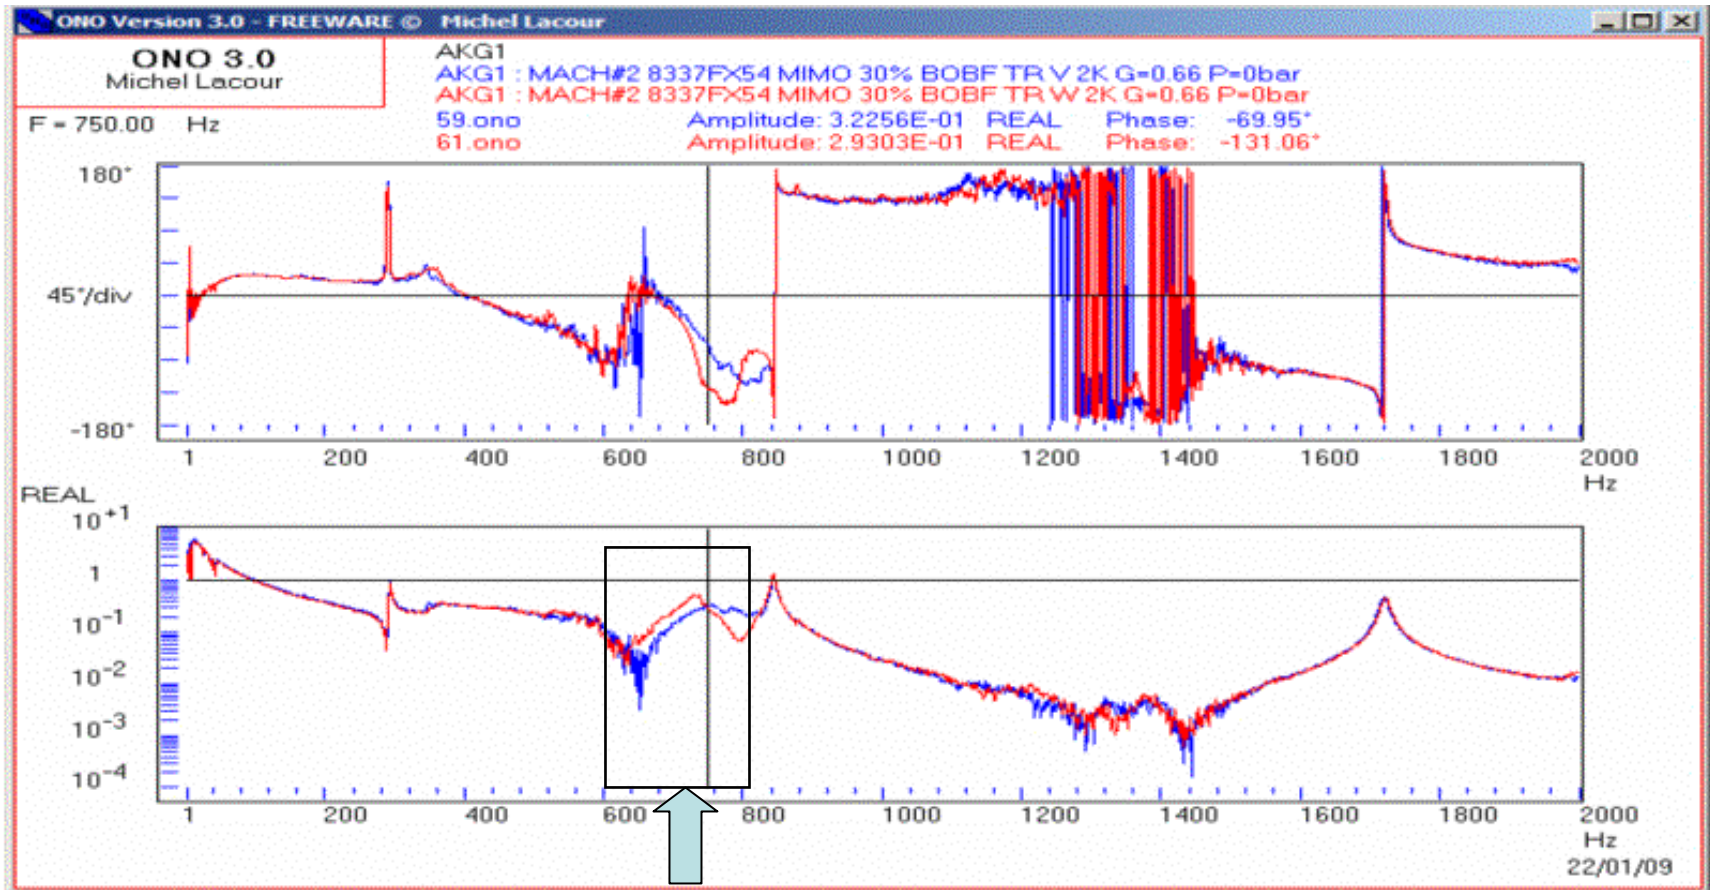
A3 – Unit #1 Controller Modified to Counter TF Change

- Controller modified to reduce mismatch response to within acceptable limit
- TEC Operational with no trips, but true fault unknown

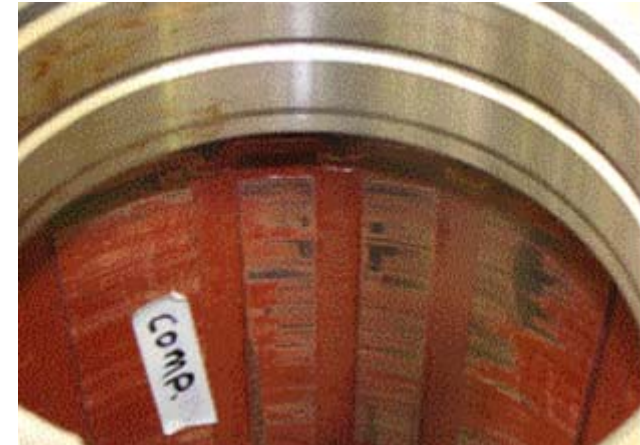
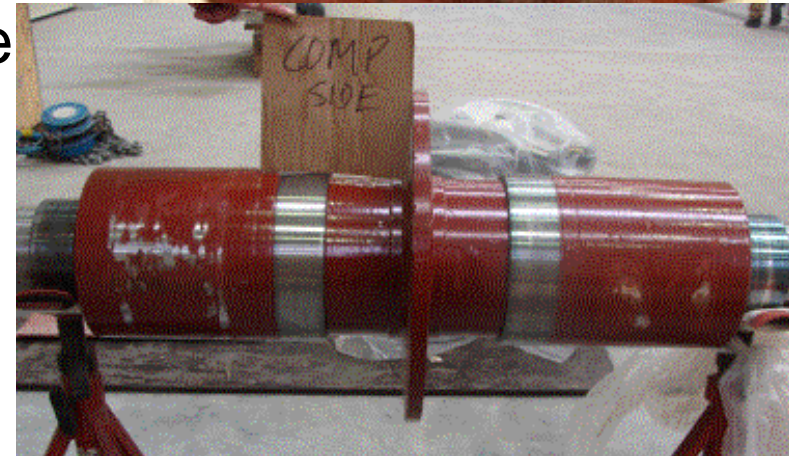
B1 – Unit #2 TEC Unstable Vibration following TF Change

Rubs on shaft and varnish

- Unstable vibration when ramp up the machine
- Cannot restart, reinstall old unit
- Severe rubs of stator and rotor (photos)

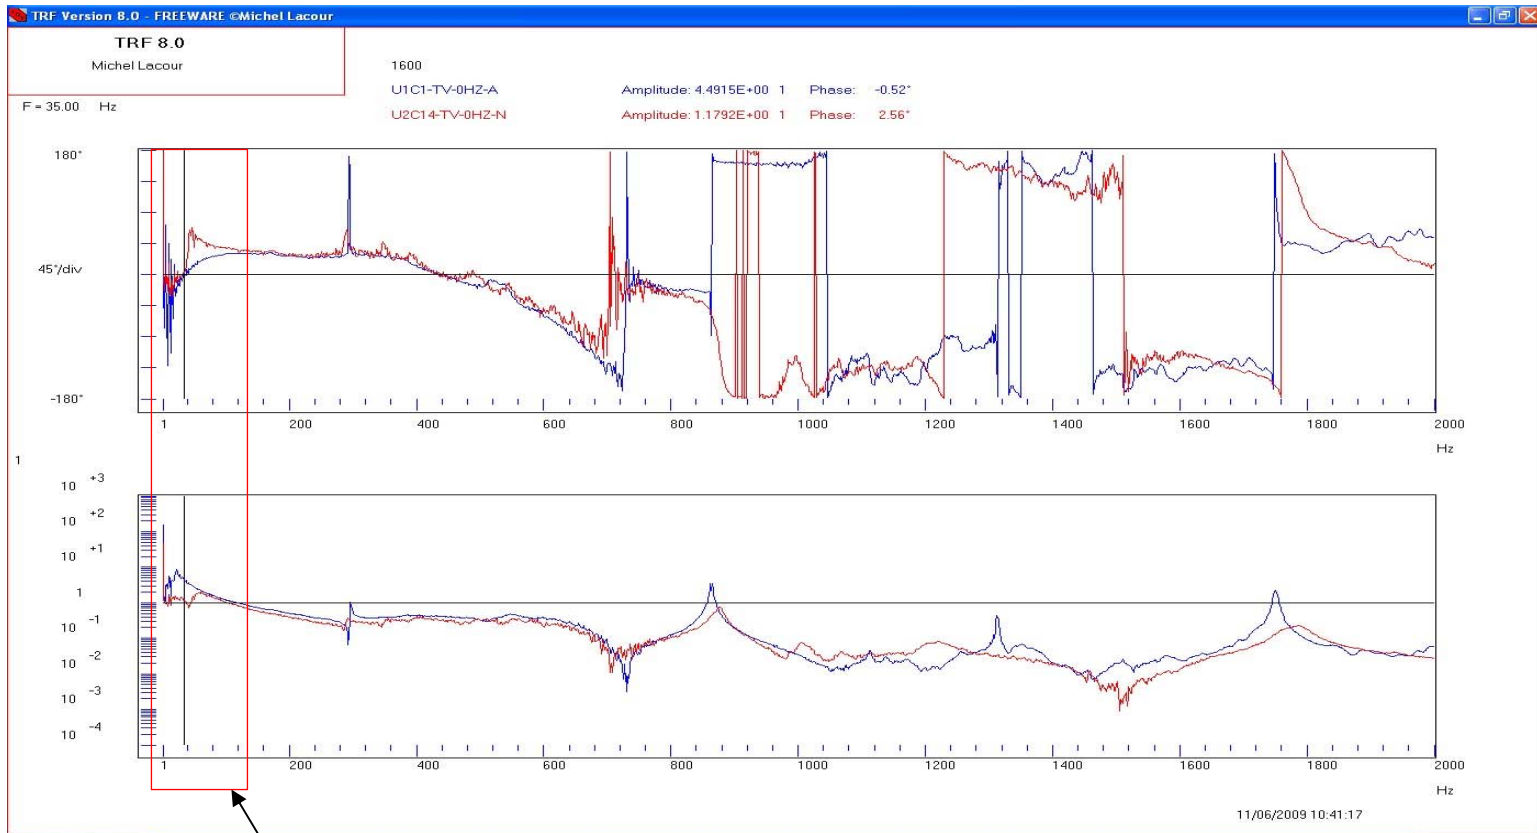
B2 – Unit #2 TF Changed at Low Frequency

- Low frequency response changed
- Indicating instability
