# Speed Signal Deterioration at High Speeds in Electronic Governor and Trip Systems

*40<sup>th</sup> Turbomachinery Symposium Case Study*

Manufacturing and Engineering Support, The Americas  
Lyondell Chemical Company, A LyondellBasell Company

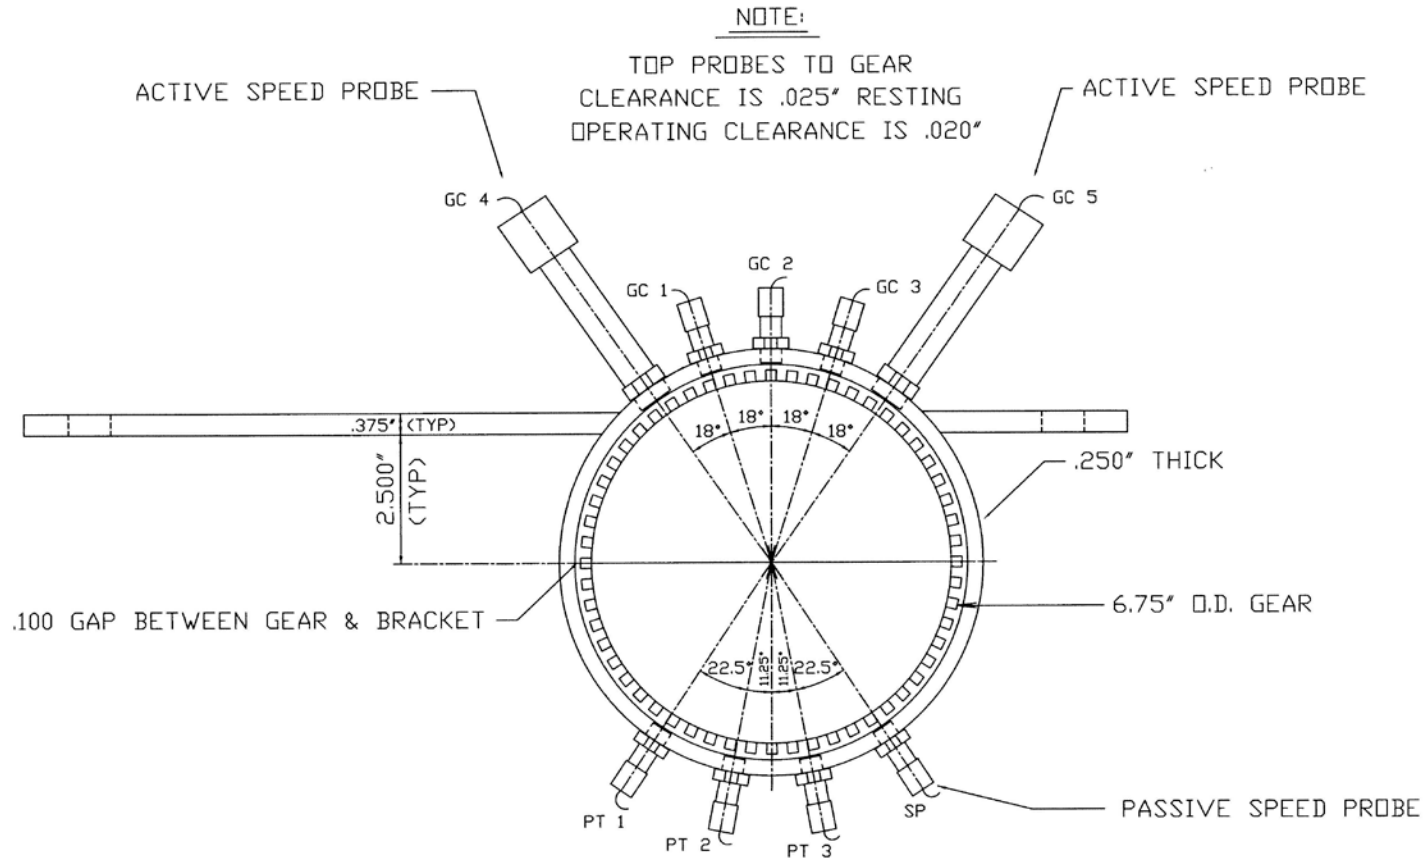
# Drawing of Bracket, Speed Gear and Probe Configuration

NOTE:  
BOTTOM PROBES TO GEAR  
CLEARANCE IS .015" RESTING  
OPERATING CLEARANCE IS .020"

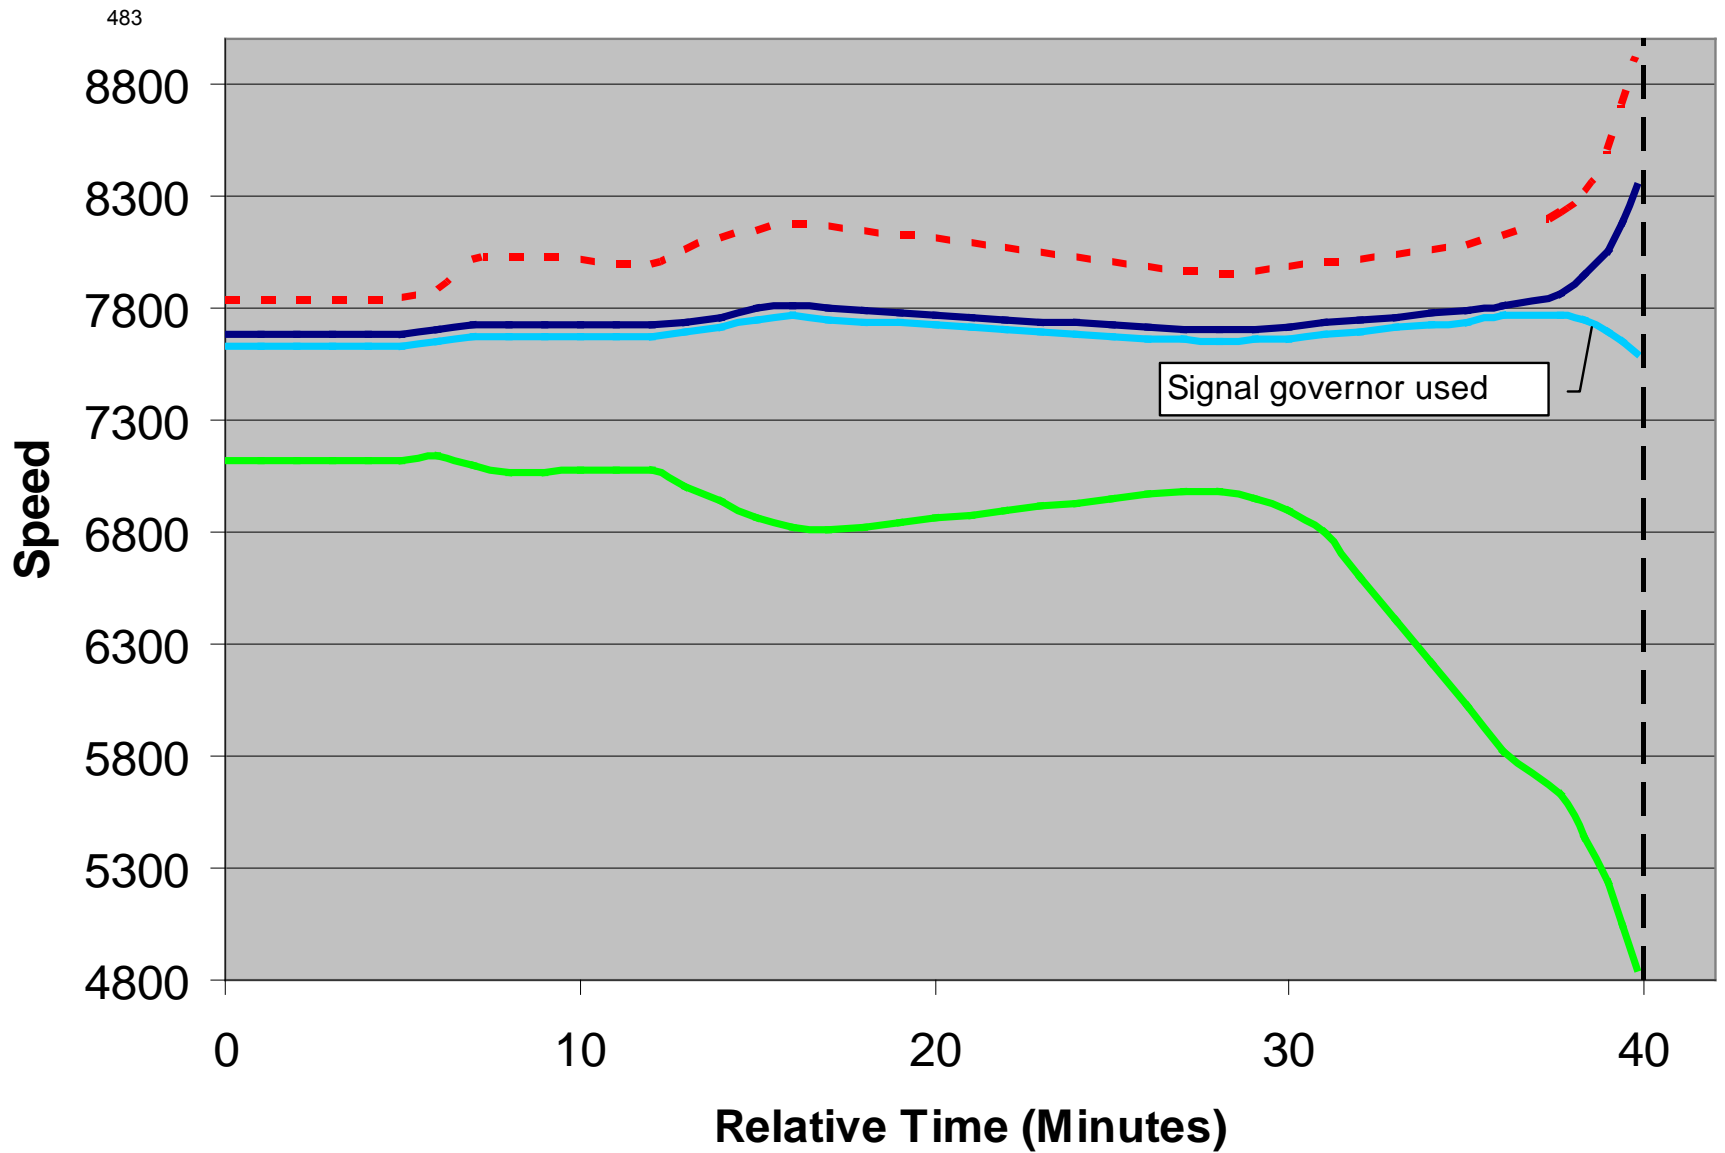
- The turbine was coupled to the compressor and the train was put online.
- The train was shut down 2 days later due to other process problems. It was again restarted without issue.
- Three days later the process required a gradual change in turbine speed . . .

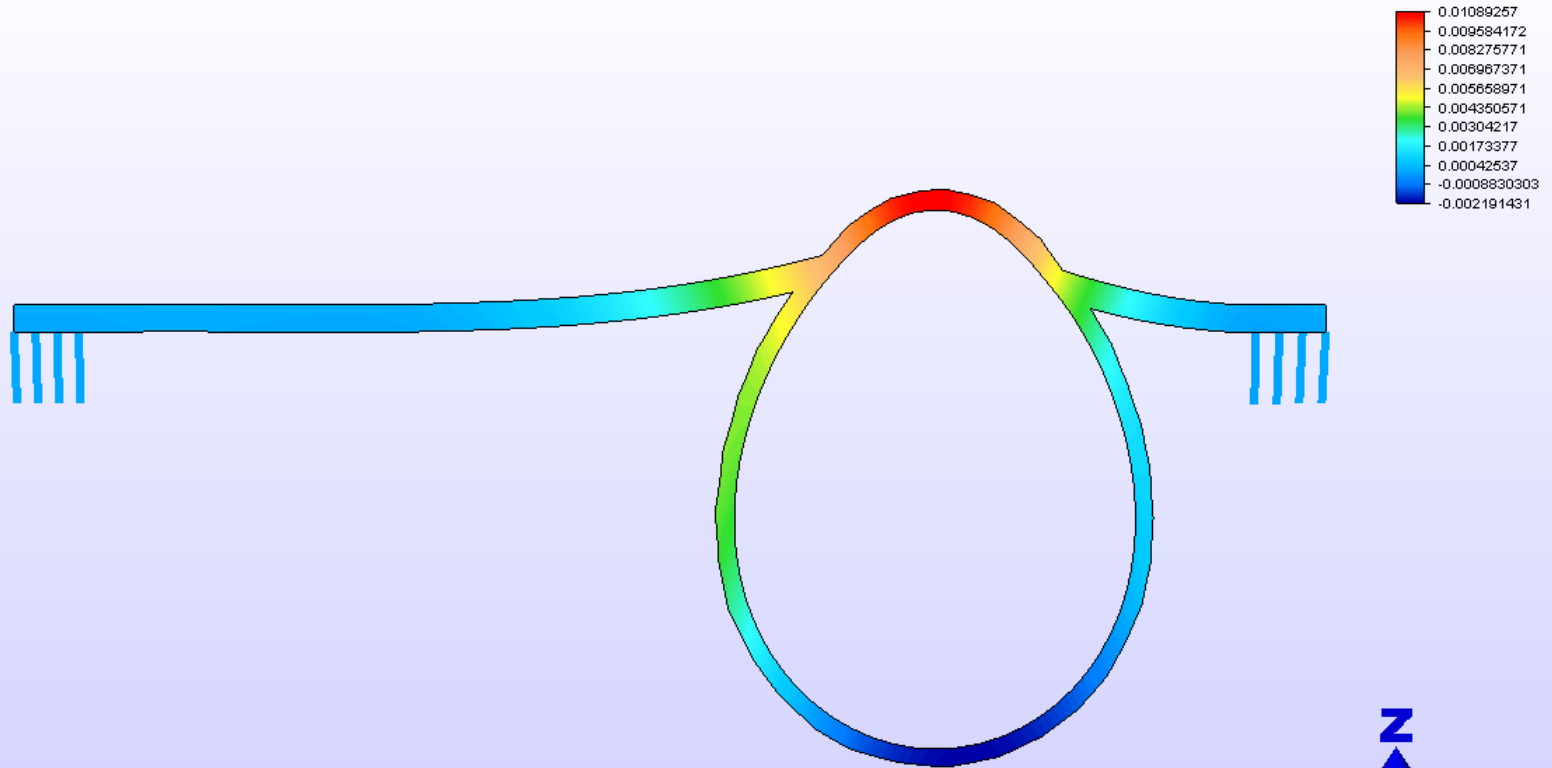
# Bracket Deformation Due to Thermal Stress

- Speed probe voltage *generated* is a function of:
  - The surface speed of the target,
  - The geometry of the speed gear, and
  - The distance between the probe and the speed gear (the “gap”).
- How could the gap be incorrect?

Maximum Value: 0.0108926 in

- New system that is pending installation has:
  - Low capacitance wire and a lower tooth count speed gear
  - A probe whose characteristics generate a higher voltage and help maintain that voltage when transmitted
  - Modified bracket that maintains a stable gap, and
  - Governor logic that is high signal select regardless of the “good” probe count.

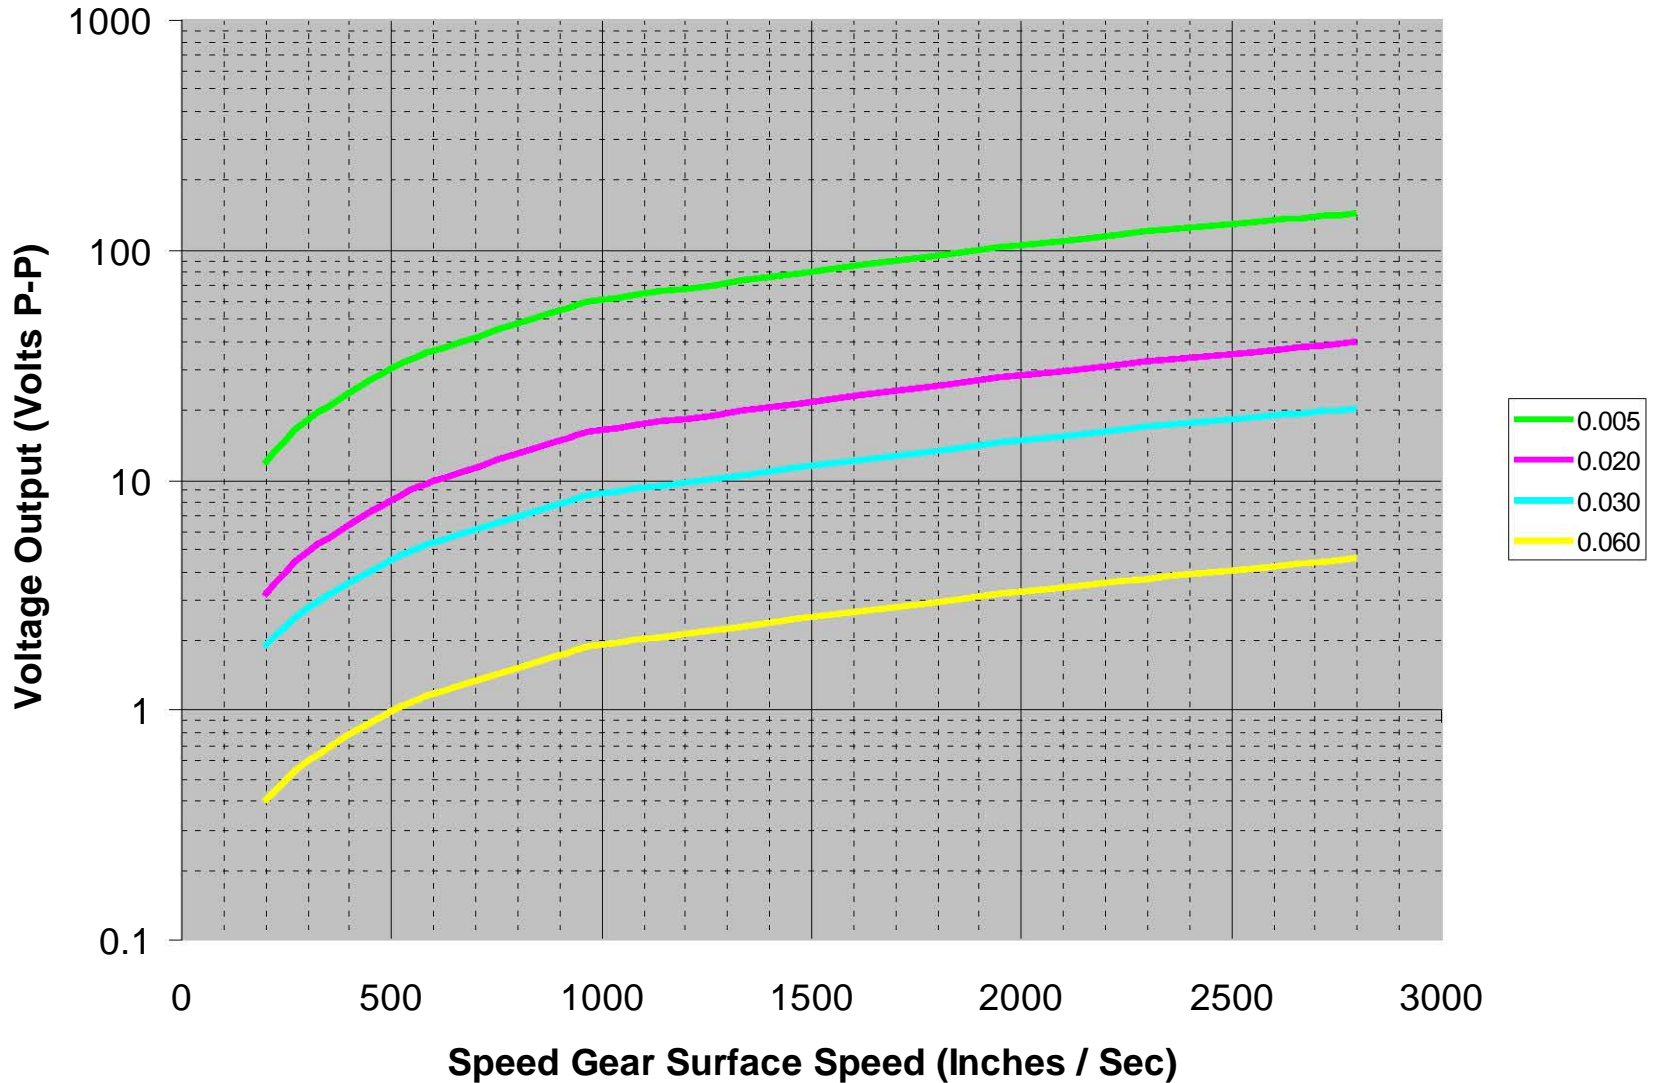
# Speed Probe Voltage Output

- Analysis of the probe signal revealed two problems:
  - A reduced voltage output from the probe as measured at the turbine, and
  - A significantly reduced voltage as measured at the input to the governor panel.

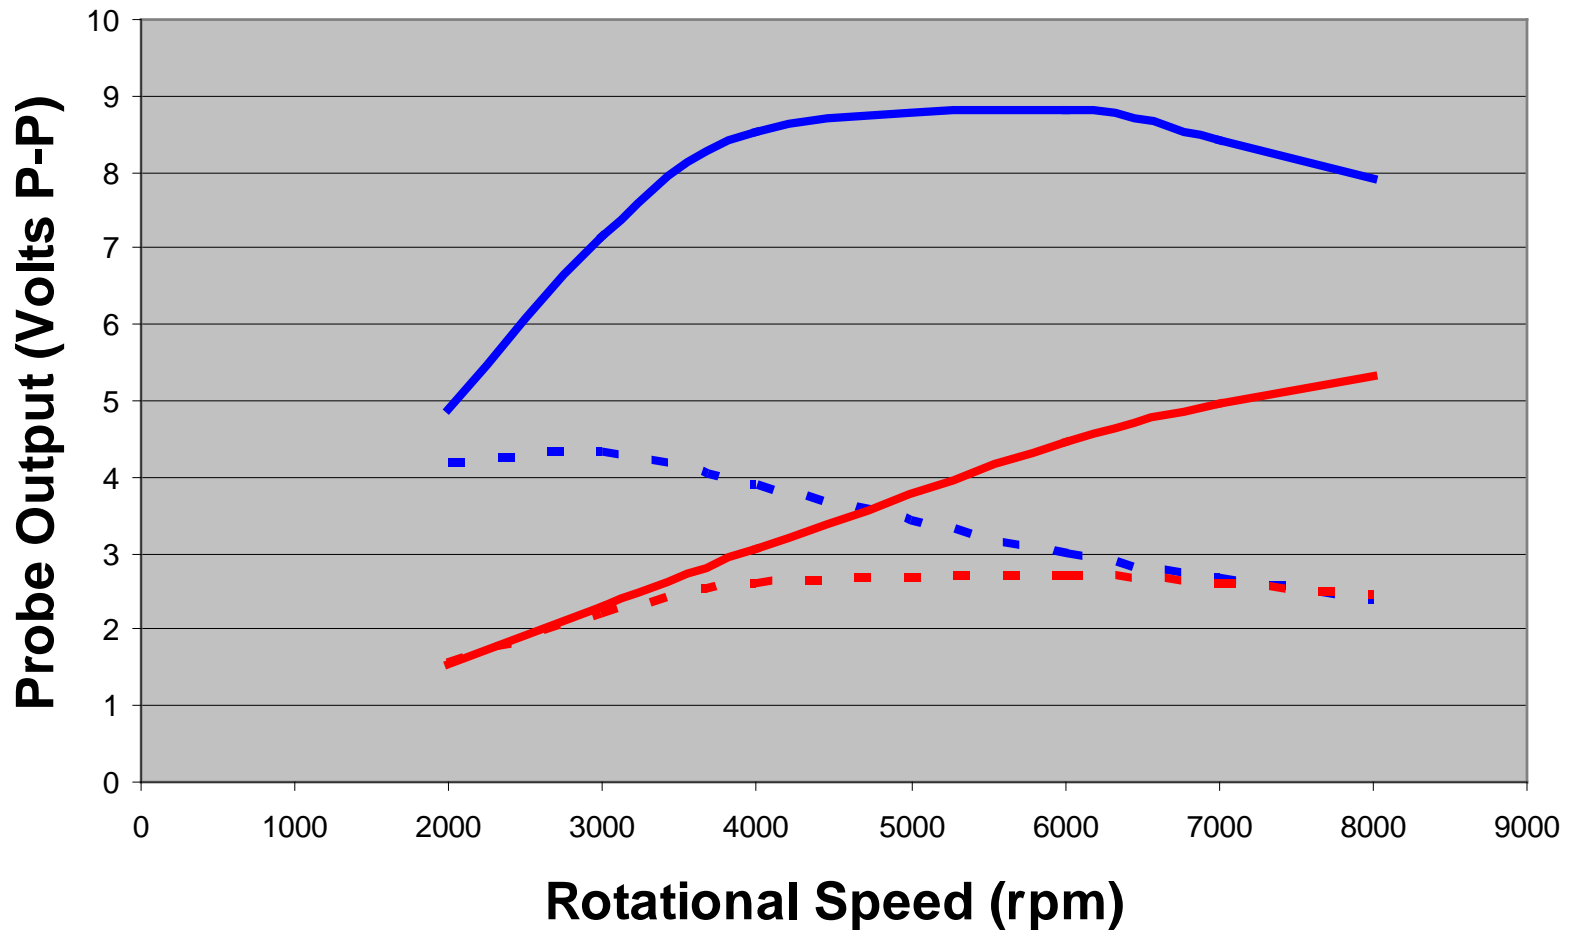
# Signal Voltage Reduction

- Signal is less than expected at the deck, but it is even lower at the control room.
- Speed probe voltage *transmitted* is a function of:
  - Capacitance of the wire (unit capacitance x length)
  - Frequency of the signal
  - Probe resistance and inductance
  - Quality of connections, voltage drop due to wire resistance, shielding and grounding.

— Low Capacitance Wire, 60 Tooth Gear    - - High Capacitance Wire, 60 Tooth Gear  
— Low Capacitance Wire, 30 Tooth Gear    - - High Capacitance Wire, 30 Tooth Gear

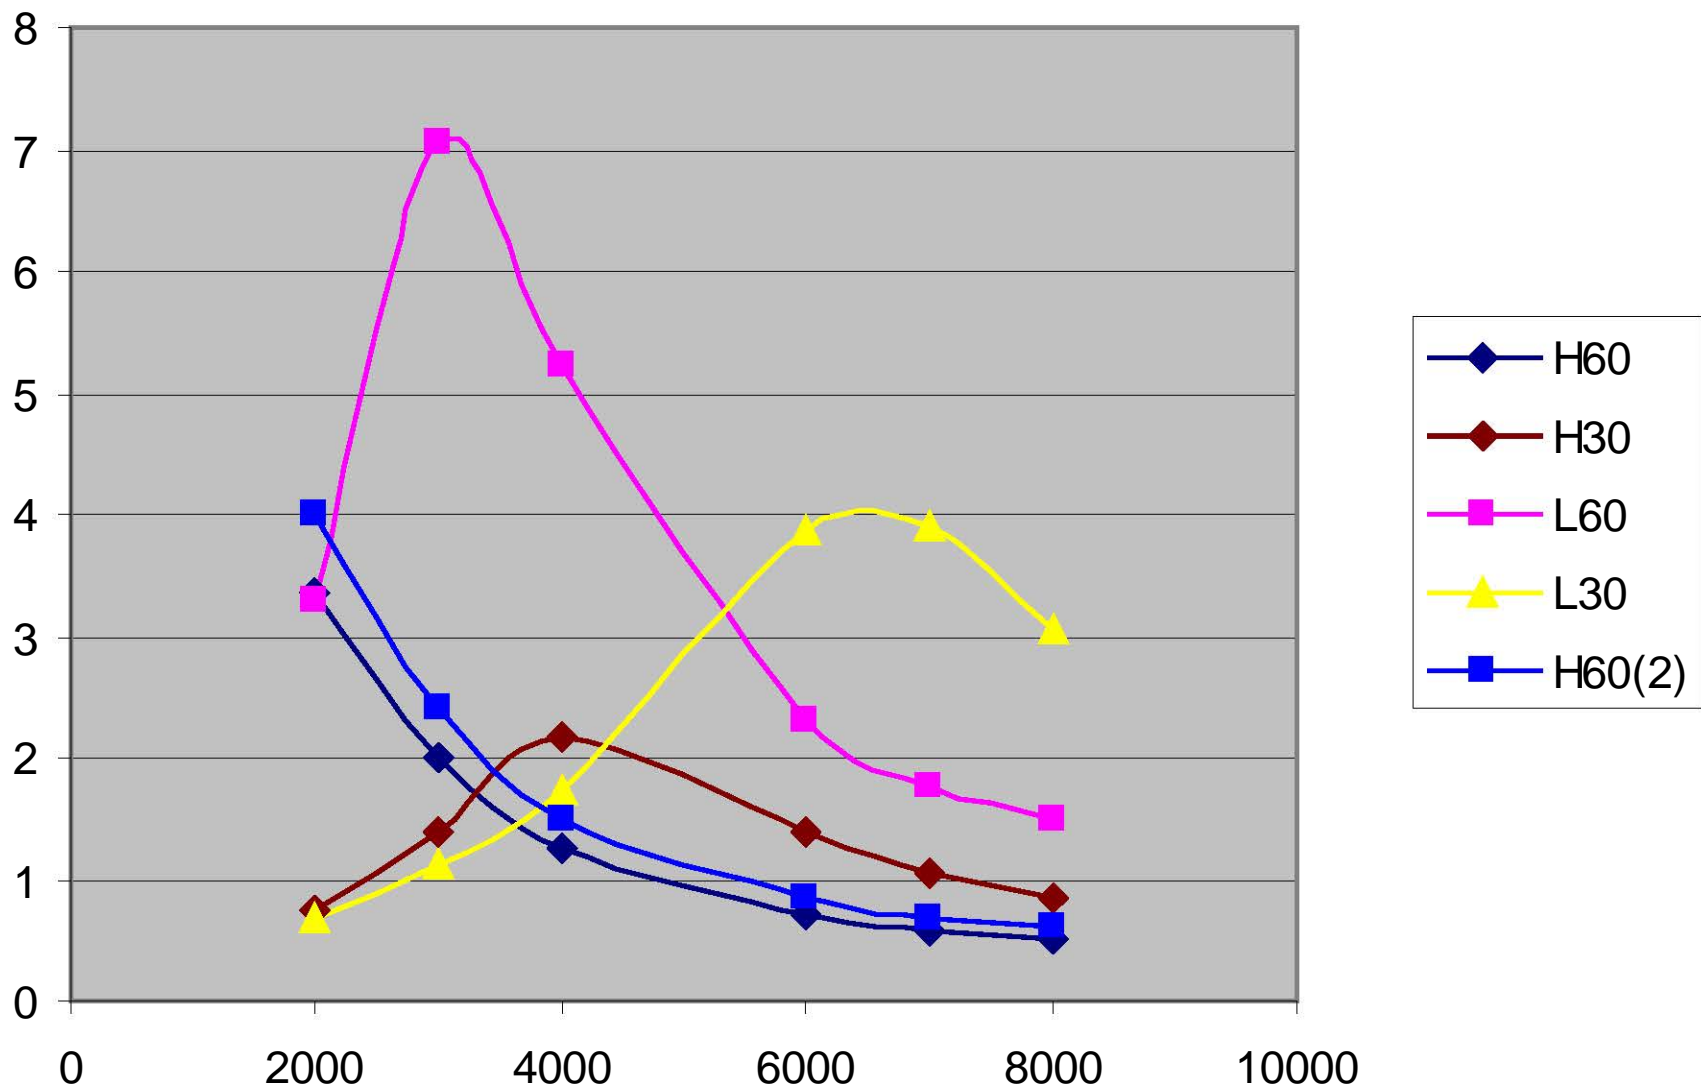
# Shop Test Data

- These calculations, conditions similar to the existing installation, and lower capacitance wire were tested at a local repair facility to validate the explanation.
- While not an exact representation, the trends closely matched what was observed in the field.
