# ***Successful Avoidance of Major Secondary Damages Using Proximity Measurements to Detect a Partially Fractured Piston Rod***

Uwe Ladwig, Dipl. Eng.  
Maintenance Manager - Rotating Equipment  
YARA, GmbH  
Brunsbüttel, Germany

# Compressor Data

GB-101B

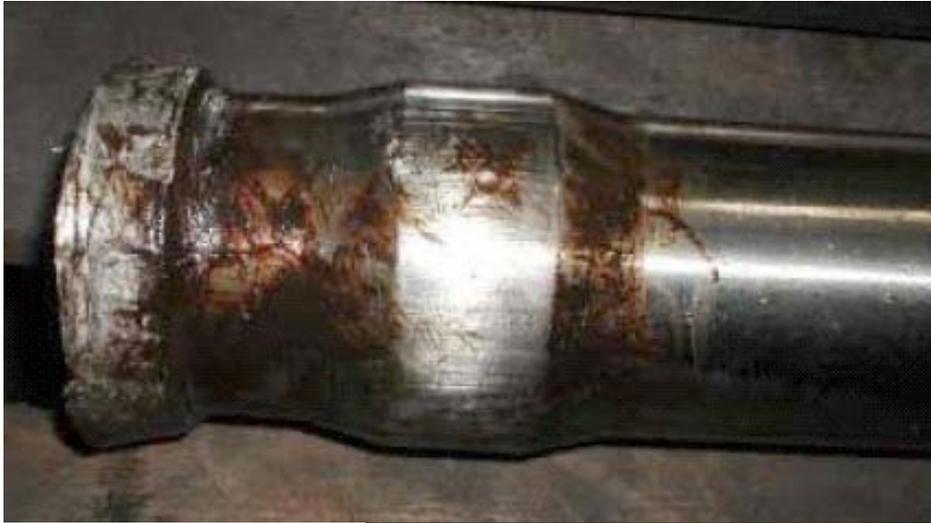
Damaged piston rod

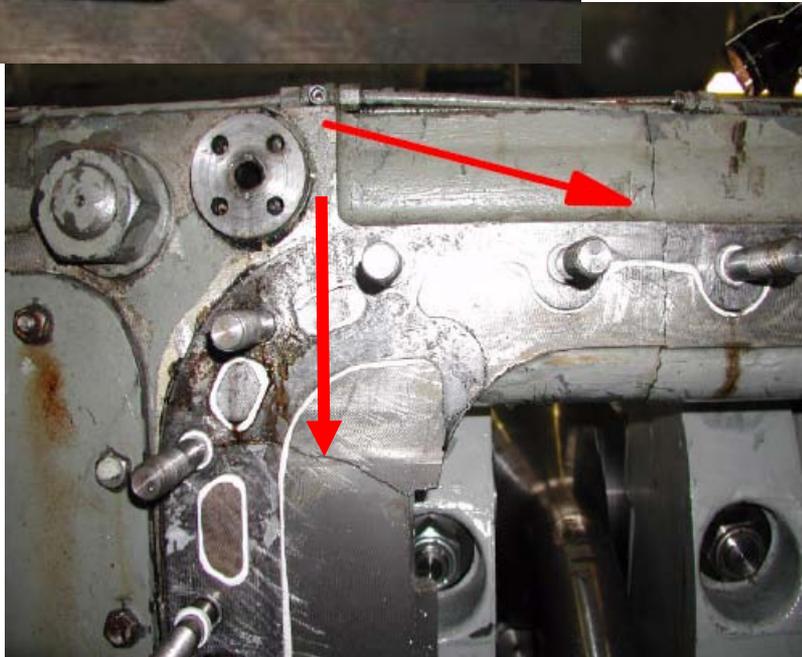
Ripped casing

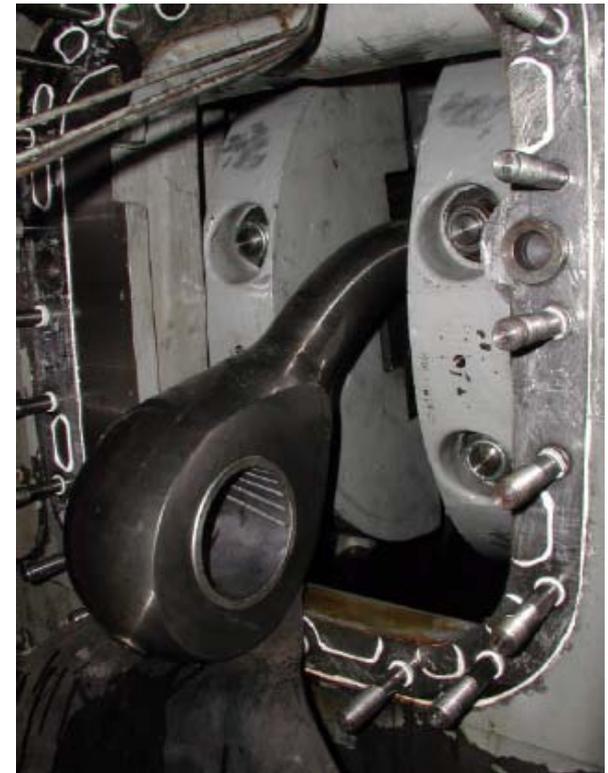
Bent con-rod

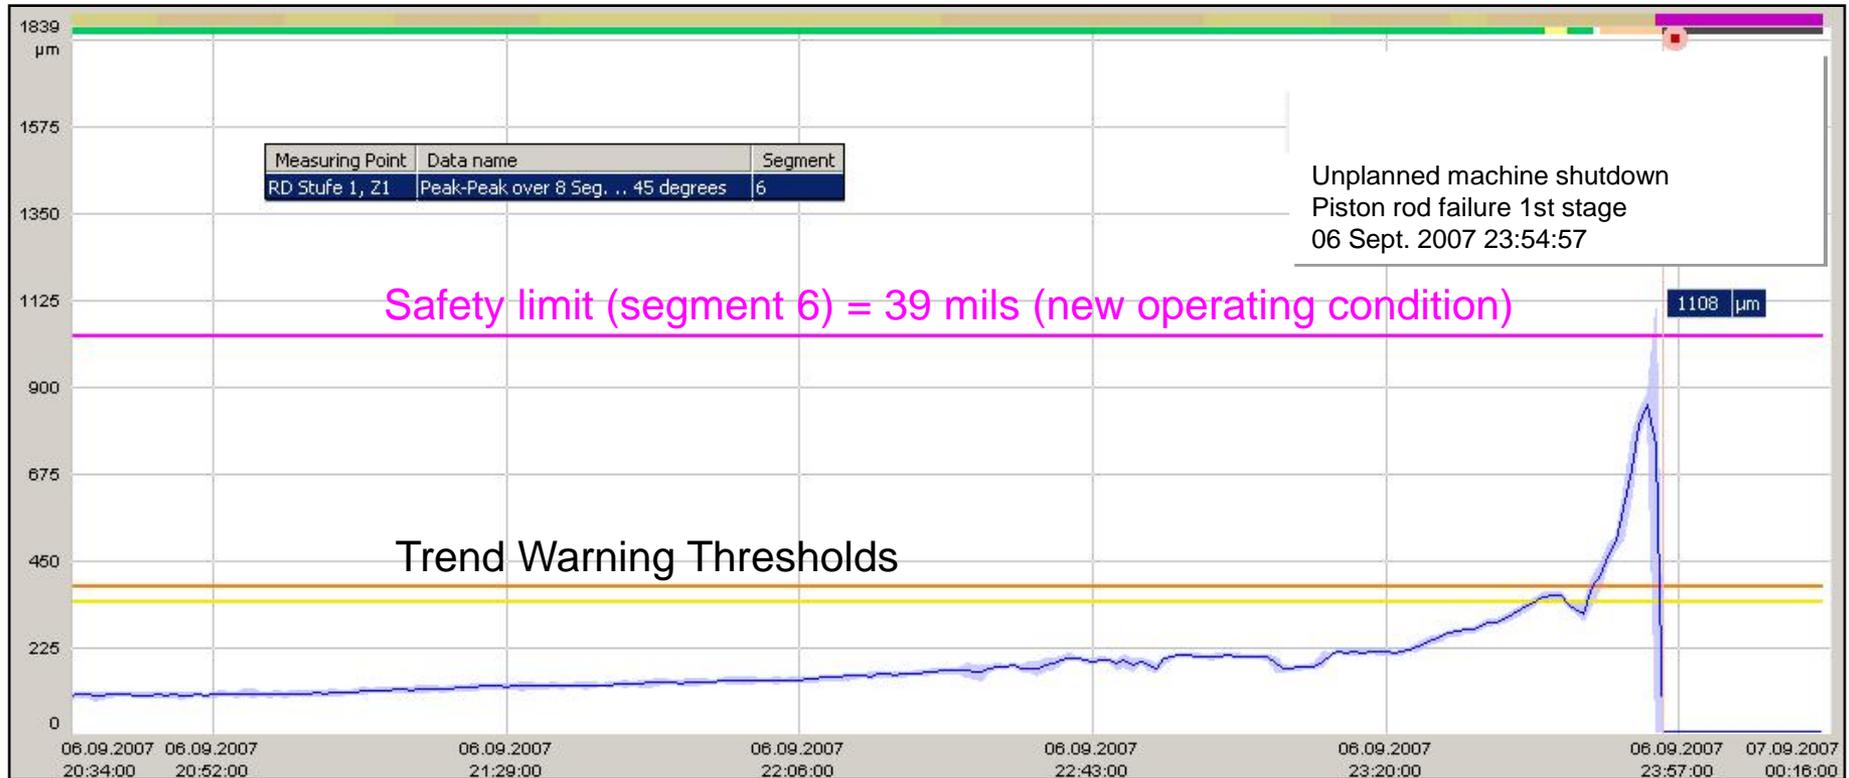
## Rod Position - Segment 6 (60-70 deg Crank Angle)

# Data Analysis - 4 hr. Trend (following process change)

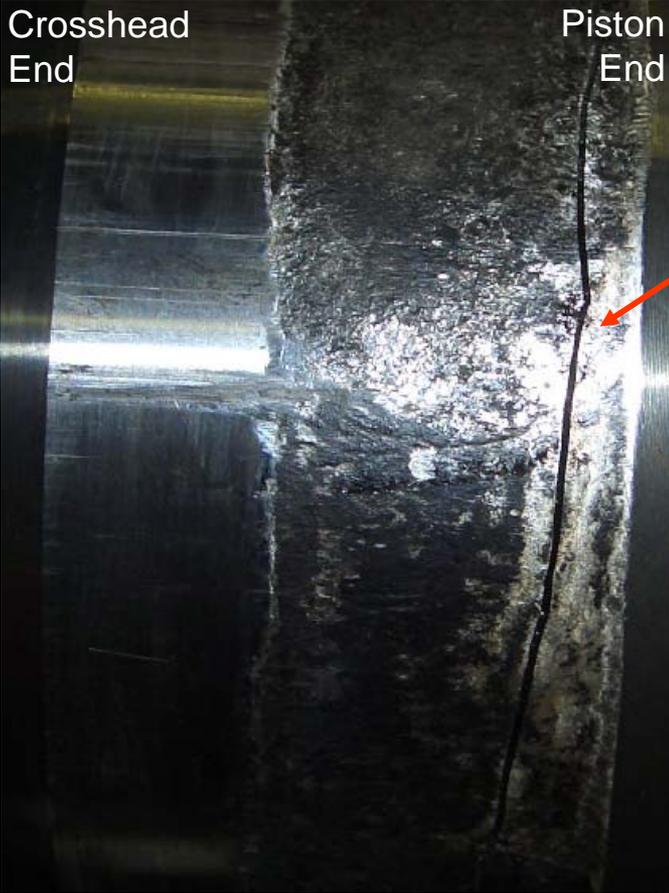
Cross section 1st stage

75% circumferential crack
