Development and Testing of a Very High Speed Oil Lubricated End Face Mechanical Seal

Six large radial inflow turbines were designed to expand isobutane for two electric power plants in Nevada which use heat from the earth (geothermal energy) as the energy source. Double end face mechanical seals lubricated by oil were selected to stop the isobutane from leaking out of the closed loop system and into the atmosphere. Two of the largest providers of mechanical seals in the world provided reference lists showing that this application was pushing the tip speed limits for existing liquid end face mechanical seals. A vendor was selected and the seals were purchased.

16 MWe Expander-Generator

Very High Speed Wet Seal Application

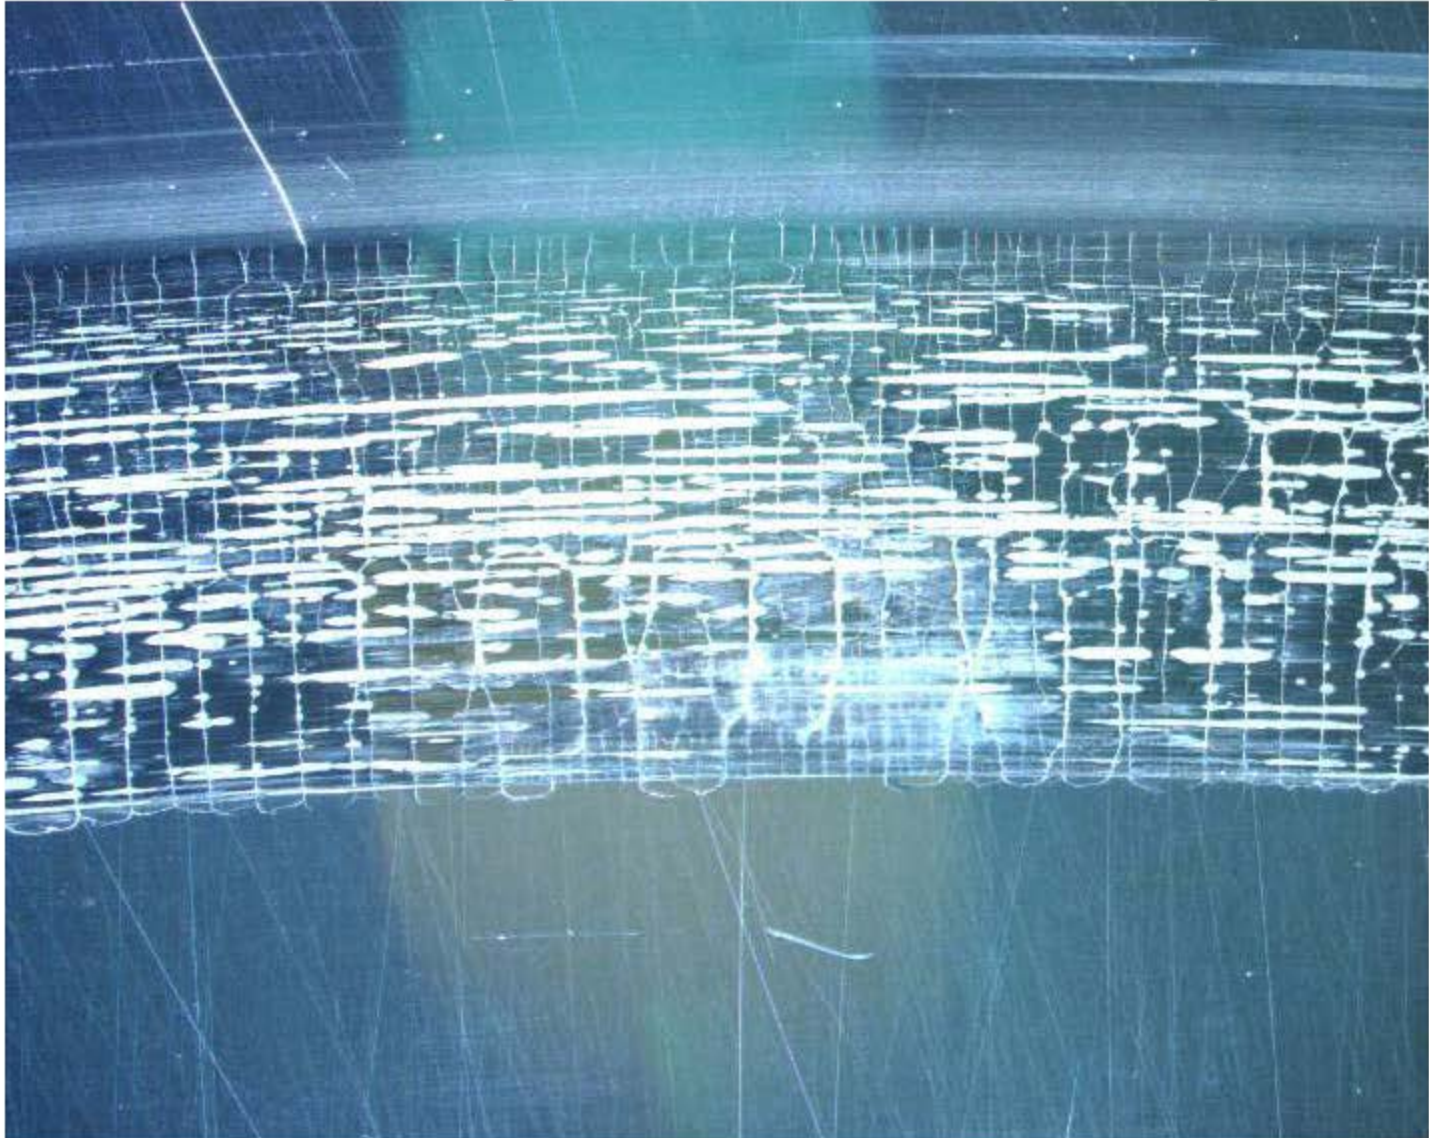
Rotating Face Damage

- The seal vendors had almost no experience at these tip speeds.
- Initial seal had “standard” seal faces (plain) and “standard” balance ratio.
- Initial testing looked good: Low leakage during test.
- Disassembly showed that seal faces had rubbed hard, and heat checking occurred.

- Reduced face loading.
- Added patented face pattern to stationary faces.
- Testing again went well.
- Disassembly showed no problems.
- First machine shipped to field with this seal.

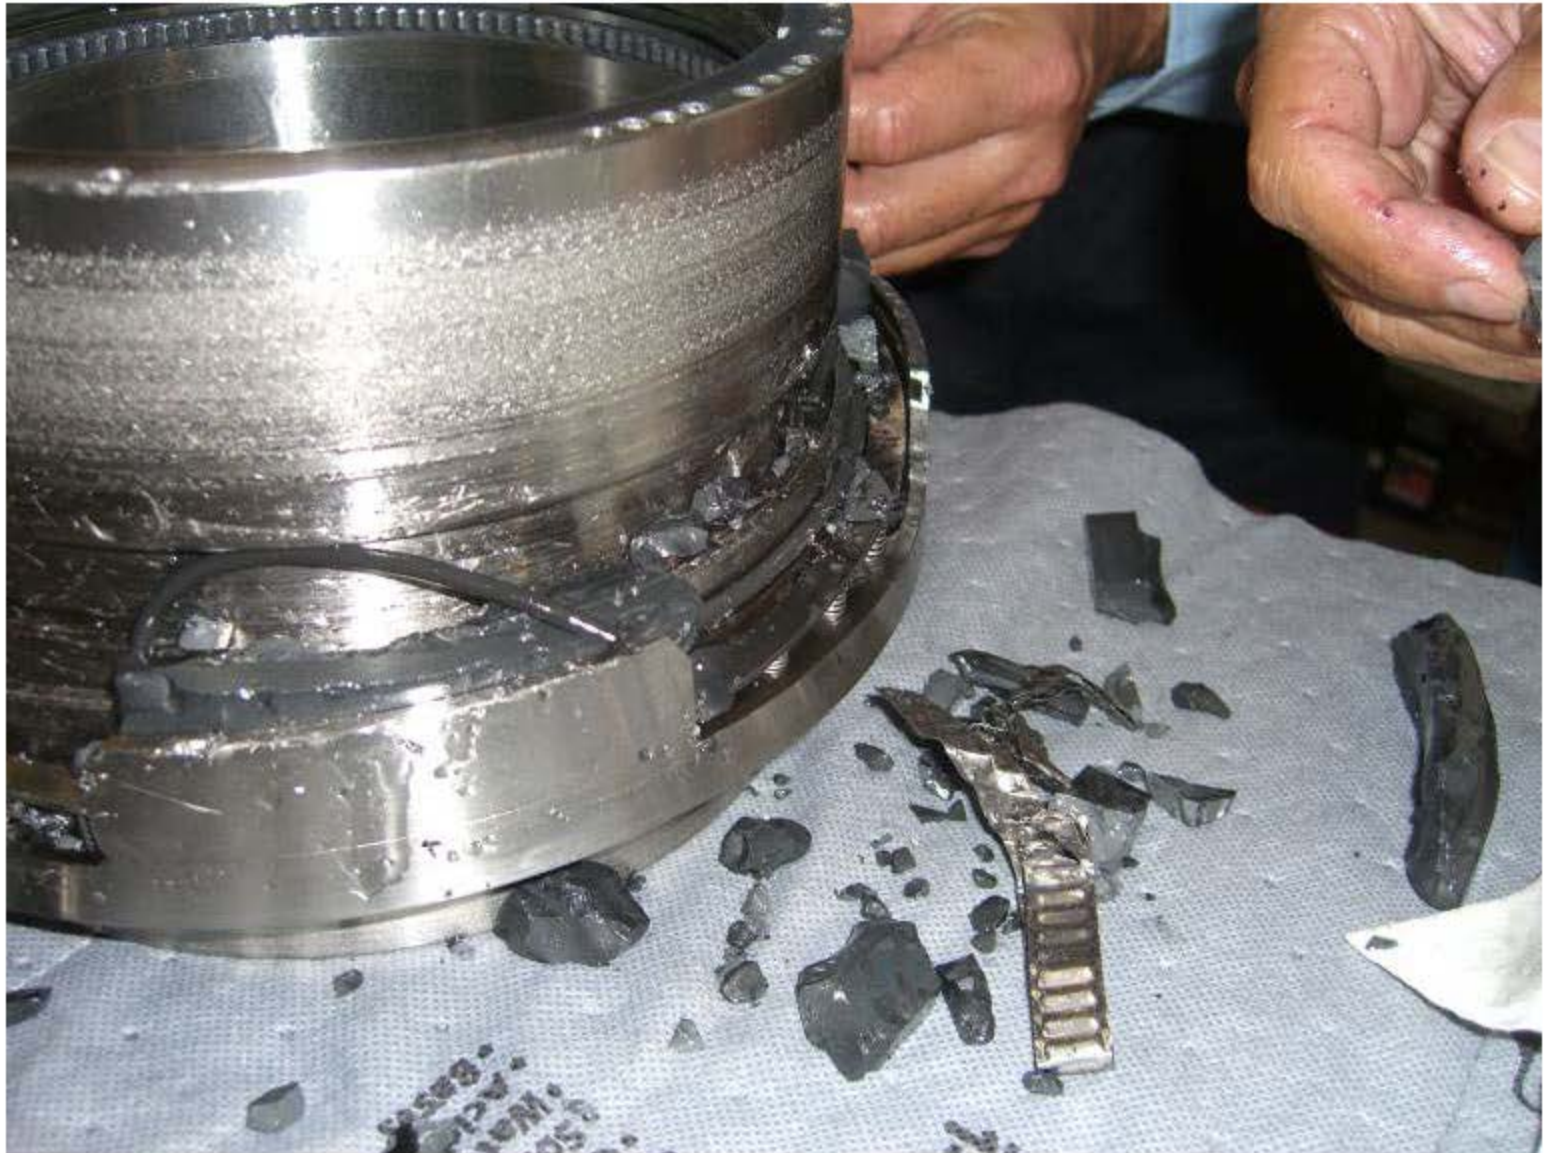
Seal Damage

- Machine was run to “Trip Speed” at beginning of test.
- After 15 minutes at Trip Speed, machine speed was reduced to MCS.
- After a brief run at MCS speed, the seal self-destructed.
- Disassembly showed major damage to all seal parts and cartridge assembly.

- Stronger material for rotating ring.
- Axial pin drive for lower stress concentration factor.
- Drive slot drilled before sintering (no EDM).
- New, lower thermal growth sleeves with more clearance when operating.
- 10,000 rpm overspeed testing on rings (154% of design speed).

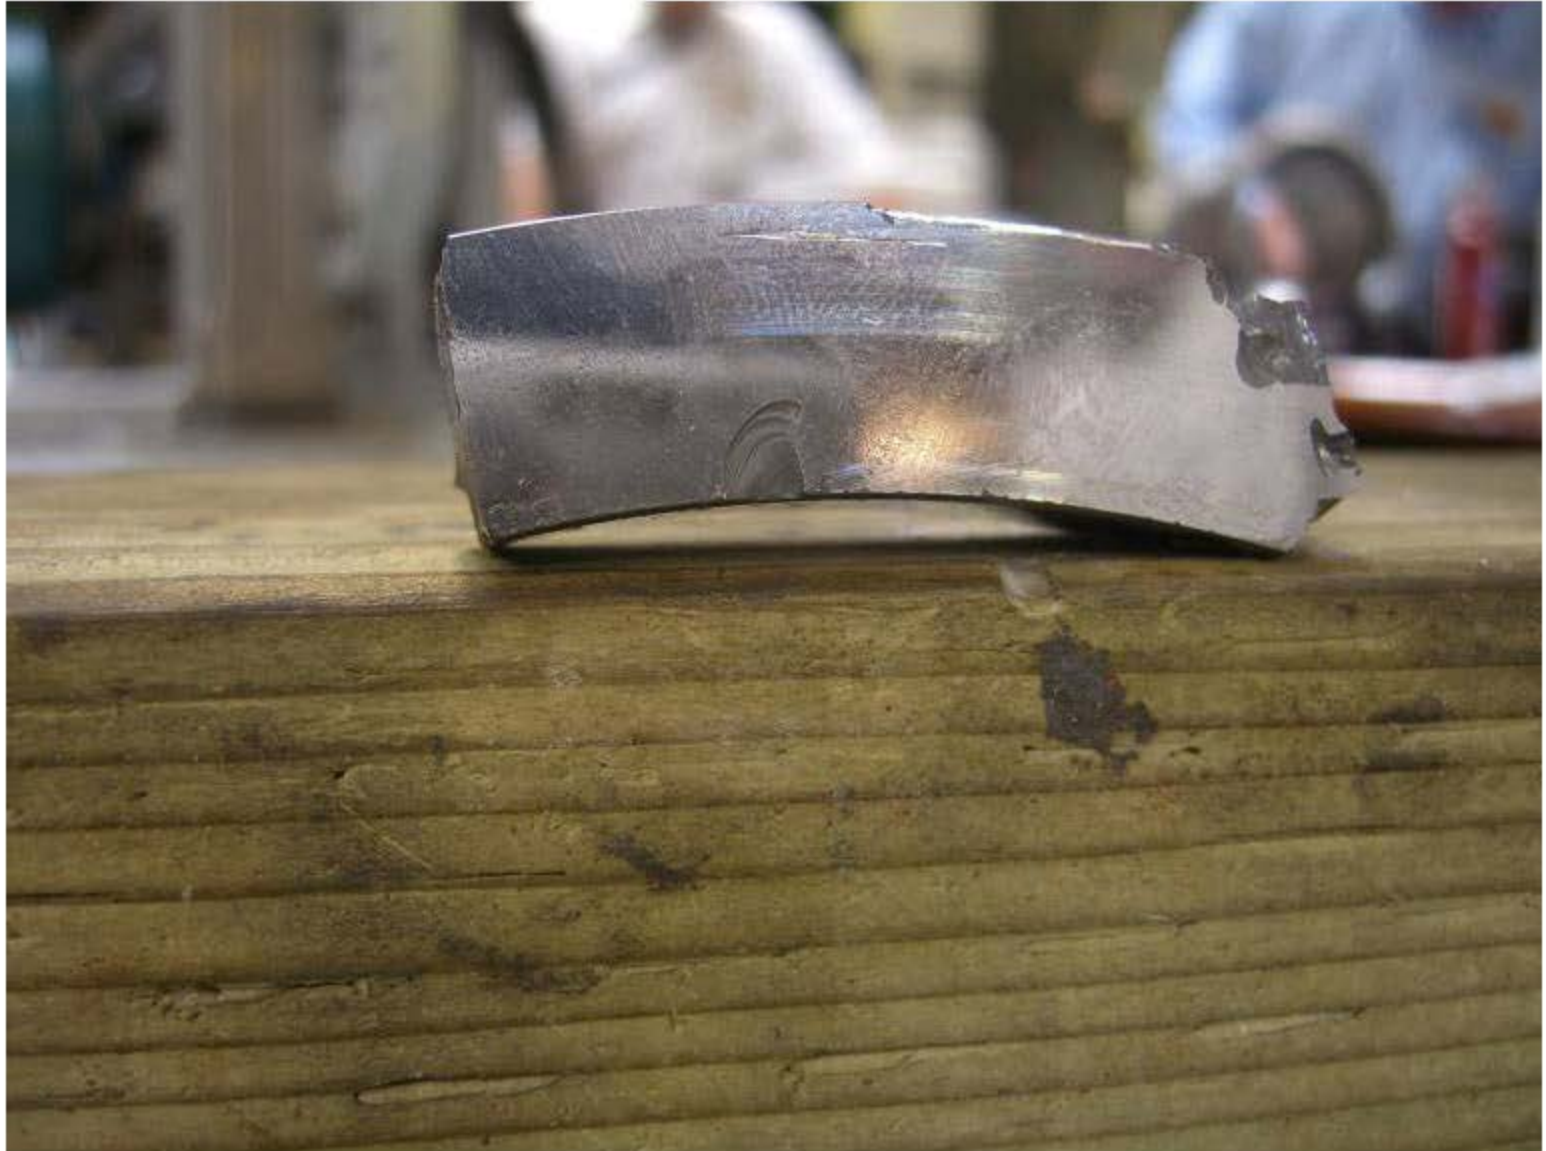
Rotating Face Damage

- Failure caused by hoop stress overload.
- Hoop stress overload caused by thermal growth of sleeve into bore of rotating ring.
- Failure mode very much like overspeed (also from high hoop stress).
- Subsequent overspeed of identical rotating ring showed very similar surface.

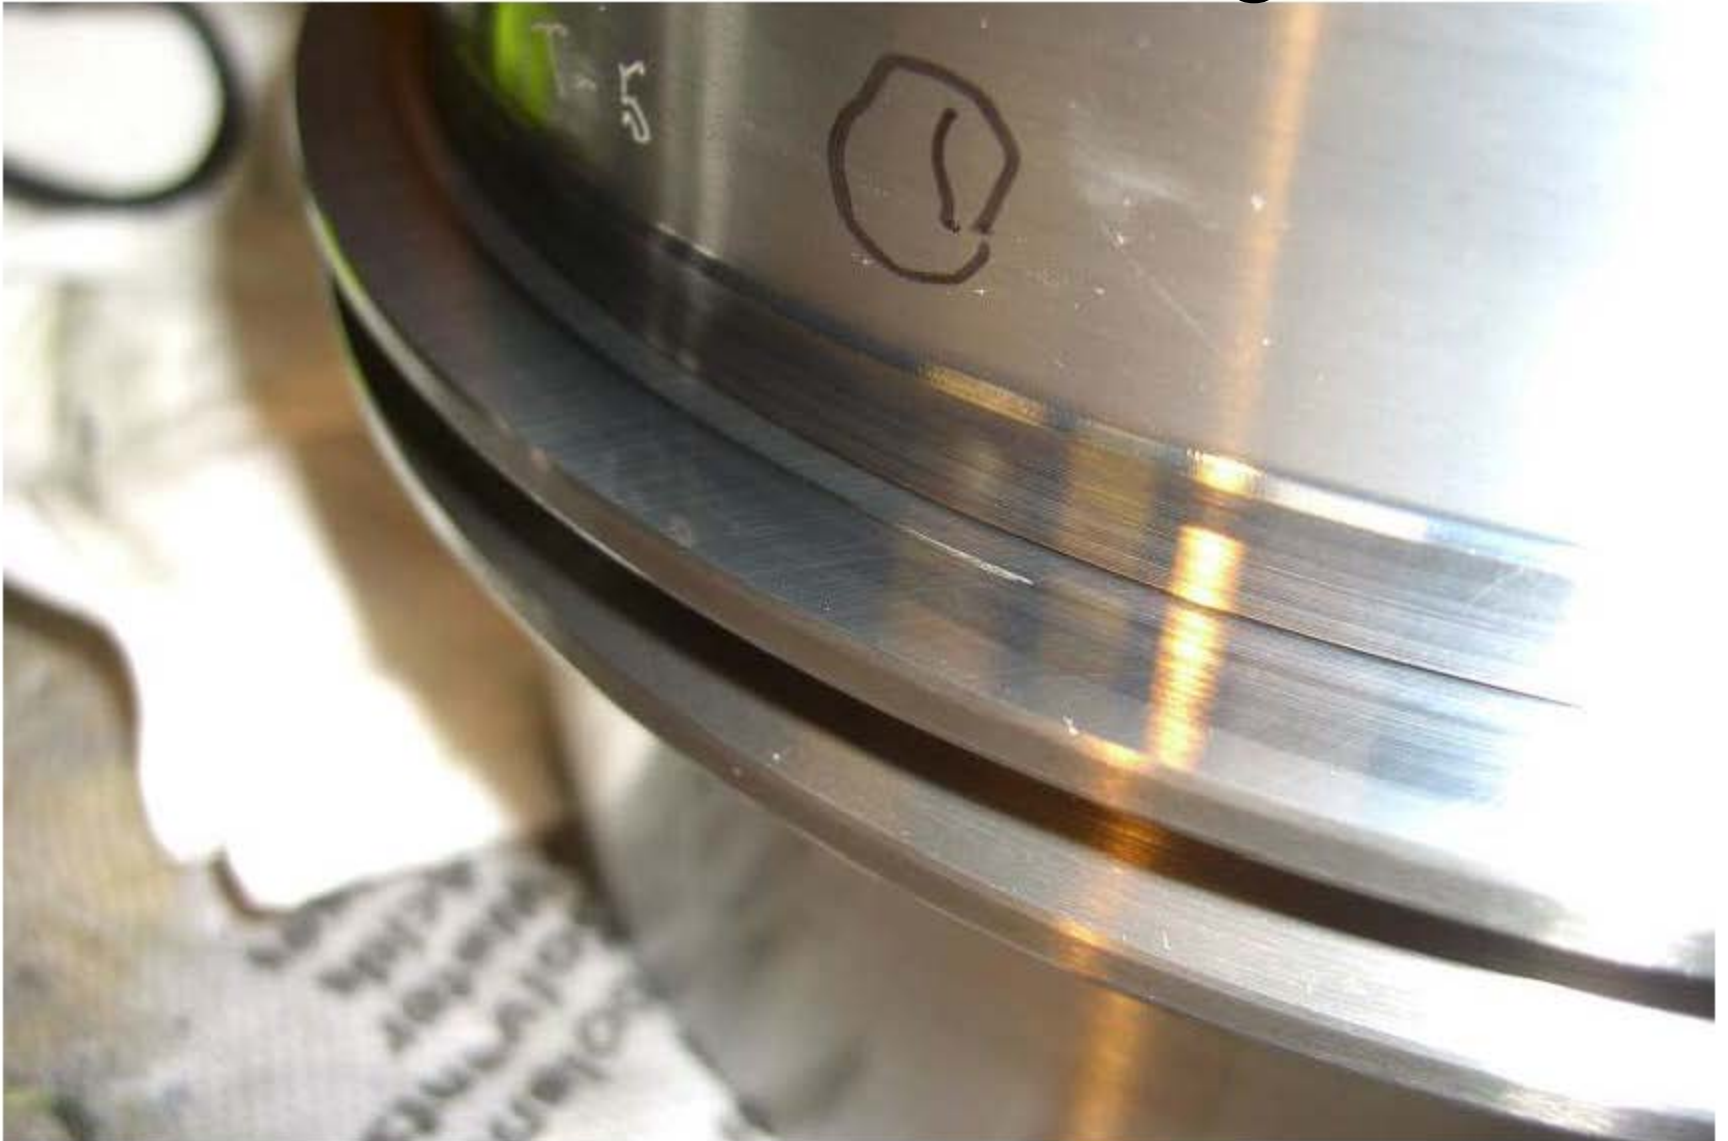
Seal Face Damage

- On test stand, the sixth machine repeatedly had small streaks of contact on the process side seal (never on GB end).
- Investigation indicated that axial forces due to seal centering could be a contributing factor.
- Pinion shaft movement in field would be greater than on test stand due to thrust reversal, possibly making this type of damage more likely in the field.

- Every third spring removed to lower both spring force and spring rate.
- Lower spring rate allowed less change in force as axial position changed.
- Special tooling designed to locate seal in proper position for operation in the field.
- Sixth (last) machine shipped and commissioned with every third spring removed.

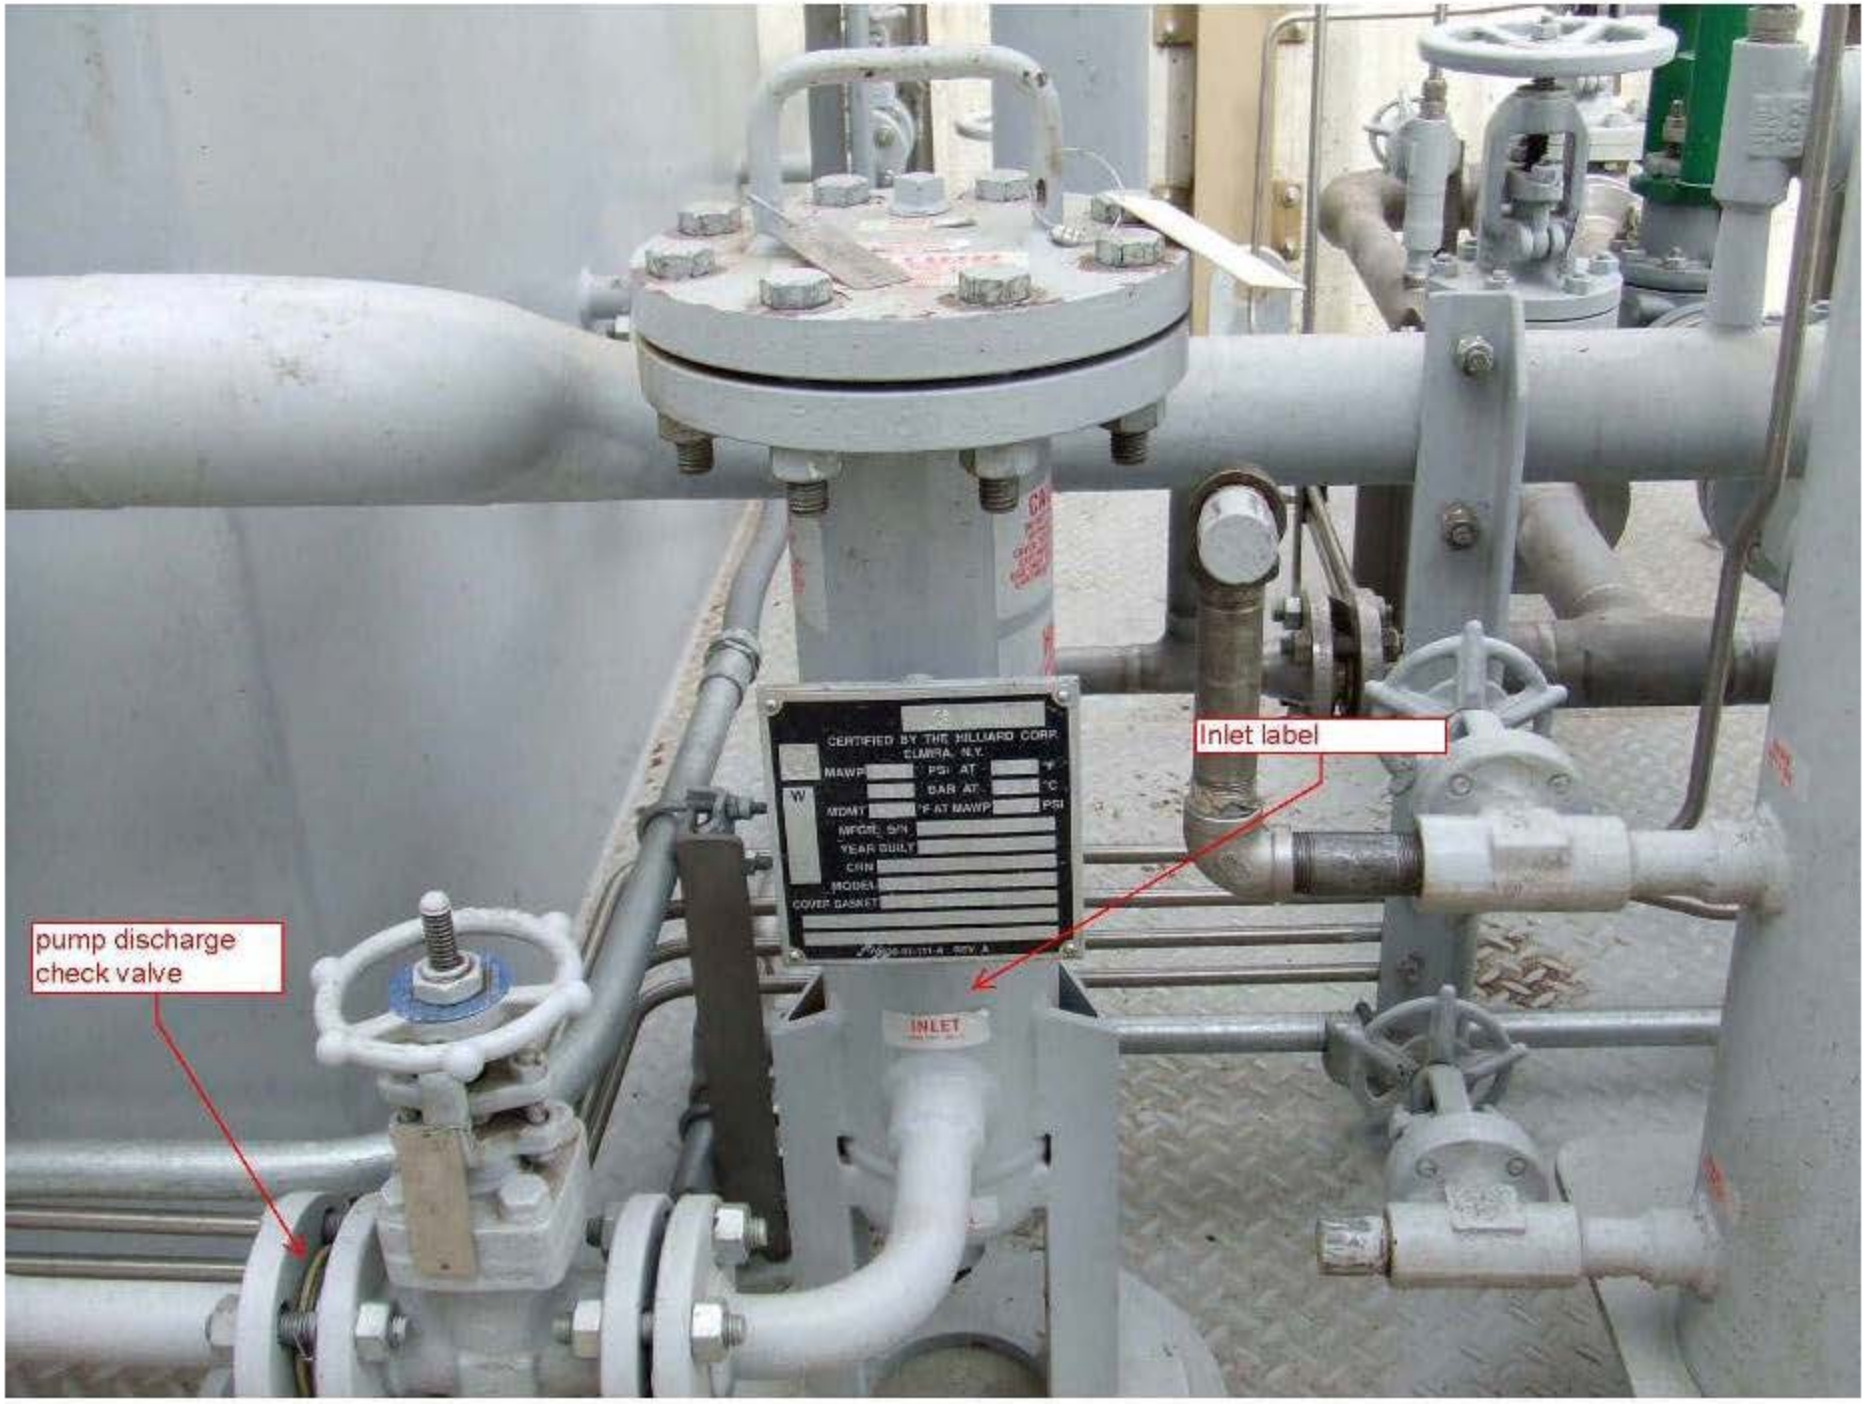
pump discharge
check valve

- All six machines continue to run well.
- All six filter housings were found to be marked (and thus installed) backwards!
- Four of the six machines continue to work with seals that experienced filter failures, but did not cause high seal leakage.
- Two seals that began leaking after filter failure were replaced and running fine.
