Case study proposal for the 37th Turbomachinery Symposium,  
Houston, Texas, USA, September 8-11, 2008

## **VIBRATIONS IN HIGH PRESSURE CENTRIFUGAL COMPRESSORS OF OFFSHORE PLATFORMS**

# VIBRATIONS IN HIGH PRESSURE CENTRIFUGAL COMPRESSORS OF OFFSHORE PLATFORMS

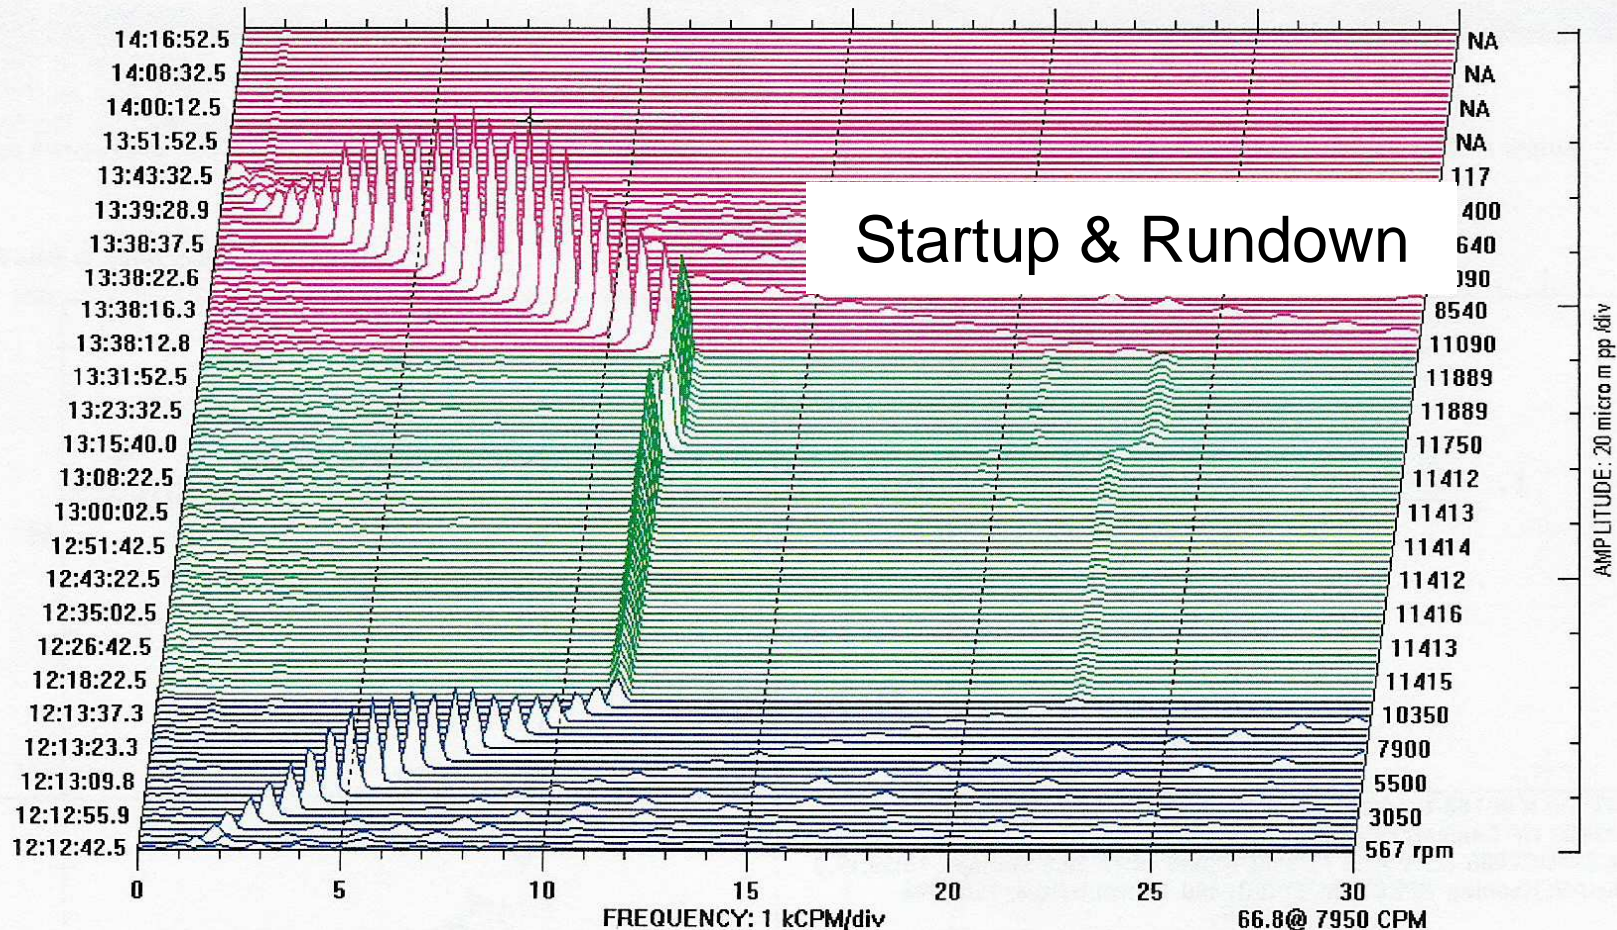
- String Test done in 2002: vibration values below the specified limits (train MCC).
- Startup of the first set of compressors, MCB, in Aug/2006: excessively high vibration at the HP compressor, mainly at the non driven end.
- Records showed that the vibration was basically the synchronous 1X component, which increased with temperature, as the recycle valve was closed.

Waterfall plot of one of the NDE sensors  
– vibration is basically 1X

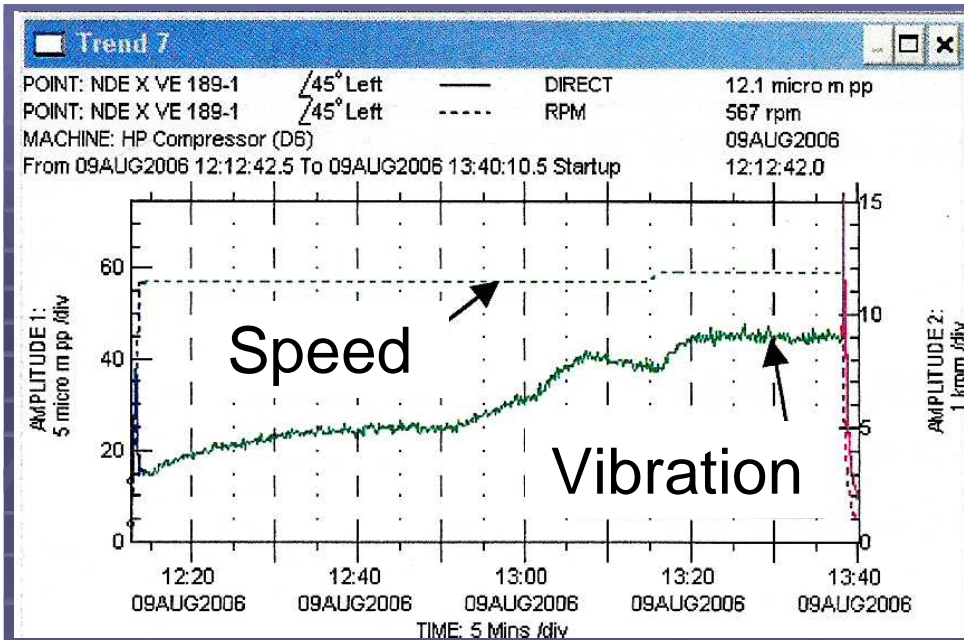
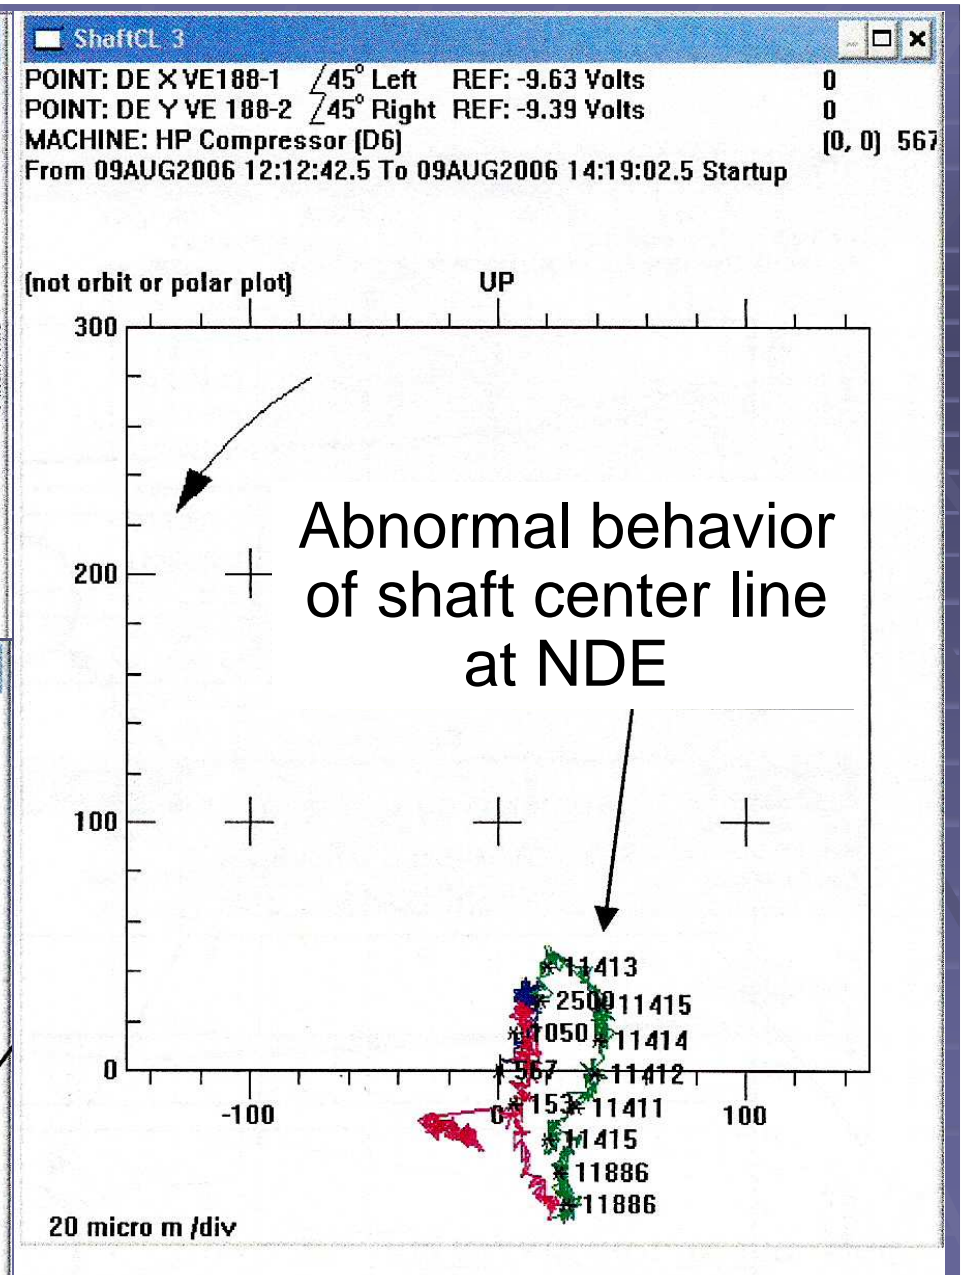
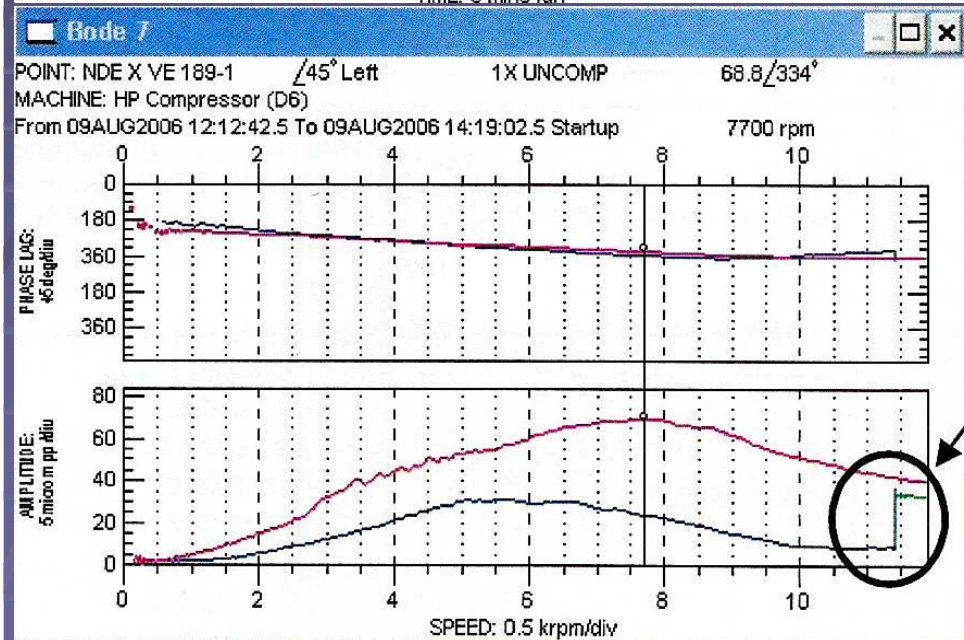
Above: Speed & NDE vibration.  
 Below: Bode plot.

NDE shaft average position: Height changes with constant speed.

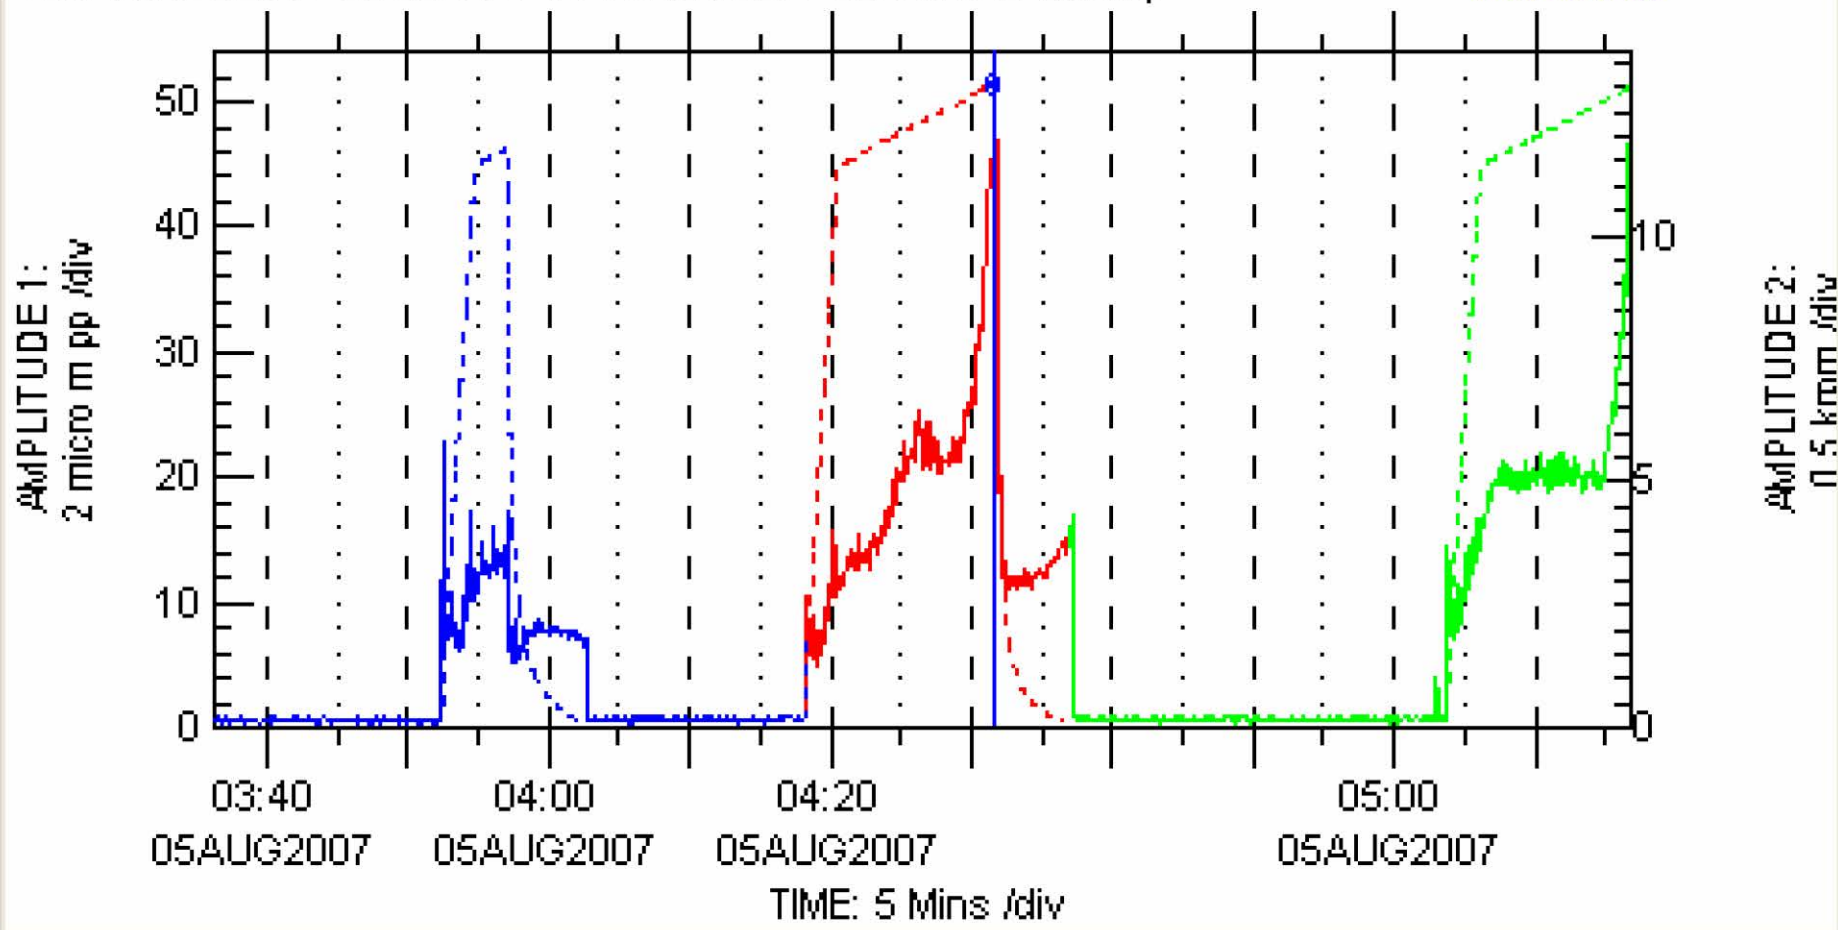
# Trend 7

- A field balancing reduced somewhat the level of vibration and the MCB train continued to operate precariously until May/07.
- MCA began operation in Sept/2006, also with high vibration on the HP, although smaller than that of MCB. Due to problems in the VSD, the compressor operation was interrupted, which enabled the placement of the MCA HP bundle in the MCB.
- The spare HP rotor, modified as explained below, was placed in the bundle that was previously in the MCB, and inserted into the MCA (Aug/2007).
- The MCC, the train with which the String Test was performed, works smoothly since its startup in Feb/2007.

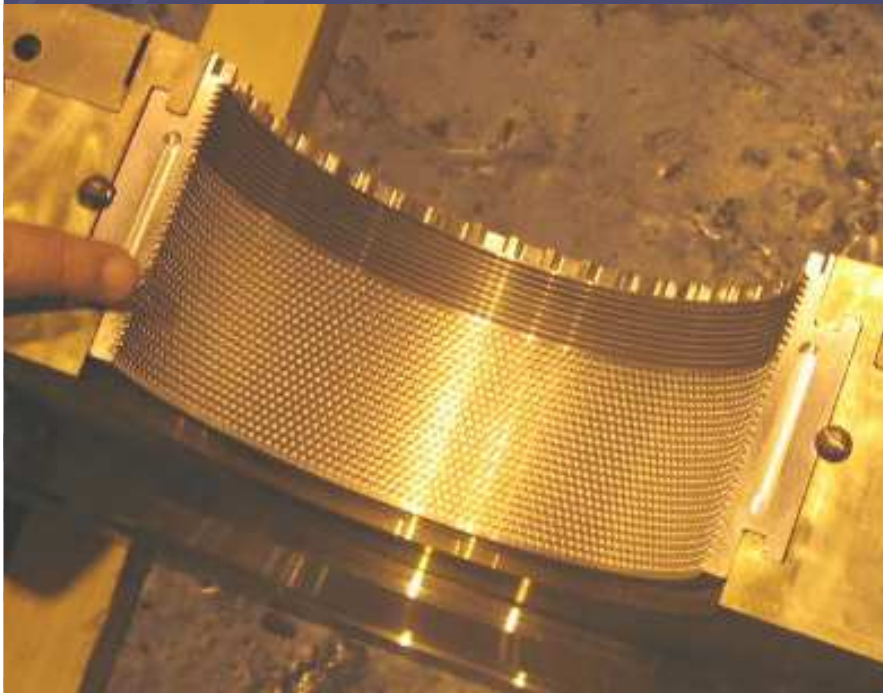
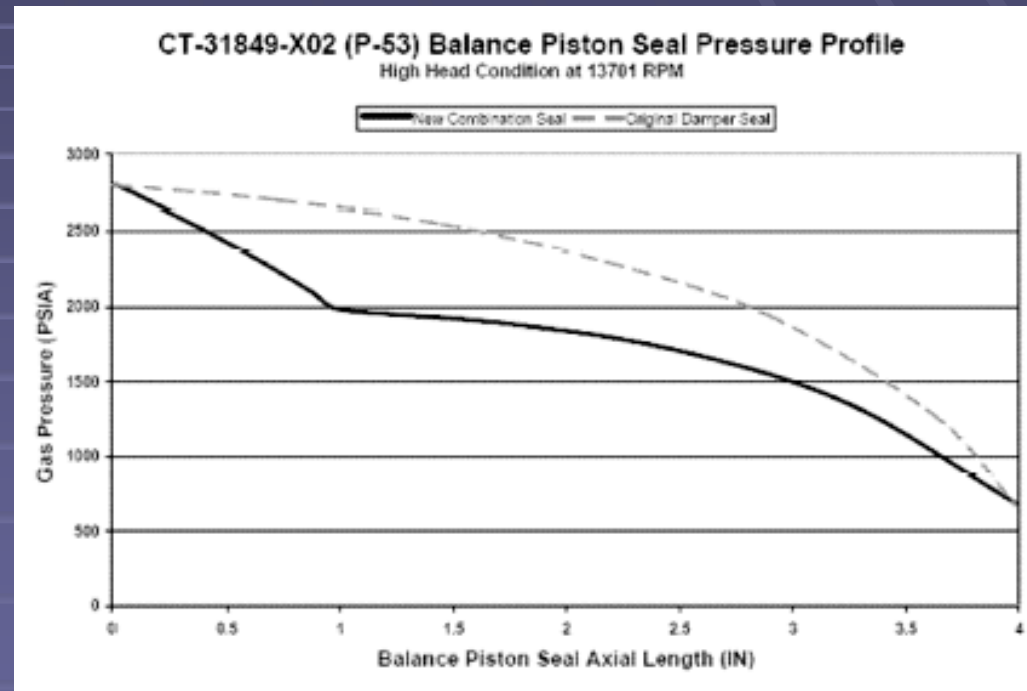
- At another pre-run, the compressor continued to show a high level of 1X vibration. However, the vibration was now more related to a pressurization effect, caused by the design of the balance piston seal.
- This was of the hole pattern type, to produce damping and ensure the stability of the rotor. However, the stiffness of the seal was of the order of the joint stiffness of the bearing and the squeeze film damper.
- In practice, a large bearing at the coupling end of the rotor. The opposite end, more flexible, became also more susceptible to vibration.
- In order to reduce the stiffness effect of the seal, a stretch of labyrinth seal was added.

Modified seal and pressure profile over the balance piston
