Turbomachinery Symposium 2008

Case study

Evaluation and Successful Modification of Impeller Using Forced Response Analysis

GE Oil & Gas, Bethlehem, PA

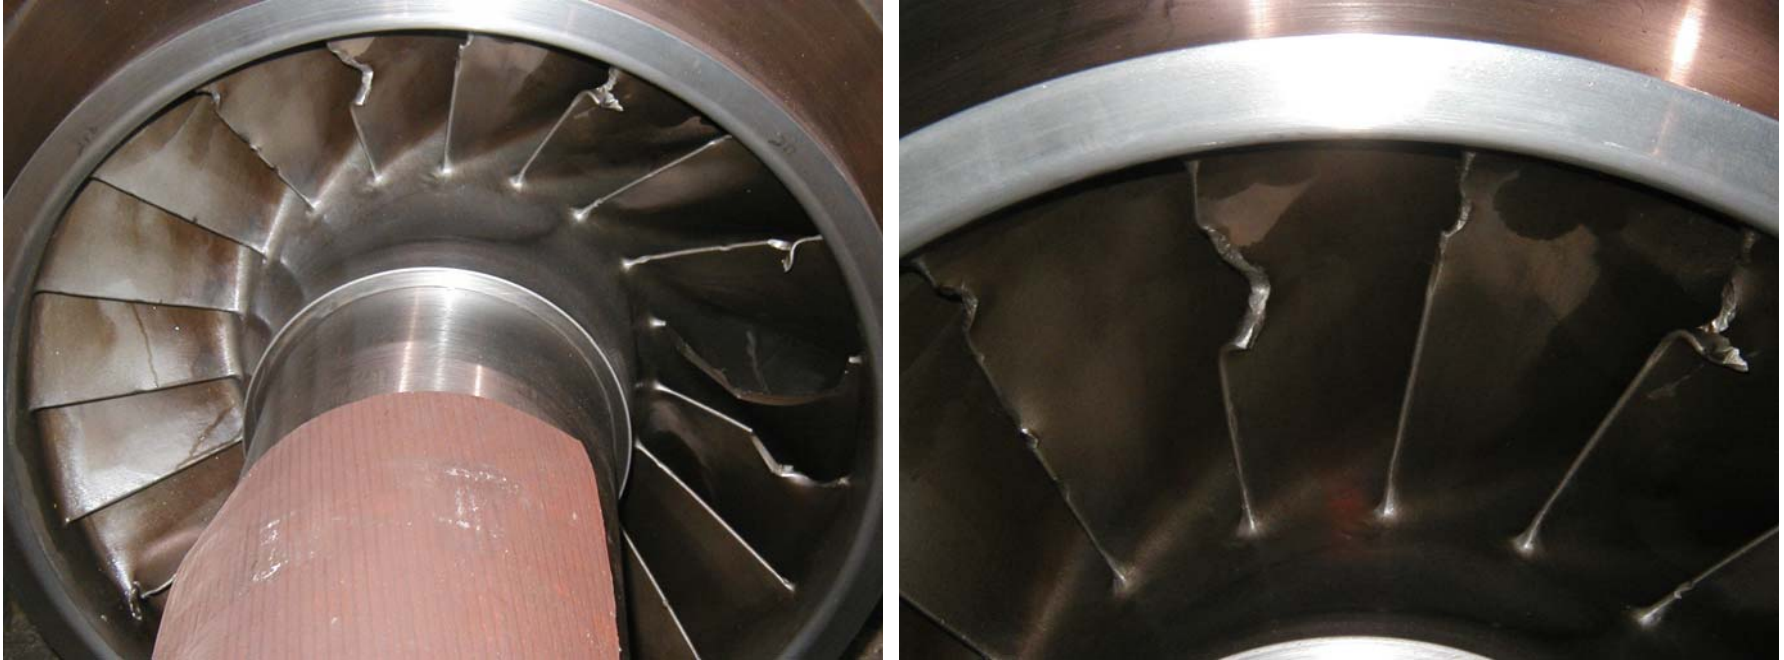
A compressor impeller failed in the field with multiple cracks and missing chunks of material from the blades were found at the inlet after 1,000~1,200 hours of service.

The spare unit tripped off line following high compressor vibration after 1,700 hours of service.

Unit was disassembled and it was discovered that the impeller blades were damaged similar to the first event.

Pictures of failed blades with missing material are shown on Figure 1.

Figure 1: Pictures Showing Failed Blades with Missing Material

- 1) Weld repair current damaged impeller.
- 2) Machine back blade Leading Edge 0.75 in. (Re-radius Leading Edge to maintain 0.17 in. normal thickness).
- 3) Perform Modal Analysis and Forced Response Analysis of new assembly.

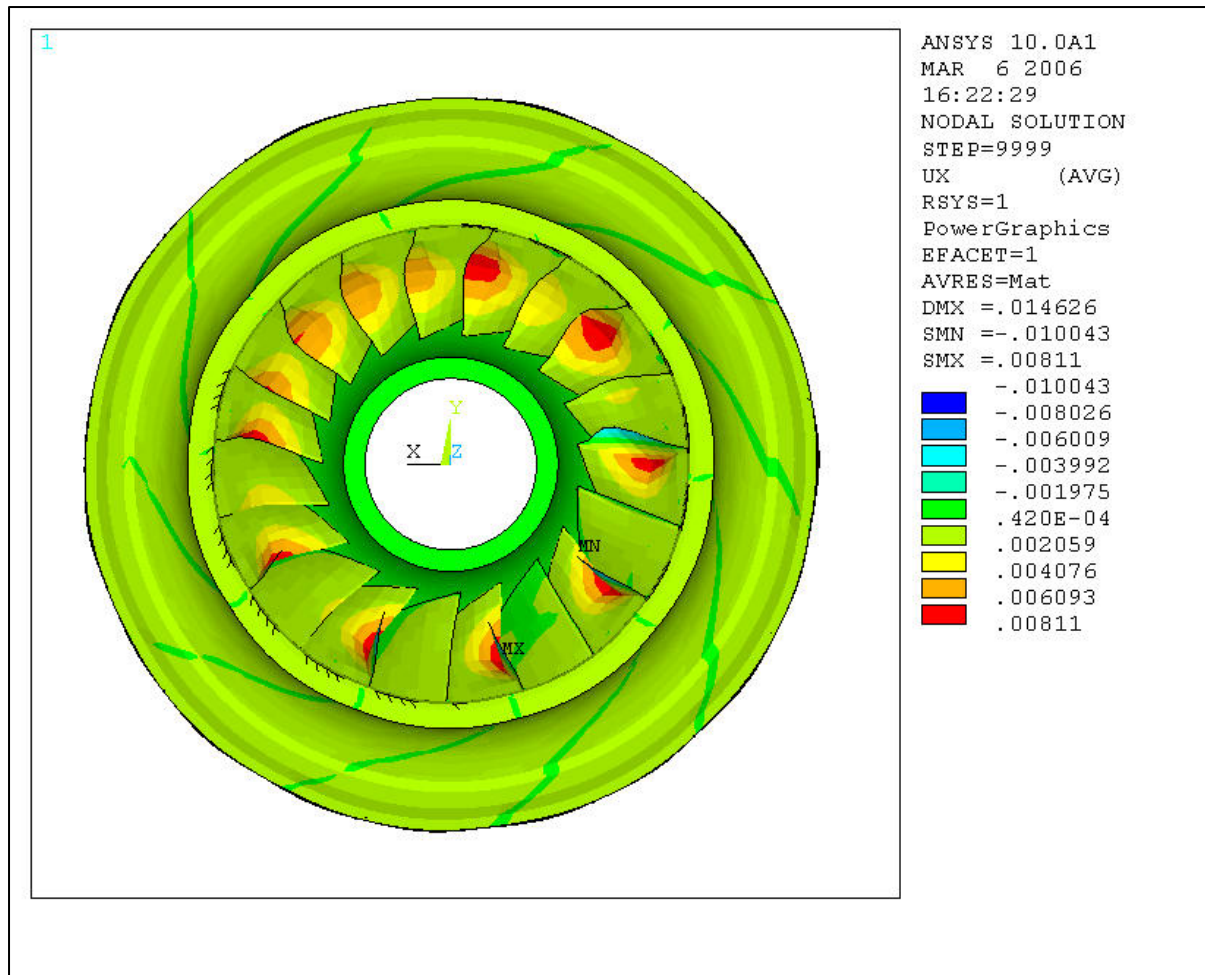
The unit has 12 Inlet Guide Vanes (IGV). Modal Analysis indicated possibility of resonance condition with 2x(IGV) forcing frequency and impeller natural frequencies at,

Figure 3: Radial Component, Mode Shape 1937 Hz, 5-ND (1C), Original Design

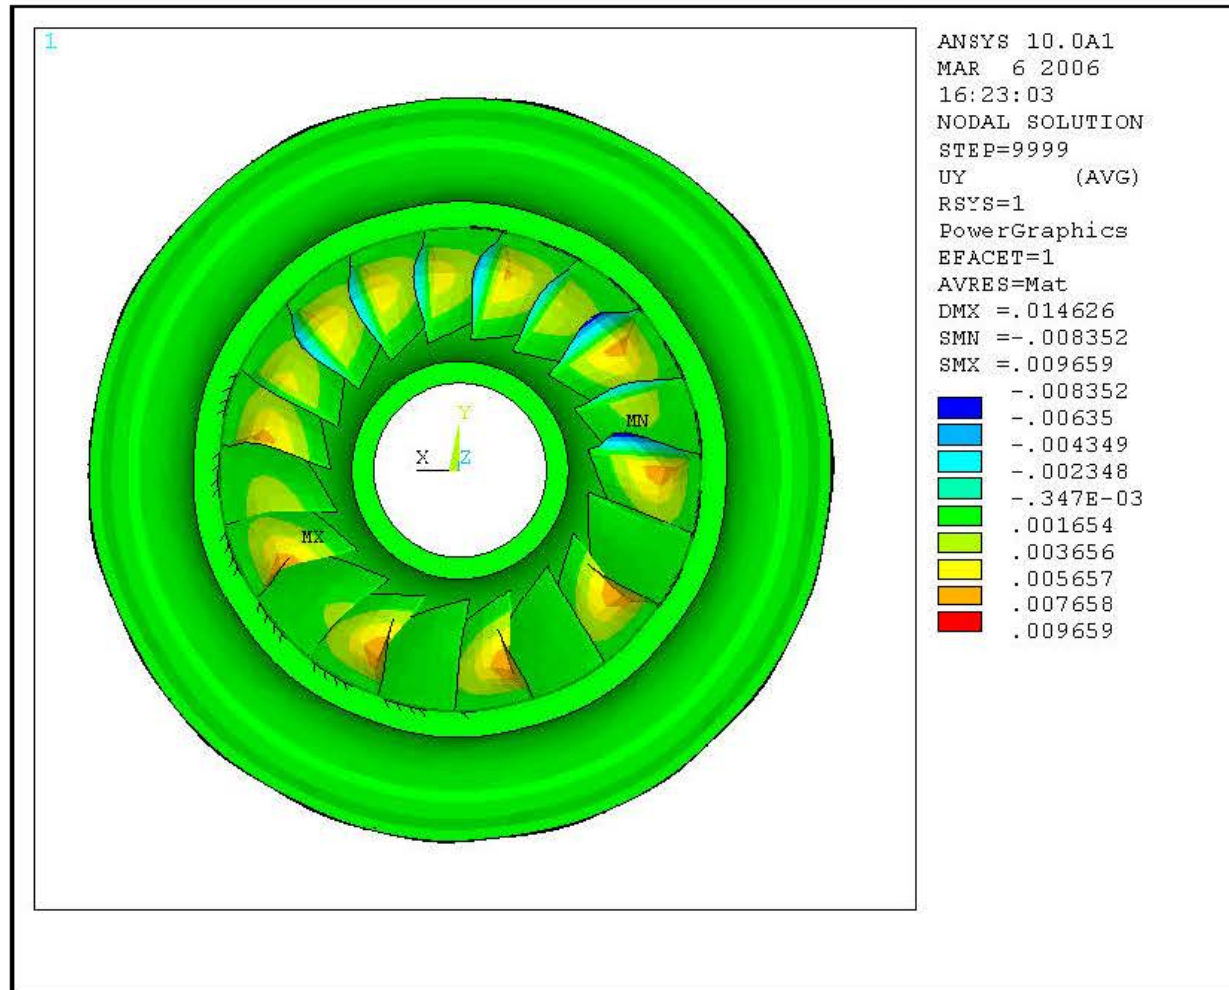
Figure 4: Tangential Component, Mode Shape 1937 Hz, 5-ND (1C), Original Design

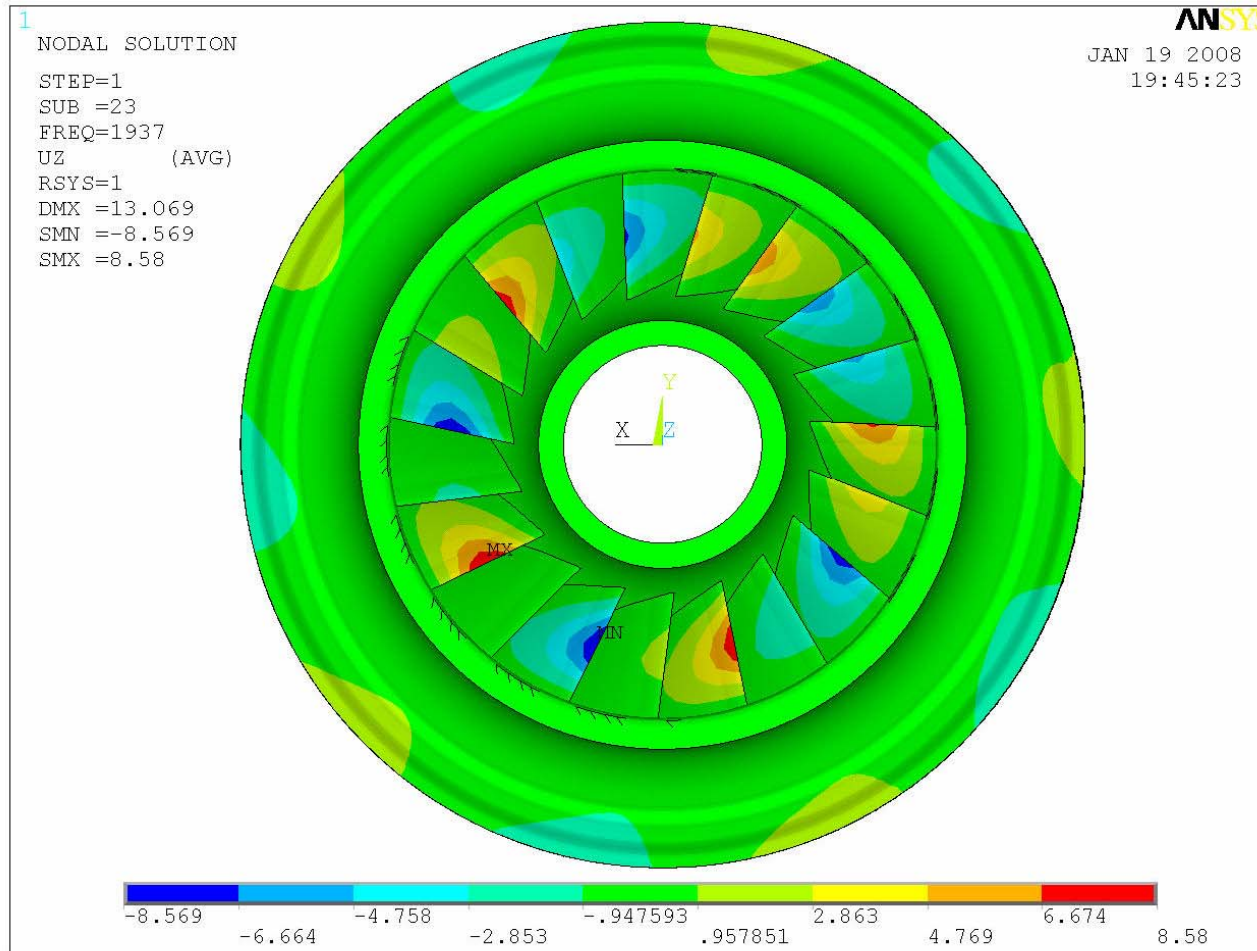
Figure 5: Axial Component, Mode Shape 1937 Hz, 5-ND (1C), Original Design

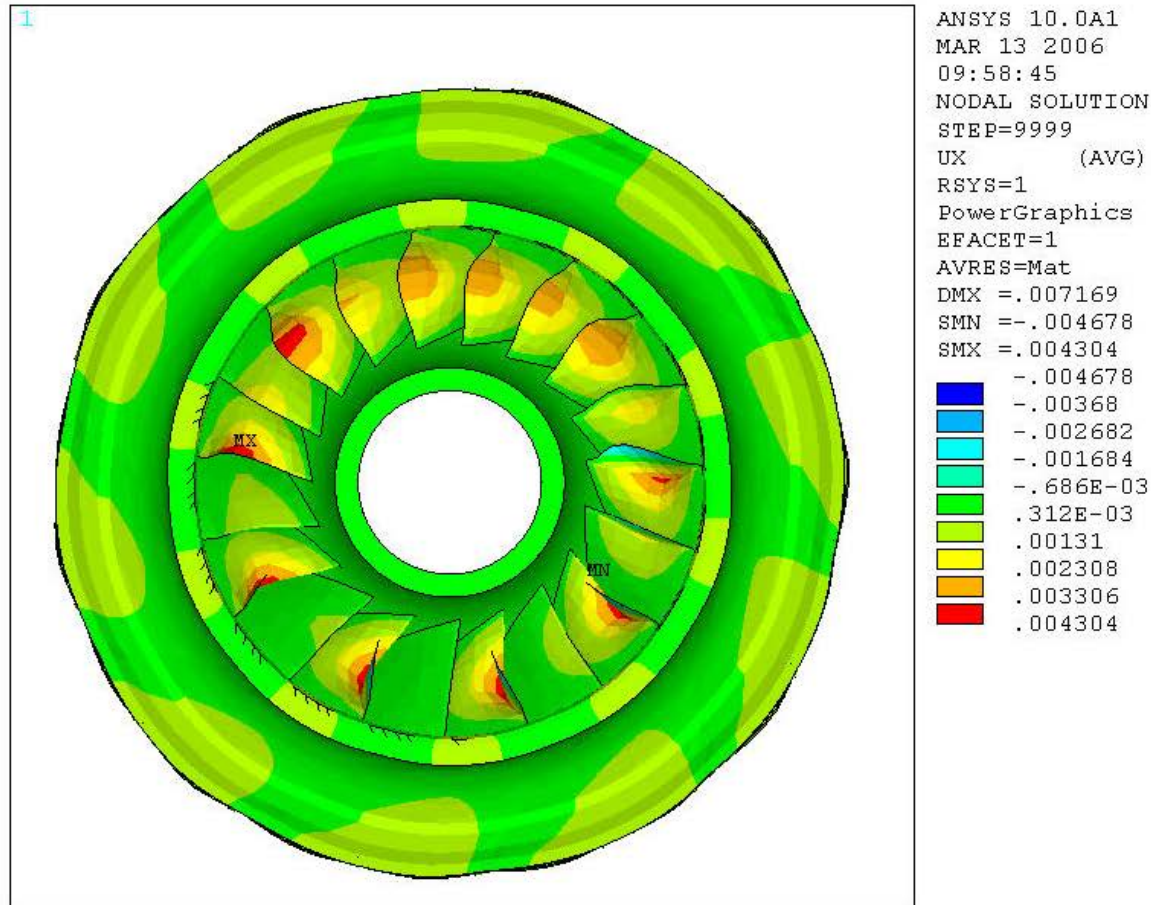
Figure 6: Radial Component, Mode Shape 2006 Hz, 5-ND (2C), Original Design

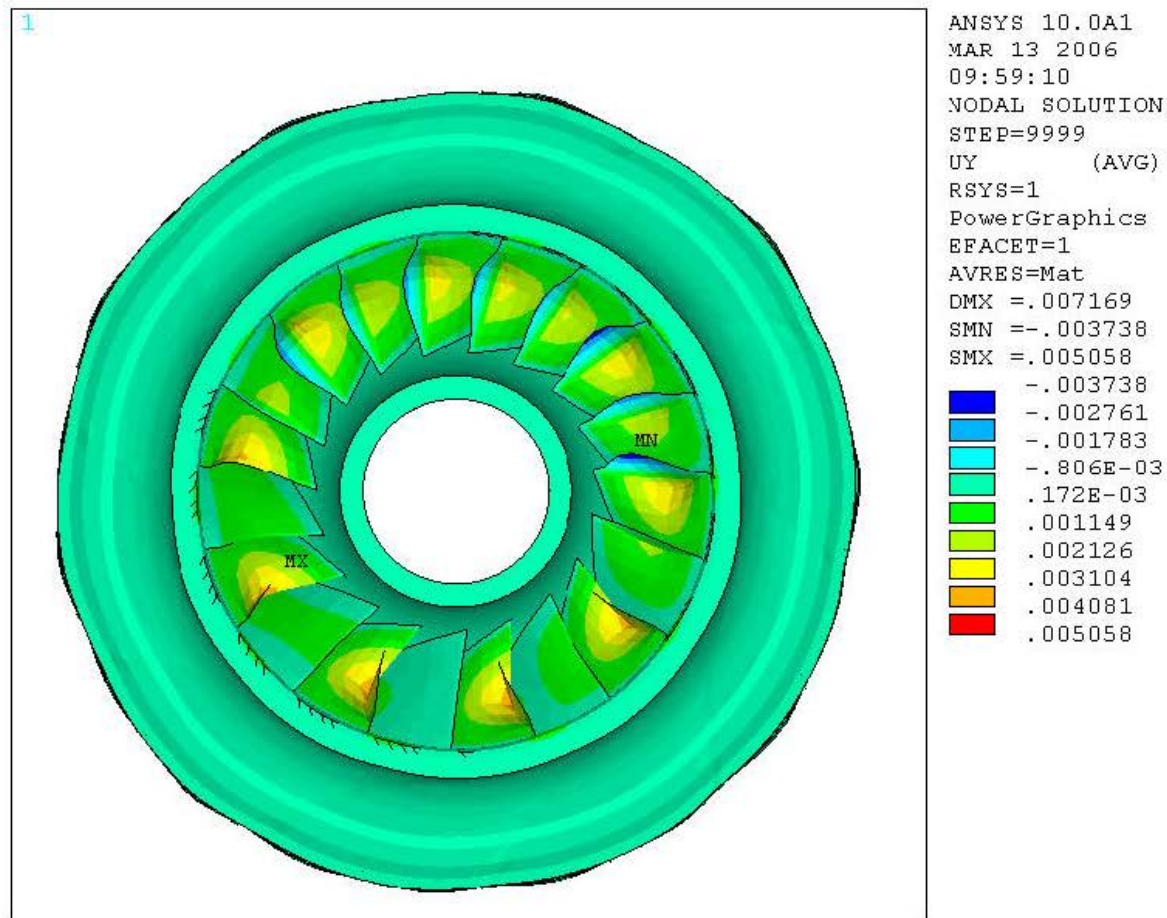
Figure 7: Tangential Component, Mode Shape 2006 Hz, 5-ND (2C), Original Design

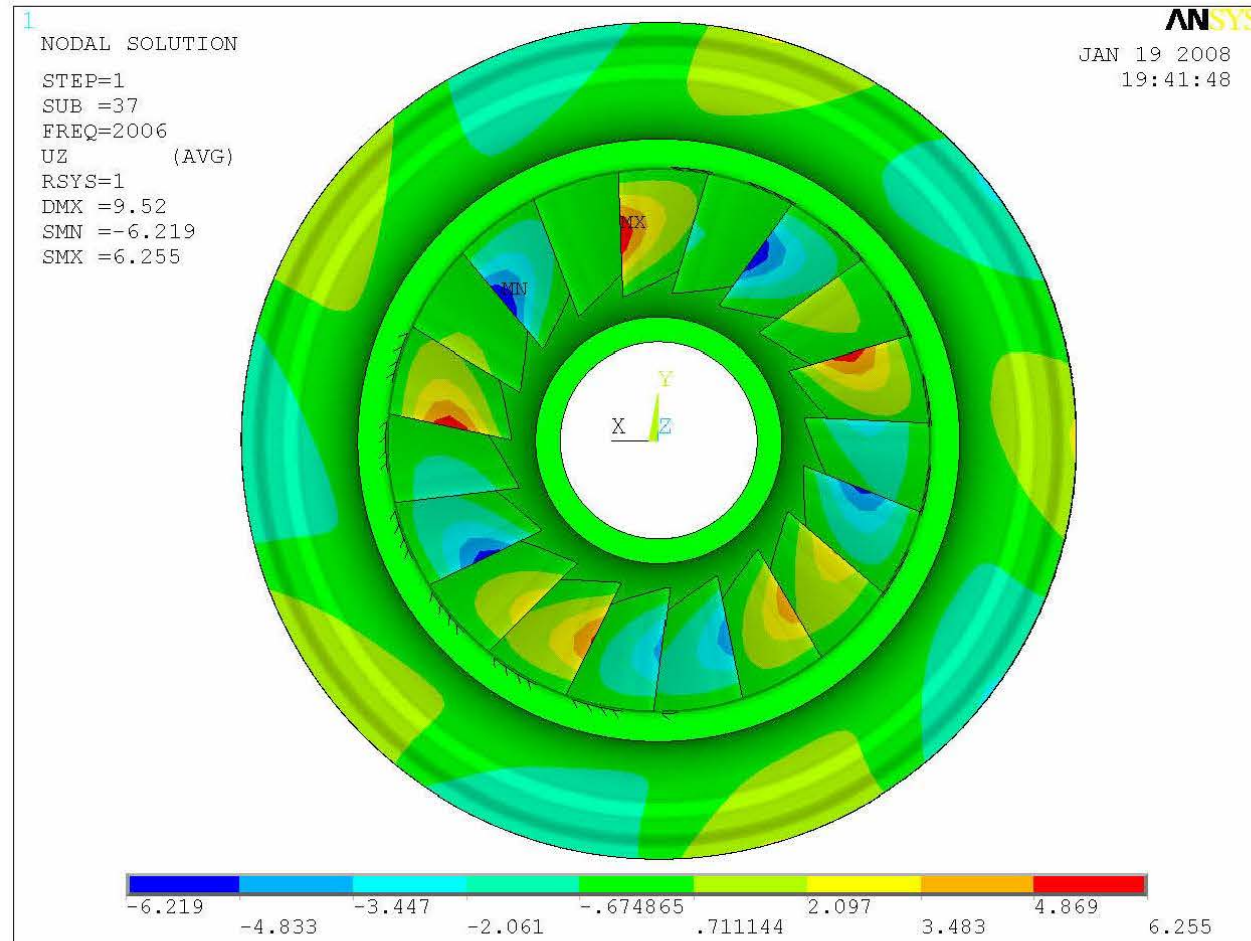
Figure 8: Axial Component, Mode Shape 2006 Hz, 5-ND (2C), Original Design

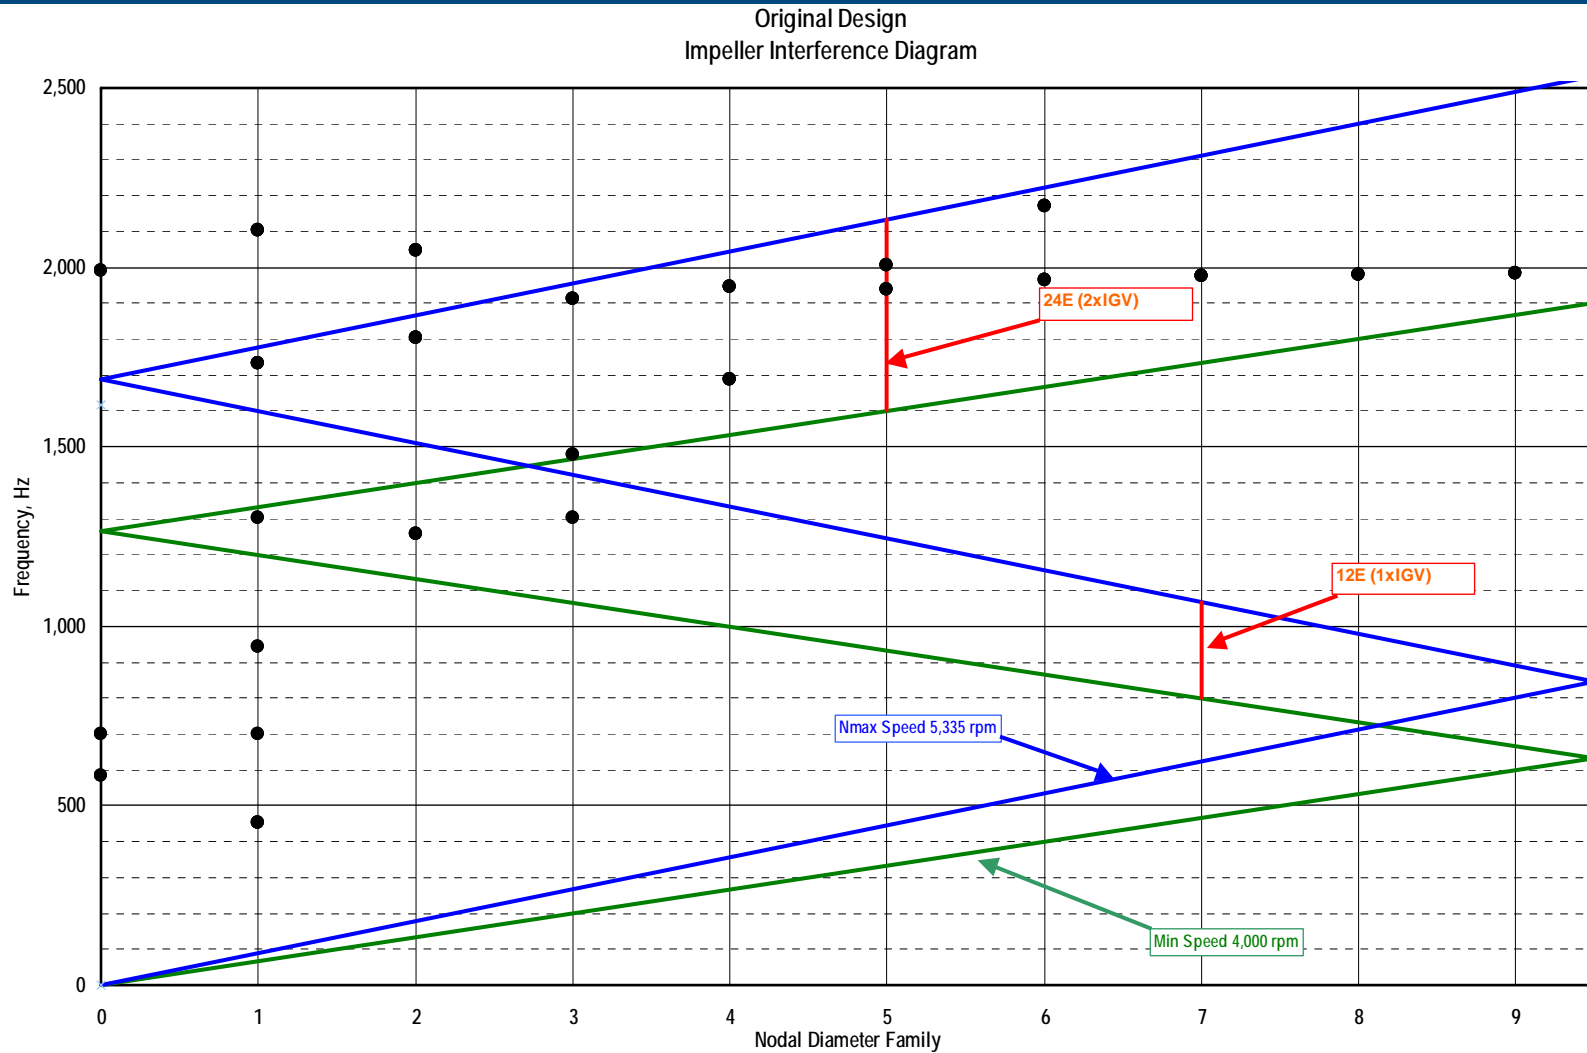
Figure 9: Interference Diagram, Original Design

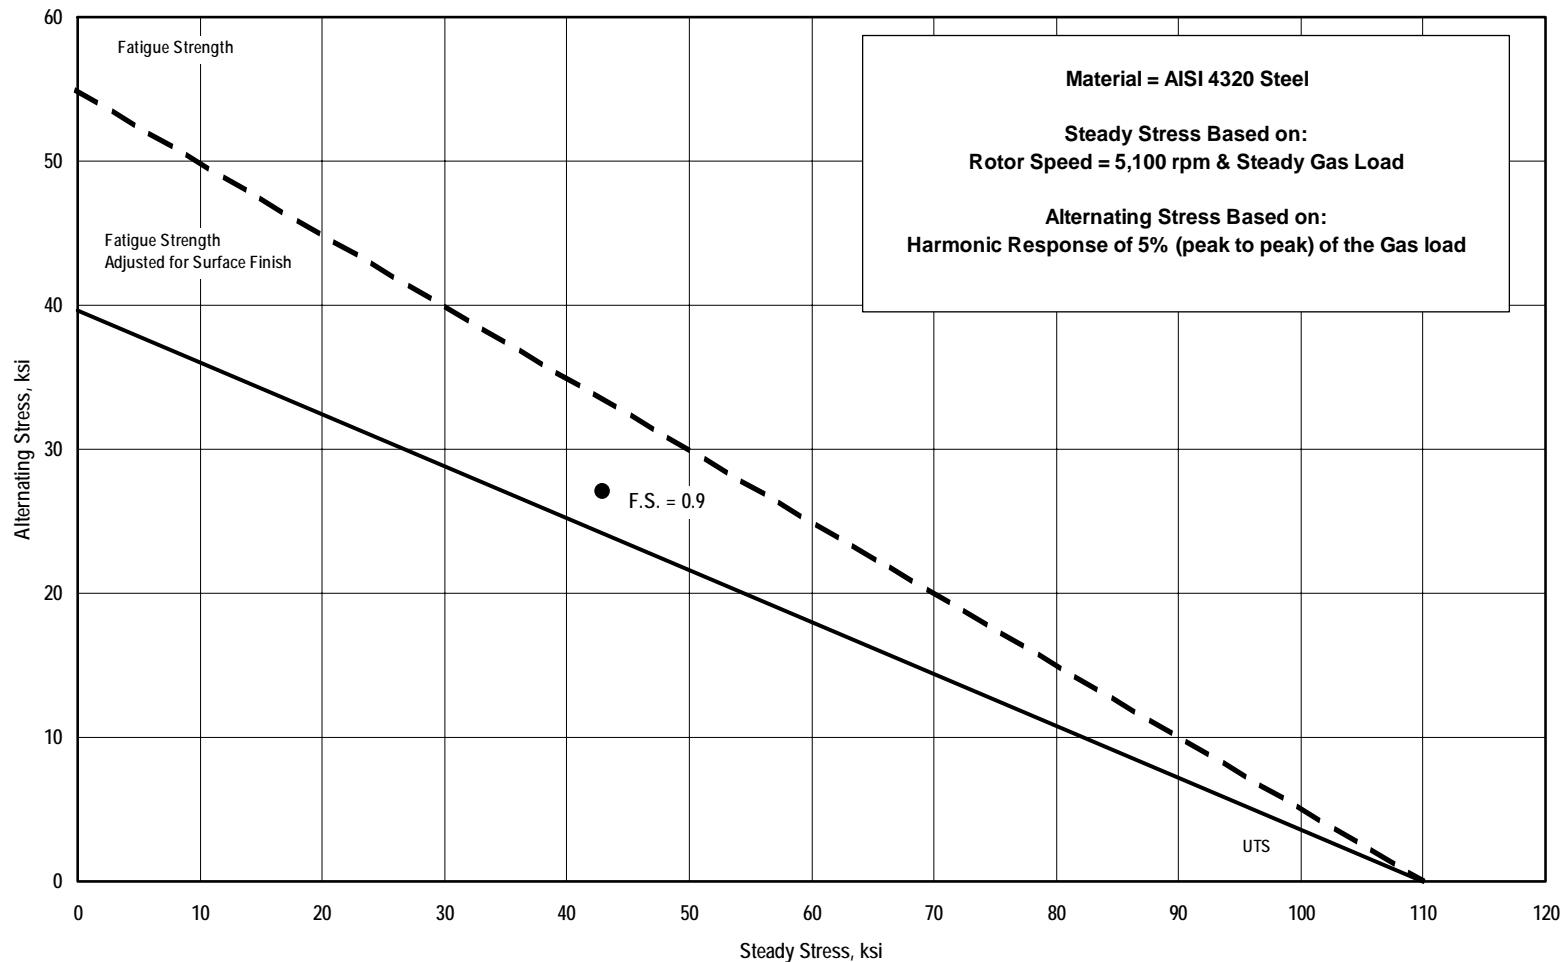
- 1) 1937 Hz, 5-ND (1C) – Goodman Factor of Safety 0.9 (Figure 10).**
- 2) 2006 Hz, 5-ND (2C) - Goodman Factor of Safety 1.3 (Figure 11).**
- 3) Goodman Factor of Safety 0.9 and 1.3 for the above cases are less than the acceptable Margin of Safety 1.5.**

Figure 10: Goodman Diagram, Response Stress, 1937 Hz, 5-ND (1C)

- **Possible Resonance condition for 2x(IGV) Forcing frequency with Impeller natural frequencies at 1937 Hz, 5-ND (1C) and/or 2006 Hz, 5-ND (2C) may have caused failure.**
- **Considering Forced Response Stress, Goodman Factor of Safety 0.9 and 1.3 for the above cases are less than the acceptable Margin of Safety 1.5, which eventually may have resulted in the failure.**

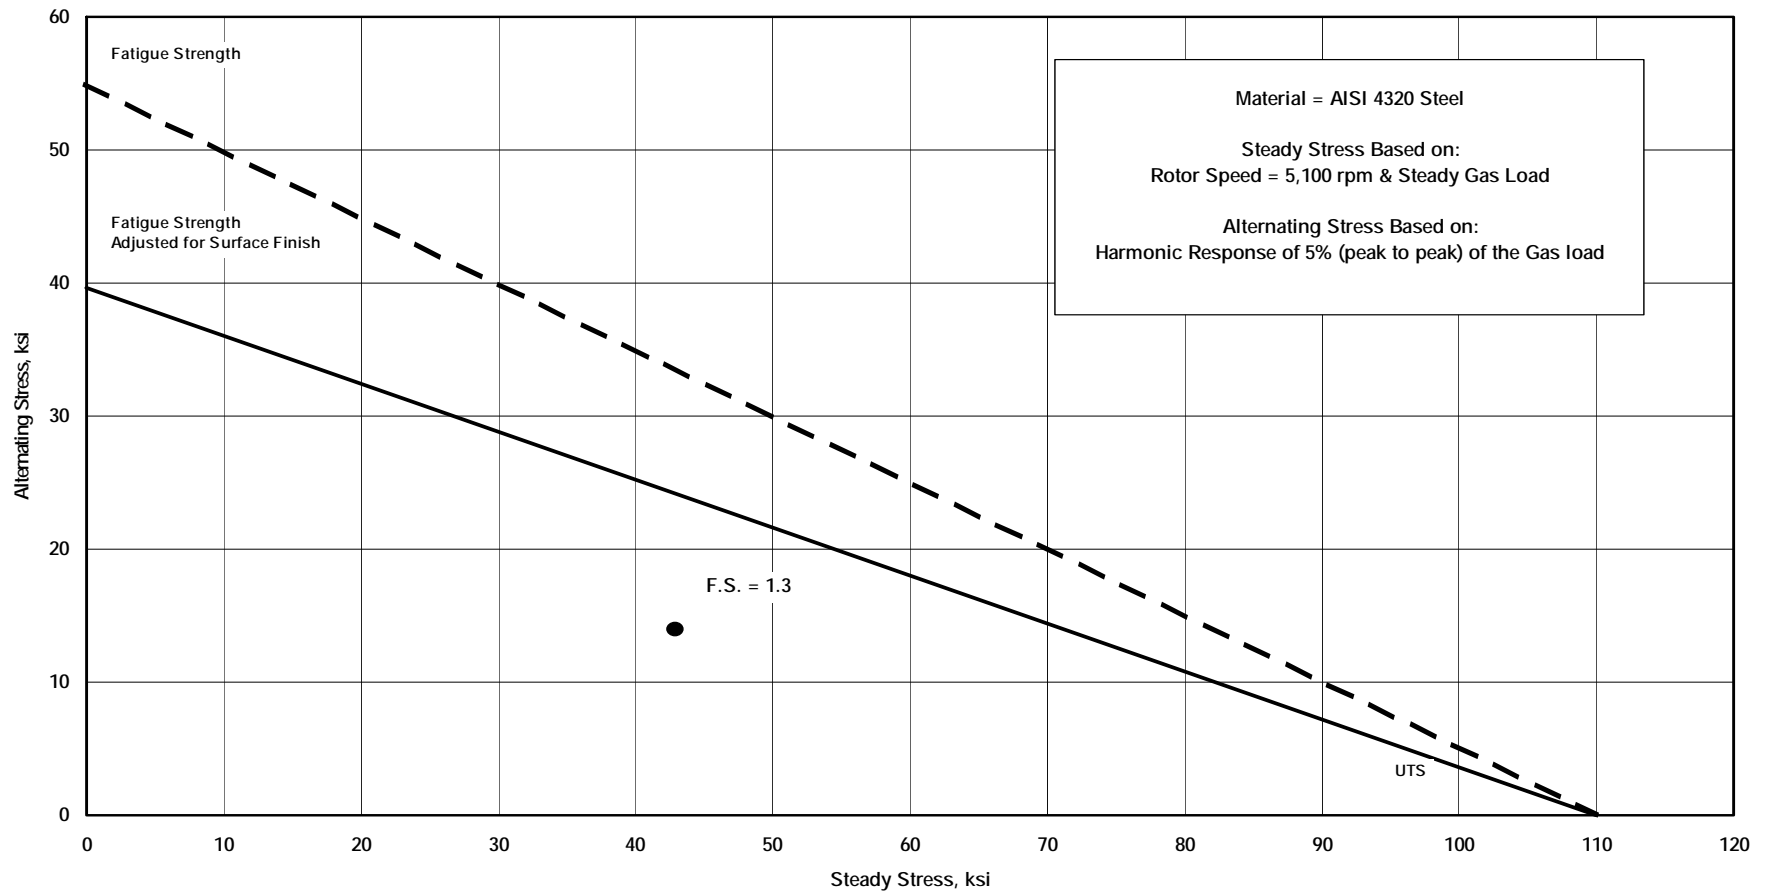
Figure 11: Goodman Diagram, Response Stress, 2006 Hz, 5-ND (2C)

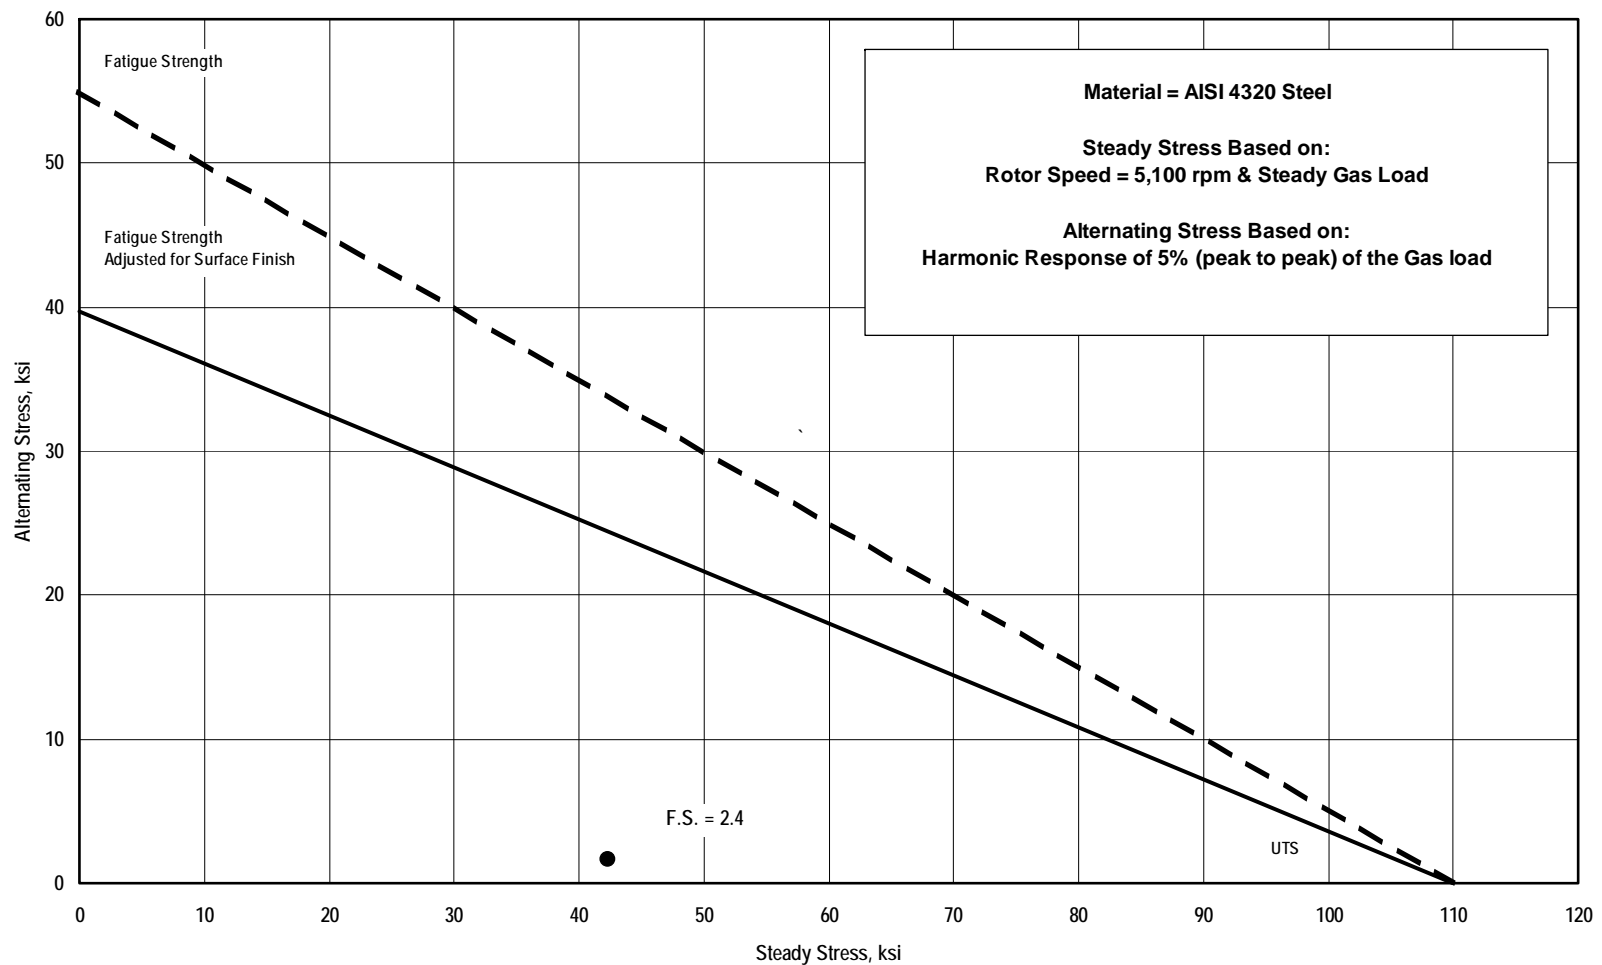
- 1) 1974 Hz, 5-ND (1C) – Goodman Factor of Safety 2.4 (Figure 17).**
- 2) Goodman Factor of Safety 2.4 for the above case is greater than the acceptable Margin of Safety 1.5.**

Figure 17: Goodman Diagram, Response Stress, 1974 Hz, 5-ND (1C)
