37th Turbomachinery Symposium

VFD Induced Coupling Failure

John Kocur, Jr. Ph.D
Machinery Specialist, ExxonMobil

Joe Corcoran
Manager Global Services & Training, Kop-Flex

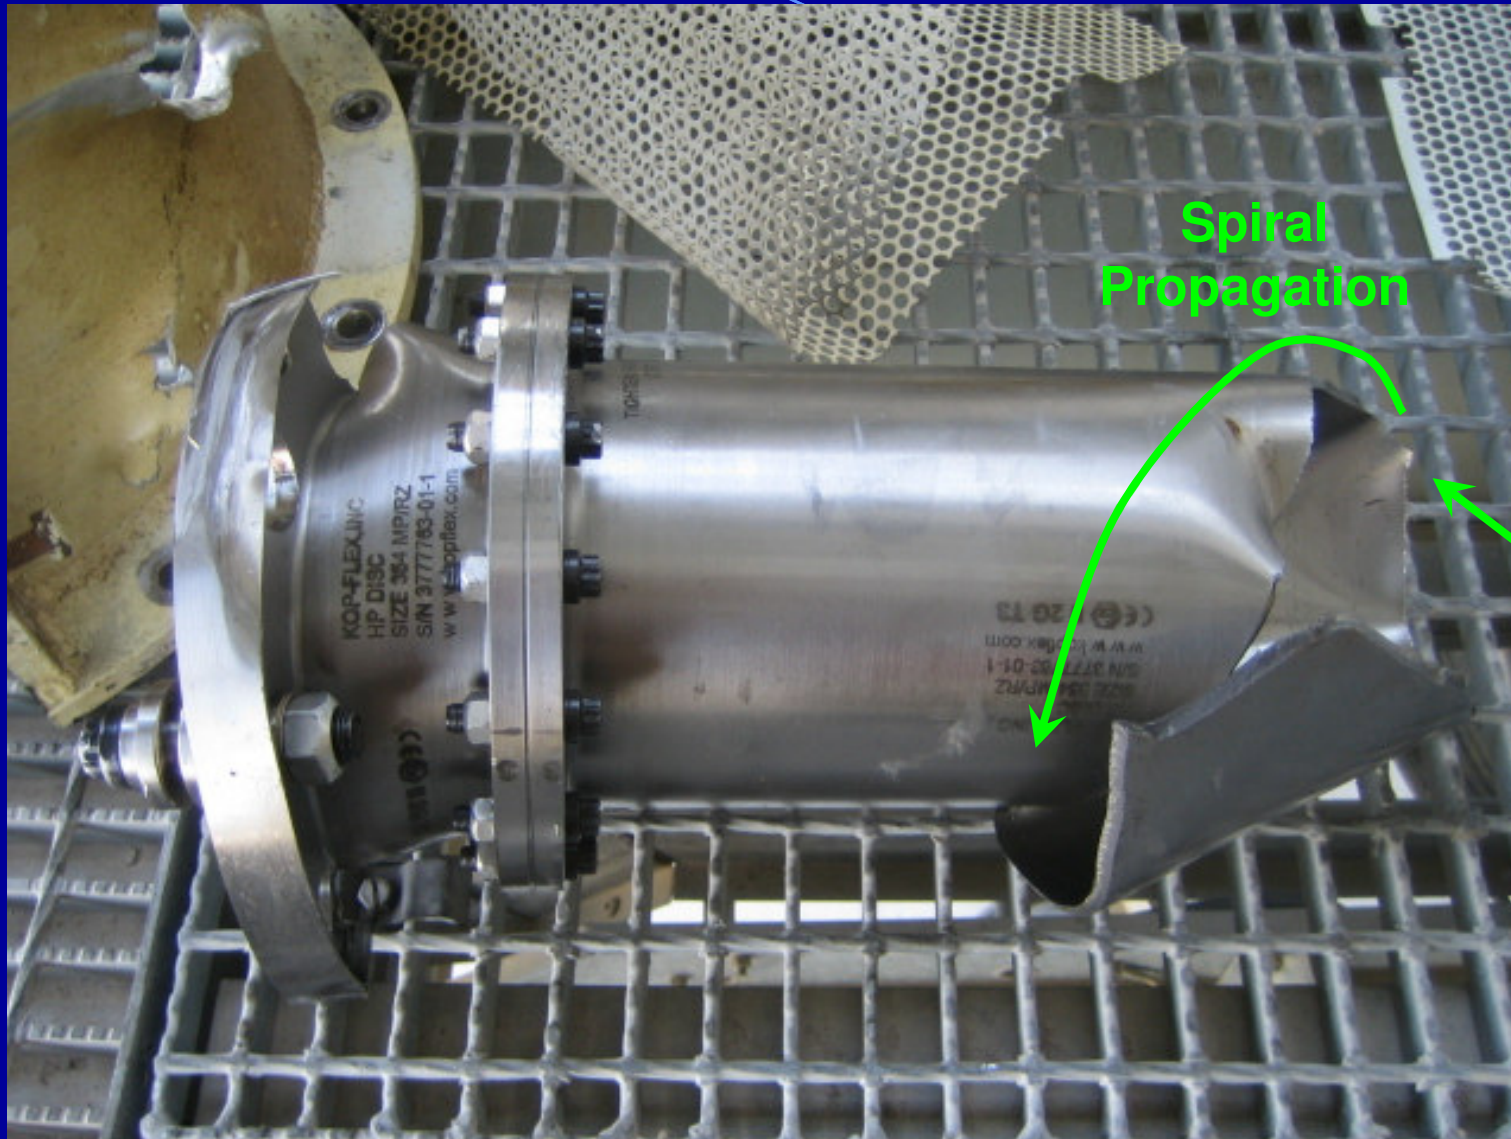
Torsion Induced Failure

**Crack
Initiation**

**Spiral
Propagation**

- **Re-excitation of 1st TNF not sufficient to cause failure**
 - Testing and analysis revealed this causes pulsating torque at 20% of rated
- **During coincidence with sidebands pulsating torque can reach 80% of rated**
 - Several sidebands present
 - Coincident during specific speeds
 - Can explain the time to failure

- Vendor unable to “tune” parameters of the vector control algorithm to minimize 1st TNF excitation and sidebands to acceptable levels
- Vendor implemented volts/Hz algorithm
 - No speed feedback
- Gear vibrations less than 4 μm acceptable
- Some tuning at site to get acceptable startup vibration levels

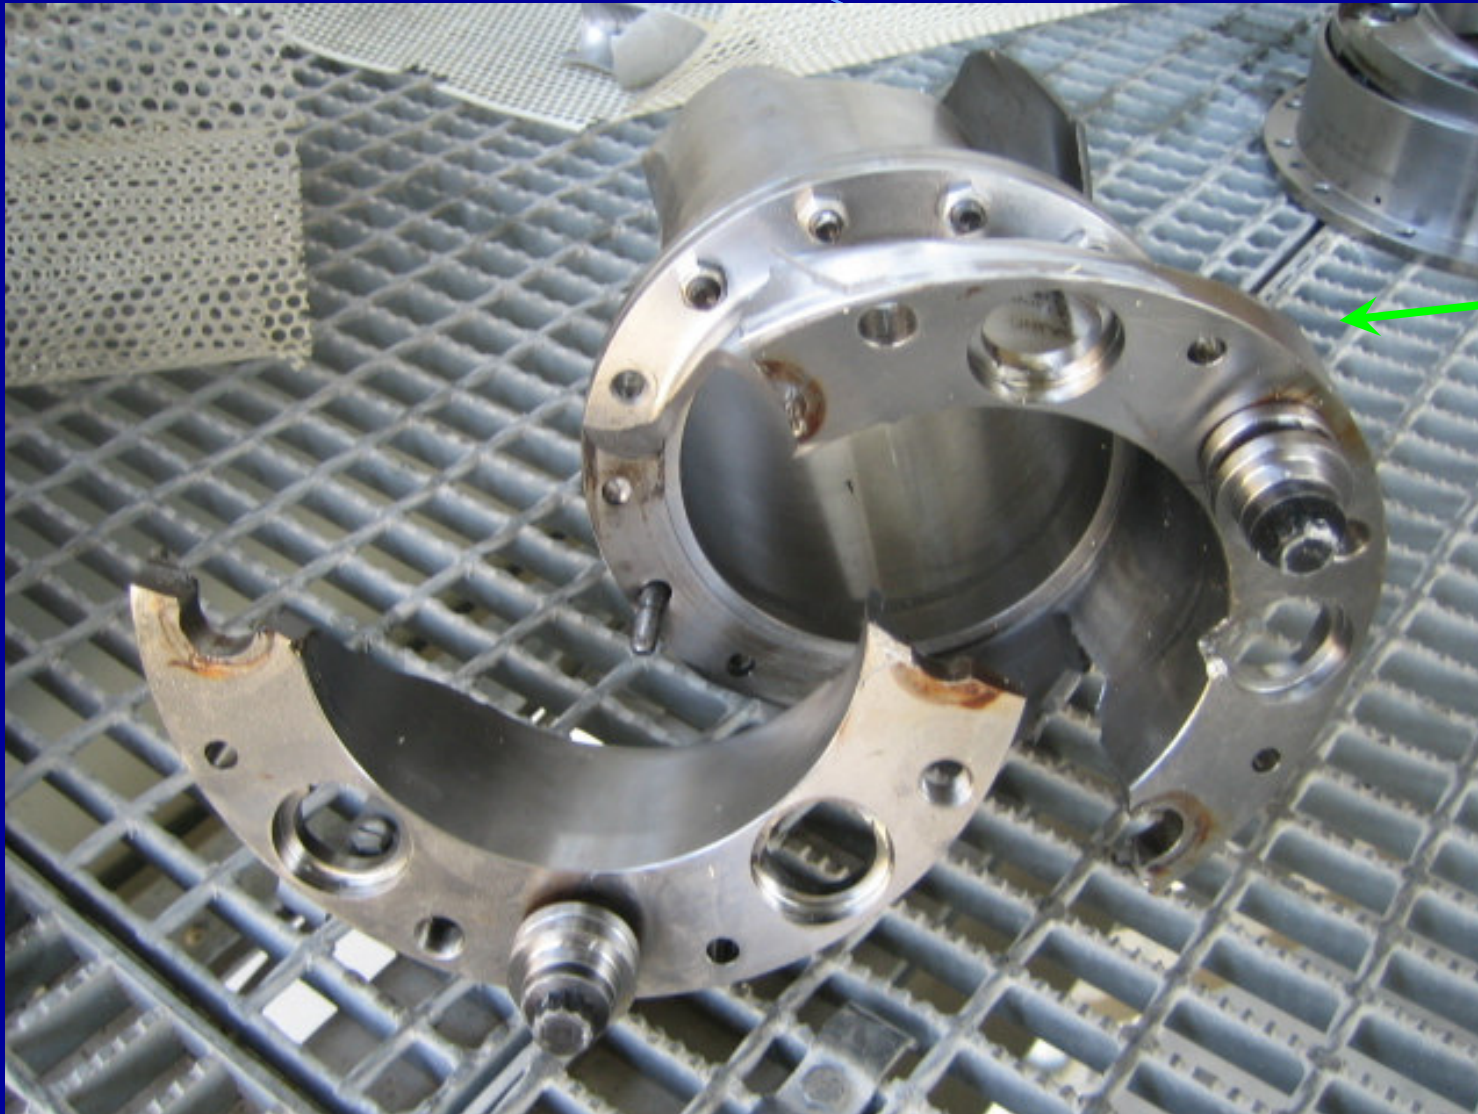
Secondary Damage

Flailing
split
retained
hub
releasing
piece

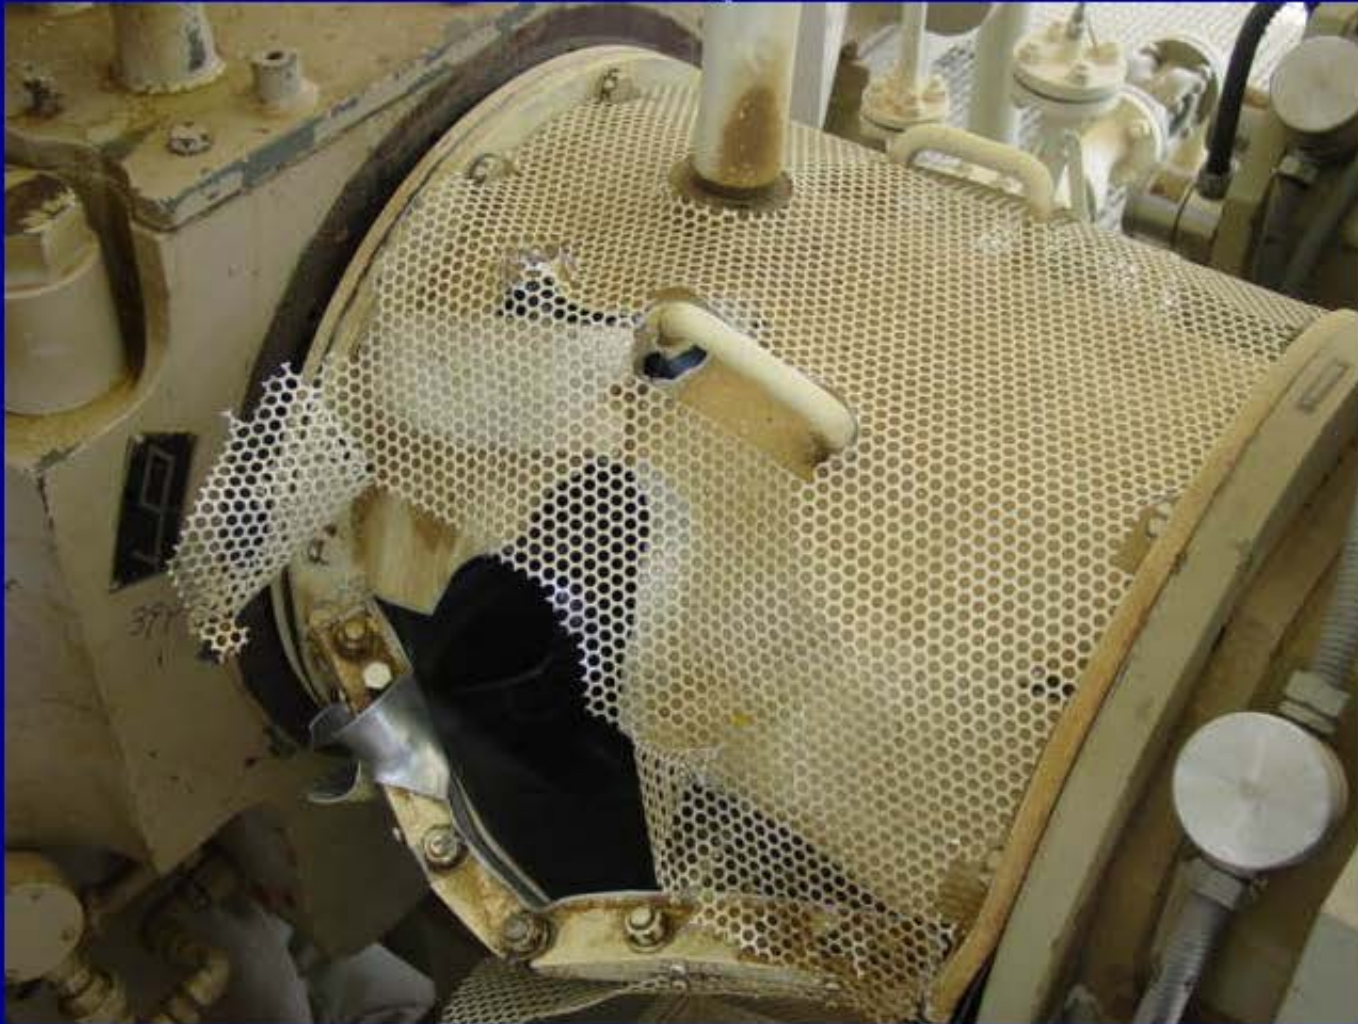
Guard Penetrated

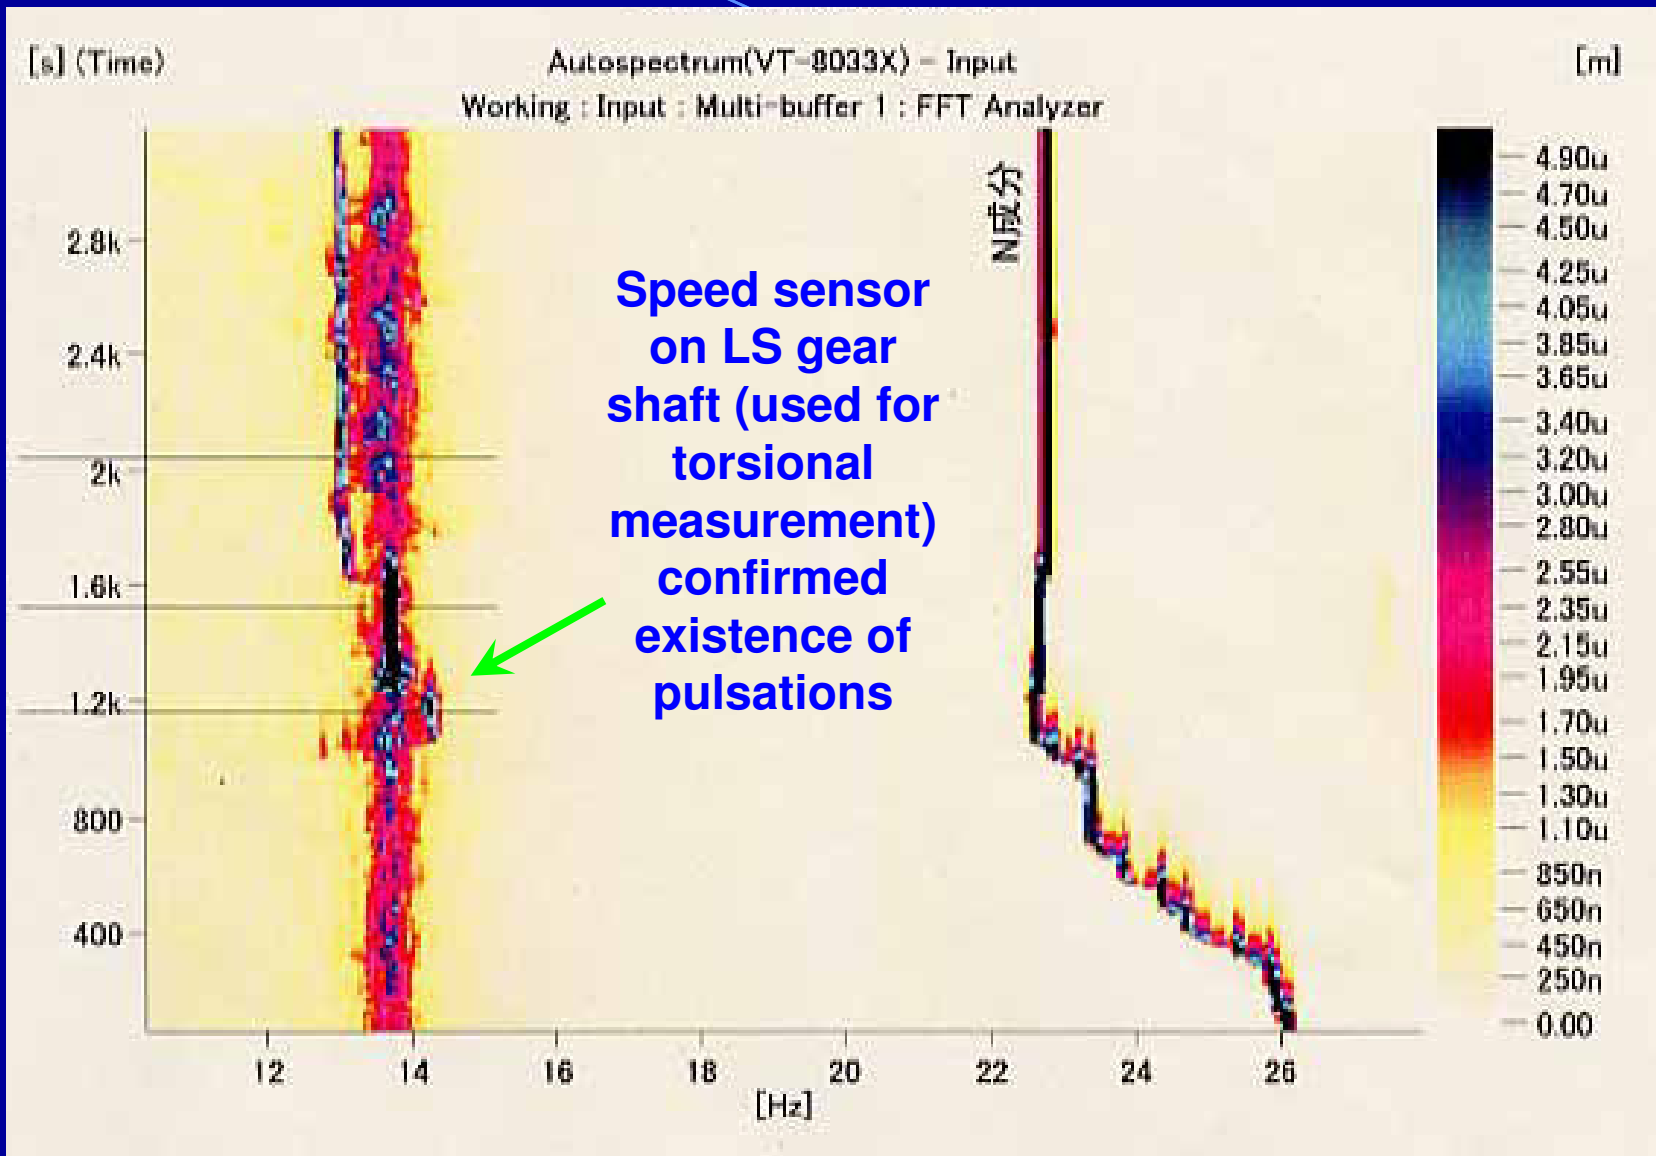
Torsional Measurements

- **Vibration signatures prior to failure**
 - Gear radial subsynchronous vibration at 13.7 Hz
 - Coincident with 1st torsional natural frequency
- **Instrumented LS coupling for torsional measurements**
 - Torsional pulsations were identified
 - Two distinct factors involved

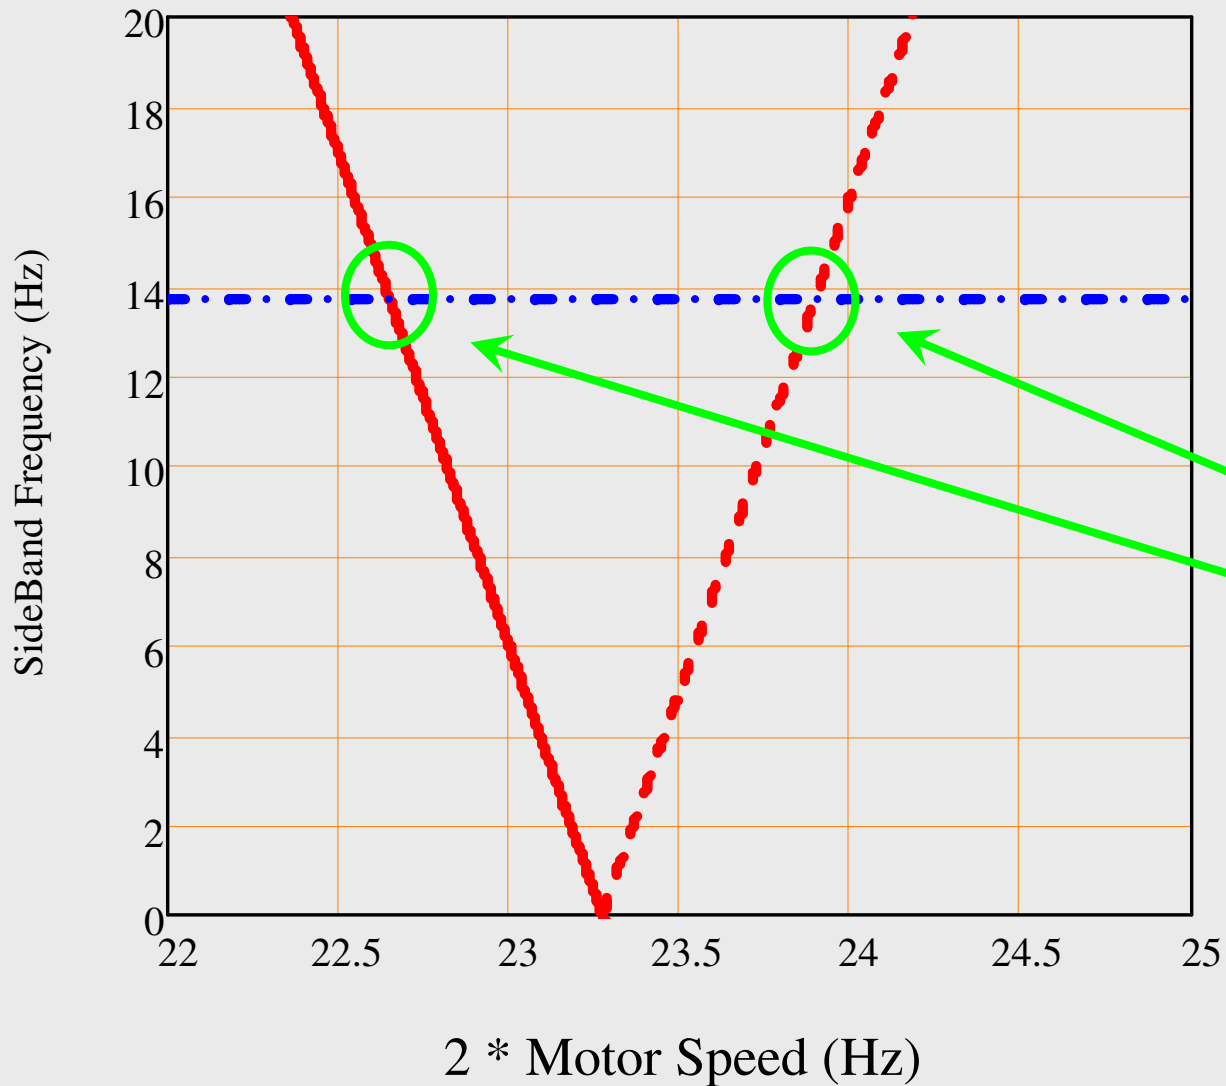
Sideband Frequency (11x)

- **Sharp peak represents sidebands of the PWM frequency**

**Coincident
with 1st
torsional
natural
frequency**

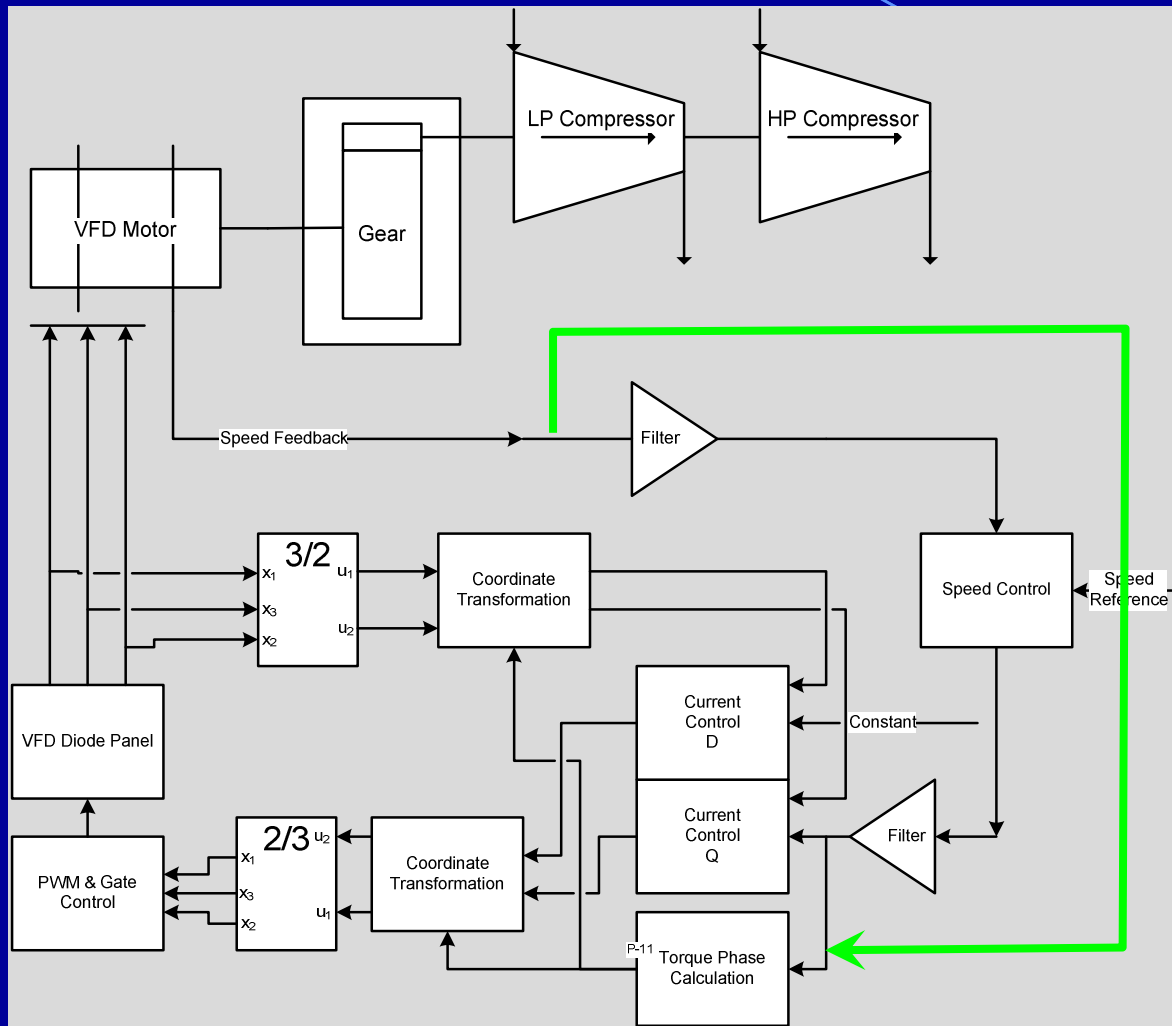
VFD Model Behavior

- **Unfiltered speed signal introduced 13Hz component into controller algorithm**

- Initial discussions w/ vendor showed speed feedback signal to be filtered

- Further investigations revealed the existence of an unfiltered branch

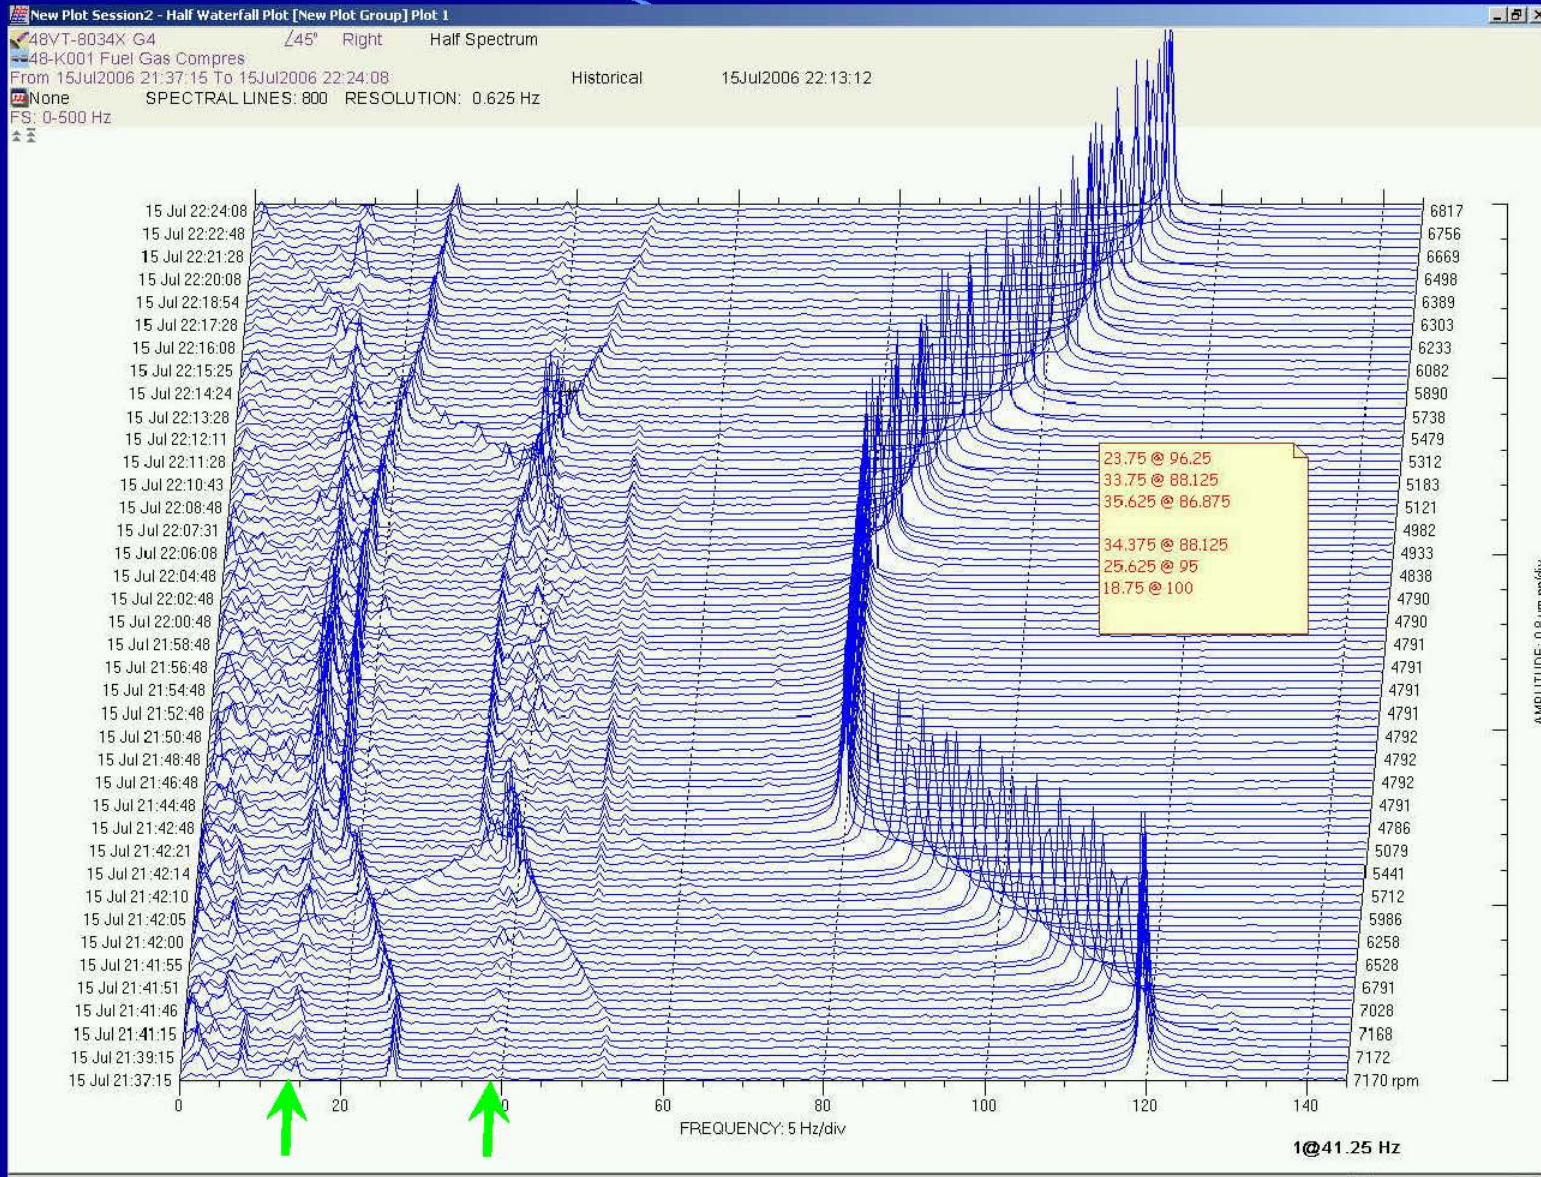
Gear Vibrations

- **New controller successful with 2 years operation**
