DESIGN AND MITIGATION TECHNIQUES FOR APPLICATIONS WITH POSSIBLE LIQUID CONTAMINATION OF THE SEALING GAS DRY GAS SEAL SYSTEM

James F. McCraw

Vladimir Bakalchuk

Richard Hosanna

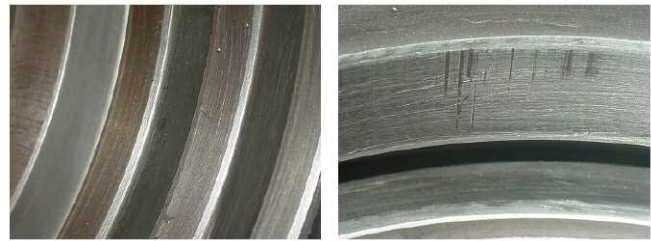
The compressor was successfully commissioned and started. After a month of operation, a seal failure occurred. The compressor's drive end seal failed catastrophically. Debris originating from the seal's SiC rotating face damaged the seal head cavity during the failure and scored the lands during seal removal (Figure 2). Prior to the failure, operating personnel had noticed a decrease in barrier seal supply flow. At factory disassembly, the nondrive-end seal exhibited signs of contamination by both liquid and particulate. Upon disassembly of the barrier seal, it was noticed that seal O-rings were thermally hardened. The degree to which the O-rings hardened was depending on O-ring location: the farther the location was from the bearing cavity, the lesser was the degree of O-ring hardening. Although this fact had been noticed, no related action was taken at that time.

Figure 2. Head Damage at the O-Ring Location Resulting from Rotating SiC Ring Catastrophic Failure.

The compressor head was repaired, a new seal installed, and the unit was restarted. In time, the flow to the barrier seal on the drive end progressively declined and eventually was reduced to a few liters per minute. At a later date, the unit was shut down to evaluate the barrier seal condition. The pattern of O-ring hardening persisted. During the shutdown, a small volume of liquid was found in the seal gas particulate filters located downstream of the coalescing ones (Figure 3).

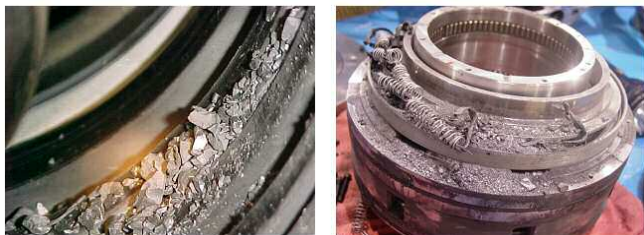
Figure 4. Catastrophic Seal Failure—SiC Fragments that Damage the Seal Head.

In both seal failures, the compressor seal cavity was damaged by shattered SiC rotating faces. To avoid the lengthy cavity repair process resulting from damage by SiC bits, the seals were retrofitted with ductile (stainless steel with tungsten carbide [WC] coating) rotating faces. Since heat generation was the reason for both seal failures, the drive-end (DE) dry gas seal and barrier seal were retrofitted with temperature monitoring devices.

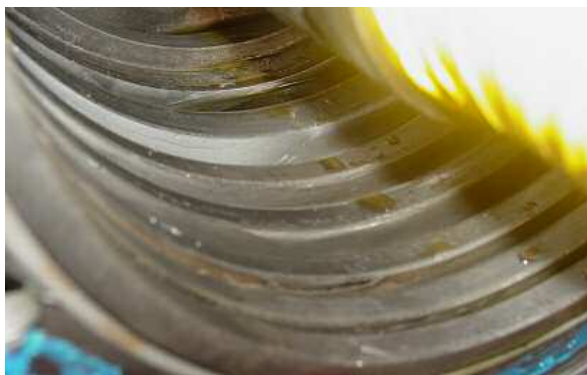
It is widely accepted that in order to maintain reliable operation, a dry gas seal requires clean and liquid-free gas. In reality, a seal is tolerant, to a certain degree, of liquid contamination by vaporizable liquids, while reacting poorly to nonvaporizable liquids. Incompressible fluid ingress onto the seal faces produces two detrimental effects: sealing film instability and heat generation. In steady-state compressor operation, if pressure differential across the compressor does not suddenly change, the rotor usually does not experience rapid axial movements (Figure 5). Thus, if a non vaporizable liquid ingress into the seal has occurred at a steady-state compressor operation, heat generation in liquid shear becomes more of a concern than sealing film instability. Generated heat, if not dissipated, leads to a thermal expansion of the rotating parts of the seal and generation of high stresses. The typical mode of such a failure would be a fracture of a rotating sealing face followed by its disintegration due to consequential impacts in rotation. Interestingly enough, the same site had other compressors with dry gas seals that have been successfully operating for years on the same sealing gas, supplied from a common header. Nevertheless, the dry gas seals in these units appeared to be tolerant of the sealing gas composition, operating up to and in excess of five years.

Figure 5. Mixture of PAG and TEG in the Seal Supply Annulus.

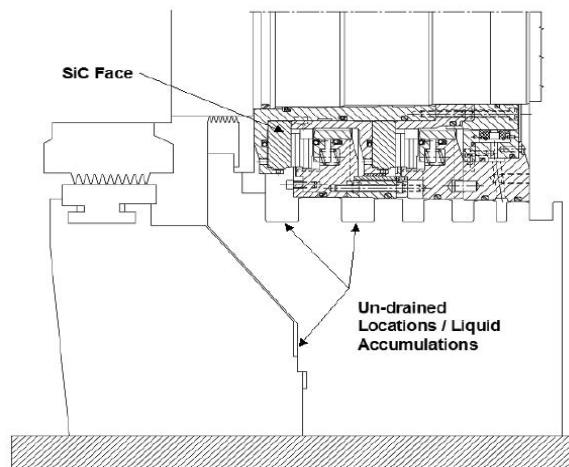
Investigation showed that the design of a cavity between the balance piston and dry gas seal provided a potential for liquid accumulation. The same applied to the primary seal supply and leakage annulus, as the correspondent ports were located in the upper quadrants. In case liquids were introduced into the primary seal, the accumulations would occur in the primary seal supply and leakage cavities annulus (Figure 7). To prevent the liquid accumulation, the cavities were outfitted with the drains (Figure 8).

Figure 7. Seal and Seal Head Prior to Modifications.

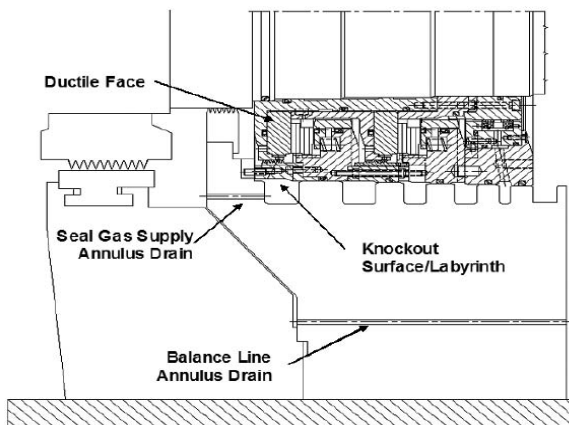
Figure 8. Seal and Seal Head after Modifications.

Part of the study was to determine what differed with regard to the compressors operating successfully at the facility from the one experiencing seal failures. When a seal gas supply path was examined, it was noted that the sealing gas was delivered immediately to the sealing faces in the problem unit, while in the other units, it was first directed onto a solid surface acting as a knock-out plate and then injected between the seal and a process side labyrinth, thus allowing for oil knock-out with further drainage away from the faces. To modify the existing design, an additional process side labyrinth was introduced. Now, the sealing gas entering the cavity is injected on the outer diameter (OD) surface of the new process labyrinth, which acts as a knock-out (Figure 8). Separated liquid is drained back to suction through an introduced drain.

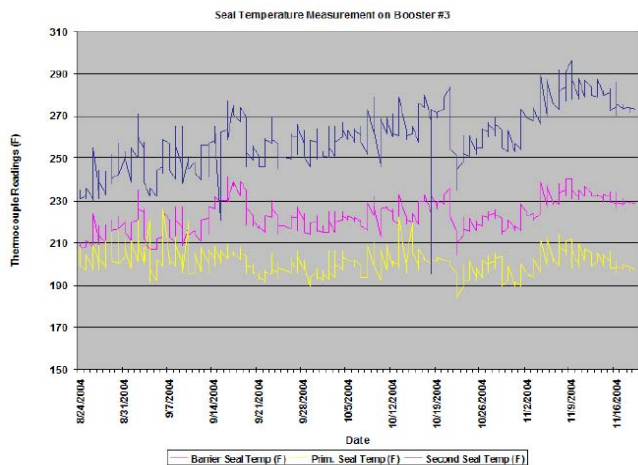
Since the liquid carryover was minute, the correlation between temperature rise and liquid presence in the filter drains and other drains proved to be complicated. Either there was no direct correlation or it was too difficult to discern the rise in the secondary seal temperature and the misting of the drains. Half a year after the startup, the secondary seal temperature was approaching 300°F with the barrier seal temperature trending high (Figure 9).

Figure 9. Seal Temperature Trends Prior to Mitigation.

The thermocouple readings validated that the secondary seal appears to be the dominant source of heat generation. The liquid ingress into the seal cavity was minimized, but some liquid continued to be accumulating on the secondary seal faces. By design, in order to conserve nitrogen and allow for an accurate reading of actual seal leakage, the intermediate labyrinth supply was flow controlled to 1 acfm (velocity of 5 to 7 fps).

The original design philosophy was based on an assumption that no liquids pass through the primary seal and, therefore, gas velocity of 5 to 7 fps would be sufficient to sweep clean leakage gas into the primary vent. But, this velocity was insufficient to prevent ingress of liquid trapped in the leakage gas into the secondary seal. Due to the fact that the primary leakage cavity pressure is small (around 1 to 2 psig), the secondary seal leakage is extremely low—a couple of NI/min. It is not sufficient to provide cooling and its flow is not sufficient to remove oil film off the secondary seal faces. In comparison, the primary seal was being cooled by more than 100 scfm of cool sealing gas and was operating at over 200 psig pressure. As long as the secondary seal operated at a low pressure with a small leakage, the above condition existed and liquids were not removed from the secondary seal faces, the amount of heat generated in this condition could not be completely dissipated. Essentially, the compressor's drive end seal head acted as a heat trap.

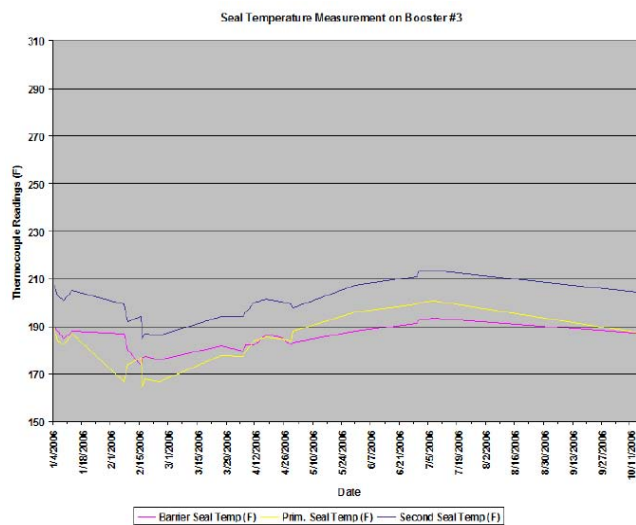
Figure 10. Seal Temperature Trends after Mitigation.

To achieve a solution to the failure problem in this application, the flow to the barrier seal was increased in steps. Temperature measurements indicated no impact on the barrier seal cooling on the secondary seal temperature, confirming that the secondary seal was the source of the heat generation. Next, the flow to the intermediate labyrinth (secondary seal supply) was increased in steps, allowing time for temperatures to settle. After a flow of 6 scfm was achieved as a result of these stepped changes to the secondary seal supply, the secondary seal temperature dropped and remained stable at the 210 to 230°F level (Figure 10).
