Centrifugal Impeller Failure via a Thermite Reaction

Author: Mike Stanko
Praxair Inc.
Engineer
Turbomachinery Group

CASE STUDY ABSTRACT

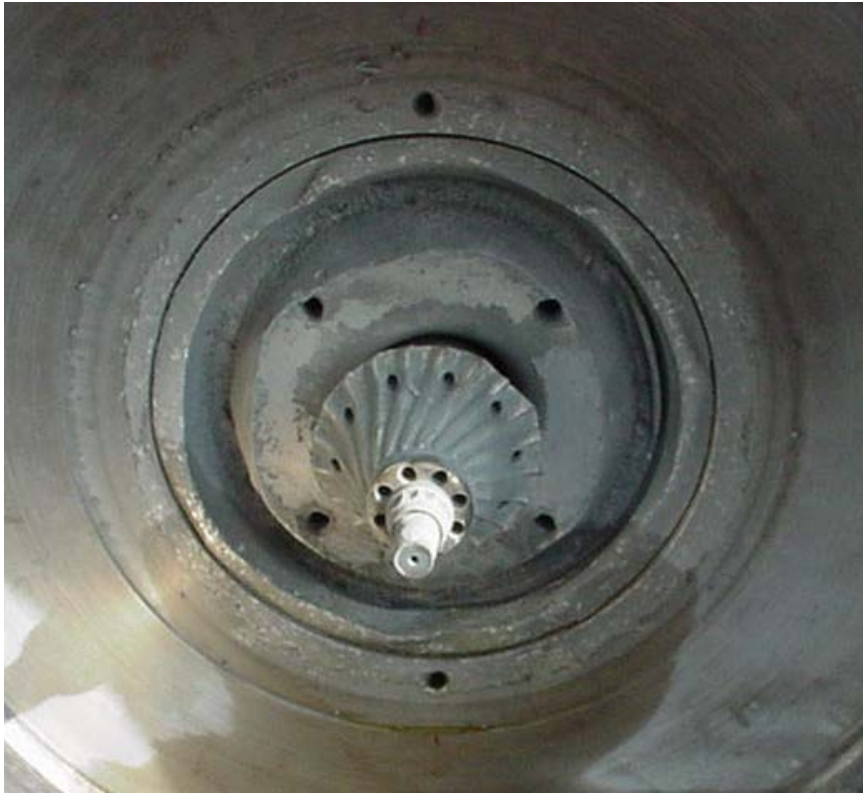
FAILED

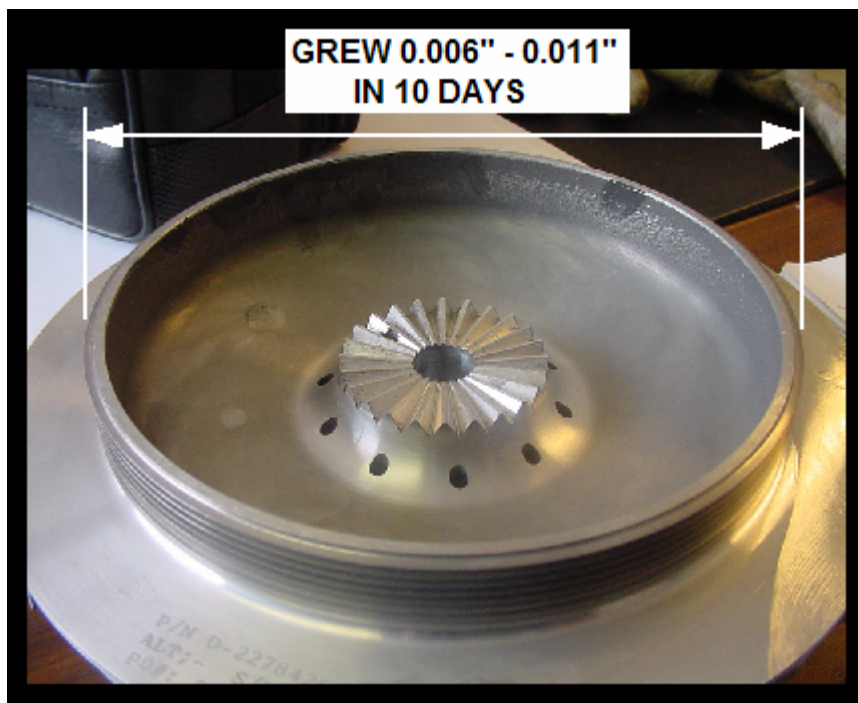
THE MISSING LINK IS FOUND !

- **CREEP IN THE ALUMINUM IMPELLER BACK DISK ROTATING LABYRINTH SEAL**
- **SHUTDOWN AND INSPECTED A “TWIN” IGC**
- **THE DISCIPLINE TO CHECK EVERYTHING YIELDED THIS KEY FINDING!**

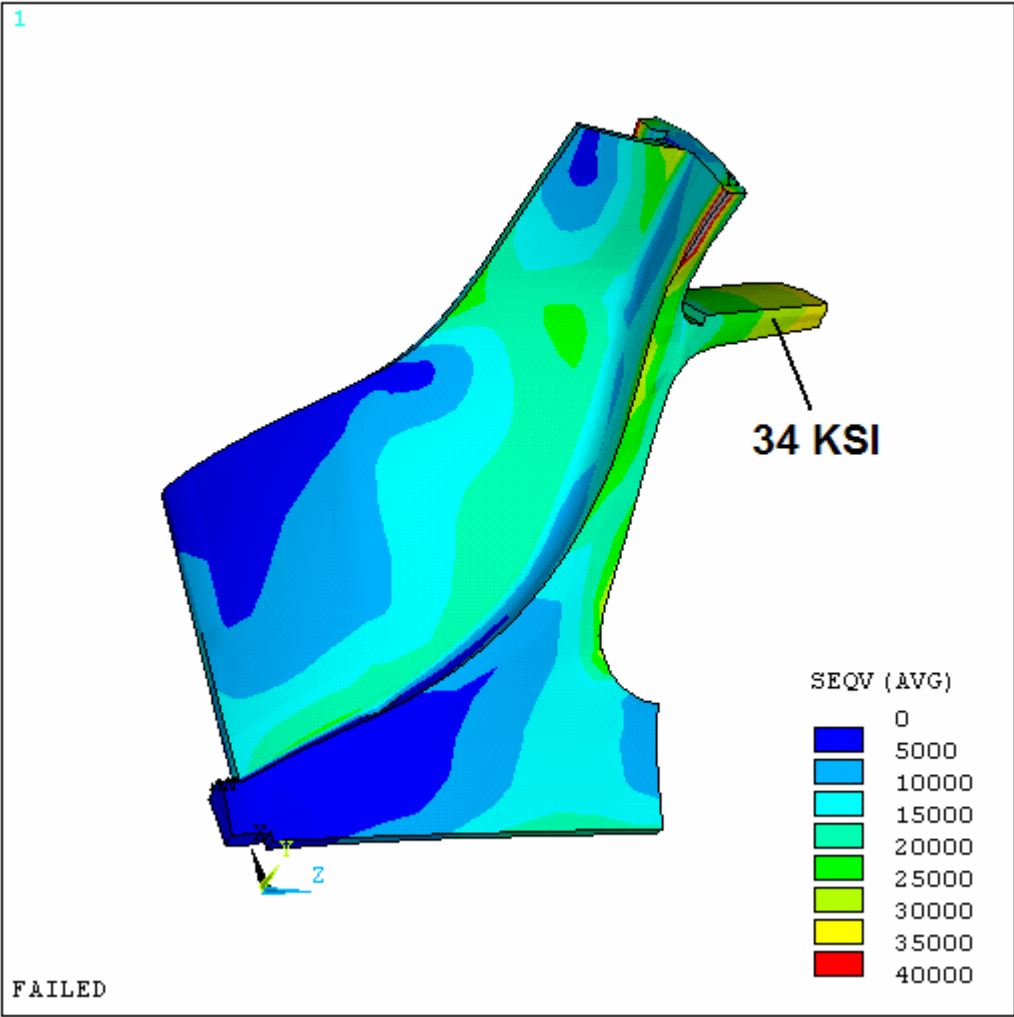
FEA OF FAILED

STRESS

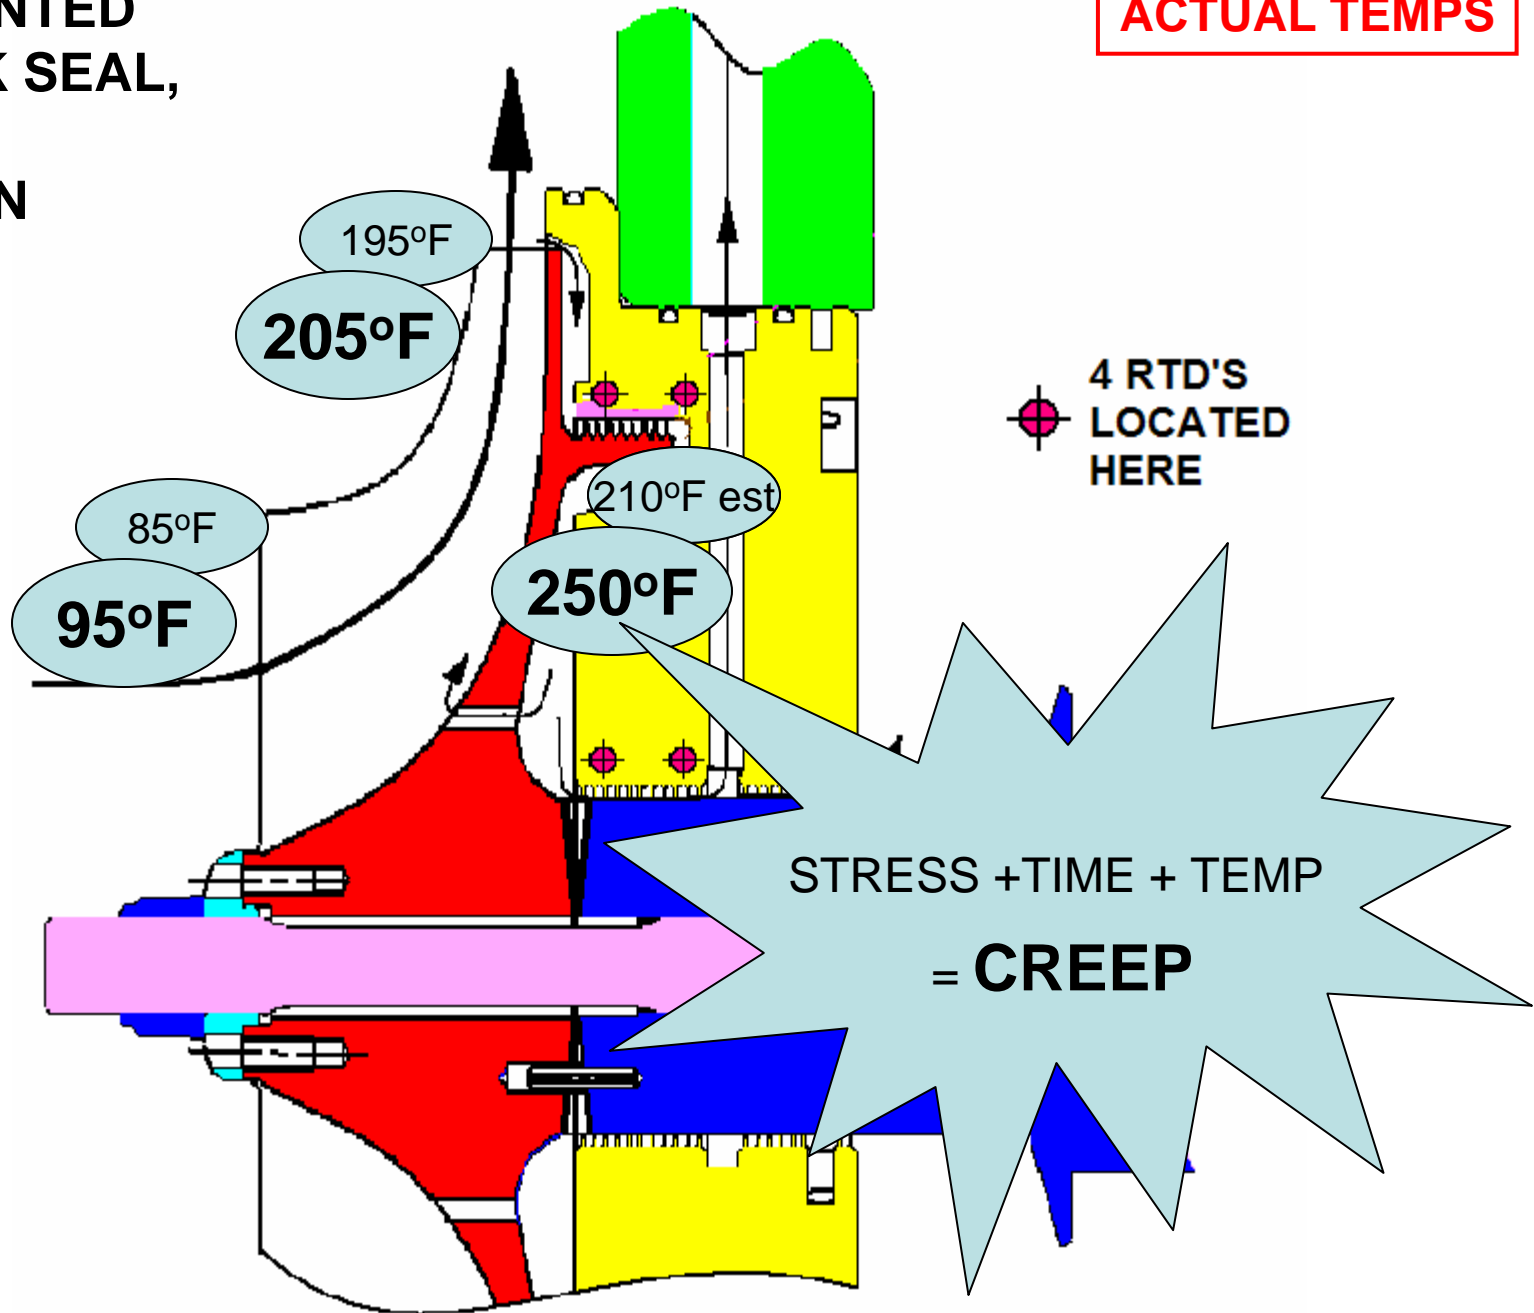
ACTUAL TEMPS

INSTRUMENTED BACK DISK SEAL, ACTUAL OPERATION

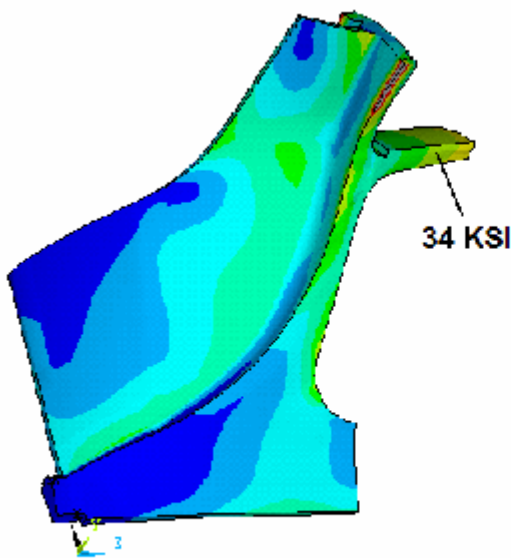
FAILED

CREEP AND COMPARISON
