Unique Short Term and Subsequent Long Term Solution to Rotordynamic Stability Problem

Tom Scott: Sr. Reliability Engineer
Frontier Refining

Bob Huffman: Product Engineering Manager
GE Oil & Gas - CONMEC

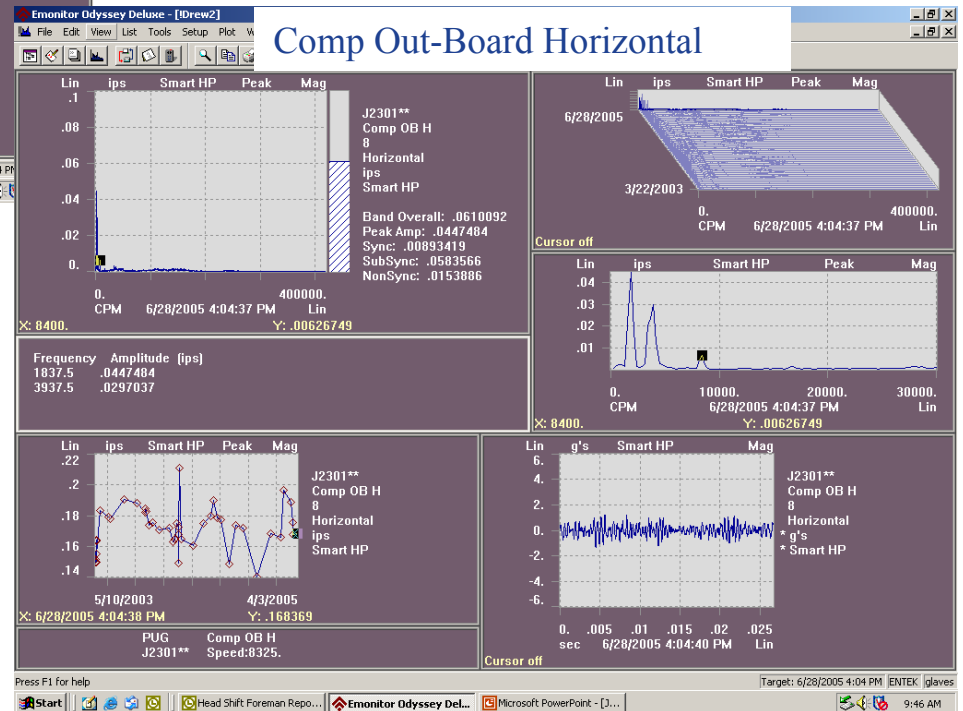
Note High 1800 RPM Amplitude & Sub-Synchronous Dominance and 2X. Cursor on 1X

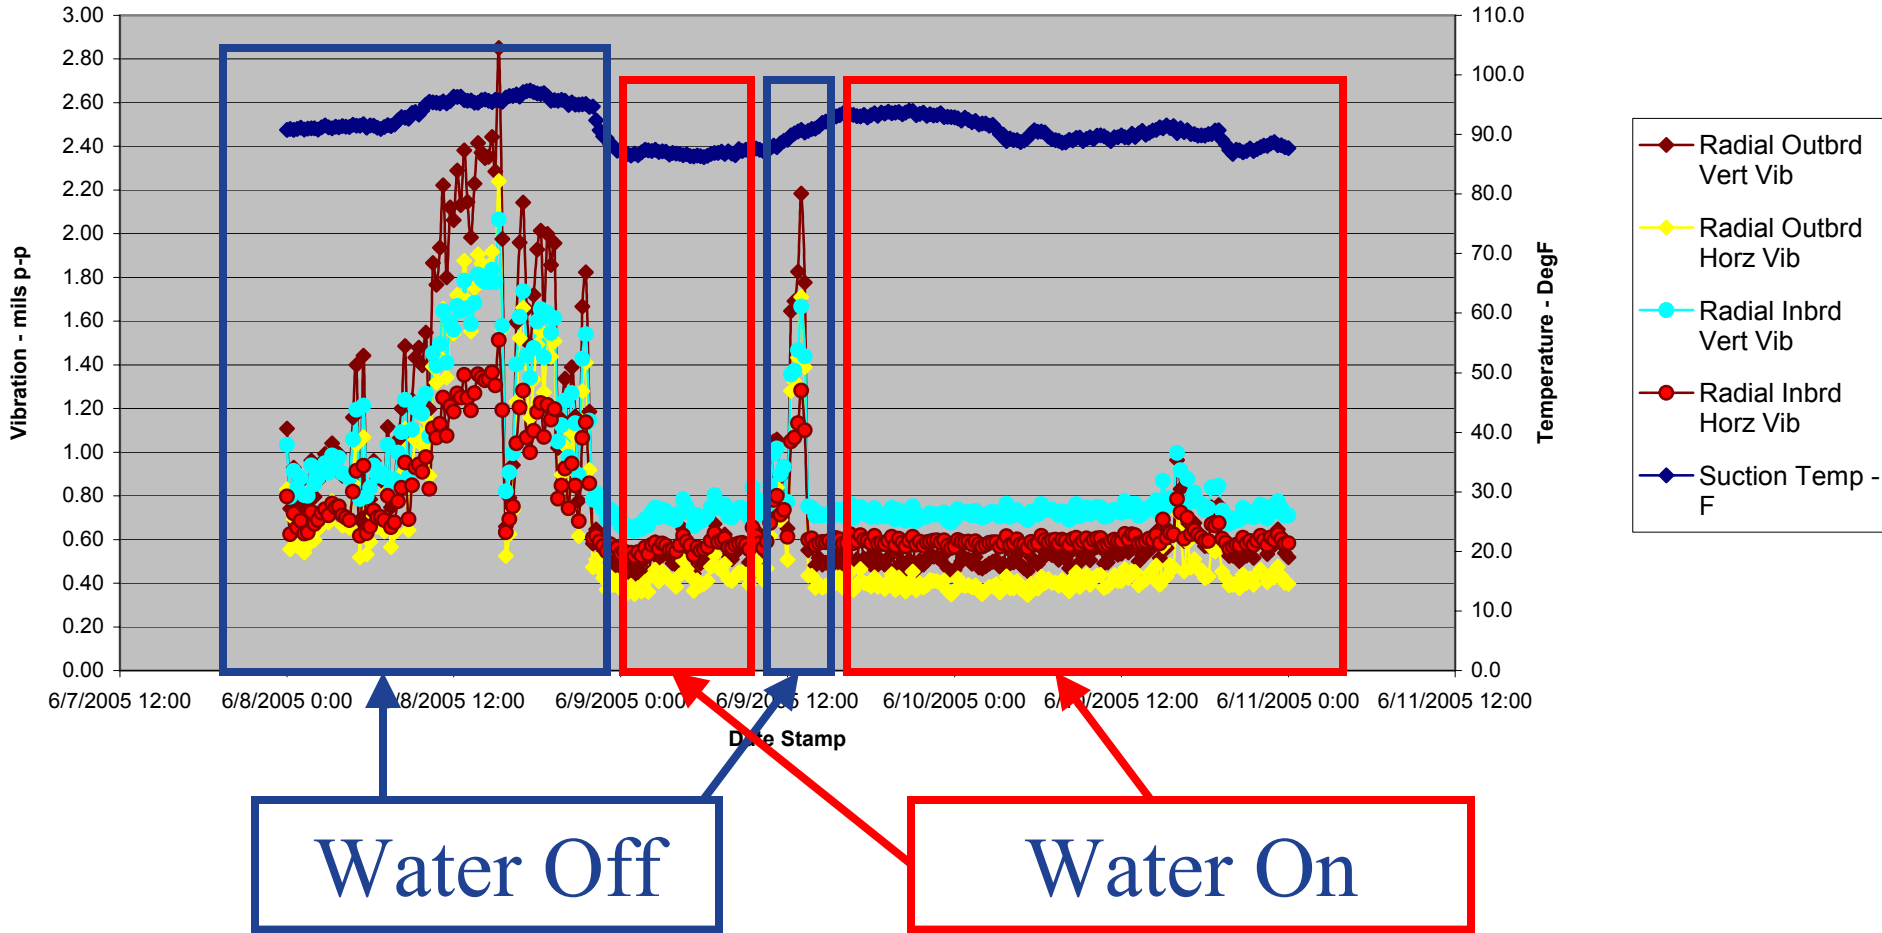
2005 Frontier Field Data - Water on Casing

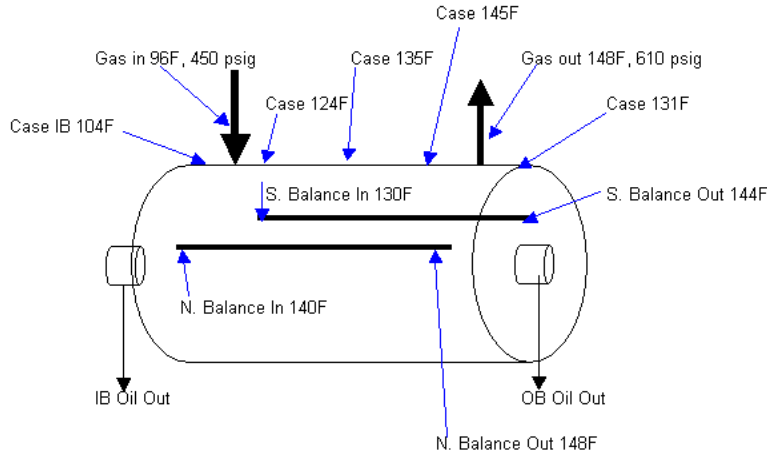
J2301 6/28/05 Water Off Case, Bentley and Case Readings Taken

Lube Oil Inlet	108F
IB Bearing Housing	119F
IB Bearing Outlet	119F
OB Bearing Housing	116F
Thrust Bearing	120F
OB Bearing Outlet	120F
Gearbox HS Bearing	168F
Coupling Guard	208F
Seal Oil Inlet	114F
Seal Oil Outlet	153F
Motor amps	680
Lube Oil Pressure	22 psig

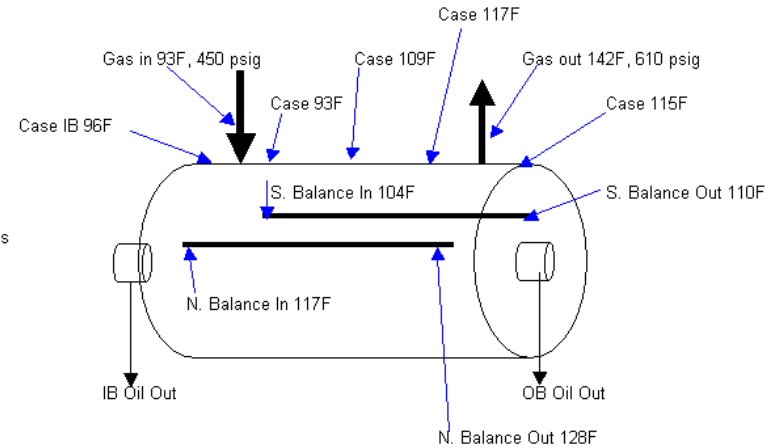
20 to 30 deg F change
in casing temperature

J2301 6/29/05 Water On Case, Bentley and Case Readings Taken

Lube Oil Inlet	116F
IB Bearing Housing	116F
IB Bearing Outlet	120F
OB Bearing Housing	116F
OB Bearing Outlet	118F
Thrust Bearing	118F
Gearbox HS Bearing	165F
Coupling Guard	192F
Seal Oil Inlet	110F
Seal Oil Outlet	142F
Motor amps	676 amps
Lube Oil Pressure	22 psi

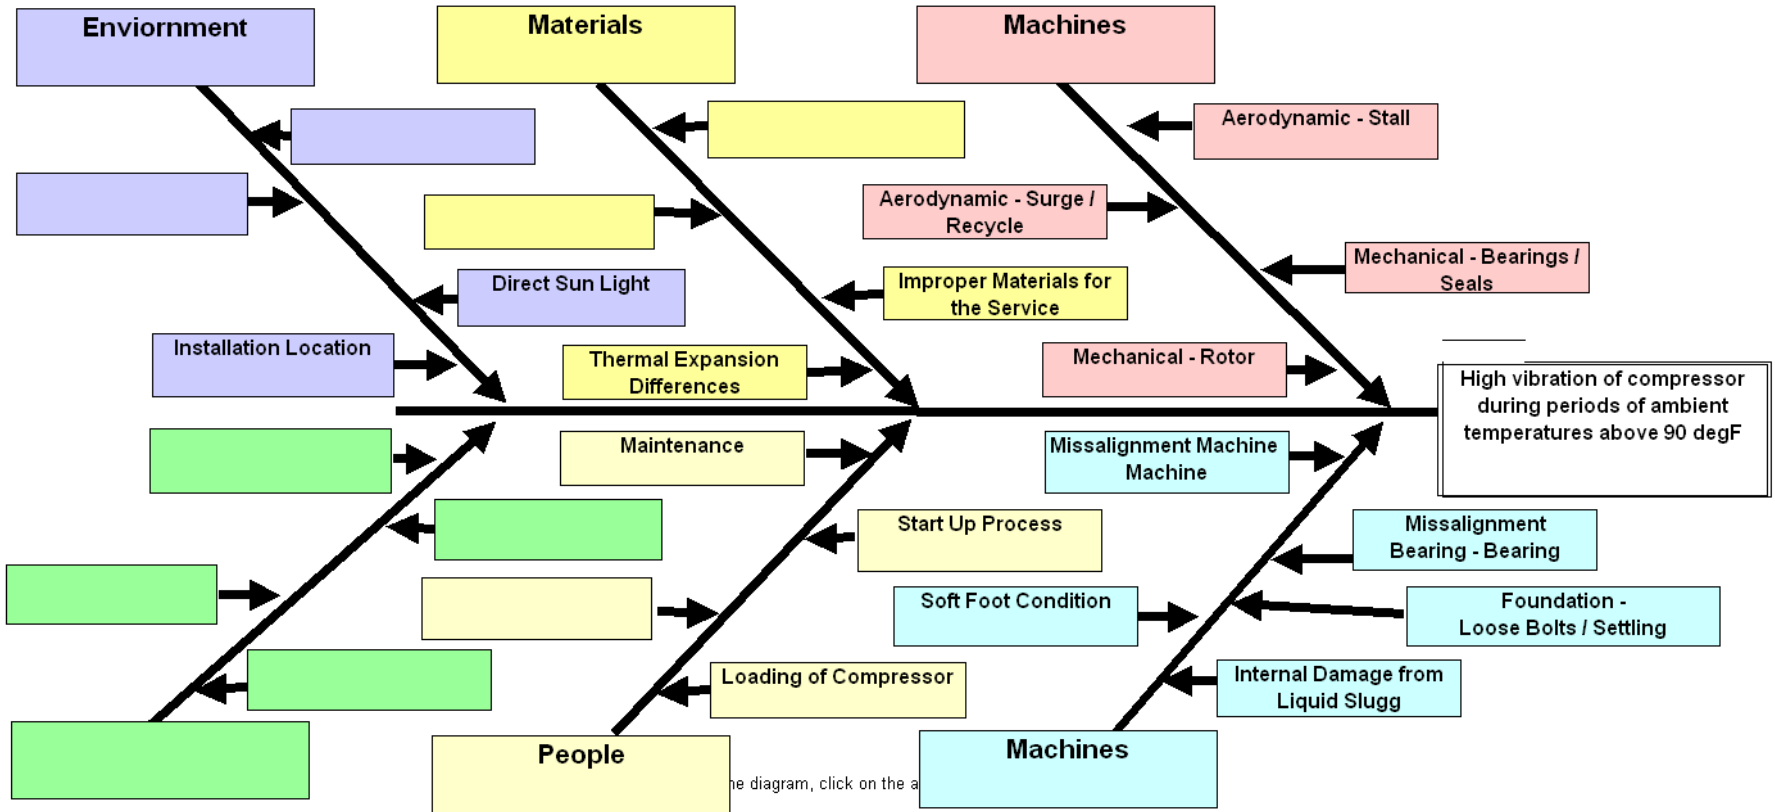
Fishbone Diagram

Remaining Potentials:

Bearing – Seals / Alignment (Soft foot – Foundation Factors)

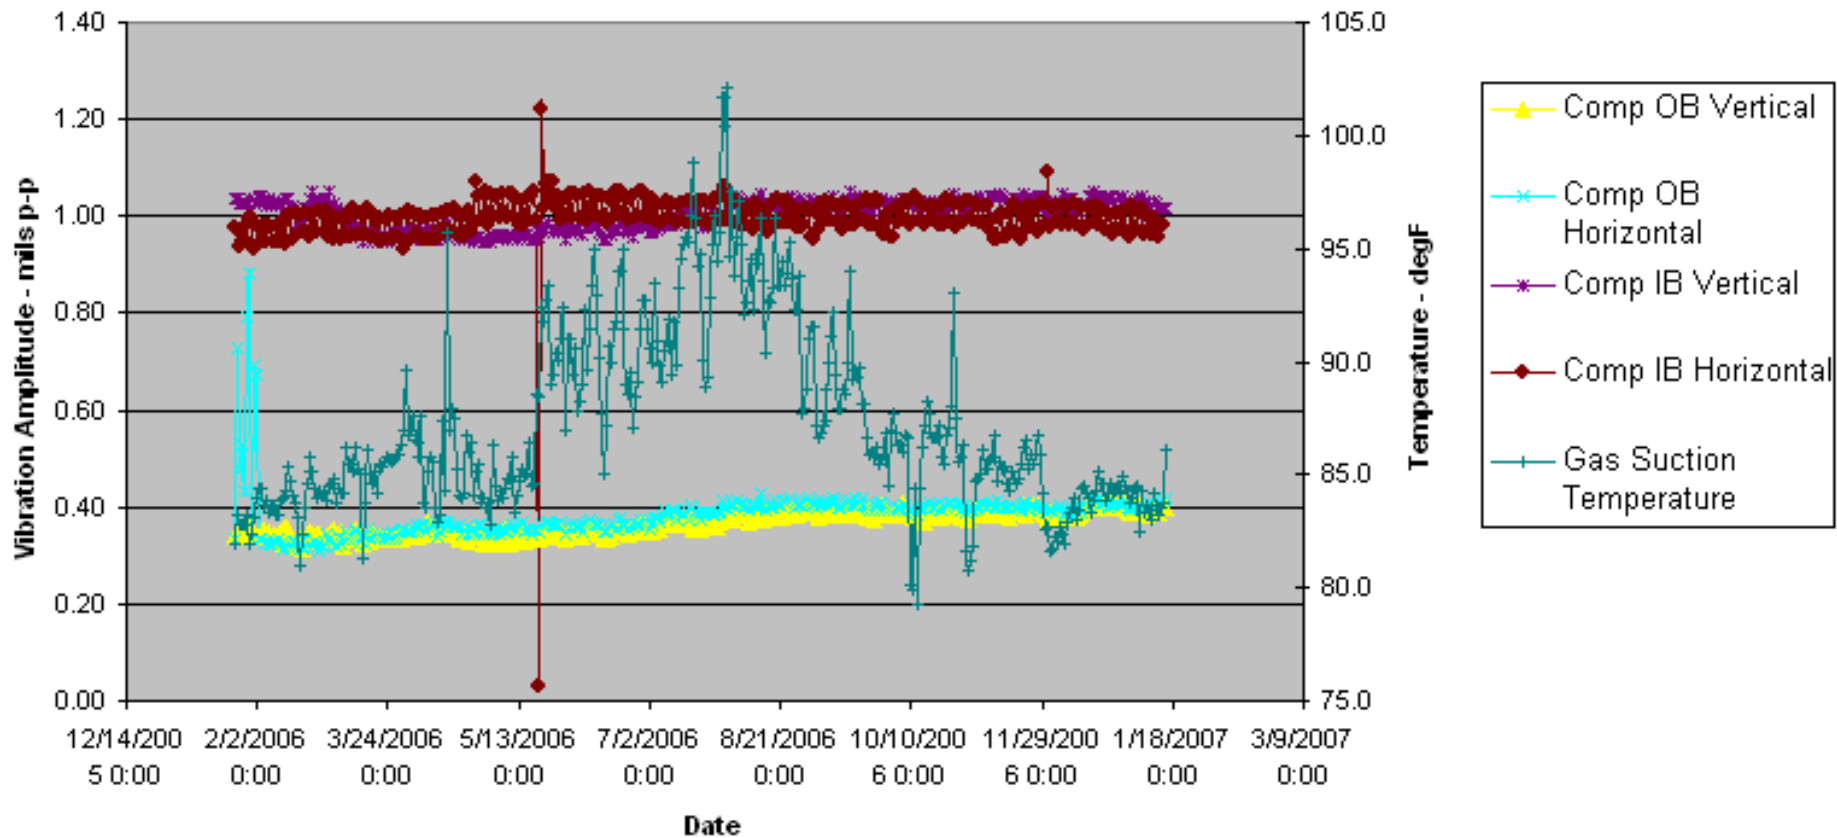
Post Bearing - Seal Redesign
New Designs Installed and Unit Restarted Jan 16, 2006
