# REDESIGN OF A HIGH SPEED COMPRESSOR DRIVE STEAM TURBINE TO OVERCOME CAPACITY, EFFICIENCY, AND RELIABILITY ISSUES

**Richard Olivier**

**Hayden Brown**

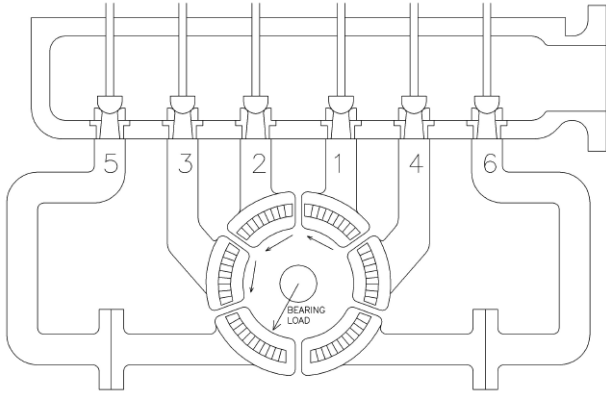
Figure 8. Original Valve Opening Sequence.

The redesigned turbine was installed and run at part load for an extended period of time. The high pressure journal bearing temperature was very high and continued to climb as steam flow to the turbine was increased. The elevated bearing temperature was determined to be the result of steam forces from the partial arc of nozzles on the first stage pushing the HP end of the rotor into the side of the bearing resulting in elevated reaction and undesirable loading angle on the HP journal bearing. Figure 8 shows the configuration of the first stage nozzle arcs and valve opening

sequence. With the first three valves open, the steam force exerted on the stage one wheel pushes the turbine rotor down and to the left. This steam force coupled with the rotor gravity load results in a very high load on the HP journal bearing, which caused the elevated bearing temperature. A new V1 camshaft assembly was installed with revised opening sequence as shown in Figure 9. With this opening sequence, the maximum bearing load was reduced and the unit was able to increase load without exceeding bearing temperature limits.

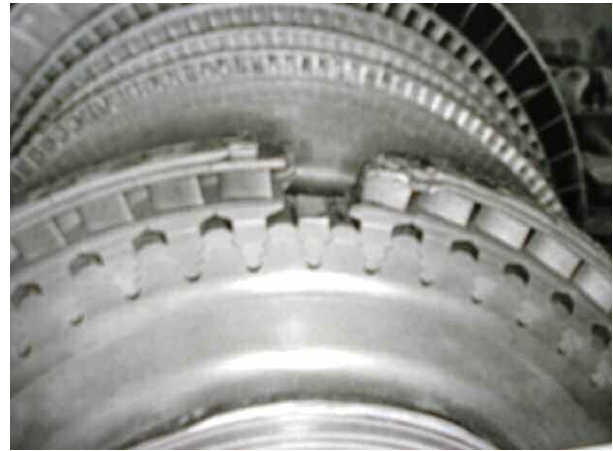
Figure 10. Failed Stage One Blade.

A piece of the failed blade was sent to a metallurgical lab for failure analysis. Although the fracture surface was somewhat compromised due to the broken blade getting bounced around within the steam path, the mode of failure was determined to be fatigue. Figure 10 shows the failed stage one blade and damage to adjacent blades.

Finite element analysis of the stage one blade and wheel was completed in an attempt to uncover the cause of the blade failure. All steady stresses were evaluated and determined to be within acceptable limits. Potential vibratory stresses due to resonance with nozzle passing stimulus were evaluated, and again were determined to be within acceptable limits. Another potential source of harmonic stimulus on the blades is the partial arc of steam being fed by the nozzle plate. On most industrial steam turbines, the nozzle plate is designed so that as the valves are sequentially opened, there is always only one continuous arc of nozzles feeding steam to the stage one blades. The stimulus from the partial arc of nozzles and resulting vibratory stress was calculated assuming a single nozzle arc and found to be within acceptable limits. However, the stage one nozzle plate configuration on this unit created multiple separate arcs of nozzles as shown in Figure 11.

The results of the failure analysis did not point to any one cause that would be expected to cause the blade to fail in such a short period of operation. However, the existing turbine configuration and operating conditions made this a very

challenging blade design. The single stage HP section results in very high stage one blade loading. A modern turbine would typically be designed with a two or three stage HP section for these operating conditions, which would dramatically reduce the load on each row of blades. The existing nozzle plate configuration could create a harmonic stimulus on the blades that could potentially result in elevated vibratory stress levels. If these issues could be addressed reliability of the stage one blades could be significantly improved.

A second redesign effort was undertaken to address the performance shortfall and blade reliability issues. This required changes to the turbine to correct the inherent problems with the original configuration. In order to reduce the high pressure ratio across first stage to improve efficiency and reduce blade loading, the HP section was converted to a two stage design. This required significant modification to the turbine rotor. The rotor was built up with weld in the area downstream of the existing first stage wheel. Two new wheels were machined with axial entry dovetails at reduced diameters. New blades were installed on the two new HP section rotor wheels.

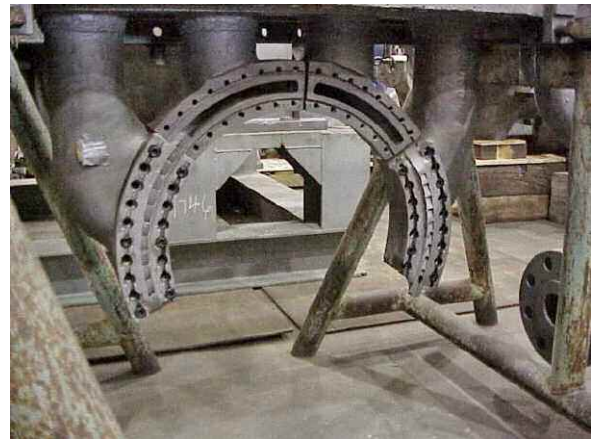
Figure 11. Original Stage One Nozzle Configuration.

The nozzle plate is made up of six segments, each fed by a control valve through a separate duct. The four inboard valves feed four upper half nozzle segments, and two outboard valves feed lower half nozzle segments via jumper pipes external to the turbine. This arrangement creates gaps between the nozzle segments creating a stimulus on the blades as they pass in and out of the active nozzle arcs. This unusual arrangement could potentially result in a harmonic stimulus resonant with natural frequencies of the stage one blade and wheel system that may have contributed to the blade failure.

A new stage one nozzle box was designed to eliminate the issues with the original nozzle duct arrangement, and also allowing a reduction in the stage one wheel diameter. This design eliminated the gaps between the individual nozzle arcs and also eliminated the restrictions in the passages between the control valves and nozzles. Figure 17 is a photograph of the new nozzle box.

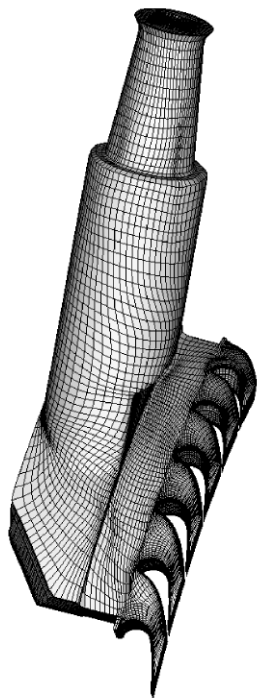
Figure 12. Model of Nozzle Duct.

The nozzle inlet duct arrangement shown in Figure 12 creates numerous restrictions for the steam passing from the control valve to the nozzles. Figure 13 shows the geometry of the inside of the duct. This configuration requires the steam to make a sharp turn at the bottom of the port to feed out circumferentially and axially to feed the nozzle arc. There is also an obstruction in the pipe that the steam must bypass before reaching the nozzle port.

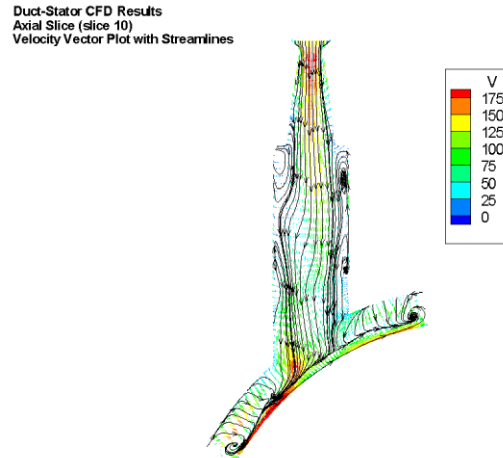
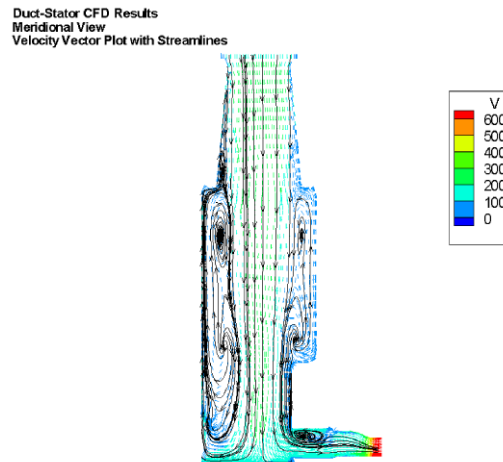
Figures 13 and 14 show that the duct geometry does not allow for smooth, unrestricted flow between the control valve and the nozzle vanes. Numerous sharp turns in the steam trajectory results in excessive pressure loss as shown in Figures 15 and 16.

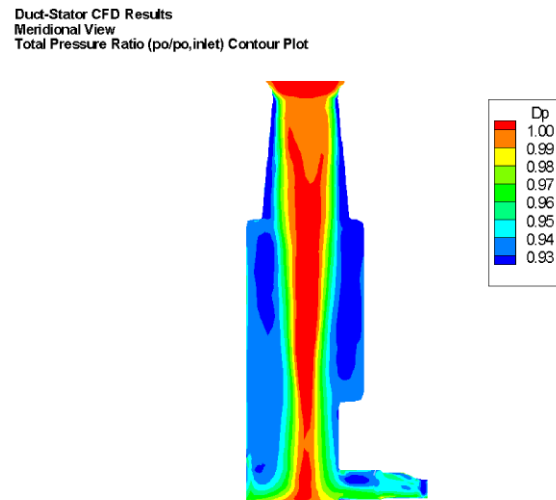
A significant pressure loss occurs before the steam reaches the inlet to the nozzle vanes. This pressure loss results in reduced available energy across the first stage and a reduction in HP section efficiency. Additionally, Figure 16 shows that there is a variation in pressure upstream of the arc of nozzle vanes. This variation results in a force variation across the arc that could increase the potential harmonic stimulus on the stage one blades mentioned earlier.
