Managing an Induction Motor Vibration

BP

Whiting Indiana

Main Air Blower Motor

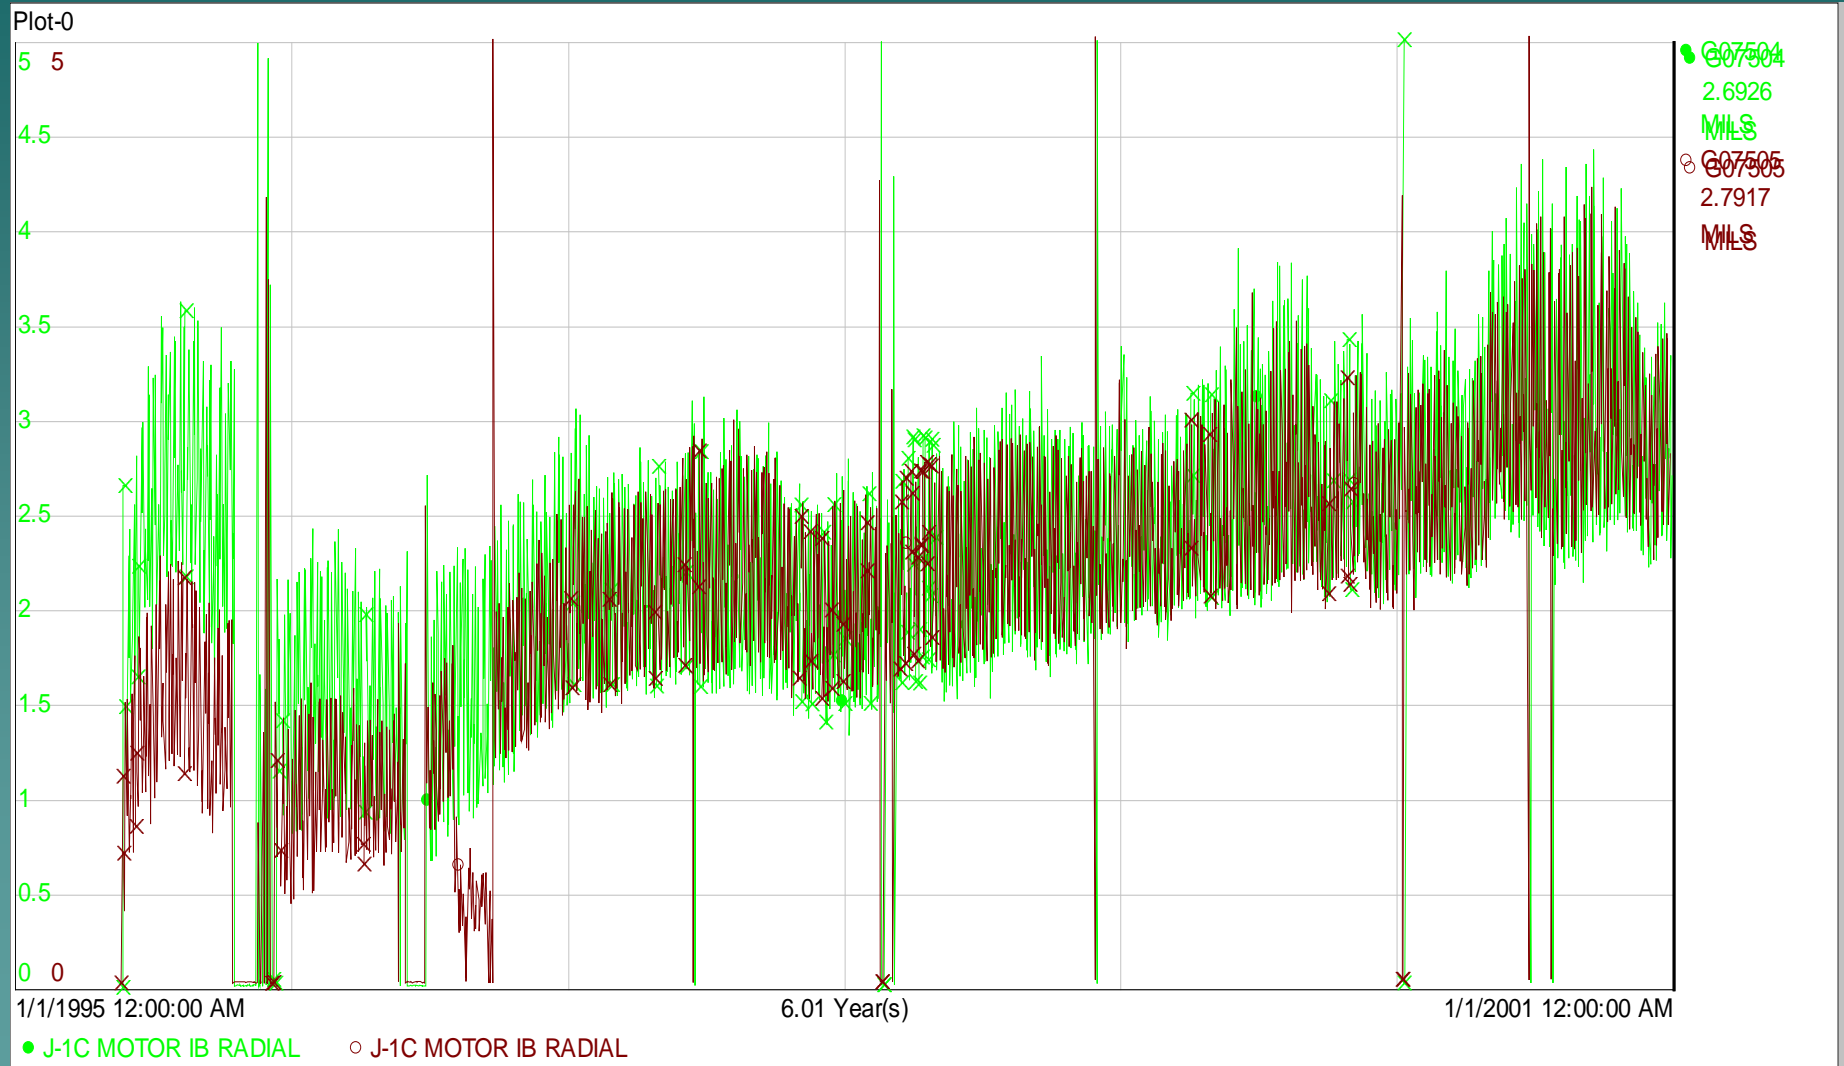
May 1995 – Jan 2001 Vib

- ◆ IB vibration levels slowly trend upward from 1996 to Spring 2001
- ◆ Verified vibration was due to some motor problem
- ◆ Eliminated "red Herring" of "bad grout"

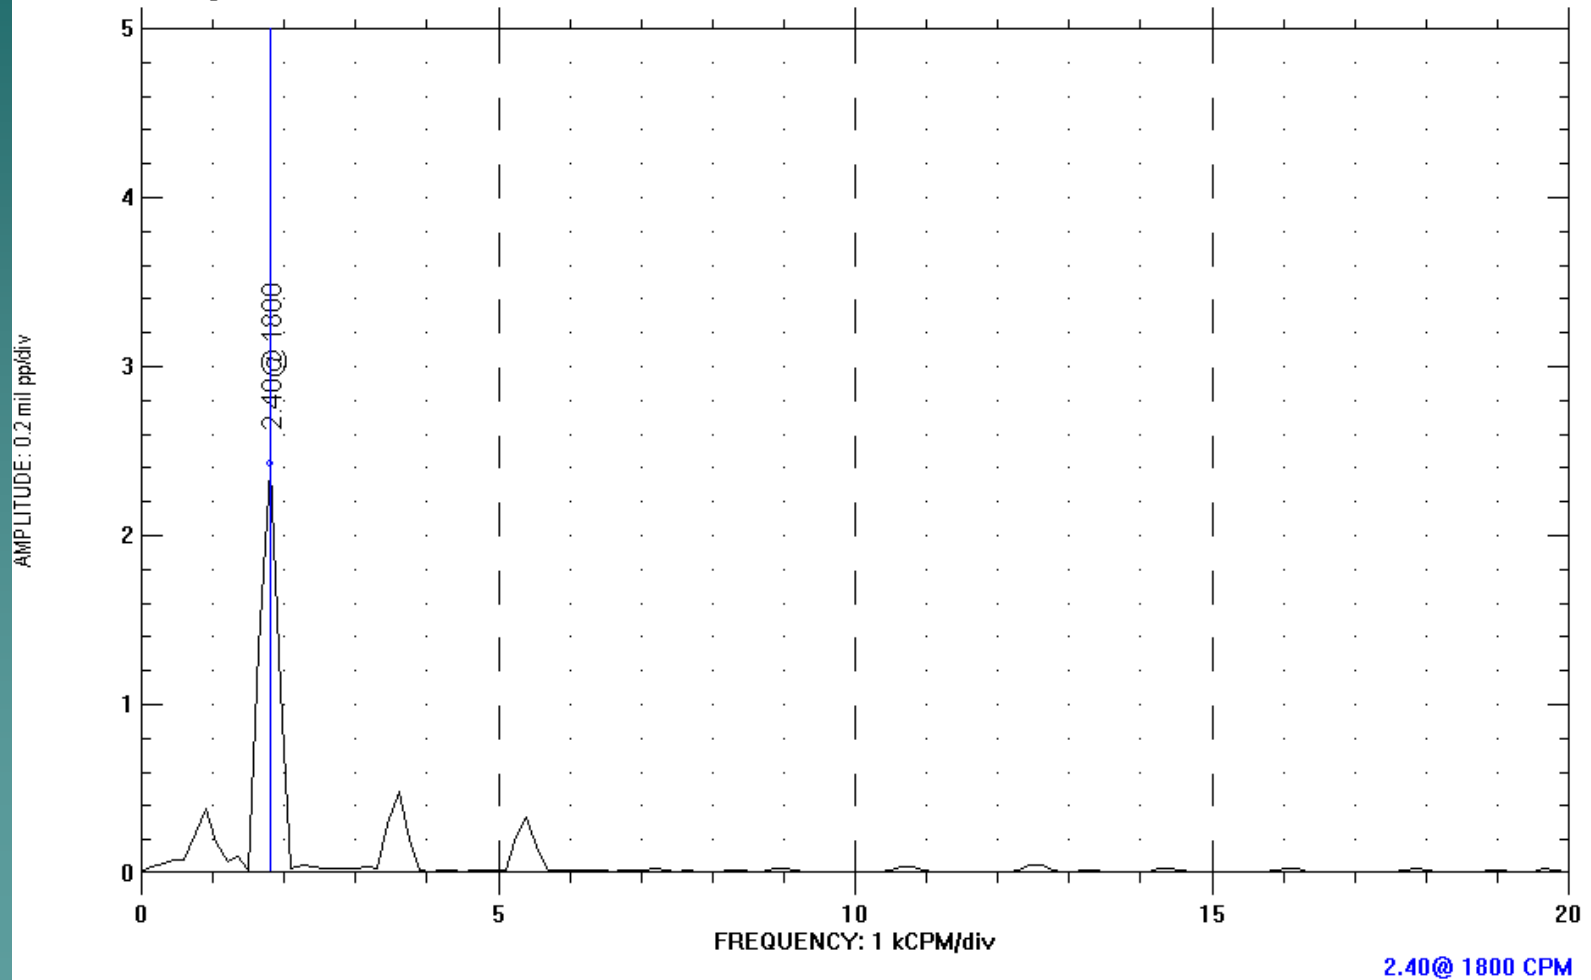
Motor Spectrum Feb 2001

POINT: 2X /45° Right DIR AMPL: 2.61 mil pp
MACHINE: MOTOR IB MACHINE SPEED: 1791 rpm
12 FEB 2001 10:49:03 Steady State
WINDOW: Hanning SPECTRAL LINES: 400 RESOLUTION: 150 CPM

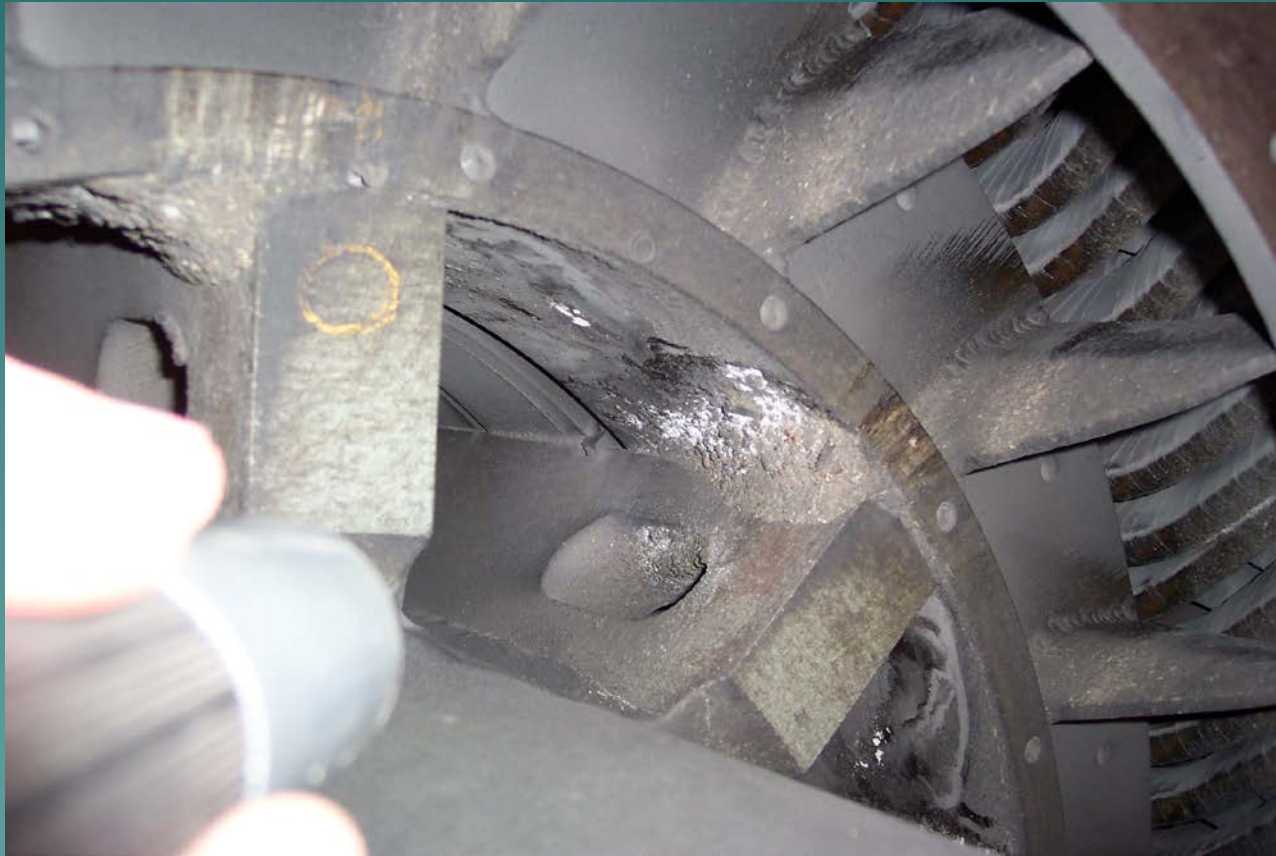
Uniform buildup

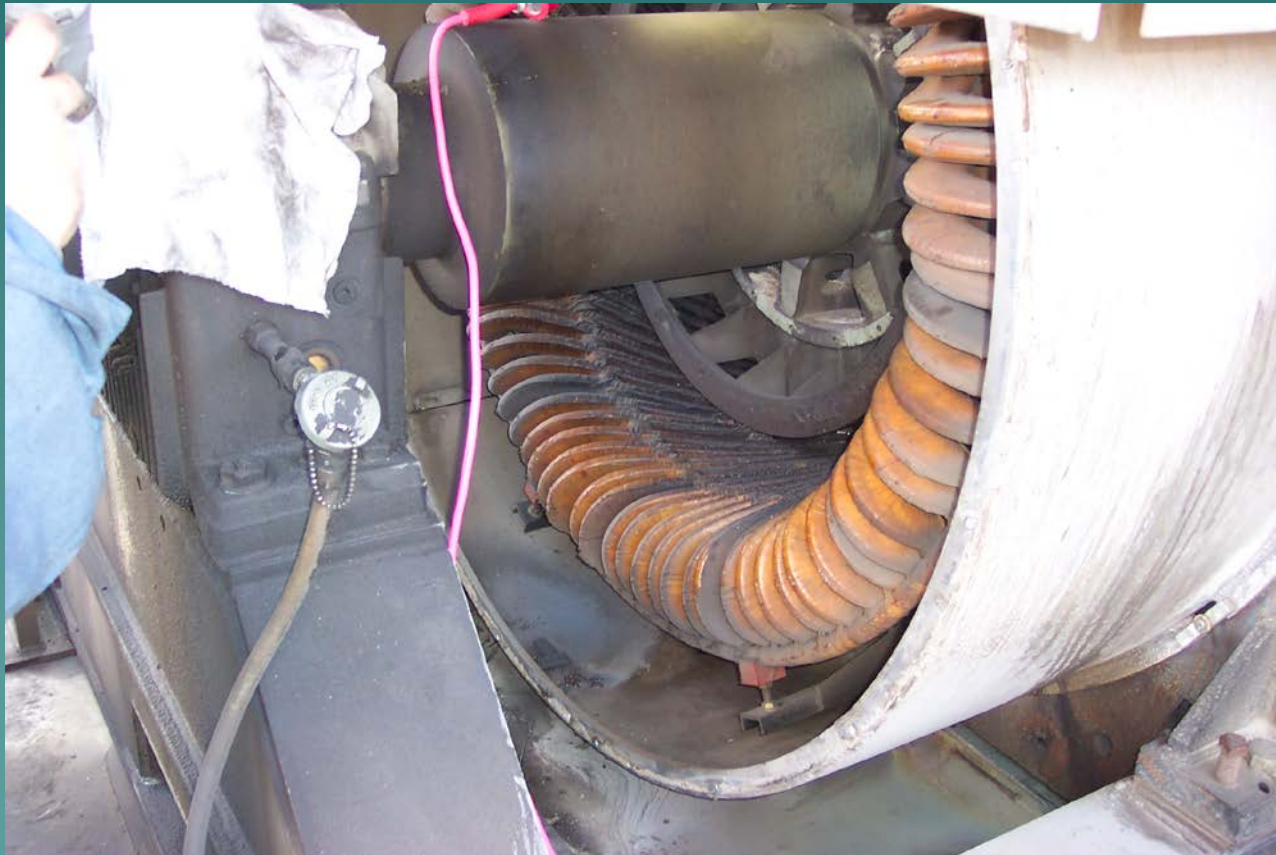
Additional Inspection decided to pull rotor

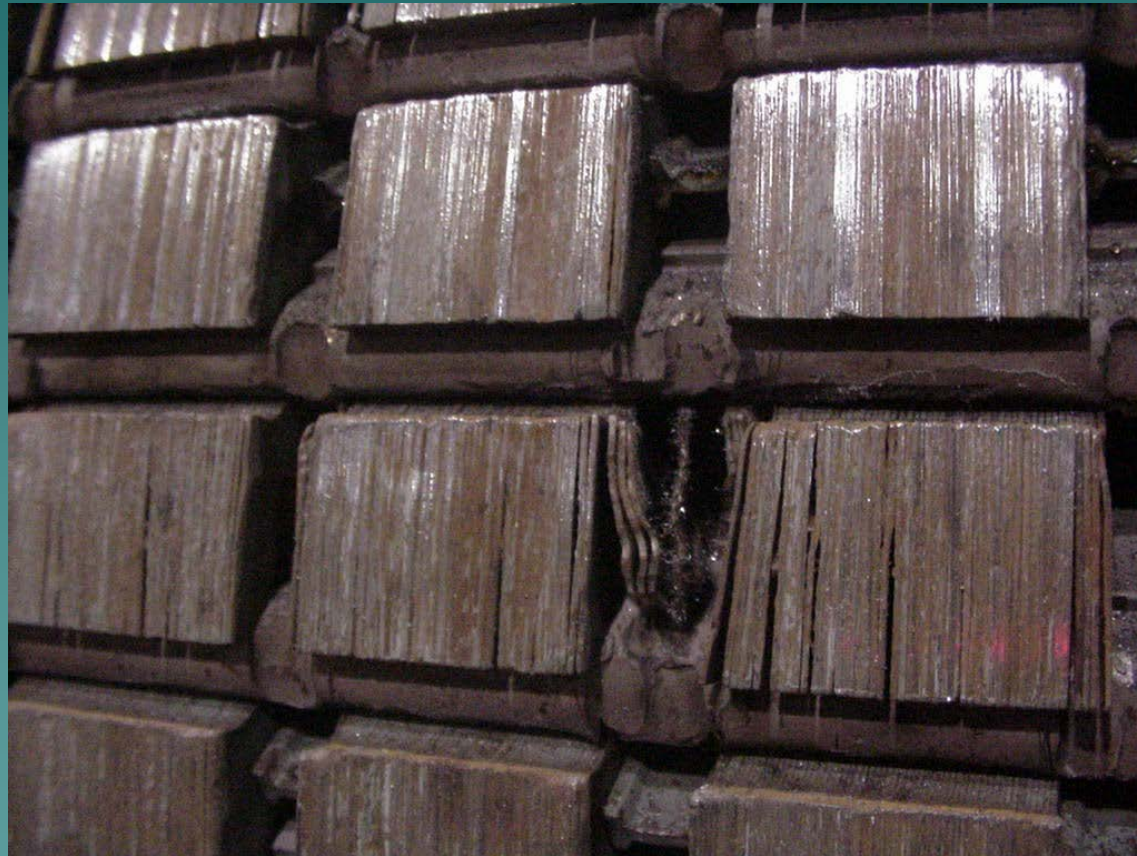
Lamination Pieces found in bottom of motor

Loose and missing Laminations

- ◆ Laminations without duct spacers shift to block air path and break off when not "clamped" by spacers.
- ◆ Increases at each startup could be explained by additional laminations breaking off on acceleration (not likely)
- ◆ Rotor expanded during heating and could not return to original position due to excessive restriction of tapered positioning pins. (most likely)

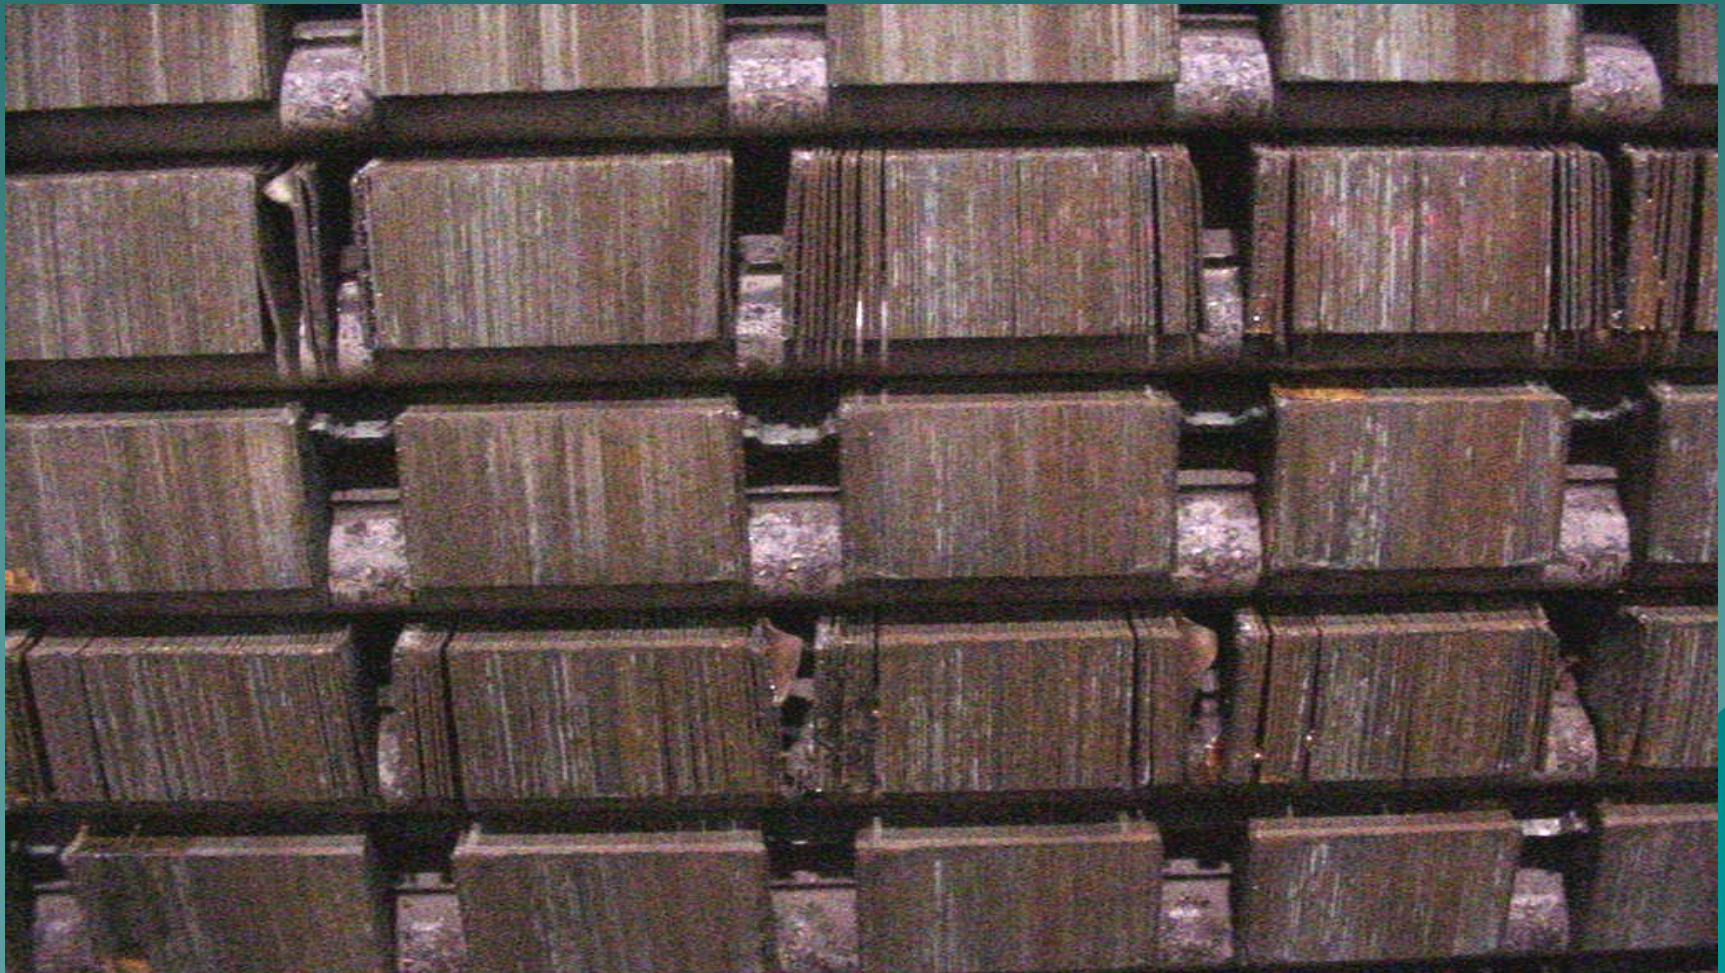
- ◆ Original design required limited inrush current
- ◆ Acceleration time increased
- ◆ More air flow required
- ◆ Vendor eliminated every other row of duct spacers in order to increase air flow

Missing duct spacers

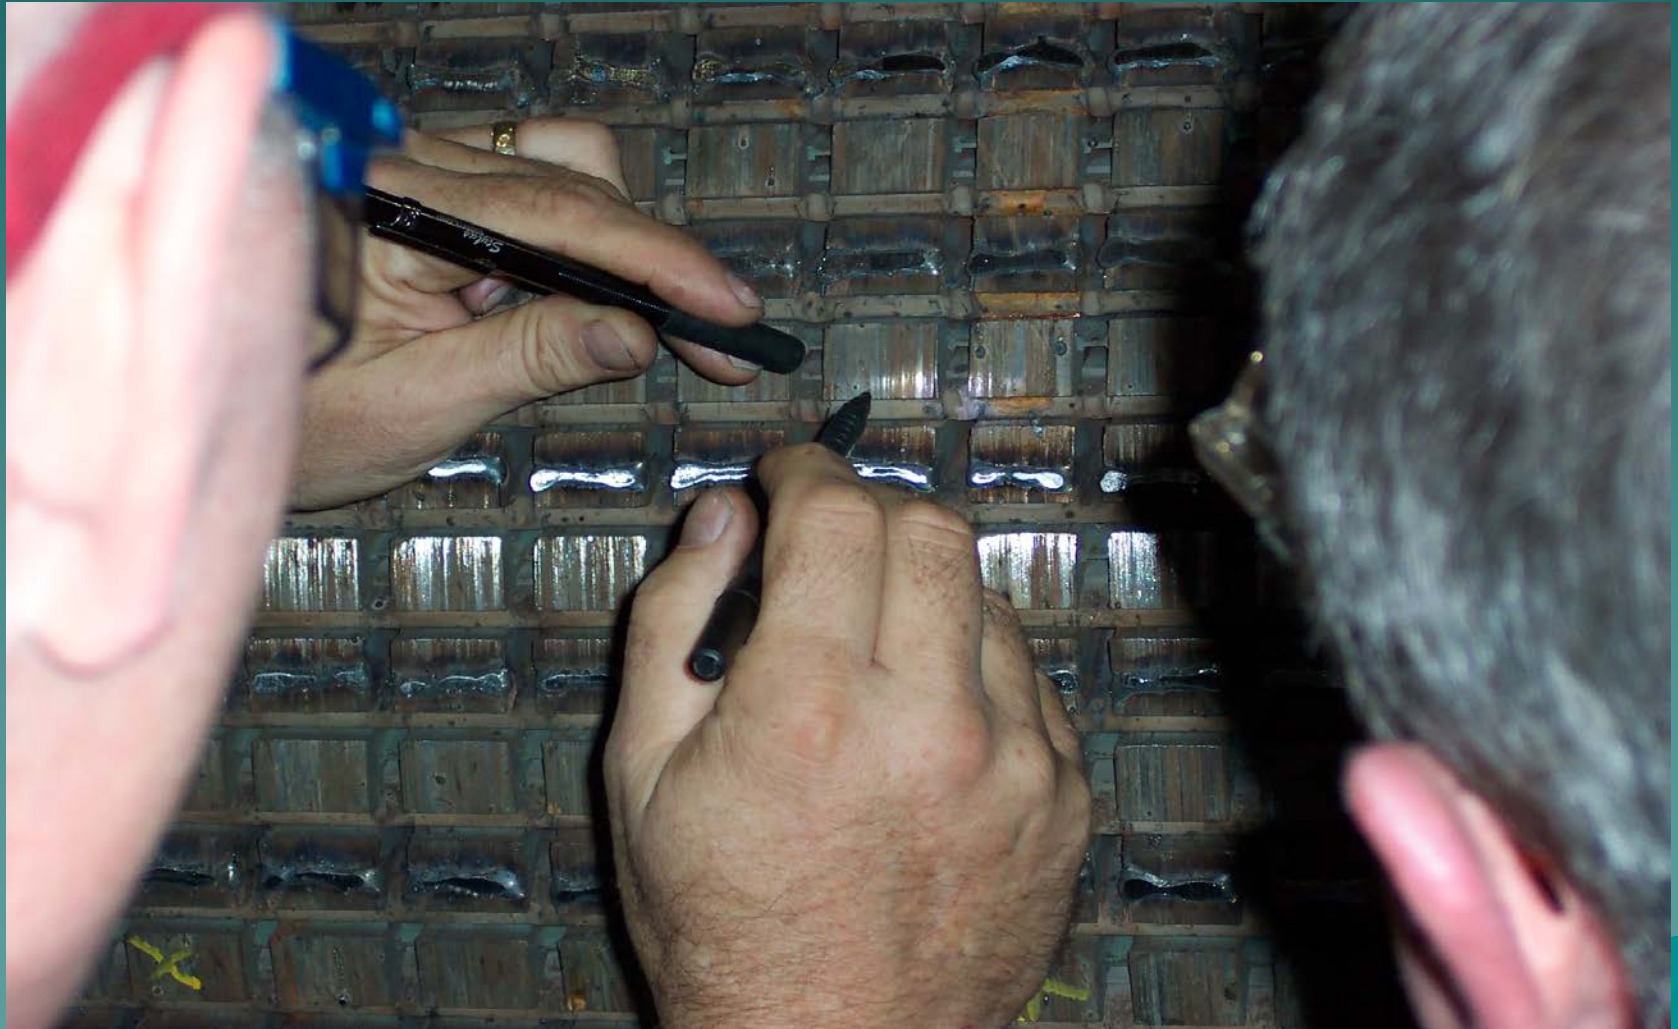
Visual inspection after welding

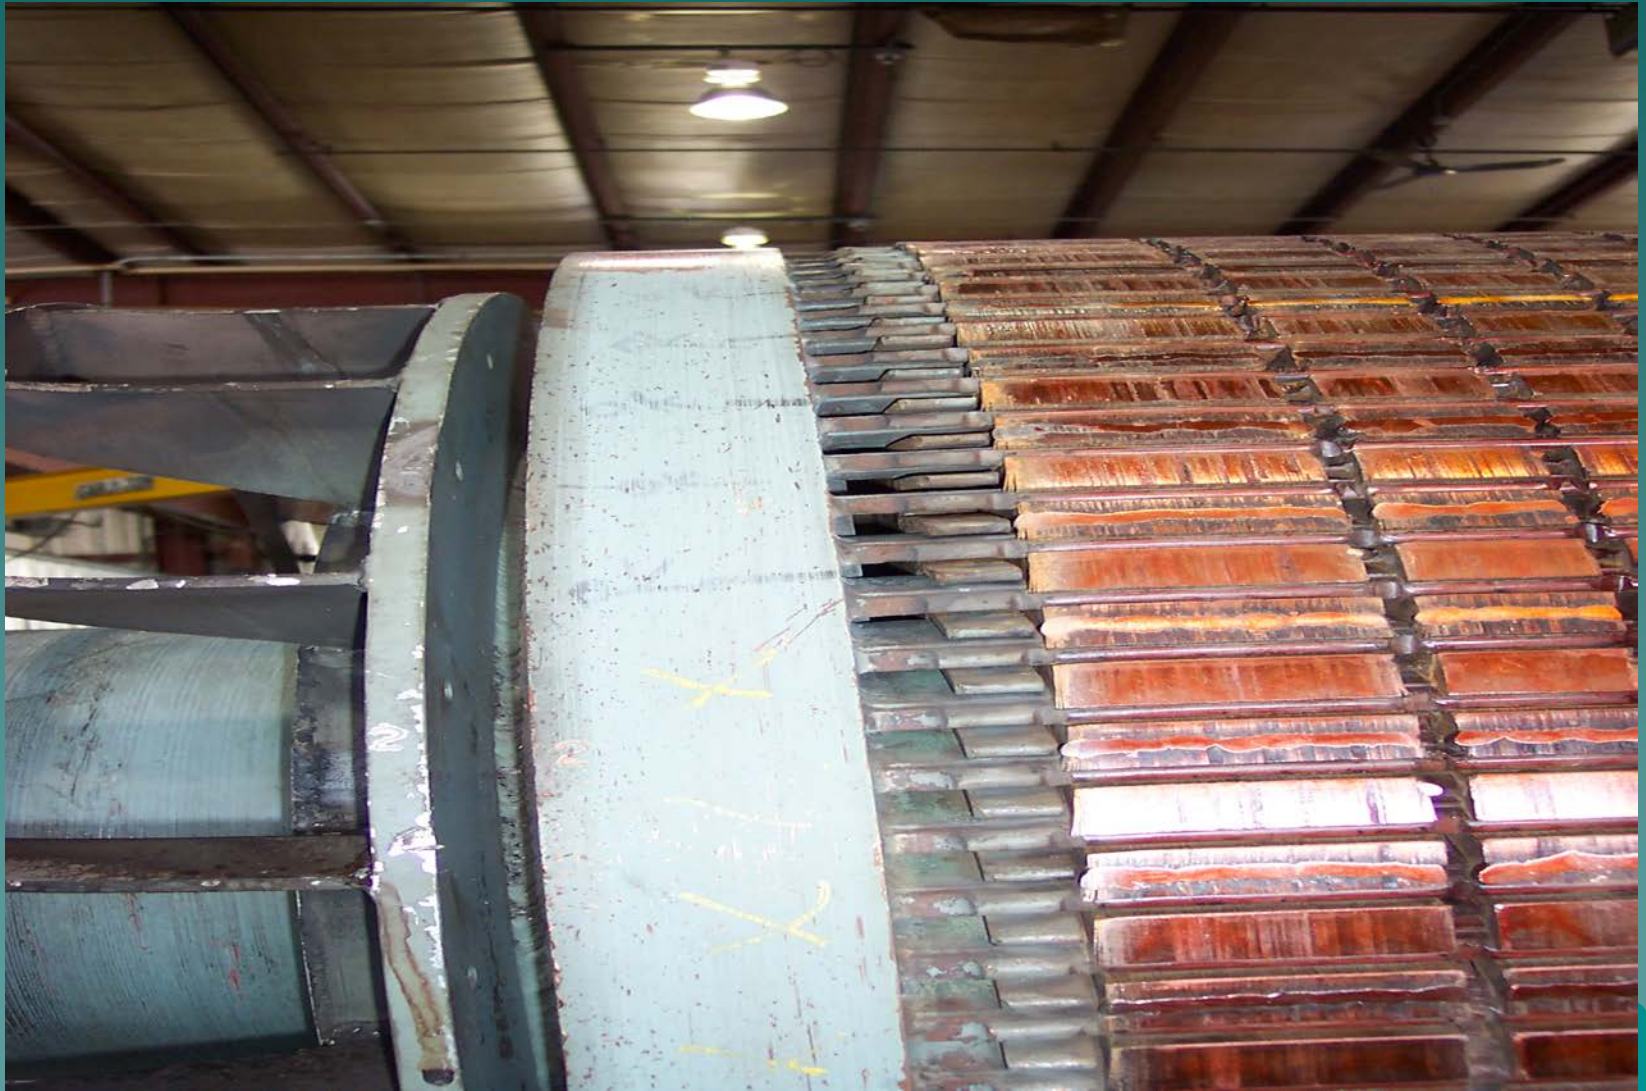
Machined O.D.

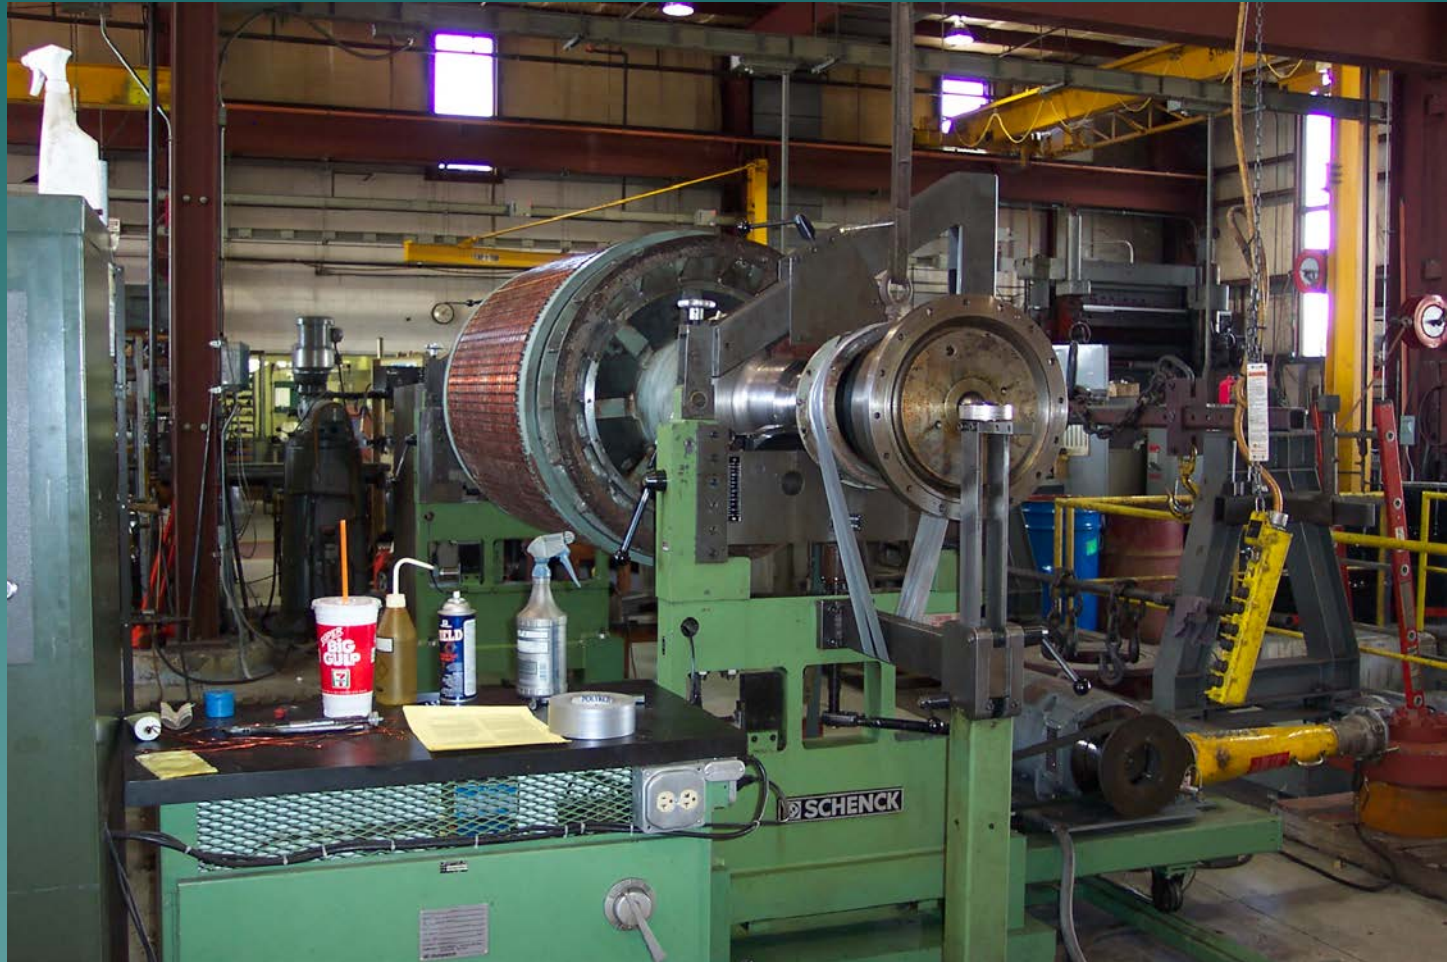
Balanced
