***“High Vibrations & Component Failure In  
Turbomachinery Due to Magnetic Currents”  
: Its Detection, Diagnosis & Correction***

**National Fertilizers Limited,  
Panipat Unit, INDIA**

Scope : The Case Study details this typical problem due to residual magnetism in Synthesis Gas Compressor at National Fertilizers Limited, Panipat Unit, INDIA, in which the problem lead to repeated overhauls of compressor, replacement of three numbers of rotors, damage to number of bearings & Oil film seal rings . It details work associated in diagnosis of the problem, measure taken for temporary relief, so as keep machine running and final work done for permanent solution of the problem.

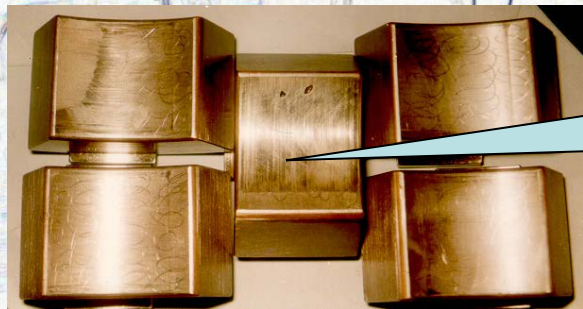
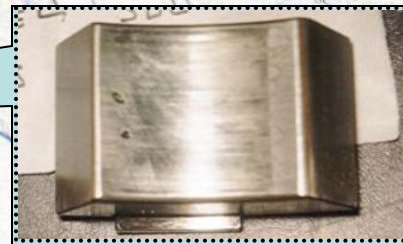
Inspected bearings and observed rubbing / babbitt removal in bottom tilting pads of Intake end journal bearing

Replaced the journal bearing with new one

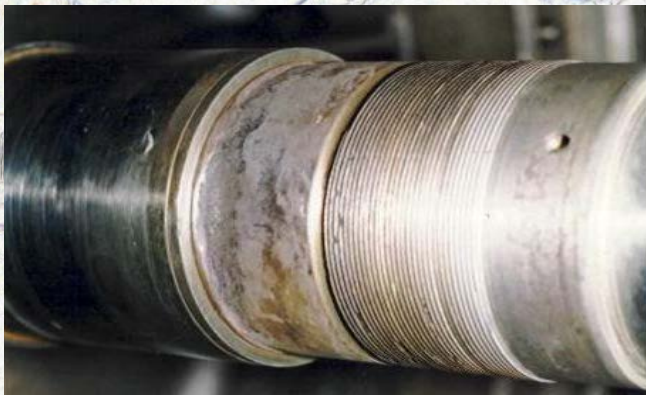
**Observations:** Corrosion (metal removal) marks were observed on rotor shaft at the seat of thrust collar.

**Work Done:** Rotor replaced with spare rotor  
Assembly was made with new journal bearings & oil seal rings

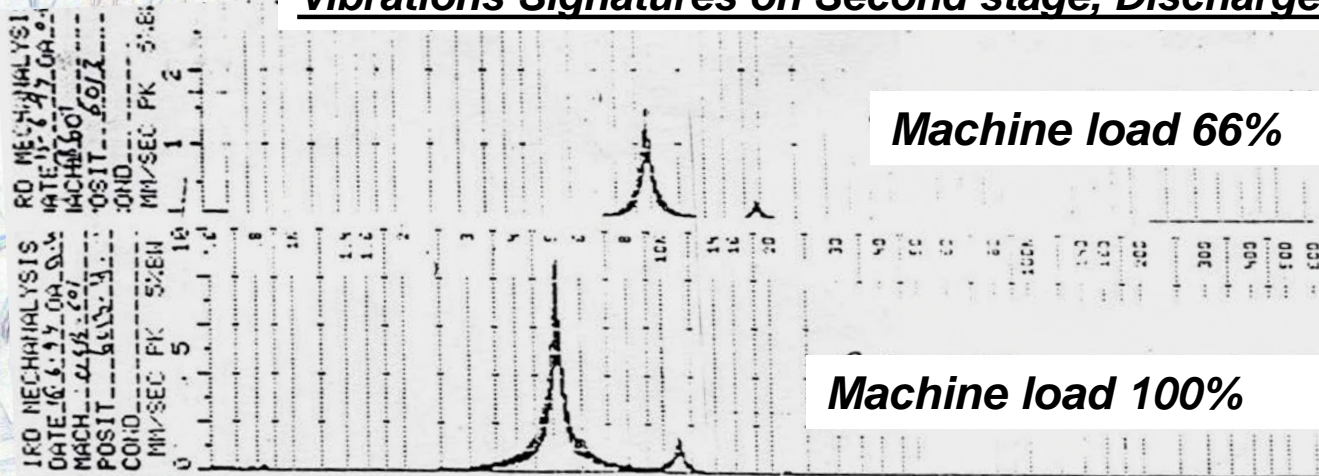
## Vibrations Signatures on Second stage, Discharge end

At 100% load peak component appeared at 0.44 times the running speed

At 66% load this component at 0.44 times RPM disappeared

**This resulted into increase in vibration level typically with frequency of 0.42 to 0.44 times running speed.**

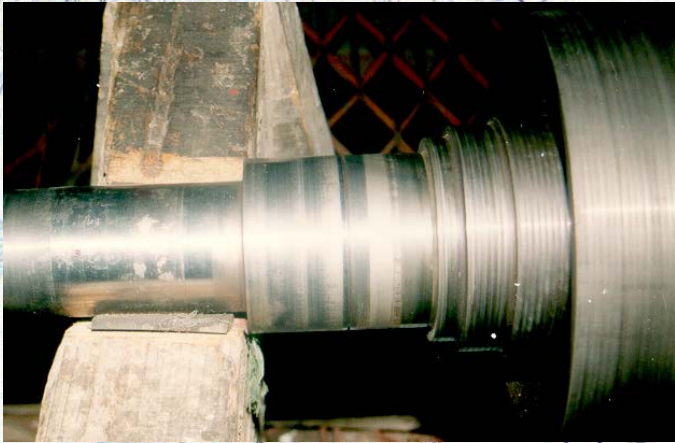
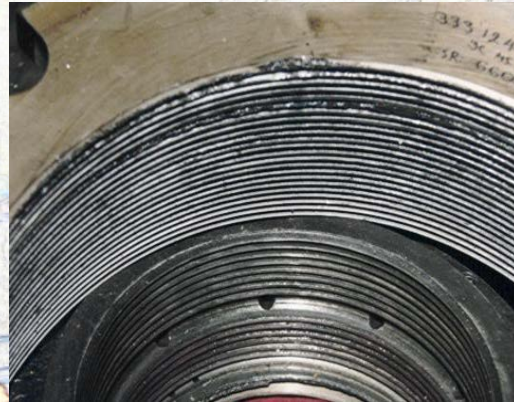
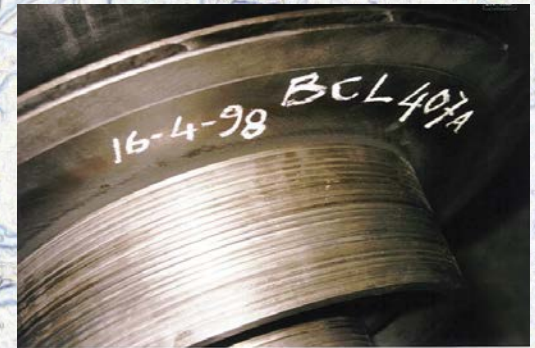
**The labyrinth seal of balance drum was rubbed / damaged & rubbing on gas seal & balance drum seal area on rotor**

**The assembly was made with spare repaired rotor, new bearings & oil seal rings**

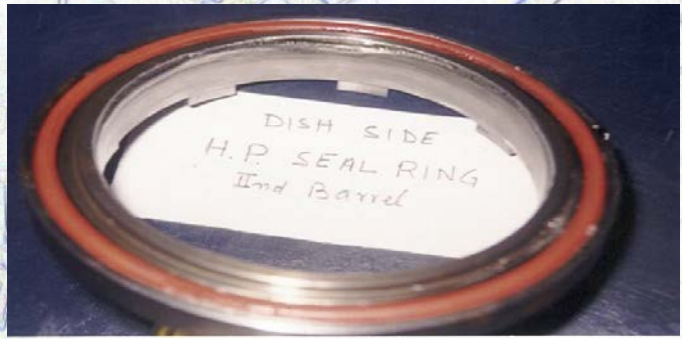
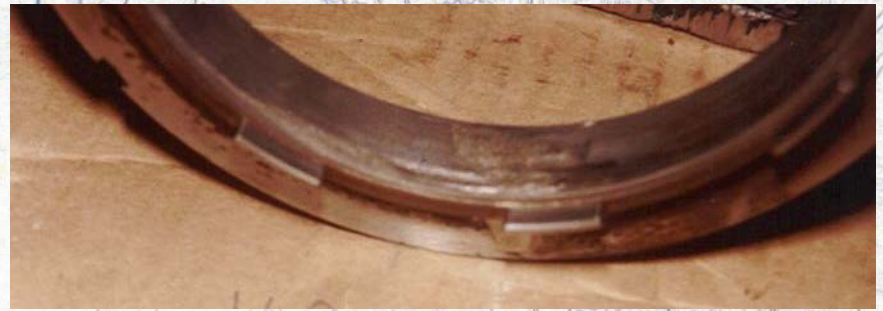
- Frosting, grooving & burning marks & spark damage was observed on babbitt of H.P. seal rings with deep babbitt removal

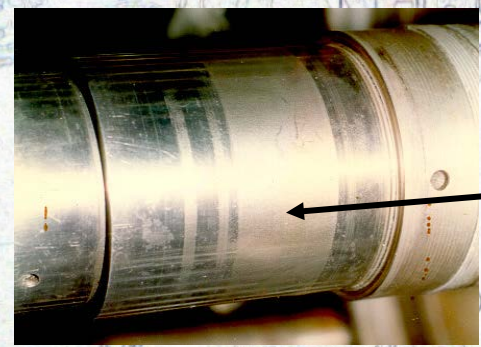
Heavy frosting on rotor shaft journal on half of circumference

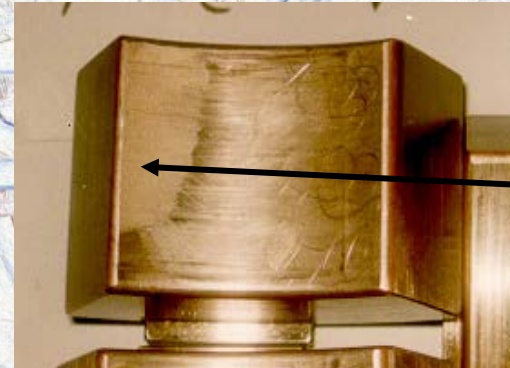
Frosting on Shaft Journal

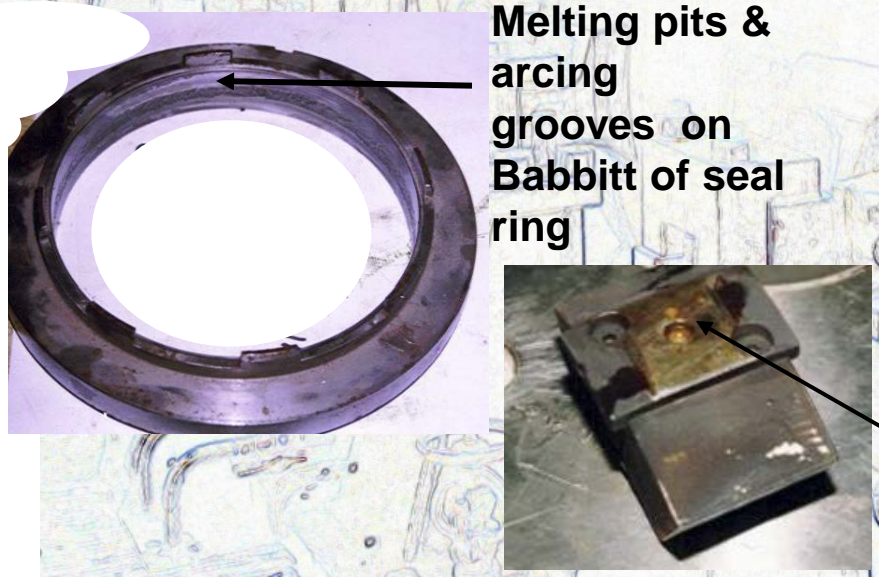
The frosting on half of shaft circumference, burning marks, repeated failure of oil seals, bearings, high vibrations, which persisted even after change of rotors, oil seal rings & bearings were showing high probability of high electromagnetic current discharge through these components.

Melting pits & arcing grooves on Babbitt of seal ring

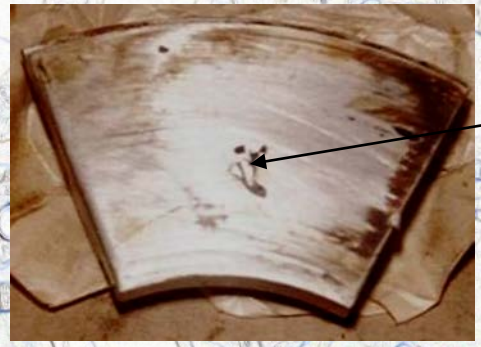
Frosting & burn spots on Thrust Bearing Pads

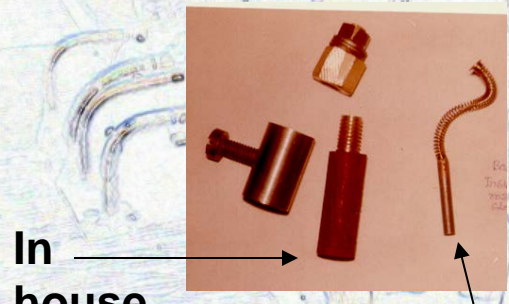
In house made holder

Carbon bronze grounding brush with spring

- To detect the presence of shaft currents & voltages & to measure them
- Shaft grounding brushes could help us in providing relief to some extent in case of presence of high shaft currents .
- Carbon Bronze spring loaded sticks in stock (provided by OEM of oxygen compressor for their machine) were fitted in in-house fabricated holder & was installed on second stage compressor on upper half of journal bearing cap of intake end (in plane of vibration probes).

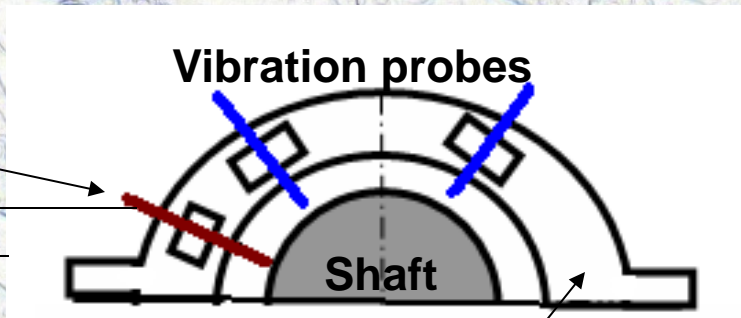
New installed grounding brush

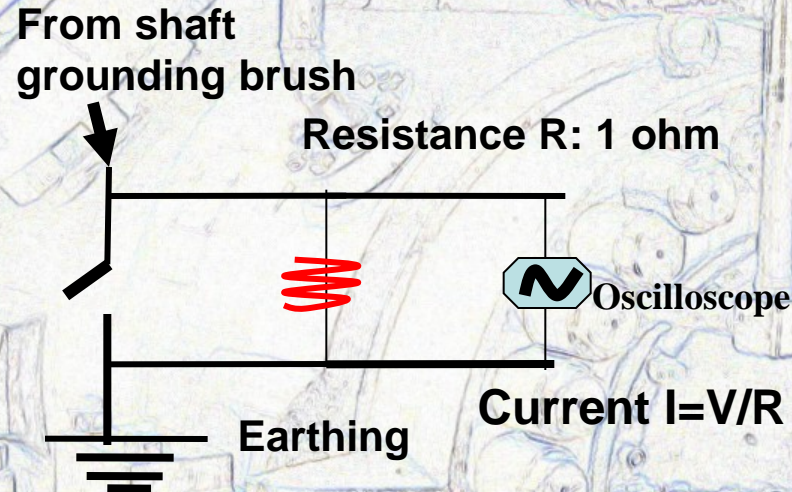
Measured Shaft current by connecting Oscilloscope. High voltage spikes were observed. Indicated presence of High electromagnetic shaft currents
