Charge Compressor 2/3 Stage Fouling/High Vibration

DuPont Sabine River Works

Problem

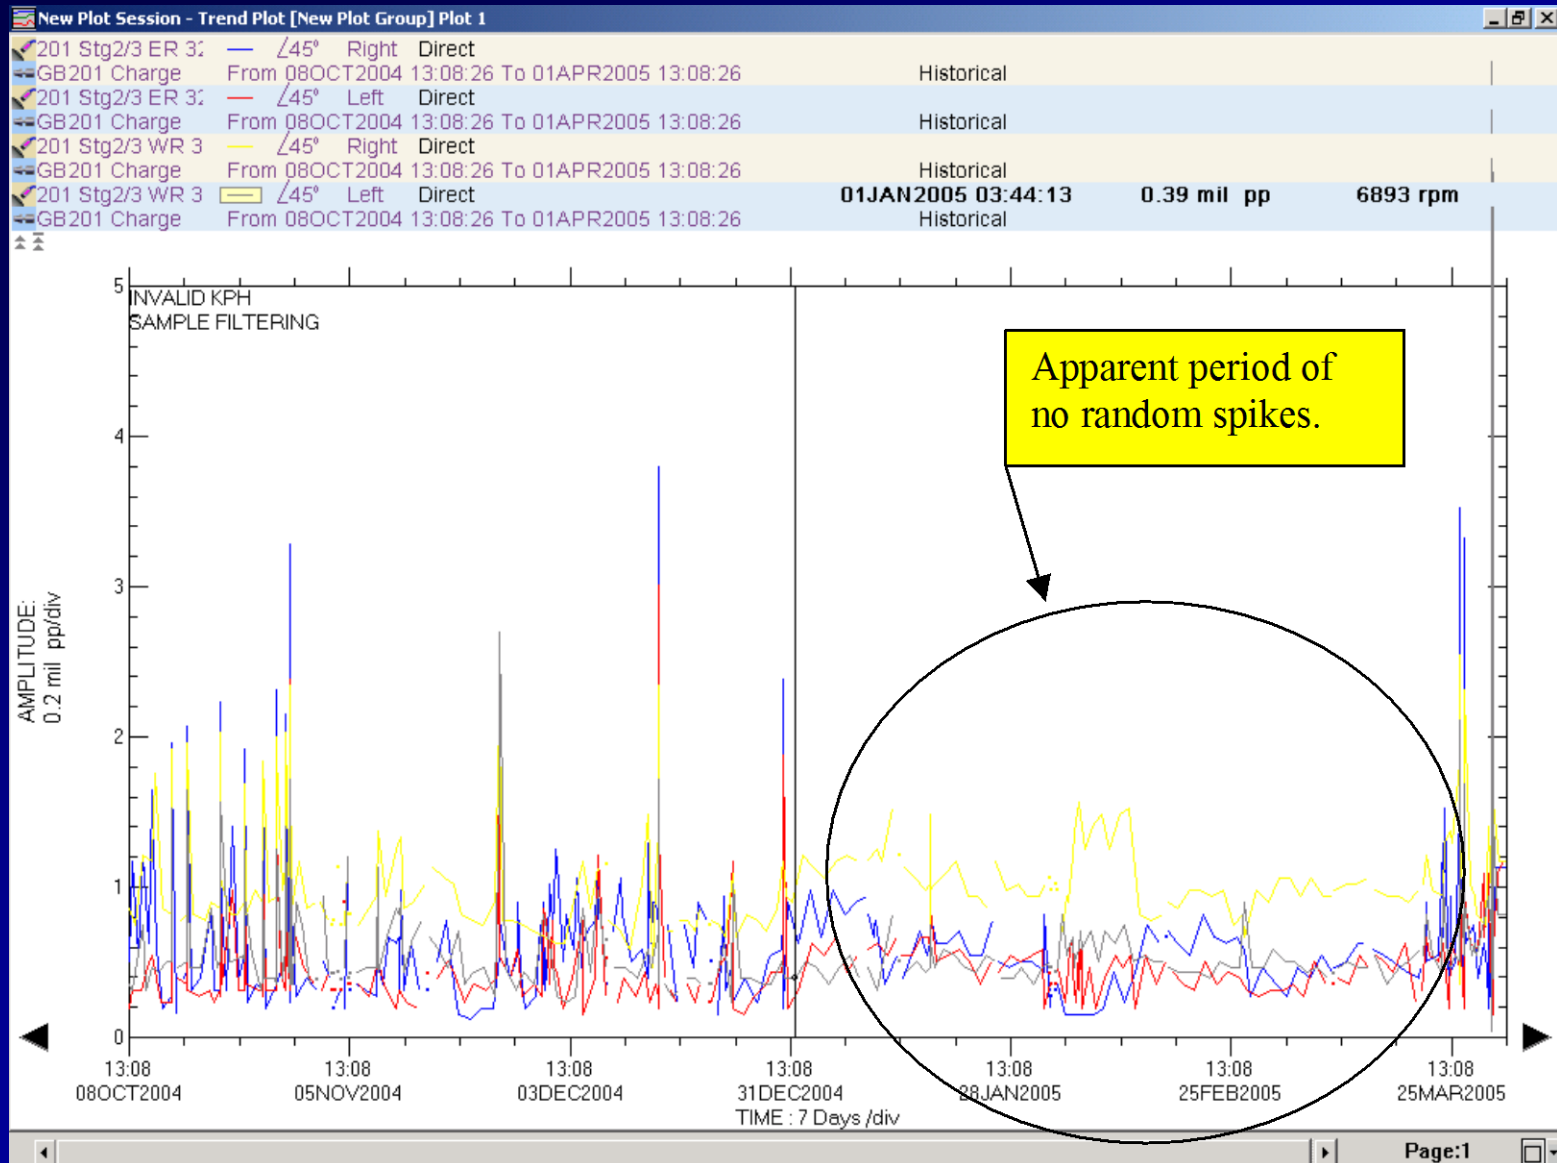
2/3 Stage Vibration Trend

- Significant performance loss and high vibration on the Charge Gas 2/3 stage compressor was experienced one year following the 2003 Turnaround.
- This followed two consecutive, highly successful runs after application of antifoulant coating in 1995.

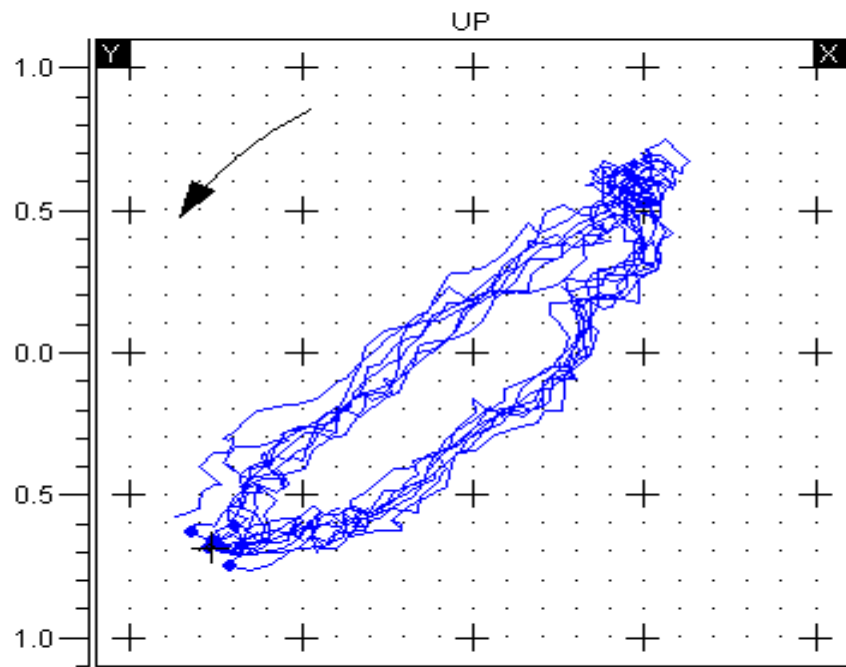
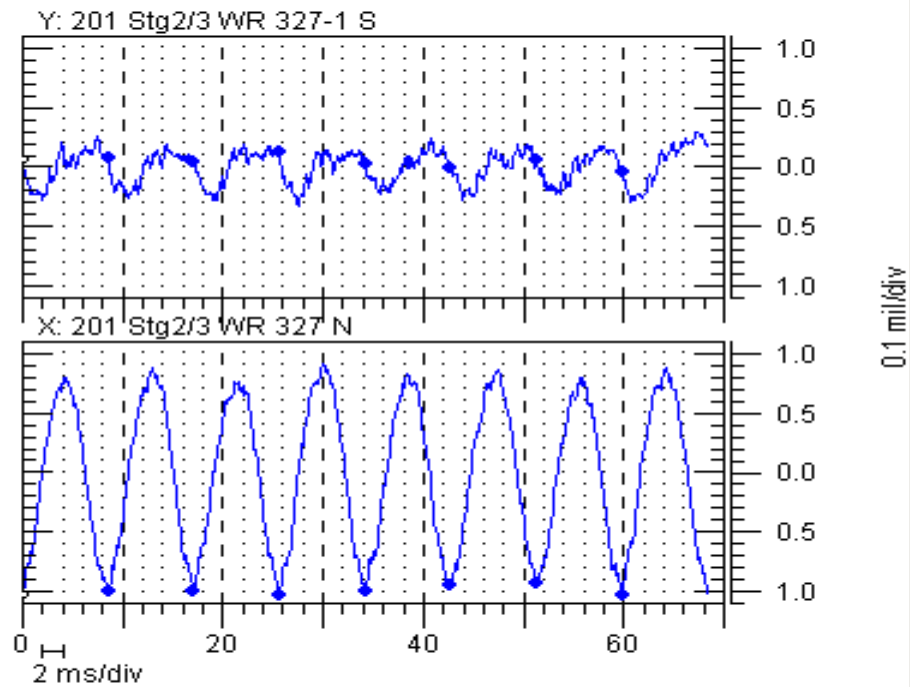
Restricted Orbit

Y:201 Stg2/3 WR 327-1 S /45° Left SYNCH WF AMP : 0.63 mil pp
X:201 Stg2/3 WR 327 N /45° Right SYNCH WF AMP : 1.95 mil pp
GB201 Charge: 10SEP2004 13:10:26 HW Alert/Alarm Direct 7012 rpm
FS: 0-64 X SMPR: 128/8

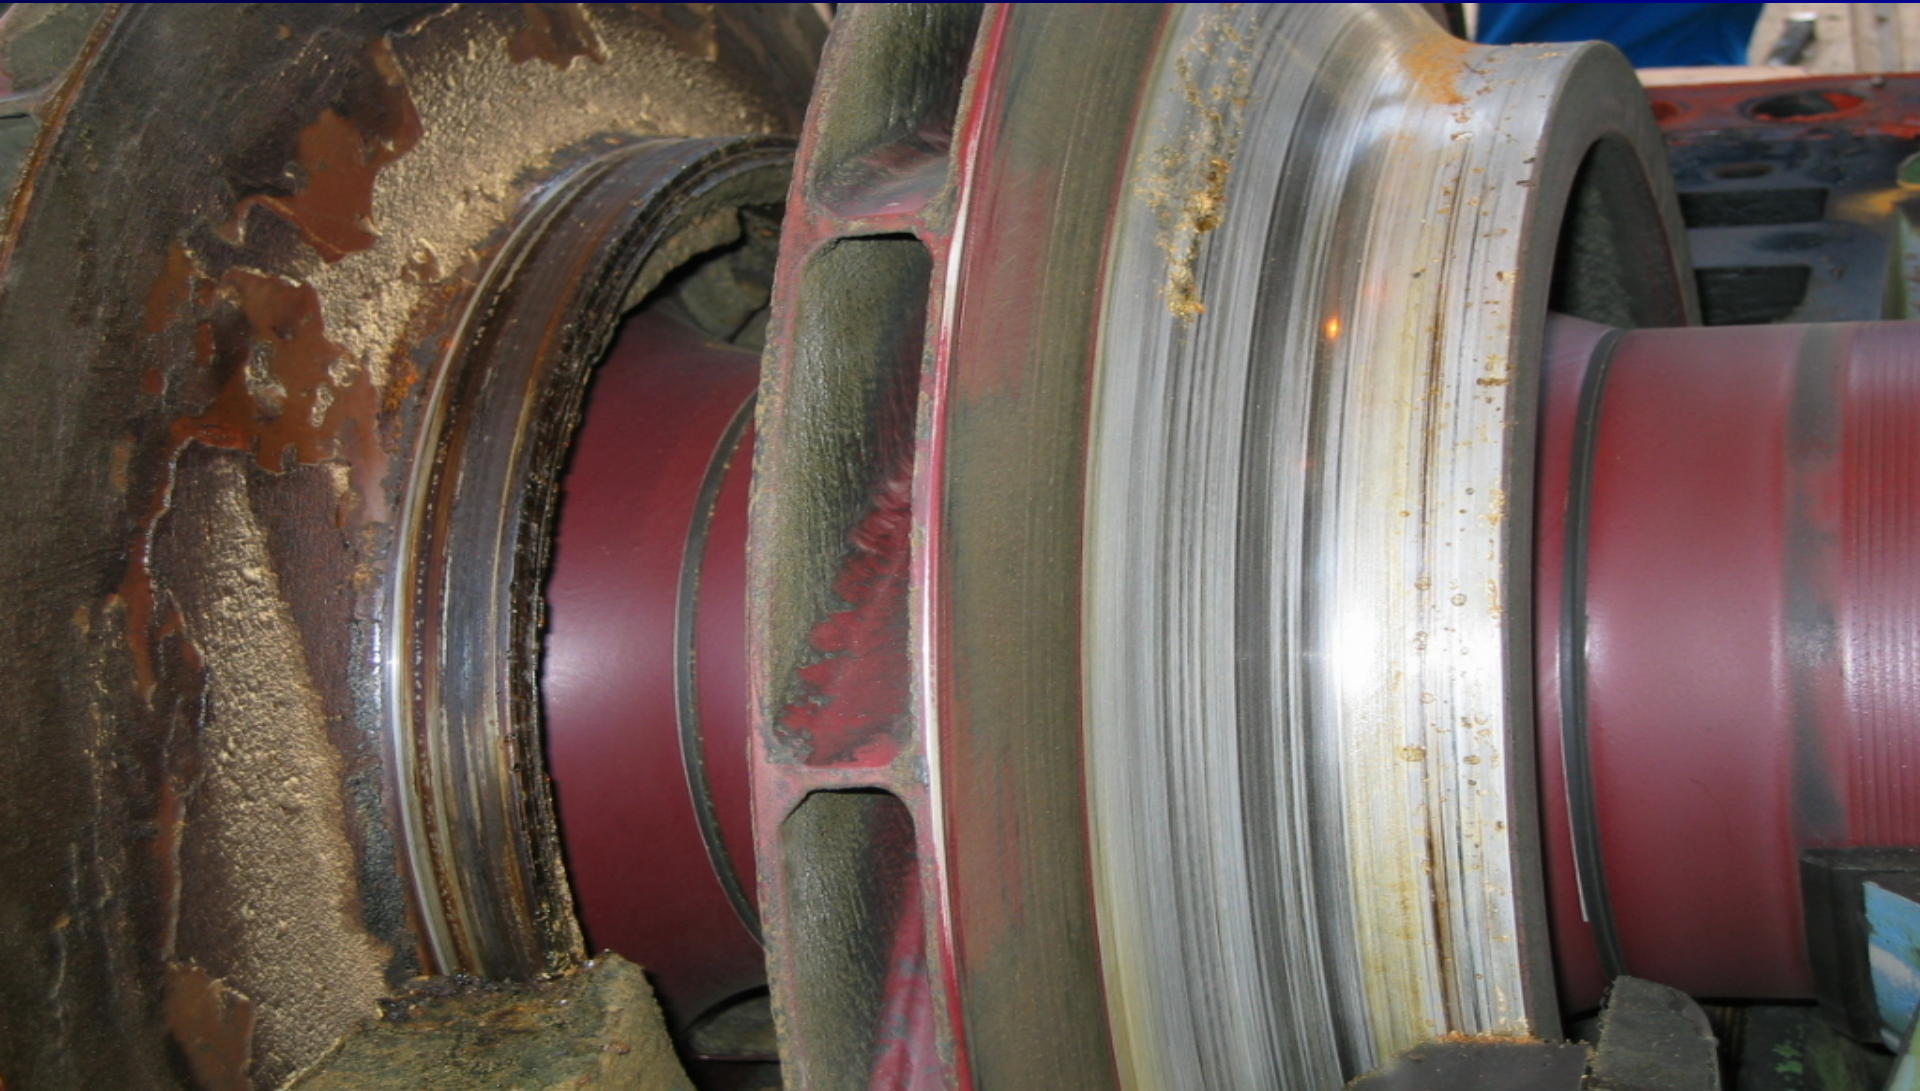
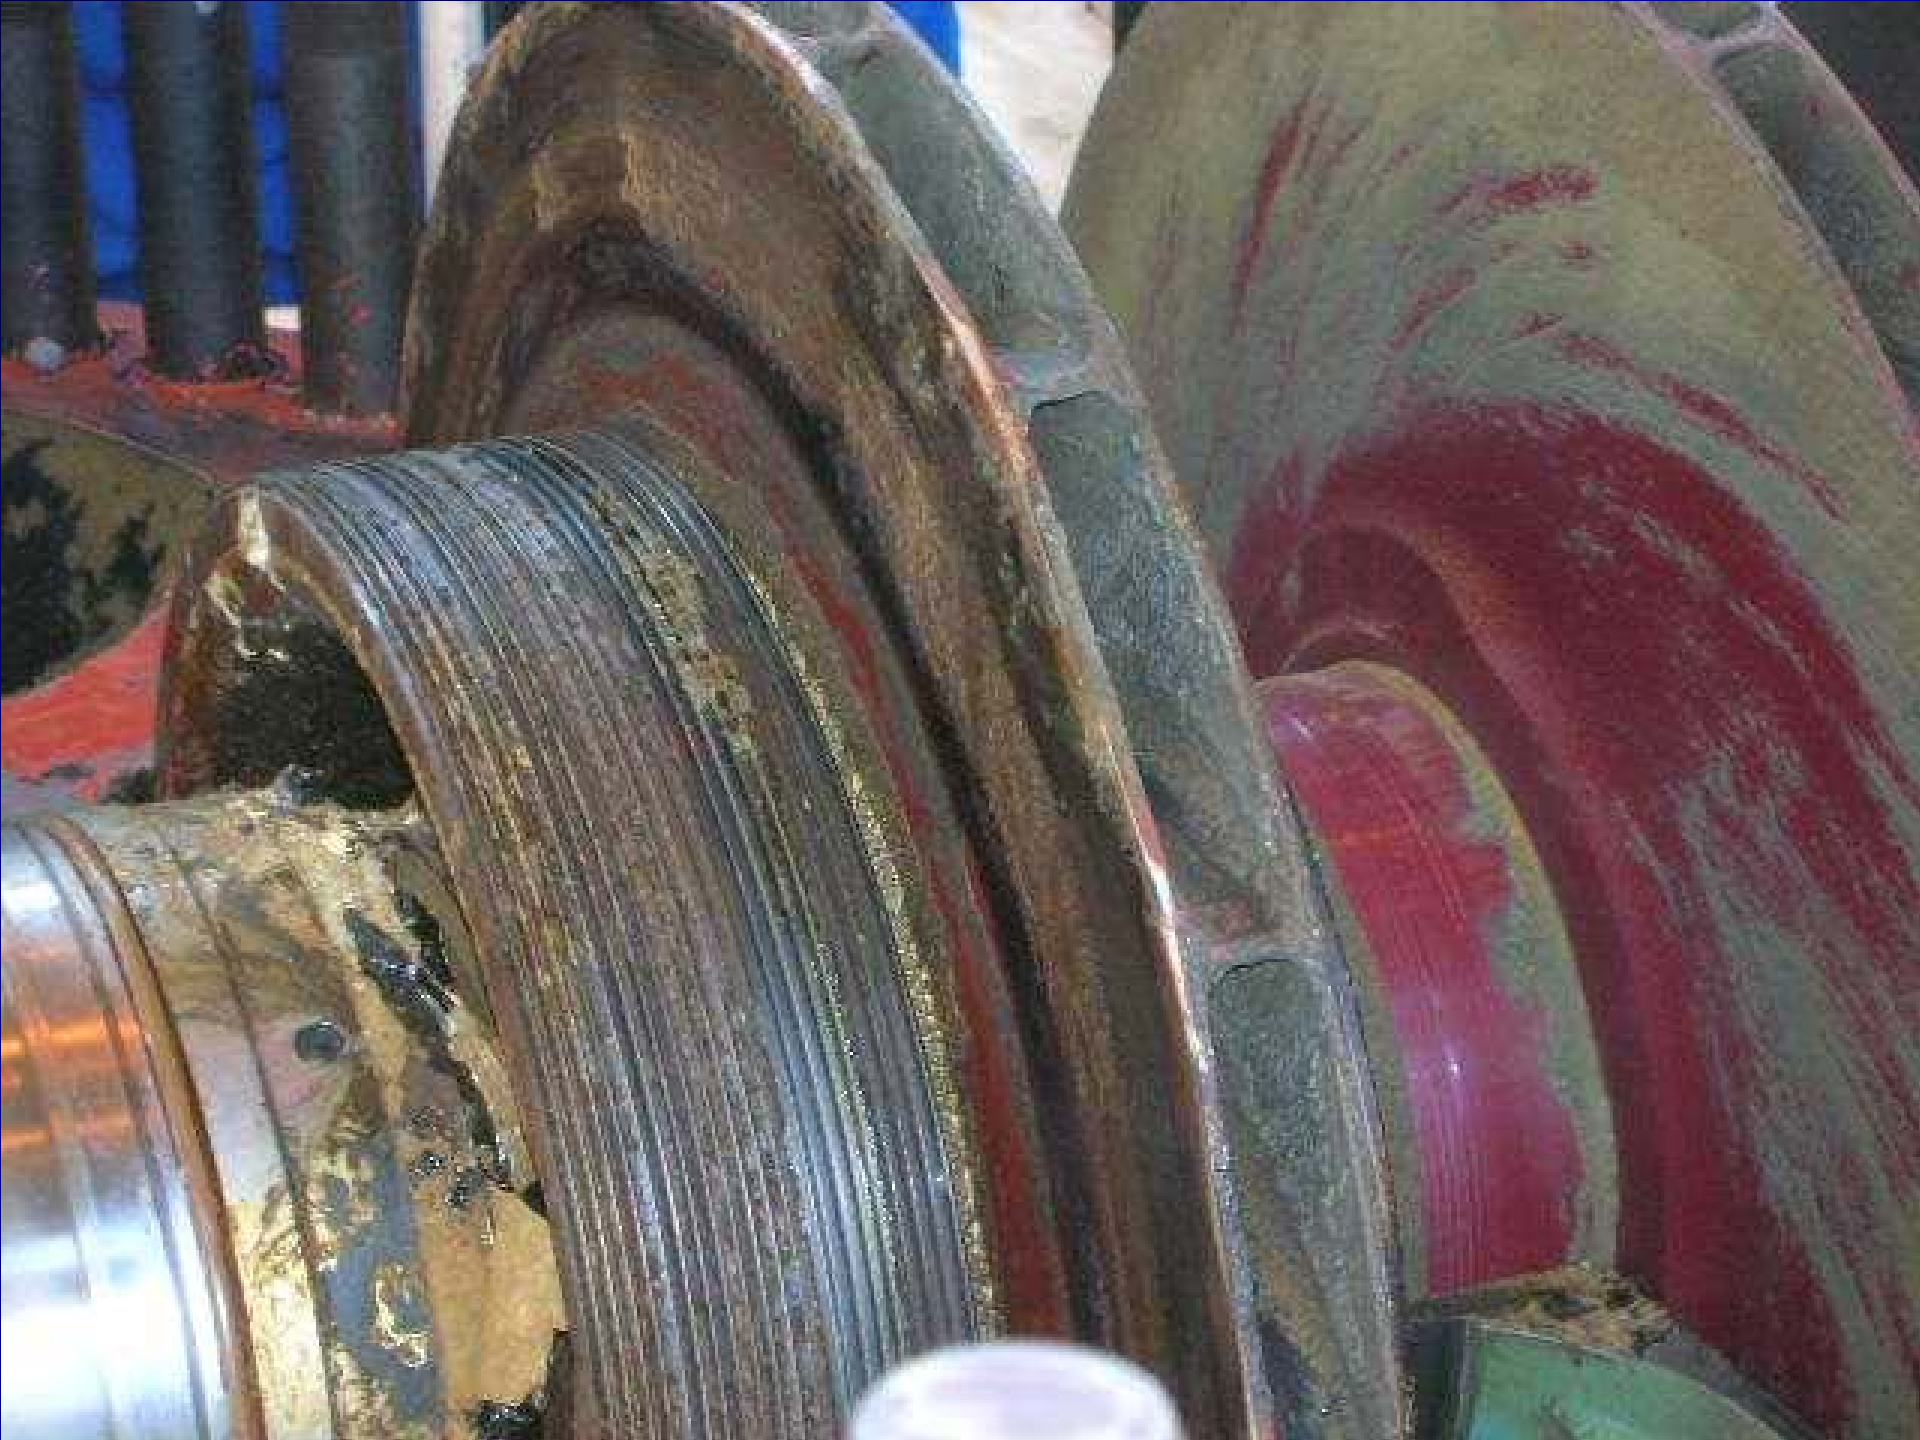
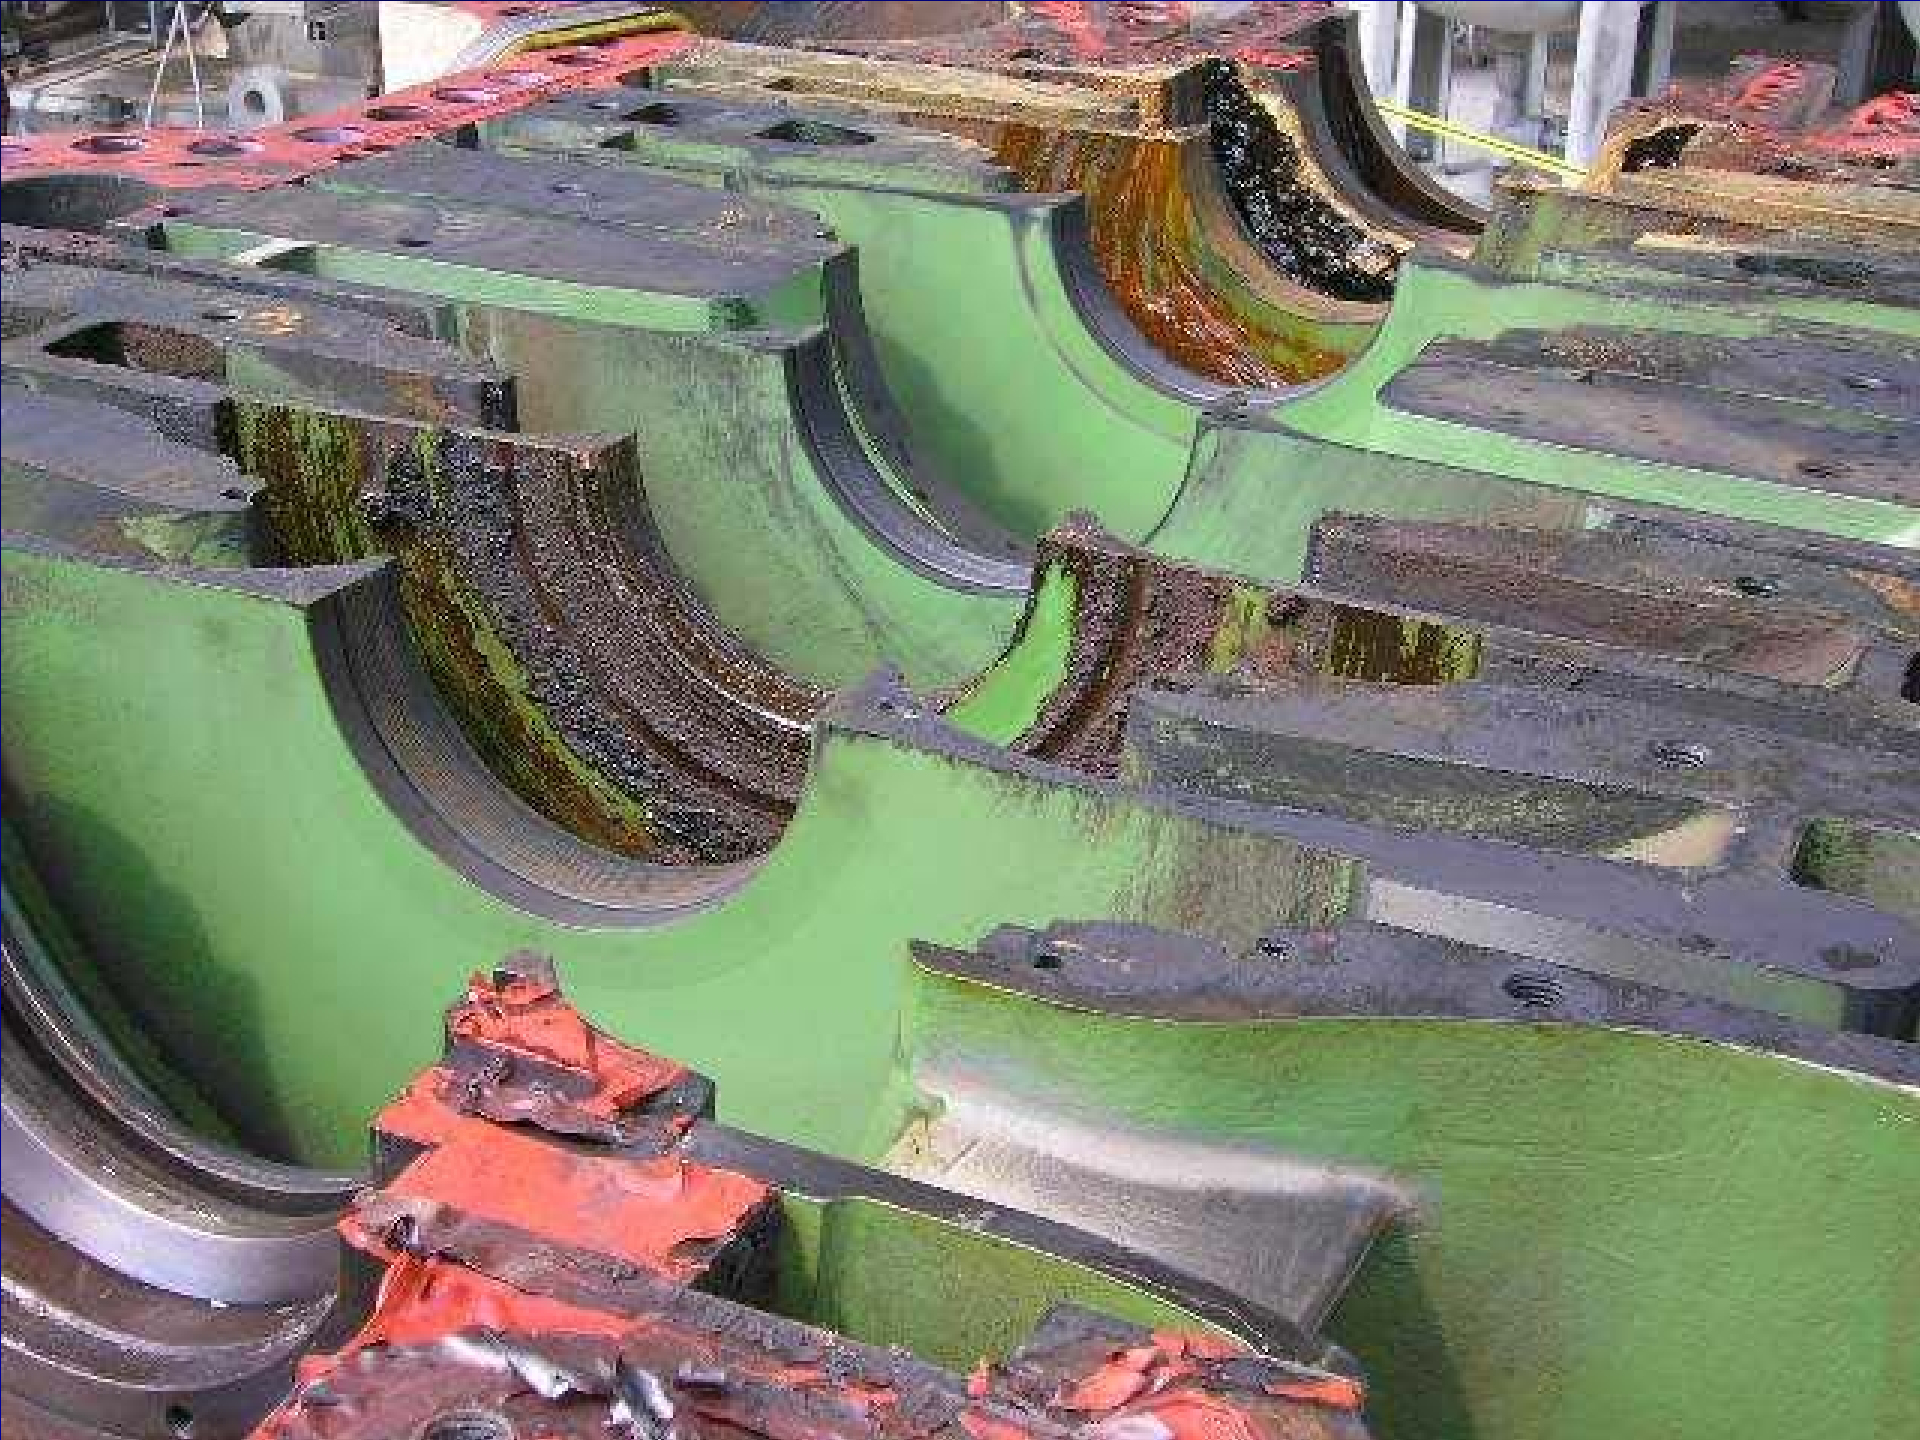
Hard Rub

- Performance loss and vibration was due to severe fouling.
- Severe fouling led to axial and radial rubs.
- Severe fouling was due to liquid carryover from suction drums.
- 2/3 stage compressor overhauled and returned to service
- Suction drum demisters upgraded to high efficiency.
