Induction Motor Vibration Experience

- ◆ Lou Trahan
- ◆ DuPont at Sabine River Works, TX
- Ethylene Unit
- ◆ Share our experience with rework of 5600 H.p. /1800 RPM motor during major TA

- Purge Propylene Refrigeration Compressor, Elliott 38M-6 driven by a Westinghouse 5600 Hp/ 1800 RPM induction motor with speed increaser to 3600 RPM

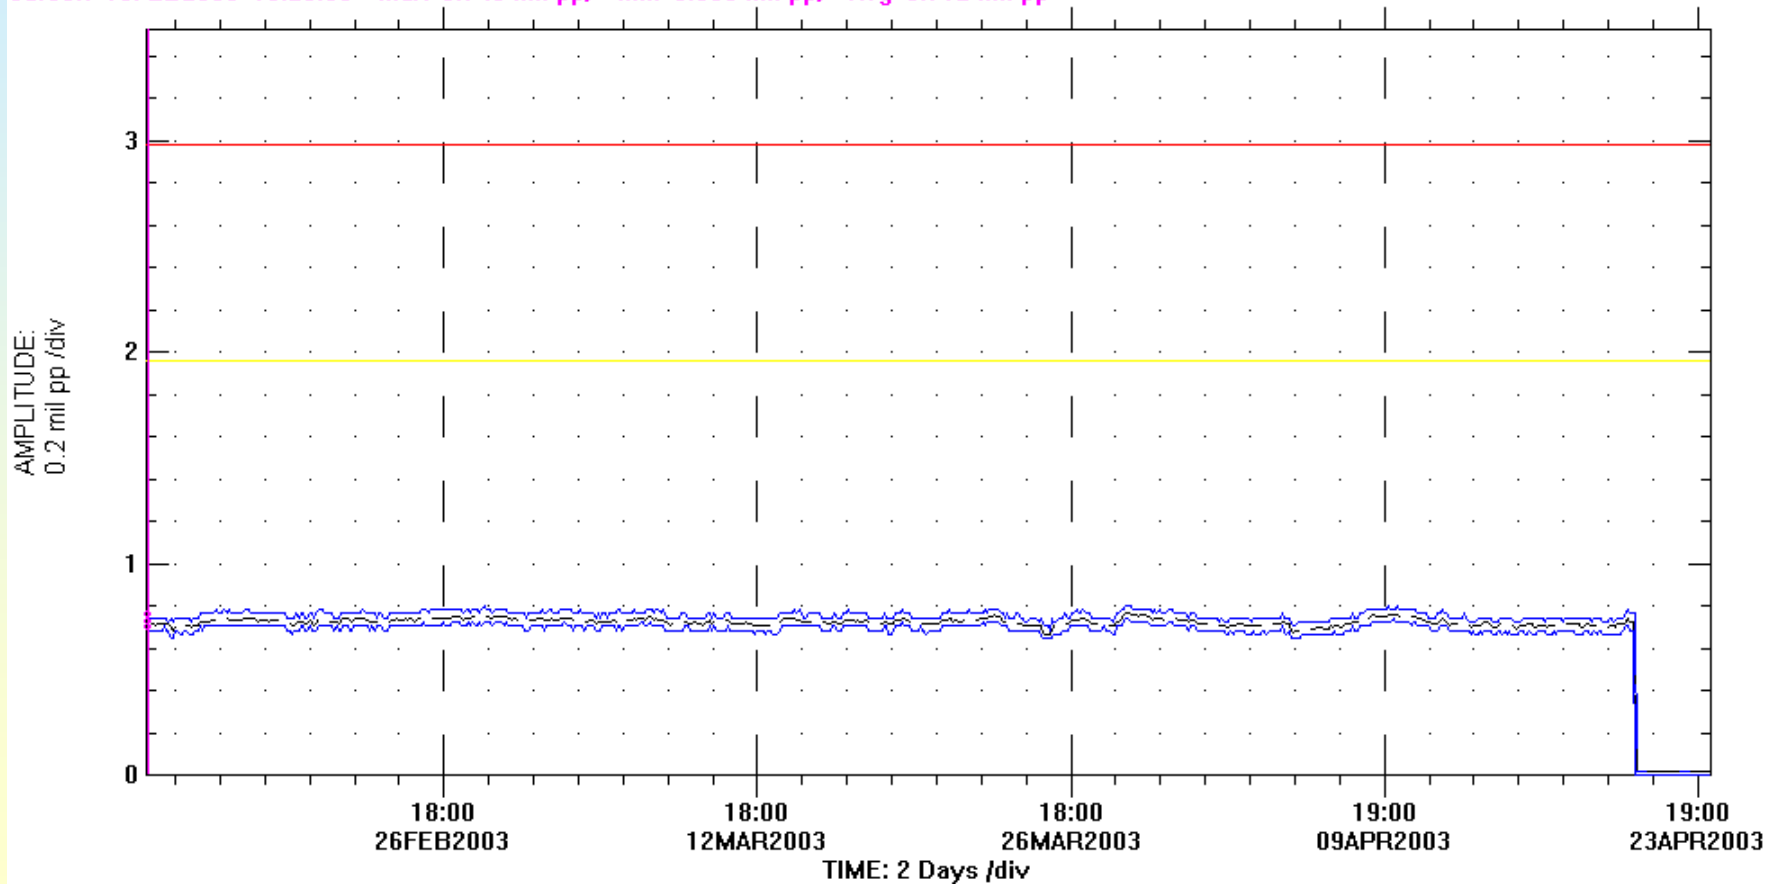
Vibration Signature Before T/A

POINT: Motor NR 391 West $\angle 45^\circ$ Right Direct

From 13FEB2003 10:54:34 To 24APR2003 08:55:46 Delta Time

Cursor: 13FEB2003 13:20:00 Max 0.745 mil pp, Min 0.686 mil pp, Avg 0.712 mil pp

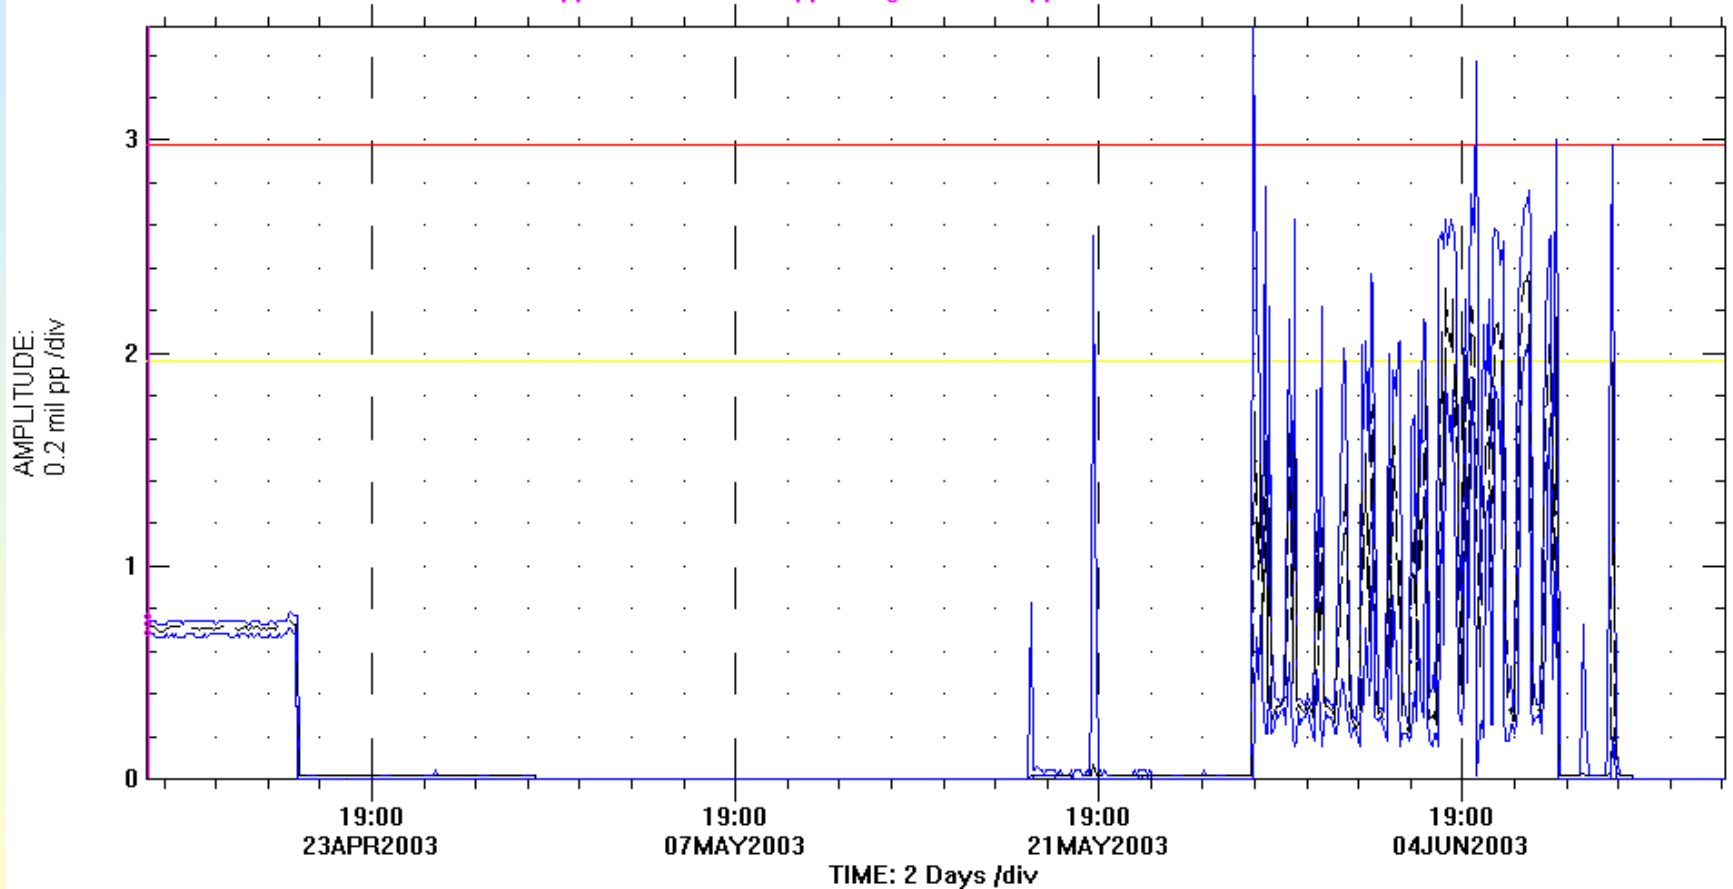
Vibration After the Overhaul

- Re-installed motor at end of the TA
- Vibration is now unacceptable
 - ◆ The frequency was from 1X to 7X
 - ◆ Over 2.5 mils peak to peak (prior to rework - 0.65)

POINT: Motor NR 391 West $\angle 45^\circ$ Right Direct

From 15APR2003 02:51:00 To 14JUN2003 21:38:56 Delta Time

Cursor: 15APR2003 05:00:00 Max 0.745 mil pp, Min 0.667 mil pp, Avg 0.712 mil pp

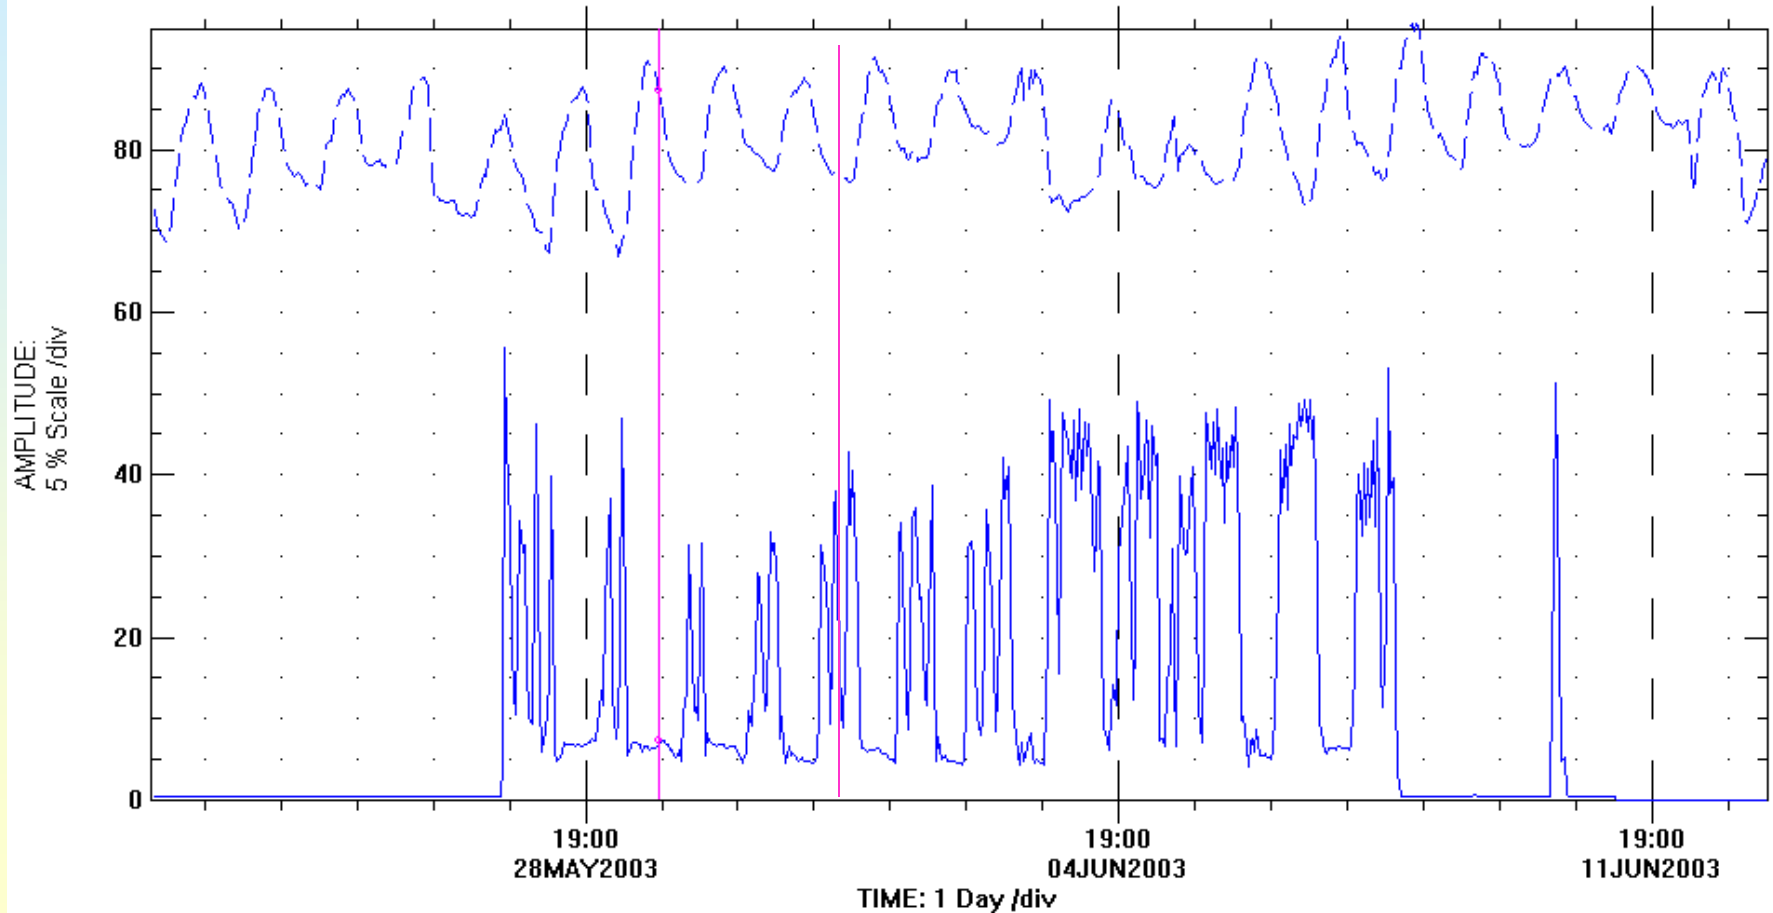
Vibration vs. Ambient Temp

POINT: Motor NR 391 West / 45° Right — DIRECT 0.343 mil pp
POINT: Ambient Pressure — DIRECT 87.0 deg F
From 23MAY2003 02:07:01 To 13JUN2003 07:21:59 Delta Time 18:00:00

- Good sound rotating equipment practices are critical to performance
- Detailed specifications are necessary
- Simple issues like these seals are critical
- Housing would shrink enough during ambient cooling to cause seal interference to worsen

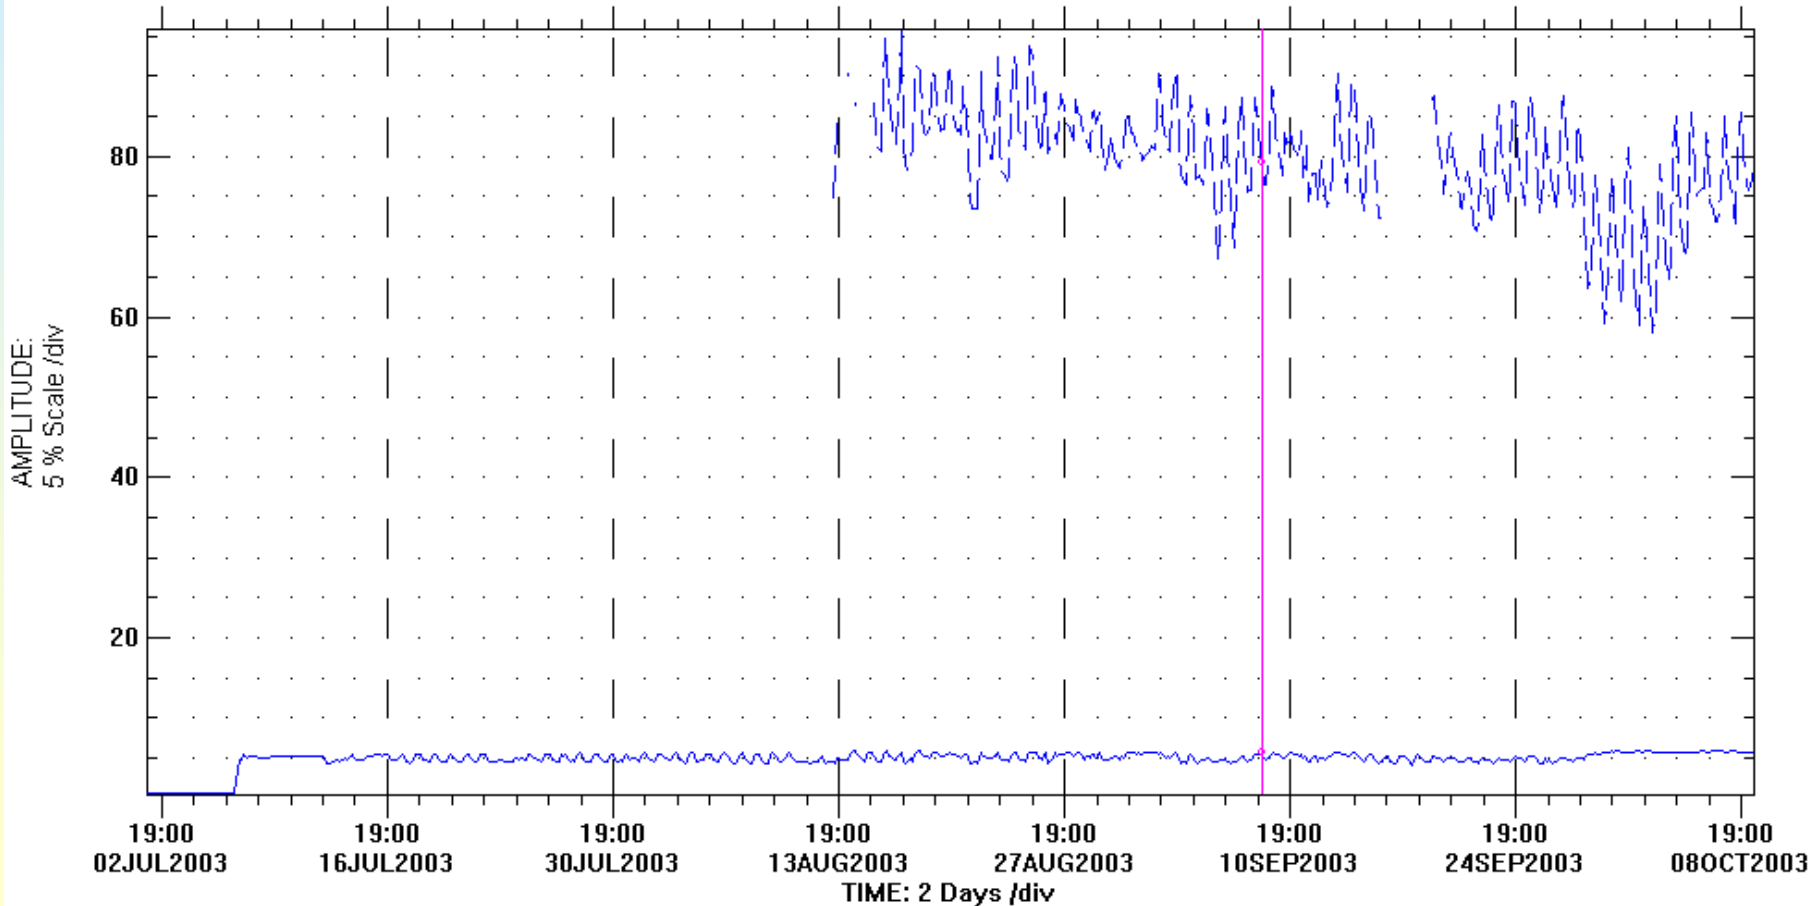
Vibration vs. Temp After Rebore Seals

POINT: Motor NR 391 West $\angle 45^\circ$ Right — DIRECT 0.258 mil pp
POINT: Ambient Temp — DIRECT 79.0 deg F
09SEP2003
01:00:00

From 01JUL2003 21:20:00 To 09OCT2003 13:40:00 Delta Time

- Plastigaged the crush on the bearings, both were loose 0.001”-0.003”
- Installed the seals with zero clearance, vendor recommends they will “RUN-IN”
- Continued monitoring vibration with motor vendor equipment and third party consultants
