Case Study: Fast Response Vibration Interlock of High Pressure Reciprocating Compressor

Invista Sabine River Works

H2 Compressor Rod Failures

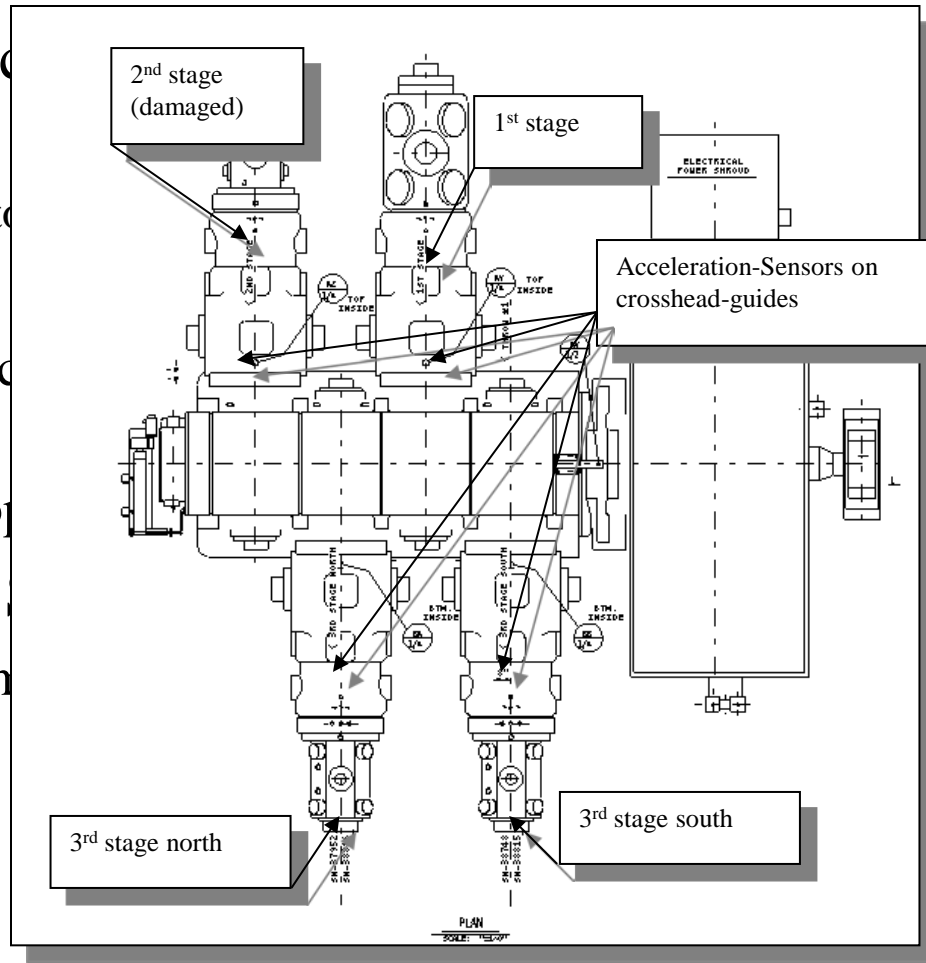
- Sudden Catastrophic 2nd Stage Rod Failure on H2 compressor
 - Bent Crankshaft to Crosshead Connecting Rod
 - 3 Weeks Later
 - Sudden Catastrophic 2nd Stage Rod Failure on other H2 compressor
 - Identical (carbon copy) in nature to first failure
 - Vibration Interlock System
 - Shutdown Both Compressors Within 1 Second
-

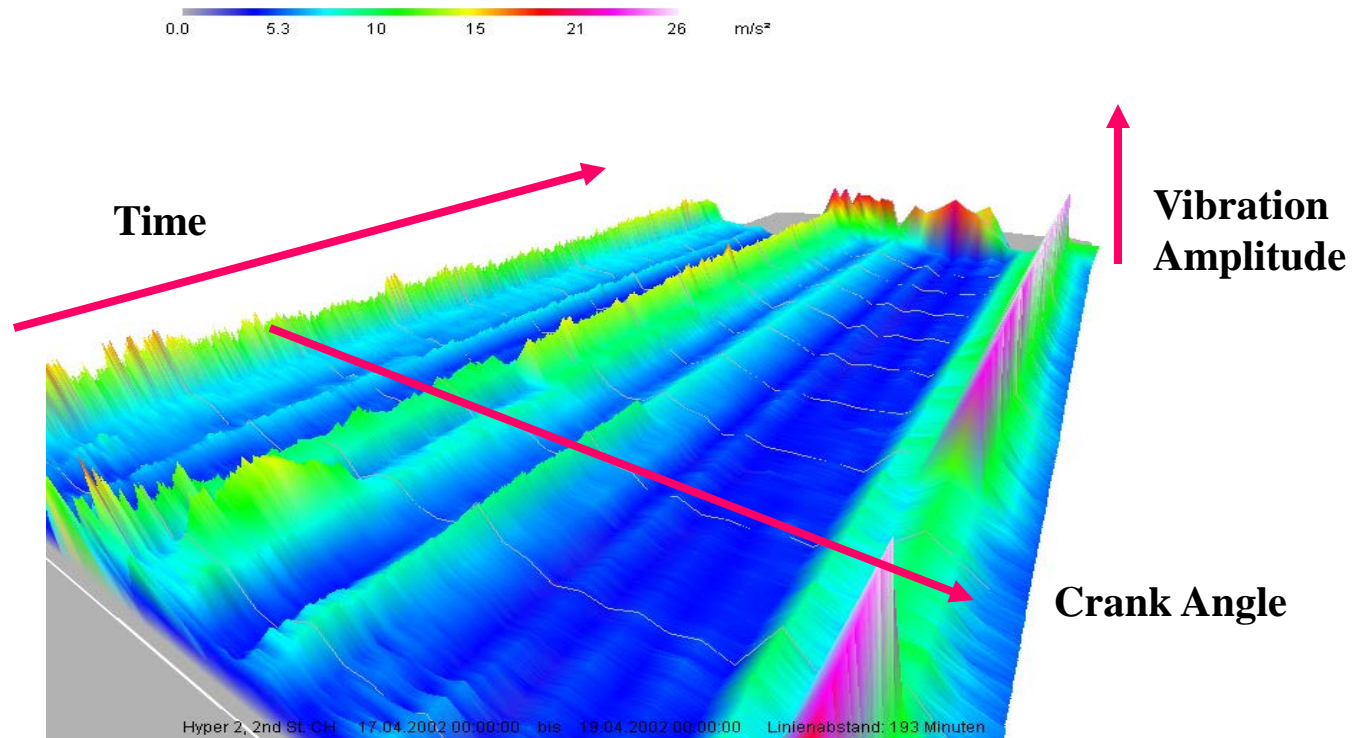
Short-term-trend (Minutely average-value) of Peak-Values on CH Cyl. 2 for one day prior to failure

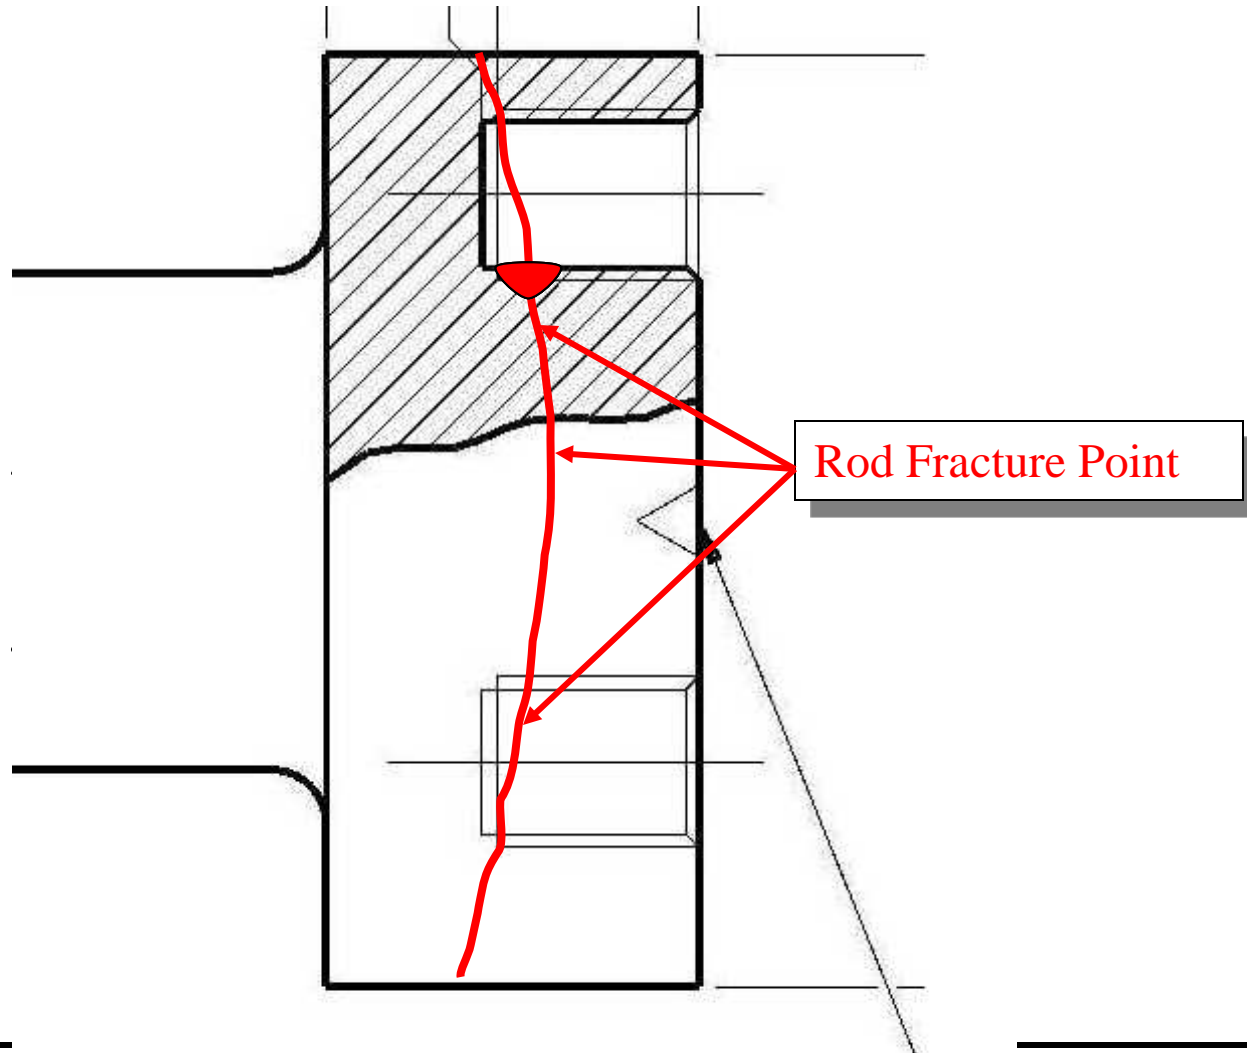
Rod Fracture Analysis

- Items considered
 - Changes in process conditions
 - Rod / Piston assembly
 - Metallurgy & Rod QA
 - Length of service
 - Key Factors
 - Rod & piston installation assembly
 - Torquing threaded stud into bottom of stud holes caused excessive stress in threads
 - Rod Taper / stud hole proximity
 - Close proximity accentuated the stress level in the threads
-

- QA Check Sheet for New Rods
 - Correct metallurgy
 - Meets specifications
 - Rod & Piston Assembly Procedure
 - Detailed instructions
 - Manufacturer input to proper assembly
 - 3 Year Rod Change Out
 - Removed rods are tested and re-furbished if no wear evidence is detected
-
