# NEW DESIGNS AND APPLICATIONS FOR INCREASED POWER RECOVERY AND IMPROVED RELIABILITY IN FCC EXPANDERS

**Ben Carbonetto**

**Greg L. Hoch**

**GE CONMEC, Inc.**

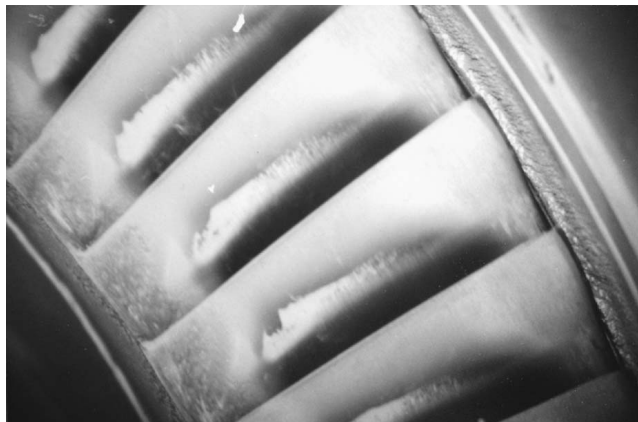
The catalyst fines have another characteristic, called deposition, which limits the expander operation. Deposition occurs when catalyst is mixed with water and other contaminants. A catalyst deposit will build up over time in areas of low flow, such as separated boundary layers. The most problematic area is the shroud above the rotor blades. This deposit can eliminate the blade tip clearance and cause a mechanical rub. A photograph taken with the unit online can be seen in Figure 1. Friction generates significant amounts of heat, sintering the catalyst deposit and potentially overheating the blade base material. Local metal temperatures have been estimated to be in excess of 2000°F (1100°C). In alloys such as Waspaloy®, the local microstructure of the material changes, resulting in increased grain size and reduced mechanical strength of the blade. A tip crack will often form and lead to a loss of a section of airfoil (Figure 2). Material upgrades to Inconel® 738 have eliminated this type of failure due to its increased mechanical strength at higher temperatures.

Figure 1. Online Photograph Showing Shroud Deposit Formation above Rotor Blades.

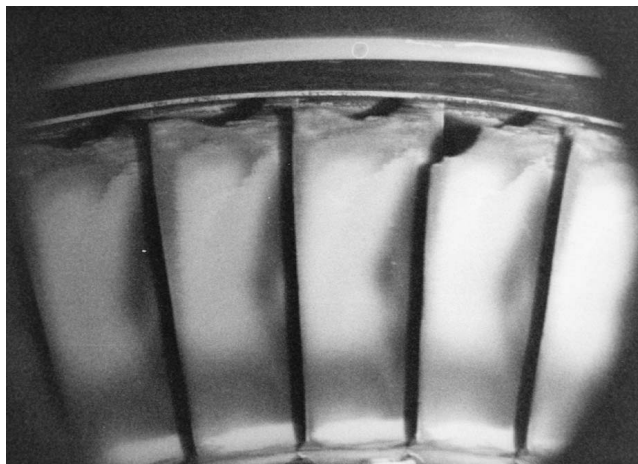
Figure 2. Online Photograph Illustrating Potential Damage Due to Blade Tip Rub with Catalyst Deposit.

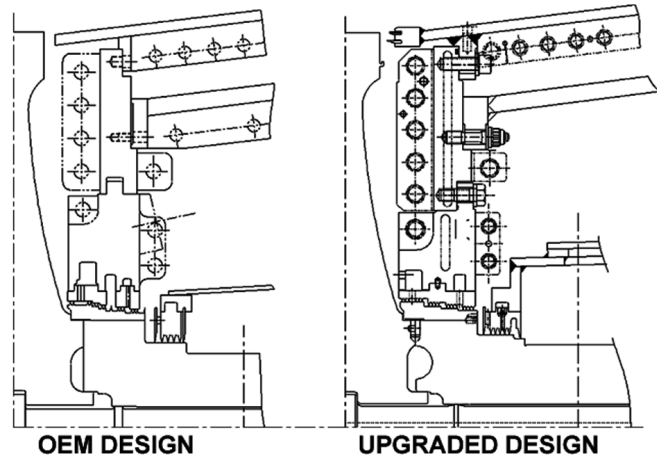
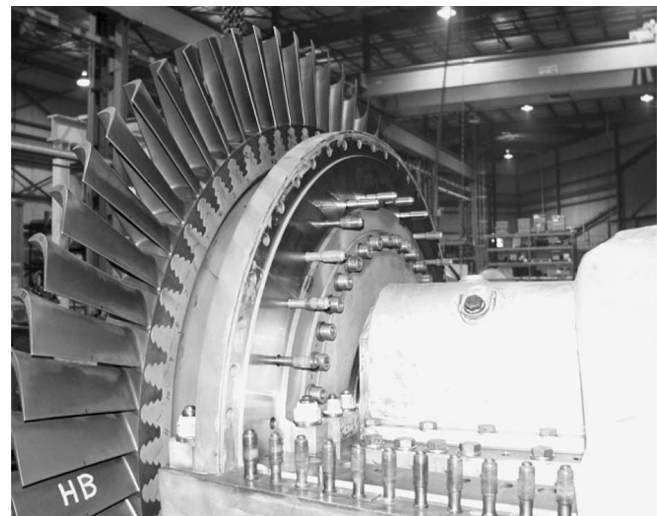
- Flange leakages were common, especially in the seal housing area where the shaft passes through the casing.
- The shaft seal would often rub on startup causing excessive clearances and leaks during normal operation.
- Flowpath erosion, especially on the rotor blades, led to potentially unsafe operation of the unit.
- The bullet portion of the nosecone collapsed on two separate instances. Although this did not affect machine performance, the potential for a catastrophic failure existed.
- The nosecone struts, which support the bullet, were found to be cracked at the leading edge weld at almost every service interval.
- Fasteners on the joints were failing due to stress corrosion cracking. This loss of clamping force led to flange leakages and erosion of the flange faces.
- The exhaust diffuser required weld repairs at each overhaul due to cracking in the weld and base material.

Figure 3. Cross Section of OEM and Upgraded Seal Housing Designs with Photograph of Installed Upgrade.

In May 1995, a replacement unit was installed and commissioned. Each component of the replacement unit was redesigned to overcome the shortcomings of the previous unit, while maintaining the same machine footprint. The seal housing area was redesigned, eliminating the slip joint configuration on the vertical flange and changing it to a bolted joint. Inconel® packing was added to the vertical flanges of the seal housing and seal housing support, as well as all outer casing vertical joints. A comparison of the old and new designs can be seen in Figure 3. The horizontal joint was stiffened and keys were added for improved joint sealing. The new configuration eliminated the seal rubs during the startup cycle.

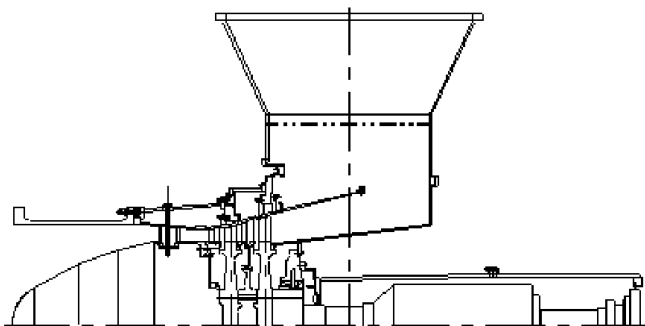
Figure 4. Cross Section of OEM Unit for Corpus Christi.

- The flowpath experienced catalyst deposition that caused blade wear and rotor vibrations.
- The intermediate casing had significant flange leakages and fastener failures during service.
- The interstage purge system was not adequate to maintain a positive purge of the disc seal area.
- The interstage seal area had experienced significant catalyst erosion on the second stage stator inner shroud, the seal diaphragm, honeycomb seals, and rotor disc seal.
- The second stage rotor blades experienced severe secondary erosion.

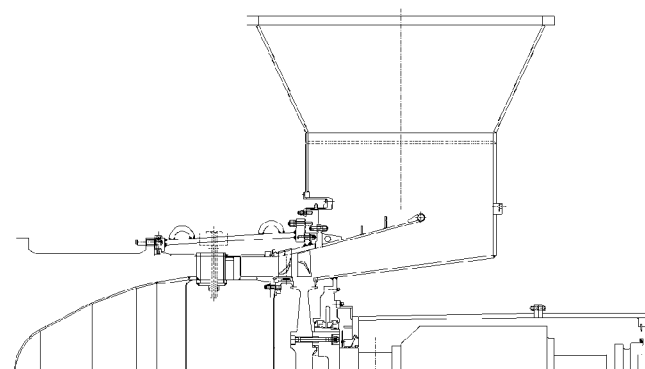
Figure 5. Cross Section of Single-Stage Conversion for Corpus Christi Unit.

The conversion process required a redesign of the intake casing assembly, hot section of the machine, to accommodate for the space created by eliminating a stage, as seen in Figure 5. This was an opportunity to eliminate the casing problems experienced with the intermediate casing, which spans the inlet to exhaust casings. A

new design was developed, which manufactured the entire intake casing assembly with a single outer casing. This eliminated a set of flanges and the potential for leaks. The casing stiffness was also increased to accommodate increased piping loads that may occur during operation. The single piece casing utilizes heavier flanges for increase rigidity and improved sealing. Fasteners were upgraded in size, quantity, and material of construction as was described in the Pembroke case. The expander was inspected for the first time four years later when the FCC unit was shutdown for other repairs in 1999. Because of the expander's good condition, it remained in service until the FCC major turnaround in March 2001. The expander overhaul cycle was increased from two years to 5.4 years.

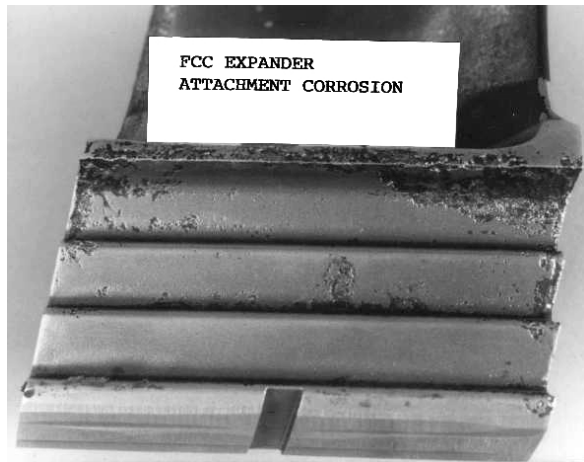
The first rotor blade failure investigation determined the root cause to be sulfidation in the blade attachment area. The flue gas, feedstock, catalyst, and operating conditions of the expander were examined. The flue gas was found to have low levels of oxygen and significant levels of carbon monoxide, which can create a reducing environment. This environment, along with sulfur from the feedstock, allows for the formation of nickel sulfide. Sulfidation attack of the base metal occurs in the fillet radii of the blade attachment. An example of this type of attack can be seen in Figure 6. Each corrosion pit creates a stress riser and can accelerate fatigue crack initiation or propagation rates.

Figure 6. Blade Attachment Damage Due to Corrosion.

In 1994, the redesigned flowpath was optimized with CFD using the existing airfoil shapes and a new nosecone. These components were manufactured and commissioned in October 1995 into the

OEM machine. The new nosecone was not only more aerodynamically designed, but also included a change in the quantity of nosecone struts to prevent a potential interference with the rotor blade natural frequencies. Improvements in the cooling system were implemented to change the local environment around the blade attachment area, reducing the potential for sulfidation to occur. The third stage separator was overhauled as well to prevent excessive catalyst carryover to the expander. The expander provided service until its scheduled outage in September 1999, when the spare rotor was installed. The next scheduled outage is fall of 2003. The redesigned expander allowed for an increased time between overhauls from an average of 1.5 years to 3.9 years.

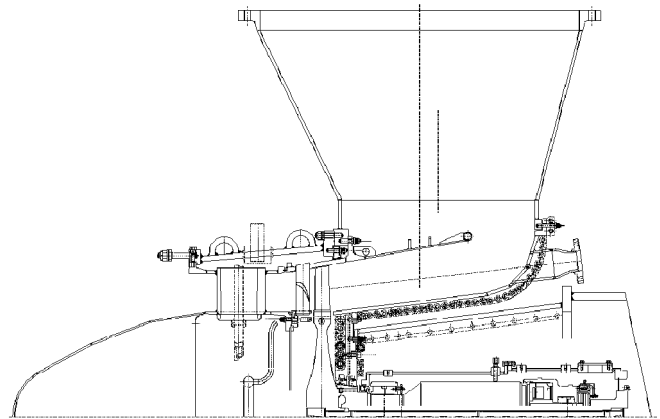
Visual inspection of the expander, following the shutdown, revealed a collapsed nosecone bullet and six missing nosecone baffle plate retainers. Due to their location in the machine and the

observed damage to the stator/rotor, it was suspected that the retainers traveled through the gas path. Additionally, three or four stator vane passages were blocked with a wire mesh material that entered the gas path from a failed expansion joint in the upstream process piping.

Examination of the failed blade suggests that the initial cracking was a result of high-cycle fatigue initiating from a notch in the leading edge of the airfoil. The notch most likely resulted from impact with the baffle plate retainers. While the notch provided a site for initiation of the crack, the high level of forced excitation created by the blocked stator openings and the collapsed nose cone ultimately caused the blade to fail in a fatigue mode.

Figure 7. New Expander for Torrance Refinery.

In March 1997, a replacement expander was commissioned. The new expander was built with the proven design principles and improvements developed for previous units (Figure 7). These improvements included:

- A single intake casing.
- Increased thickness on the nosecone bullet, aerodynamic strut designs, and elimination of the bolted retaining clips for the baffle plate.

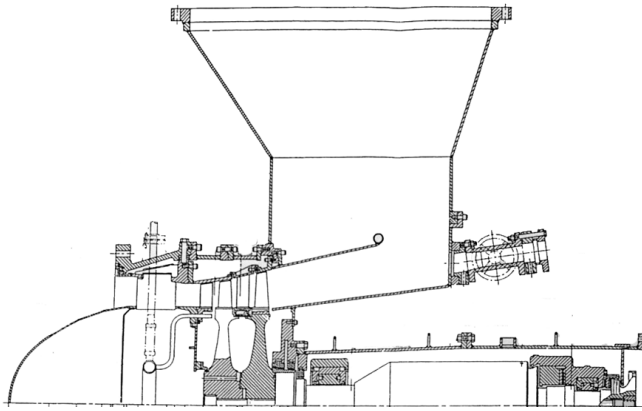
expander designed by the original OEM was commissioned in December 1995. A machine cross-section can be seen in Figure 11. The unit experienced heavy flowpath erosion and catalyst deposition that caused blade wear and rotor vibrations, forcing an unscheduled shutdown in November 1996. By May of 1997, rotor vibrations had again increased and the unit was forced to shutdown due to excessive rotor blade erosion. The expander experienced a high vibration shutdown in August 1997 and again in October 1997. At that point the OEM redesigned the interstage seal and disc cooling systems and brought the unit back online in June 1999. During the heat-up cycle, the expander rotor vibration levels increased due to mechanical rubs and were taken offline. Since January 2000, the expander operated at partial load, producing only 30 percent of its rated power, due to increasing vibration levels with expander load. The decision was made to operate the expander at 30 percent load until the next scheduled outage in April 2001. Applying the design developed for the multistage unit in Corpus Christi, Texas, a single-stage conversion was performed and a new intake casing assembly was manufactured. A cross-section of the converted unit can be seen in Figure 12. The intake casing assembly uses the latest one piece intake casing design, integral stator/shroud, and improved nosecone

Figure 11. OEM Two-Stage Expander Design for Yosu.

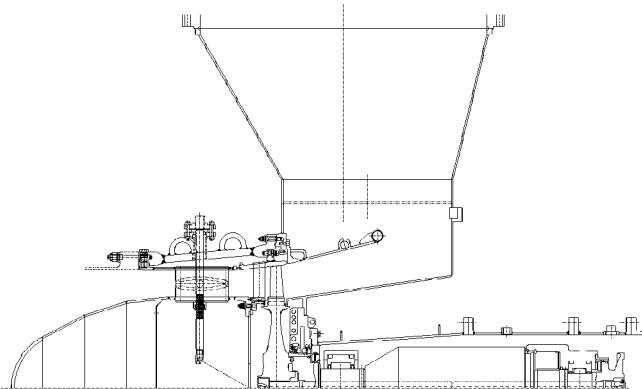
Figure 12. Single-Stage Conversion for Yosu.

design. The existing two-stage rotor was disassembled and reassembled as a single stage. New rotor blades of upgraded metallurgy, Inconel® 738, were installed for increased erosion resistance. The redesigned expander was commissioned in May 2001. At full capacity and power, the rotor vibrations are below 0.7 mils (18  $\mu$ m). At the time of this publication, the expander had almost a year of operation. Prior to the conversion to a single stage, the expander averaged less than 150 days between unscheduled shutdowns. The next scheduled shutdown is Spring of 2003.
