# PRACTICAL USE OF ROTORDYNAMIC ANALYSIS AND TROUBLESHOOTING SKILLS TO CORRECT A LONG-TERM SYNCHRONOUS VIBRATION PROBLEM IN AN OVERHUNG TURBOBLOWER

The case to be discussed involves two 3000 hp motor-driven overhung turboblowers of titanium construction, manufactured by Robinson Industries, Inc., shown in Figure 1. The two subject blowers, units “A” and “B,” are nominally identical and are located adjacent to one another. Operated in parallel, they are used to provide wet chlorine gas to a critical process at a large chemical plant in the southwestern United States. Both blowers run at a constant speed of 1780 rpm.

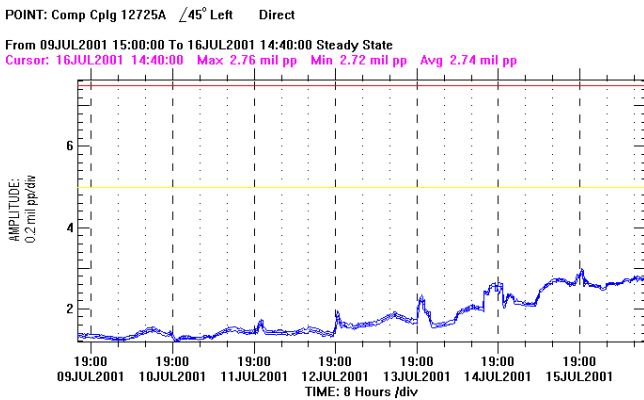
The authors felt that the rubbing theory had a lot of potential for several reasons. First, in machines suffering from rub-induced vibrations, the high vibrations tend to appear and disappear in an unpredictable fashion. This blower is nothing if not unpredictable. Second, rub-induced vibrations do not tend to build up gradually—they tend to appear and disappear instantaneously, similar to this machine’s vibrations (Figure 3). Third, the dependence of the high vibrations on time and weather conditions (i.e., rainstorms) would make sense since the rubs would most likely only occur under certain thermal conditions. Finally, rubs are probably the most well-known cause of reverse precessions in rotating equipment, and there were unconfirmed “reports” that reverse precessions had occasionally been observed on this machine.

Figure 3. Vibration Amplitude Versus Time.

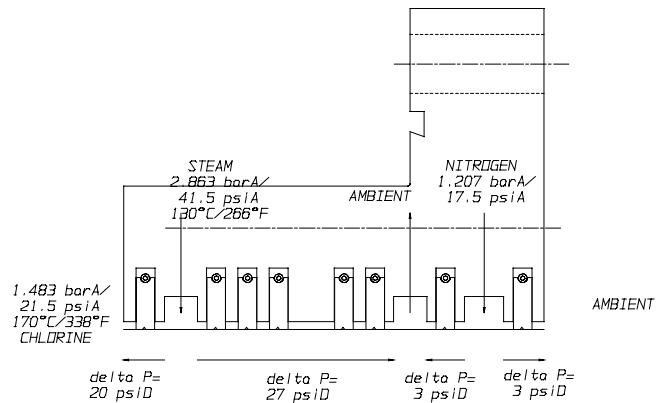
A detailed analysis of the carbon-ring shaft seal, which is shown in Figure 4, was performed by a third party. They recommended

Figure 4. Eight-Stage Carbon-Ring Shaft Seal (Purged).

some slight modifications of the sealing faces of the carbon seal rings to reduce the side pressure loading. This was done to allow the carbon rings to more easily adjust to rotating shaft position changes. However, they concluded that, when properly installed, the carbon ring seal did not seem to have any inherent design characteristics that would lead to the intermittent vibration problem observed.

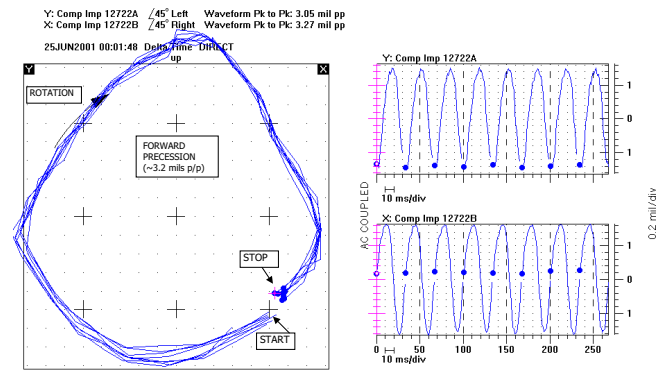
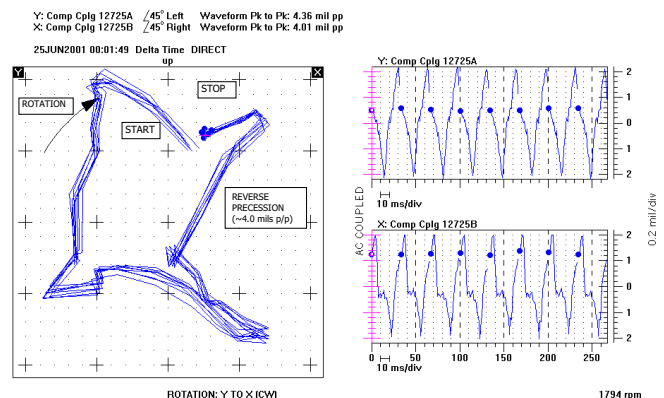
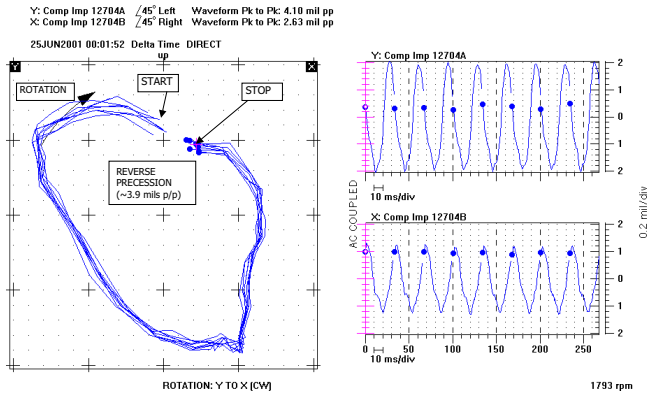
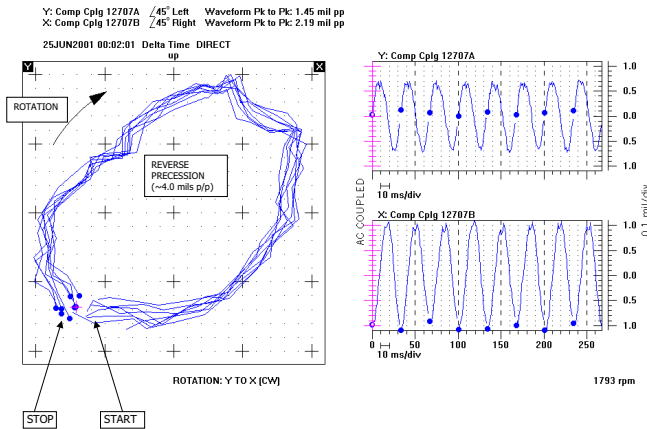
Shortly thereafter, shaft orbit plots during operation at “normal” and “high” vibration periods were finally collected (Figures 5, 6, 7, and 8). Inspection of these figures reveals clear evidence of both forward and reverse precession. Accordingly, in spite of the third party’s findings, the authors continued to consider carbon seal rubbing as a primary candidate for the cause of this problem.

- The orbit plots show that both the "A" and "B" blowers are whirling in the backward direction during periods of high vibration. The only practical mechanism that can cause backward whirling is a rub.

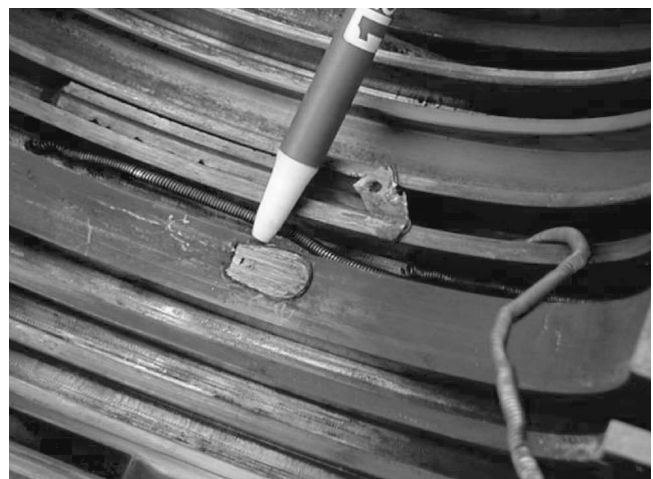
After review of this report, the user shut down one of the blowers and the carbon ring shaft seal was carefully inspected. In three places, titanium antirotation detent plates (that prevent the carbon rings from rotating) were found to have come loose. These titanium parts were galled to the seal housing and rubbing on the rotating shaft sleeve, even to the point of causing a buildup of material on the shaft sleeve in two places (Figures 9 and 10).

Figure 9. Antirotation Tab "Smeared" onto Seal Housing.

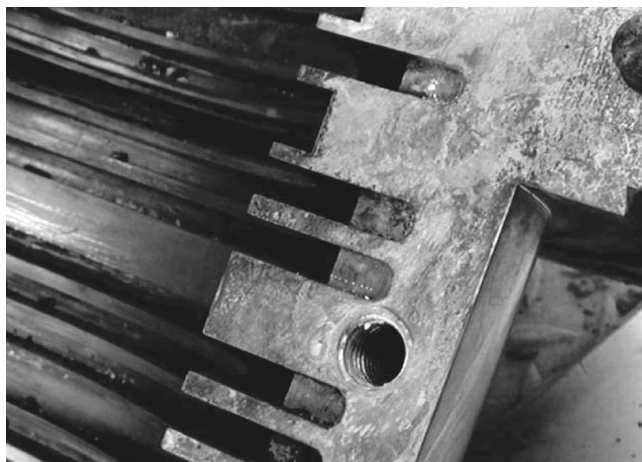
Figure 10. Seal with Slots for Antirotation Tabs.
