TWO UNUSUAL AND CATASTROPHIC BEARING FAILURES CAUSED BY ELECTRICAL ARCING IN THE OIL FILM, THEIR CAUSES, AND THE SURPRISINGLY SIMPLE SOLUTIONS THAT CURED THEM

Jigger Jumonville

Erik Rasmussen

ABSTRACT

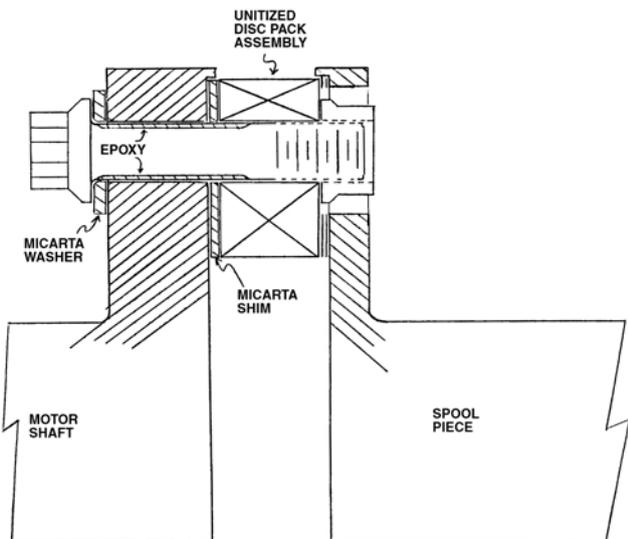
Whenever there is an electric motor or generator in the train, one of the first places to look for the source of stray electrical currents is from this component. Discussions with the plant electrical personnel and the consultants concluded that it was worth converting the motor-to-pinion coupling to an electrically insulated coupling so that any stray currents from the motor could not enter the pinion shaft. It was the consultants' opinion that the motor was the most likely source of the problem, and that an insulated coupling had a high probability of fixing it. A late night of redesign engineering and some calls around sunrise to local machine shops produced an insulated coupling in time for the startup (Figure 1, the original sketch from 1989). The design was marginal, in that the resin impregnated material used to insulate the shoulder of the bolts was not of sufficient strength to withstand the full bolt torque, according to the calculations. A quick test in the shop confirmed this. Calculations were then made for reduced torque, and it was decided that the coupling would be safe enough for a trial run, but that if it were successful, stronger materials would have to be installed. When the unit was eventually restarted with this coupling, all unnecessary personnel were removed from the area, and safe zones were established for those that were required to be in the area. The calculations proved correct, and the coupling worked flawlessly during the trial running.

Figure 1. Original Coupling Modification Sketch to Form Electrical Insulating Barrier.

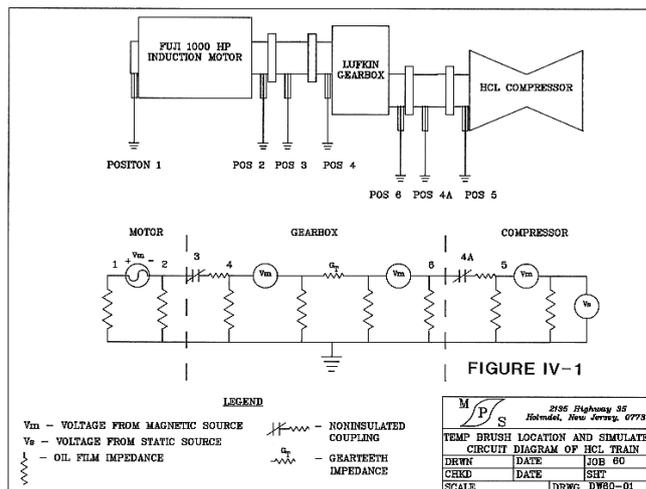
Prior to the consultants' arrival on site, a ground brush was installed on the high-speed pinion shaft. This did not seem to help, since the machine failed again, even with this brush installed. The consultants recommended that shaft voltage and current readings should be taken at all available access points while the machine was in operation. A plan was developed whereby the electric motor would be run alone, then the gearbox would be coupled (using the insulated coupling), and finally the entire train would be run. Shaft voltage and current were measured at each step. Figure 2 shows the locations of these temporary brushes.

Figure 2. Temporary Grounding Brush Locations.

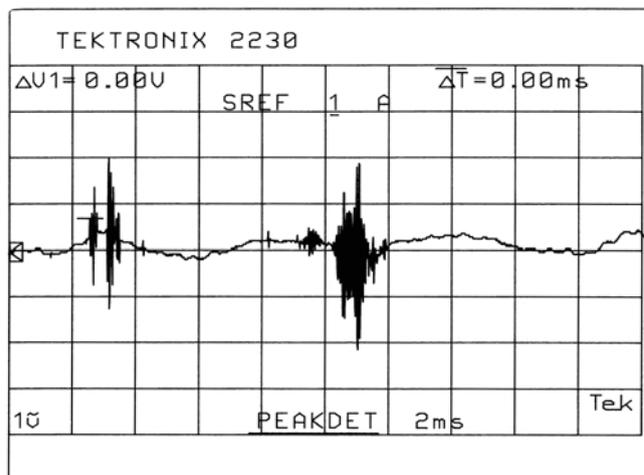
A sample of the data taken is included as Figure 3. The things learned from this effort:

- Shaft voltages and currents of meaningful levels were measured, and "spikes" were observed.
- There were no accessible points at which grounding was effective at stopping the damage. The conclusion from this was that the path of the electrical circuit that was causing the arcing was

Figure 3. Electrical Discharge Spikes from Grounding Brush.

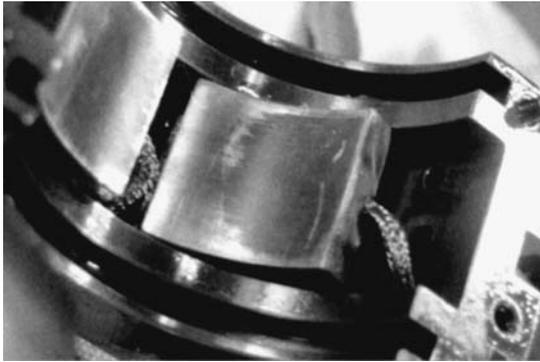
The restart of the unit occurred with fresh VG-32 turbine oil. In a relatively short period of time, it was determined that the oil pH was dropping. When the oil pH dropped to about five, we began to notice that the bearing temperatures for the gearbox pinion bearing started to increase. A sample of the lube oil was taken to the lab to experiment with how much oil would have to be drained from the reservoir and replaced with fresh oil to raise the pH high enough to see if the bearing temperatures would stop rising. The results indicated it could be done without risking the machine, so the pH was raised and the bearing temperatures stabilized! Note that the bearing temperatures did *not* return to normal, they simply stopped rising. It was later determined by shutting down the train *before* it failed completely that the electrical arcing at the trailing edge of the pads was slowly changing the pad curvature from a positive preload to a negative preload, thus causing the temperatures to rise over time in relation to the amount of material removed from the trailing edge of the bearing (Figures 4, 5, and 6).

Figure 4. Arcing Damage to Loaded Pad Prior to Total Failure.

ash” oil, as opposed to something like an engine oil, which has a higher ash content to absorb the acid formed during combustion. Ash is one of the items in oil that helps it to absorb acid. It acts somewhat like a buffer, allowing acids to be absorbed into the oil with minimal adverse effects. Higher ash oil was rushed to the site, allowing the unit to continue operation.

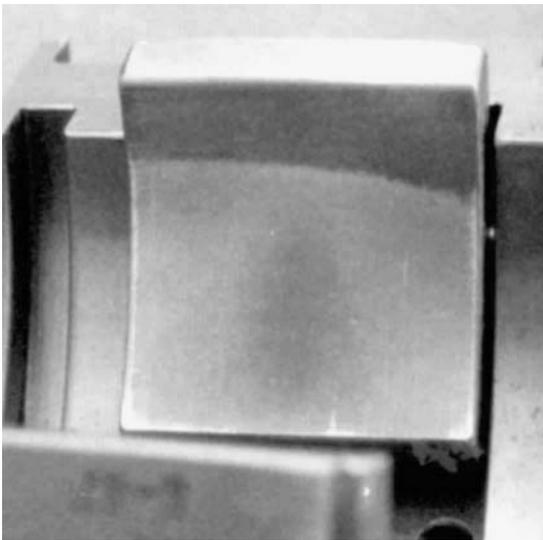
Figure 5. Arcing Damage to Partially Loaded Pad Prior to Total Failure.

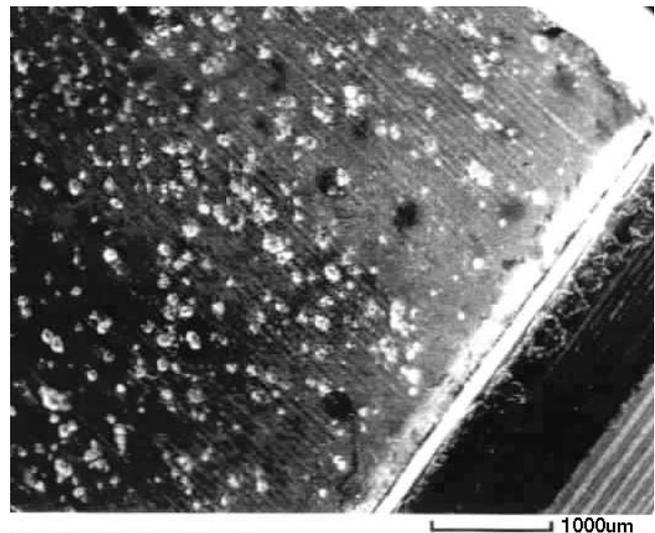
This unit is located on an offshore platform in the North Sea, as shown in Figures 7 and 8. The turboexpander is designed to produce about 3000 hp (2240 kW) at a speed of about 12,500 rpm. Very soon after startup, it was noticed that the bearings were experiencing rapid failures. Initial operating life ranged from a few weeks to a few months. All bearing failures exhibited signs of electrical arcing in the oil film. Magnified views of this arcing are shown in Figures 9, 10, and 11.

Figure 9. Pits on Babbitt Surface.

Initial tests were encouraging, and a field trial was started. Plant personnel routinely performed conductivity checks of the oil in the reservoir. These results were also very encouraging. Months have turned into years, and enough time has elapsed to declare the solution a success. Additional additive is periodically required to maintain the correct conductivity, however the additive is relatively inexpensive and does not seem to cause any other harm in the turboexpander or filter system. The turboexpander has been free of electrical arcing in the bearings since the addition of the conducting additive several years ago. Details of the type and quantity of additive can be found in the APPENDIX.

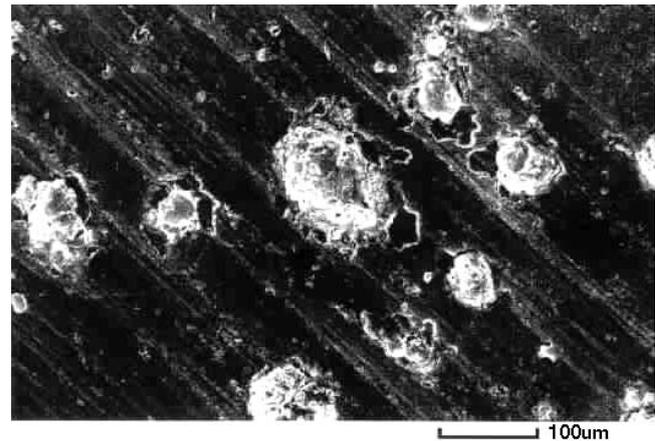
Figure 10. Enlarged Picture of Pits on Babbitt Surface.

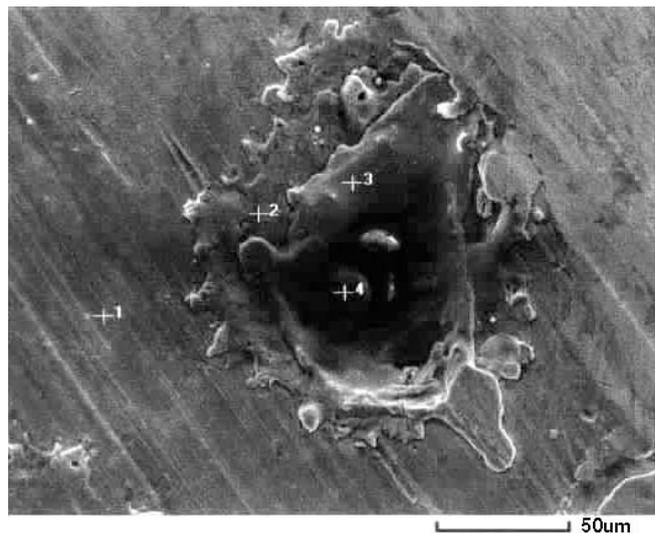
Figure 11. Enlarged Picture of Single Pit Showing Melted Surface of Pit.

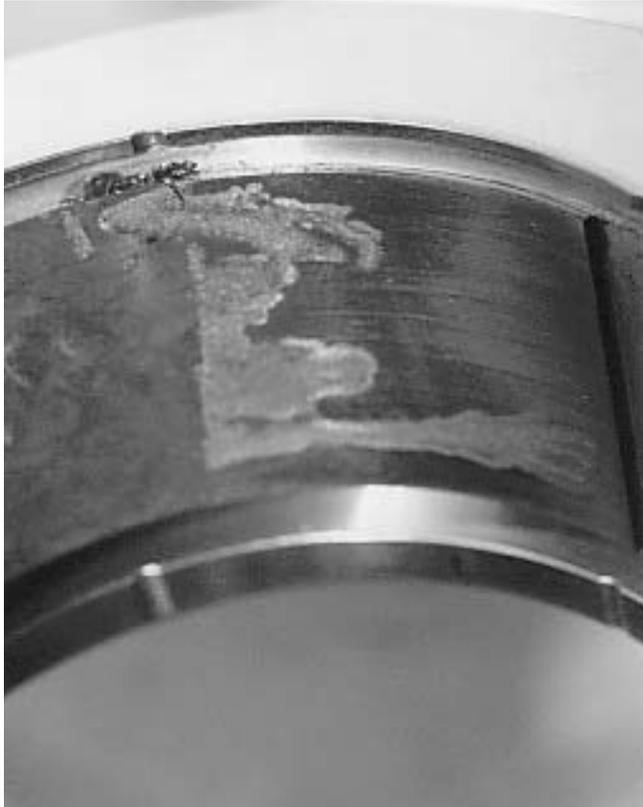
Unfortunately, the consultant found very little that could explain the failures being observed in this application. All components were checked, and any areas that seemed suspicious were degaussed to bring them to acceptable levels of magnetism. Figure 13 shows the shaft being degaussed, and Figure 14 shows the bearing housing being degaussed. The machine was put back together and restarted. Within a short time, the bearings failed again due to arcing in the oil film (Figures 15, 16, and 17).

Figure 15. Bearing Surface Showing Bearing Damage Due to Pitting.

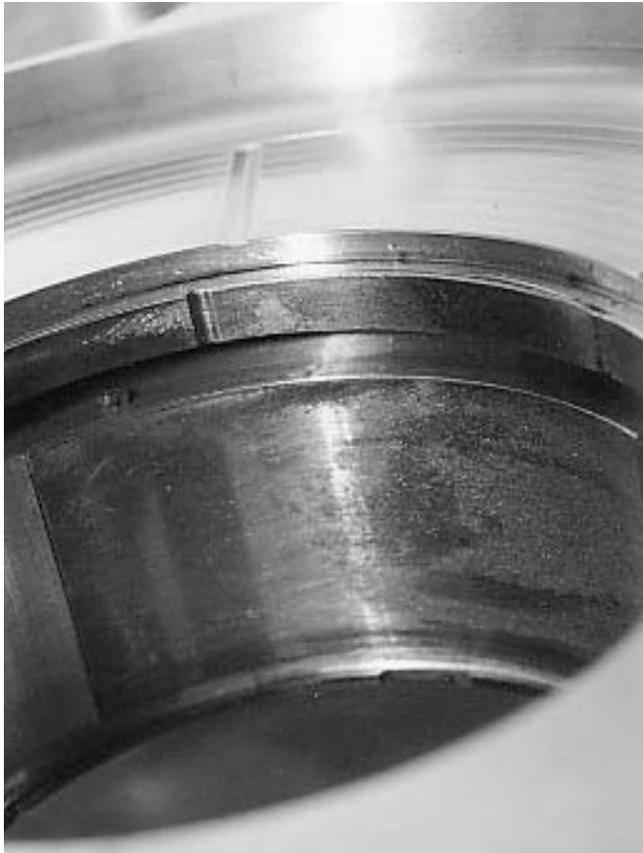
Figure 16. Bearing Surface Showing Pitting Damage.

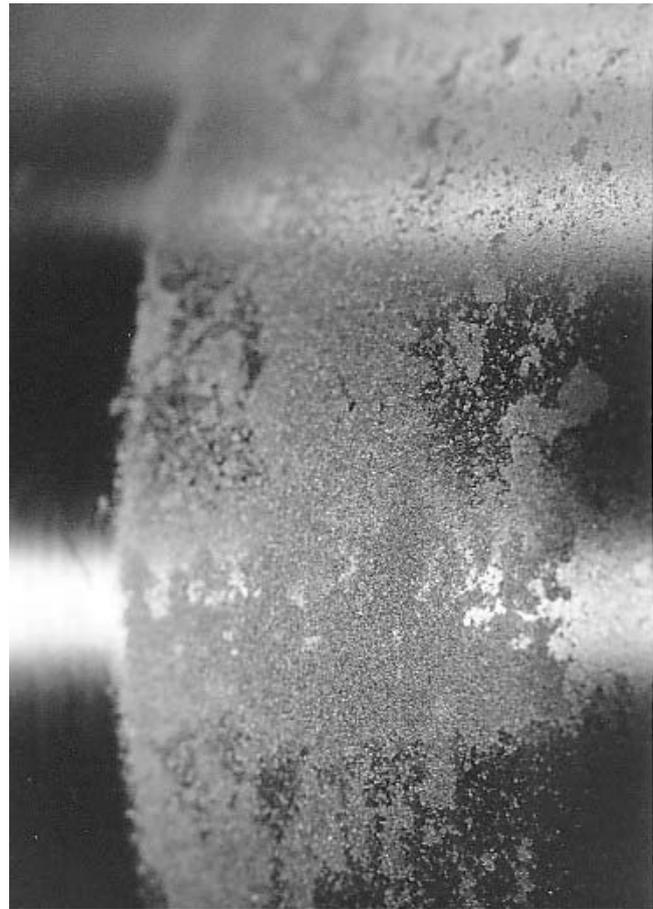
Figure 17. Shaft Journal Surface Showing Both Pitting and Deposition of Babbitt from Bearing to Shaft.
