INFLUENCE OF PREVIOUS OPERATIONAL CYCLE ON THE MICROSTRUCTURE OF REJUVENATED NI-BASE SUPERALLOY GAS TURBINE BLADES AFTER THEIR RETURN TO SERVICE

Preco Turbine & Compressor Services, Inc.

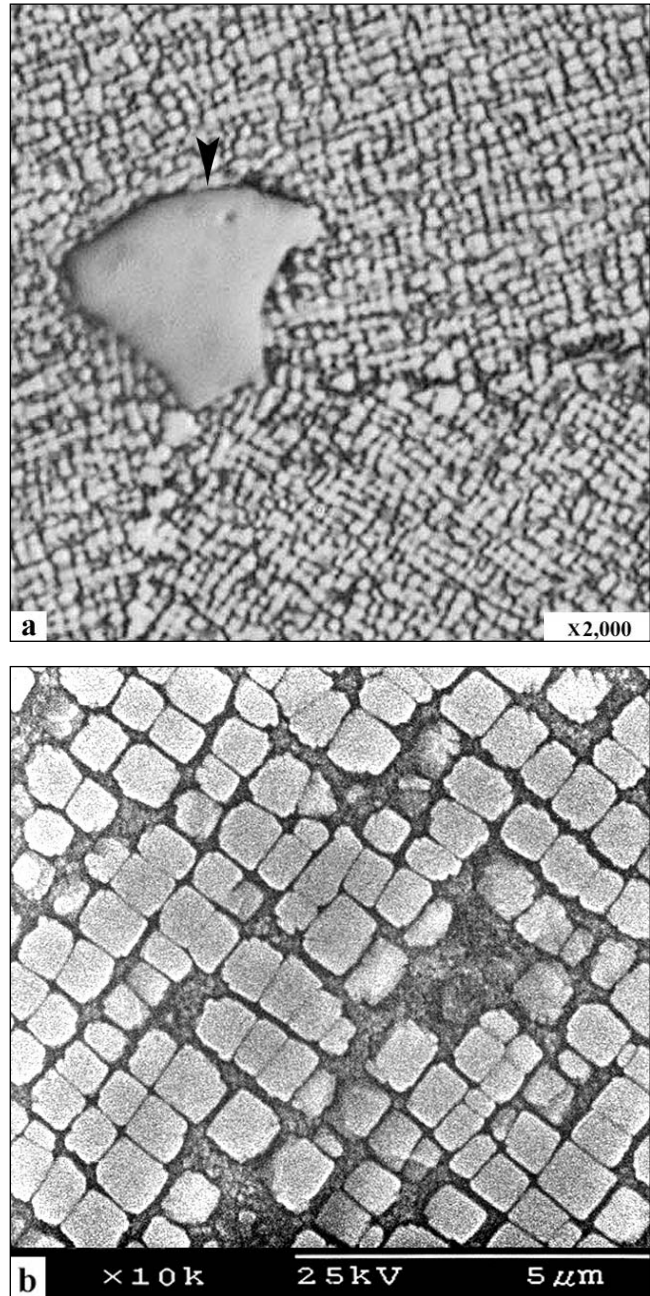
The microstructure of the shank specimens of Blade 1 and Blade 2 is presented in Figure 2 and Figure 3, respectively (the microstructure of the Blade 3 and Blade 4 shank specimens is very similar to that of Blade 2). The shank microstructure is typical for a virgin cast superalloy: γ -phase exists in three distinctive morphologies—eutectic lamellar γ formed between dendrite arms, primary cuboidal γ (average side size 0.7 μ m in GTD-111 and 0.4 μ m in IN-738), and very fine secondary spheroidal γ ; primary MC carbides formed at the grain boundaries and in the interdendritic areas; fine globular secondary M₂₃C₆ carbides decorated the grain boundaries.

Figure 2. Microstructure of Blade 1 Shank Specimen in the As-Received Condition. ((a) Optical micrograph; (b) SEM micrograph. Arrowhead indicates primary MC carbide. (Etchant—electrolytic chromic acid))

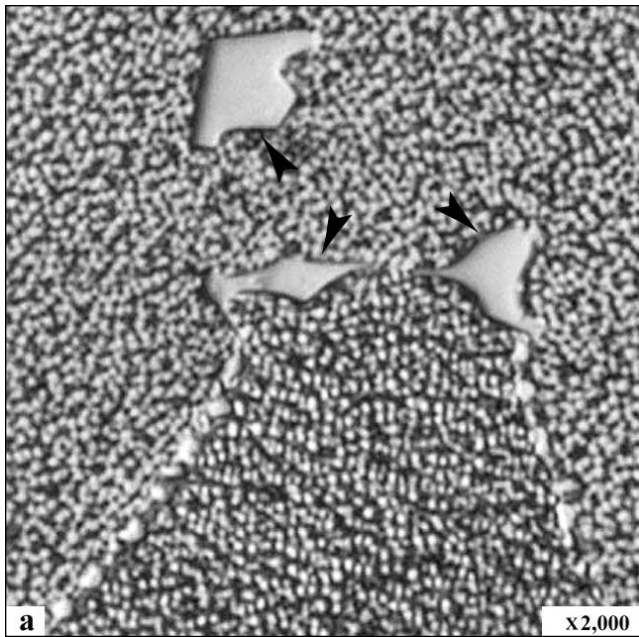
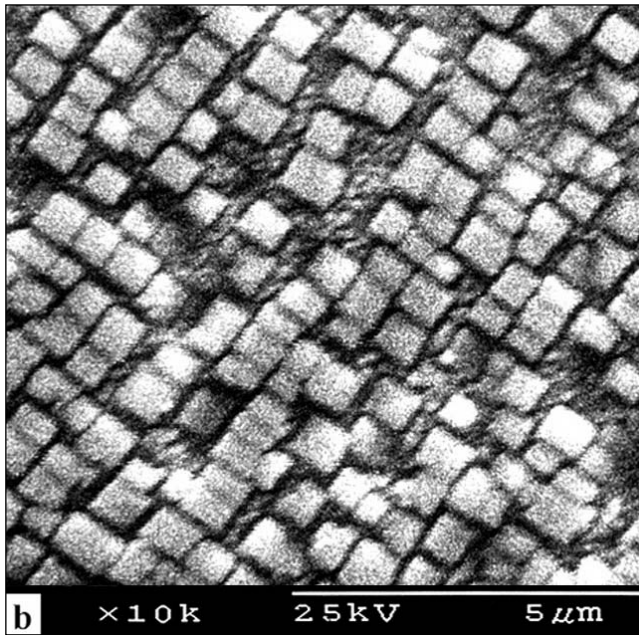
Figure 3. Microstructure of Blade 2 Shank Specimen in the As-Received Condition. ((a) Optical micrograph; (b) SEM micrograph. Arrowheads indicate primary MC carbide. (Etchant—electrolytic chromic acid))

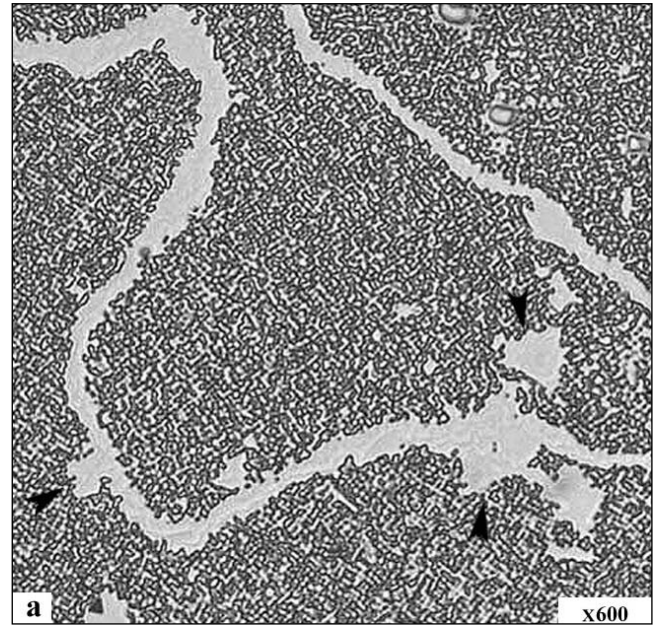
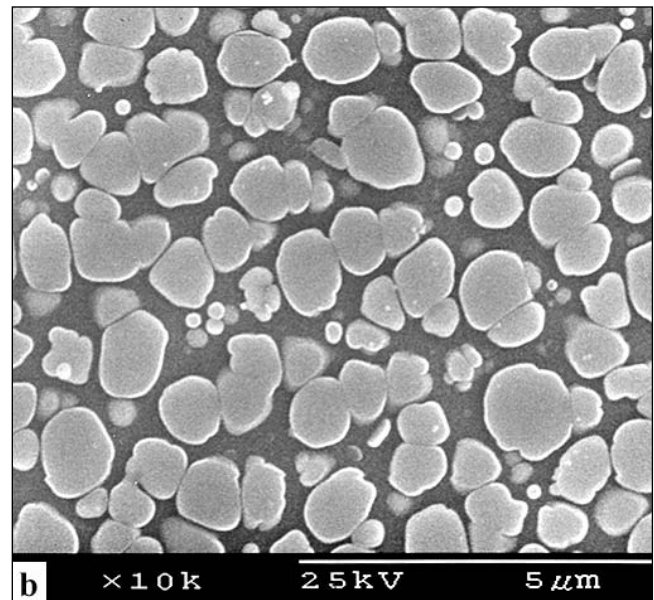
The micrographs of the Blade 1 and Blade 2 leading edge specimens at one-half airfoil height are presented in Figure 4 and Figure 5, respectively (the microstructure of the Blade 3 and Blade 4 leading edge specimens is very similar to that of Blade 2). Service-induced changes in the leading edge microstructure compared to that of the shank are significant and typical for service-exposed gas turbine blades. The micrographs revealed severe overaging induced by thermal and stress exposure during service. The cuboidal primary γ precipitates rounded and coarsened considerably at the expense of the secondary γ , their diameter ranges from 0.8 μ m to 1.5 μ m in GTD-111 and from 0.6 μ m to 1.3 μ m in IN-738. The grain-boundary M₂₃C₆ carbide particles coarsened and coalesced, overloading the grain boundaries and forming continuous films at some areas; primary MC carbides degenerated losing their sharp edges.

Figure 4. Microstructure of the Blade 1 Leading Edge Specimen in the As-Received Condition. ((a) Optical micrograph; (b) SEM micrograph. Arrowheads indicate degenerated primary MC carbides. (Etchant—electrolytic chromic acid))

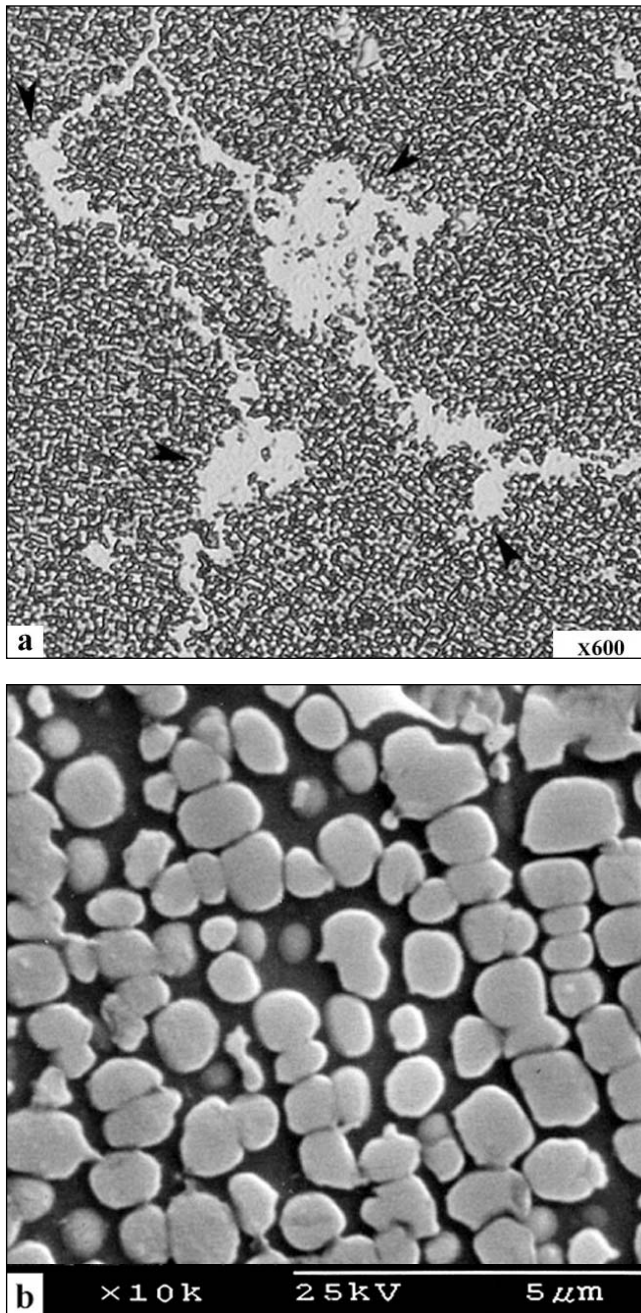
Figure 5. Microstructure of the Blade 2 Leading Edge Specimen in the As-Received Condition. ((a) Optical micrograph; (b) SEM micrograph. Arrowheads indicate degenerated primary MC carbides. (Etchant–electrolytic chromic acid))

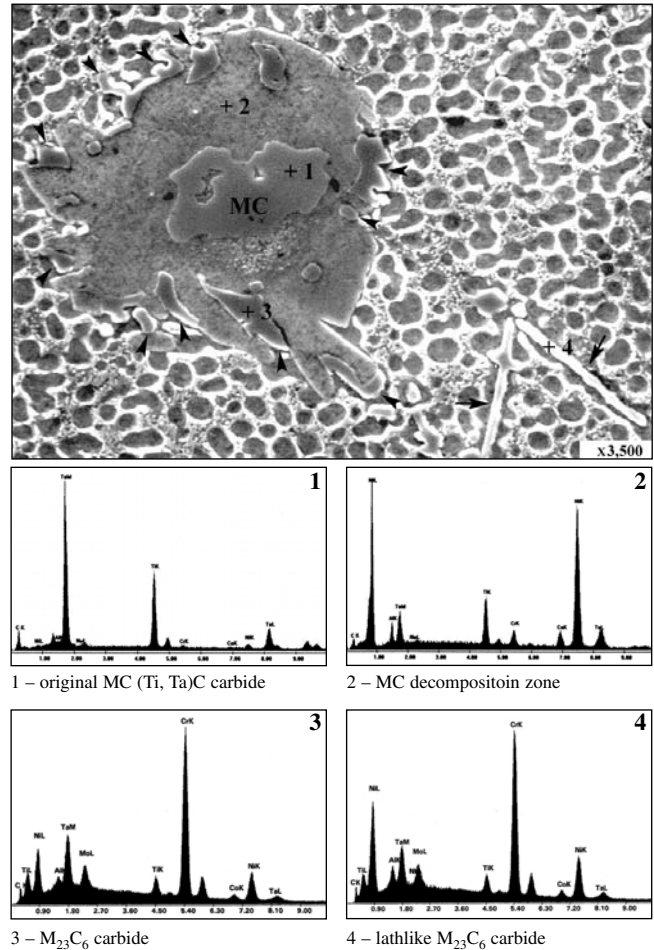
Figures 6, 7, 8, and 9. It can be noted that MC decomposition results in a considerable reduction of its size and a formation of numerous $M_{23}C_6$ carbides at the edges of the original MC carbides. $M_{23}C_6$ carbides formed also in the lathlike morphology at the MC periphery as well as in the grain interiors, which was confirmed by EDS analyses. The diminished core of the degenerated MC carbide is surrounded by a smooth-looking substance being a product of MC decomposition along with $M_{23}C_6$ carbides (Figures 6 and 7). EDS analyses revealed the composition of the primary MC carbides as (Ti, Ta, Mo, Ni, Cr)C in GTD-111 alloy and (Ti, Ta, Nb, Mo, Ni, Cr)C in IN-738 alloy (Figures 8 and 9). The replacement of the strong carbide forming atoms such as Ti, Ta, and Nb, with Mo, Ni, and Cr atoms, is known to weaken the interatomic bonds in the MC carbides resulting in a decrease of their stability. This leads to the MC decomposition with a formation of more stable $M_{23}C_6$ -type carbides.

Figure 6. SEM Micrograph and EDX Spectra of the Degenerated MC Carbide in the Blade 1 Leading Edge Specimen in the As-Received Condition. ($M_{23}C_6$ carbides formed at the edges of the original MC carbide (arrowheads). $M_{23}C_6$ carbides precipitated also in the lathlike morphology (arrows). Energy-dispersive X-ray spectra from marked locations in the micrograph are shown. (Etchant–Kalling's reagent))

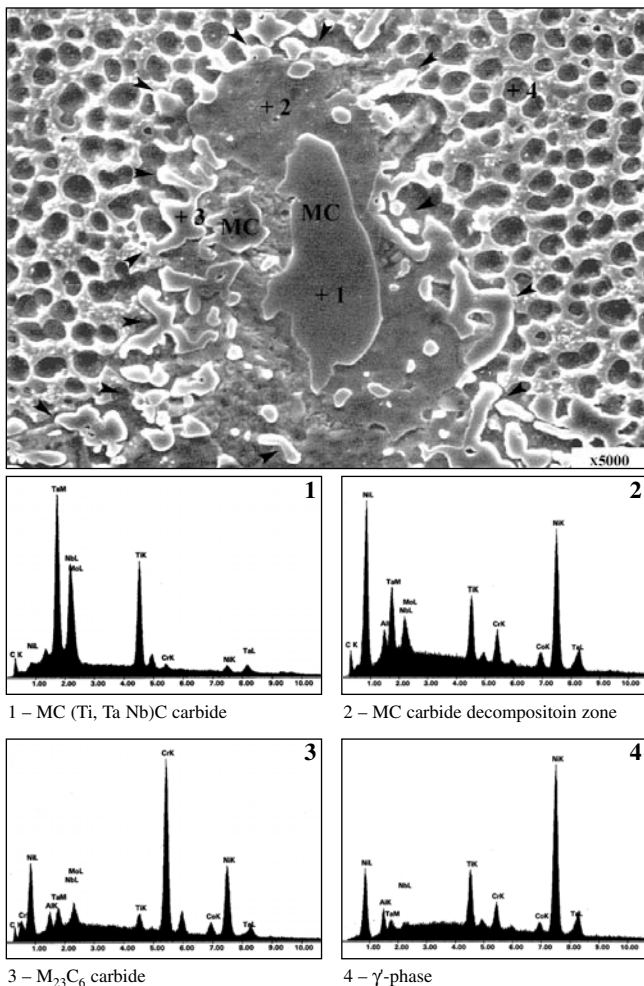
The MC carbide decomposition reaction was reported to be $MC + \gamma \rightarrow M_{23}C_6 + \gamma$ (Maccagno, et al., 1989; Ross and Sims, 1984; Castillo and Koul, 1986; Koul and Castillo, 1994). $M_{23}C_6$ carbides form at the periphery of the original MC carbides, and the area adjacent the MC core is supposed to consist of γ -phase. The EDX spectra of the decomposition zone surrounding degenerated MC carbides in the service-exposed Blade 1 and Blade 2 leading edge specimens, given in Figures 6 and 7, did not confirm this assumption. These spectra demonstrate a presence of a substantial amount of carbon, which indicates that the phase from which they were taken cannot be γ . The comparison of the spectrum from the γ -particle with that from the MC decomposition zone in Figure 7 illustrates the difference.

Figure 7. SEM Micrograph and EDX Spectra of the Degenerated MC Carbide in the Blade 2 Leading Edge Specimen in the As-Received Condition. ($M_{23}C_6$ carbides formed at the edges of the original MC carbide (arrowheads). Arrowheads indicate $M_{23}C_6$ carbides formed at the edges of the original MC carbides as a result of MC decomposition. Energy-dispersive X-ray spectra from marked locations in the micrograph are shown. (Etchant-Kalling's reagent))

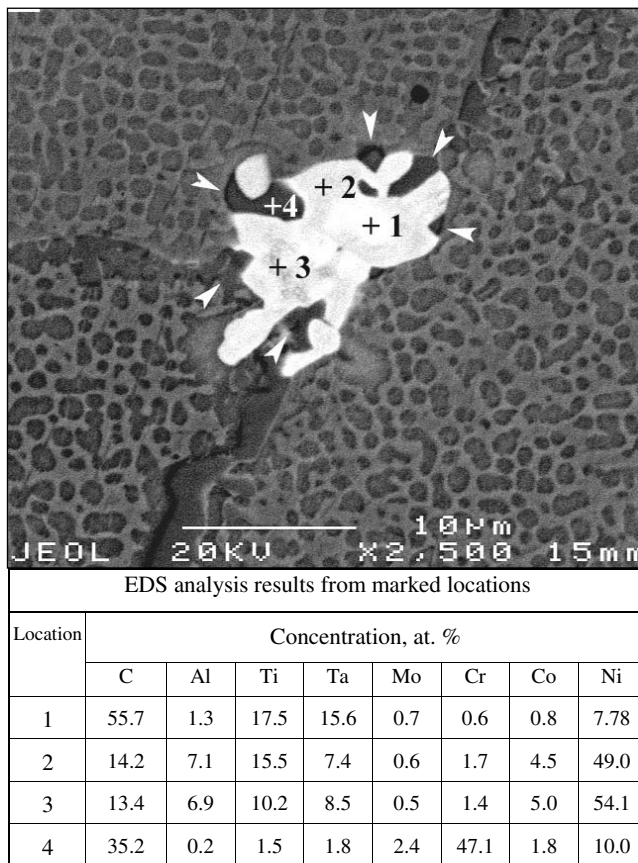
Figure 8. SEM-BEI Micrograph of the Degenerated MC Carbide in the Blade 1 Leading Edge Specimen in the As-Received Condition. ($M_{23}C_6$ carbides (arrowheads) formed at the periphery of original MC carbide as a result of the MC decomposition. EDS analysis data from marked locations are shown in the table. (As-polished))

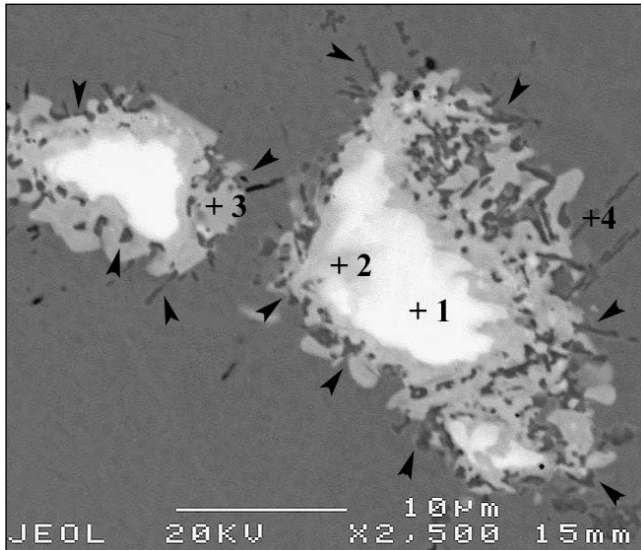
Figure 9. SEM-BEI Micrograph of the Degenerated MC Carbides in the Blade 2 Leading Edge Specimen in the As-Received Condition. ($M_{23}C_6$ carbides (arrowheads) formed at the periphery of original MC carbides as a result of the MC decomposition. EDS analysis data from marked locations are shown in the table. (As-polished))

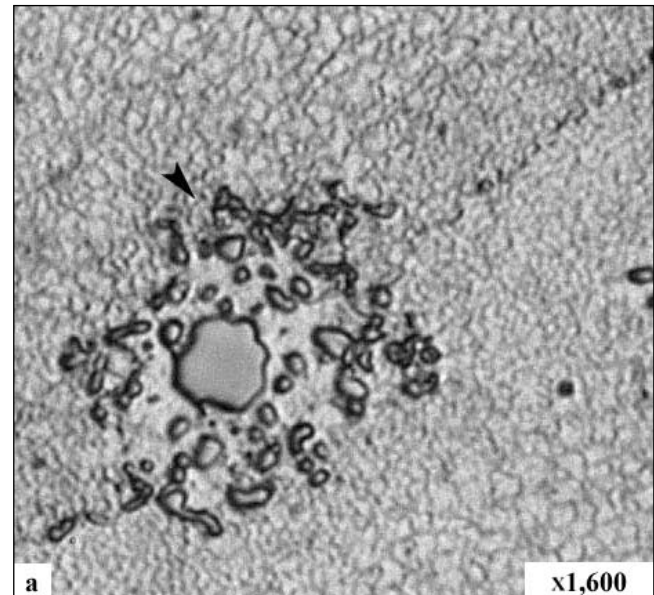
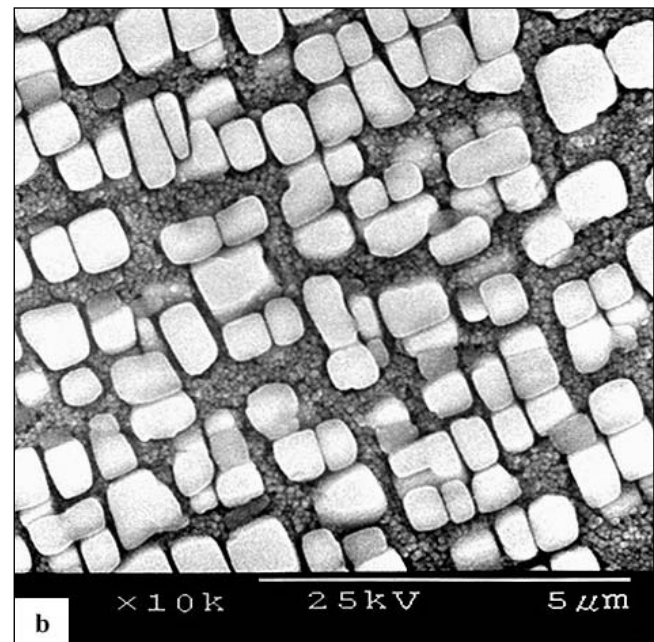
The improvement of the material properties was a result of the restoration of the airfoil microstructure. The micrographs in Figures 11 and 12 reveal the elimination of the excessive grain-boundary carbide precipitation, and the refinement of the primary and secondary γ particles. The morphology of the primary γ particles is cuboidal, with the average side size $0.6 \mu\text{m}$ in GTD-111 and $0.4 \mu\text{m}$ in IN-738. The microstructure of the rejuvenated leading edge specimens looks similar to that of the shank in the as-received condition, except for primary MC carbide morphology: instead of large blocky particles with sharp edges, there are fragments of the original primary carbides present (Figures 11a and 12a). The products of the MC carbide decomposition ($M_{23}C_6$ carbides and low-carbon degenerated portions of MC carbides) were dissolved in γ -solid solution during

Figure 11. Micrographs of the Blade 1 Leading Edge Specimen After Rejuvenation. ((a) Optical micrograph; (b) SEM micrograph. Arrowhead indicates disintegrated primary MC carbide. (Etchants: (a) Kalling's reagent; (b) Electrolytic chromic acid.))

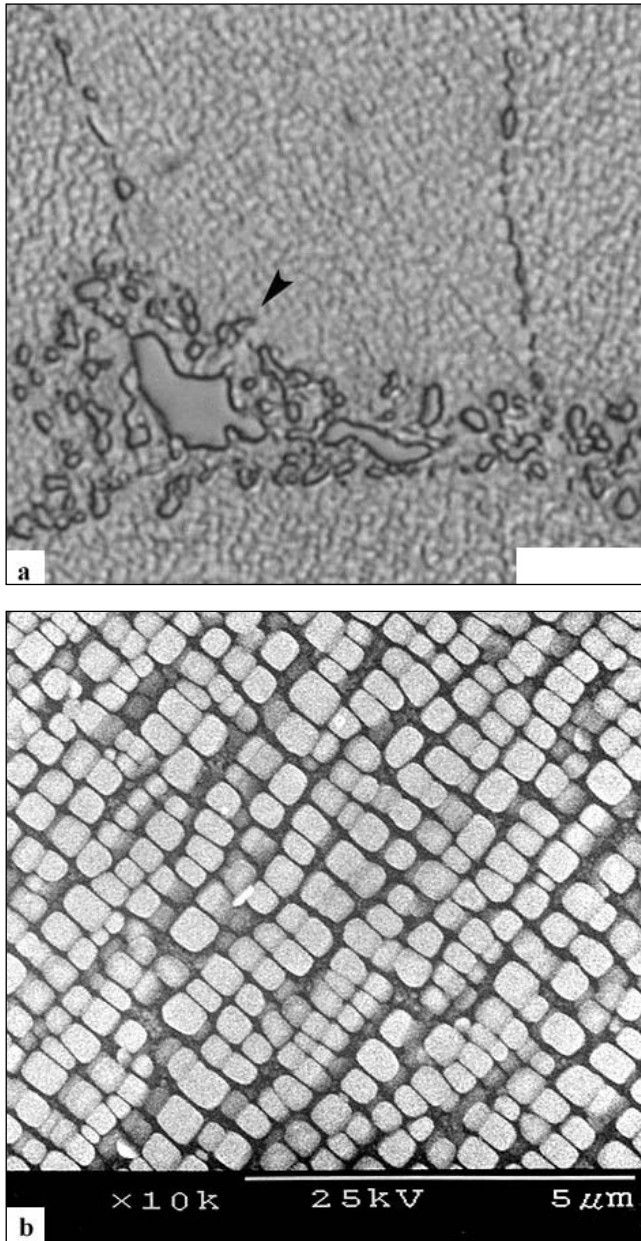
Figure 12. Micrographs of the Blade 2 Leading Edge Specimen after Rejuvenation. ((a) Optical micrograph; (b) SEM micrograph. Arrowhead indicates disintegrated primary MC carbide. (Etchants: (a) Kalling's reagent; (b) Electrolytic chromic acid.))

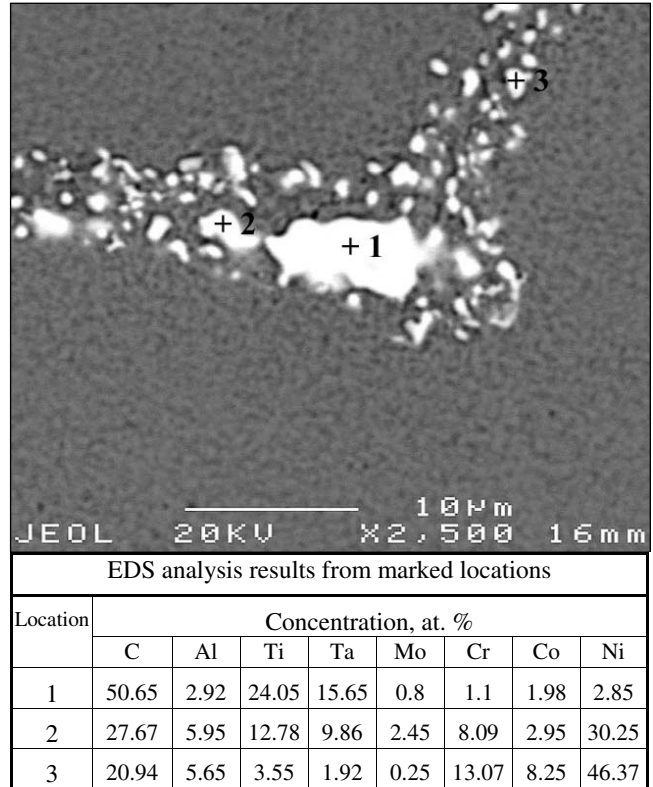
HIP, leaving remnants of original primary MC carbides—an unaffected core surrounded with small MC fragments. The EDS analysis data in Figures 13 and 14 show lower carbon concentrations in the surrounding debris compared with that of the unaffected central part of the original MC carbides. Obviously, dissolved degenerated MC portions had even lower carbon concentration.

Figure 13. SEM-BEI Micrograph of the Degenerated MC Carbide in the Blade 1 Leading Edge Specimen after Rejuvenation. (EDS analysis results from marked locations are shown in the table. (As-polished))

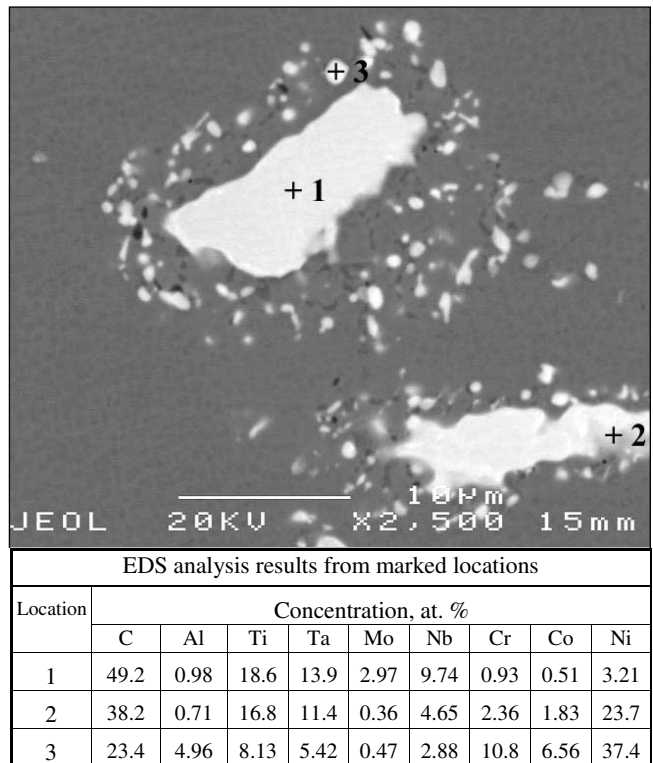
Figure 14. SEM-BEI Micrograph of the Degenerated MC Carbides in the Blade 2 Leading Edge Specimen after Rejuvenation. (EDS analysis results from marked locations are shown in the table. (As-polished))

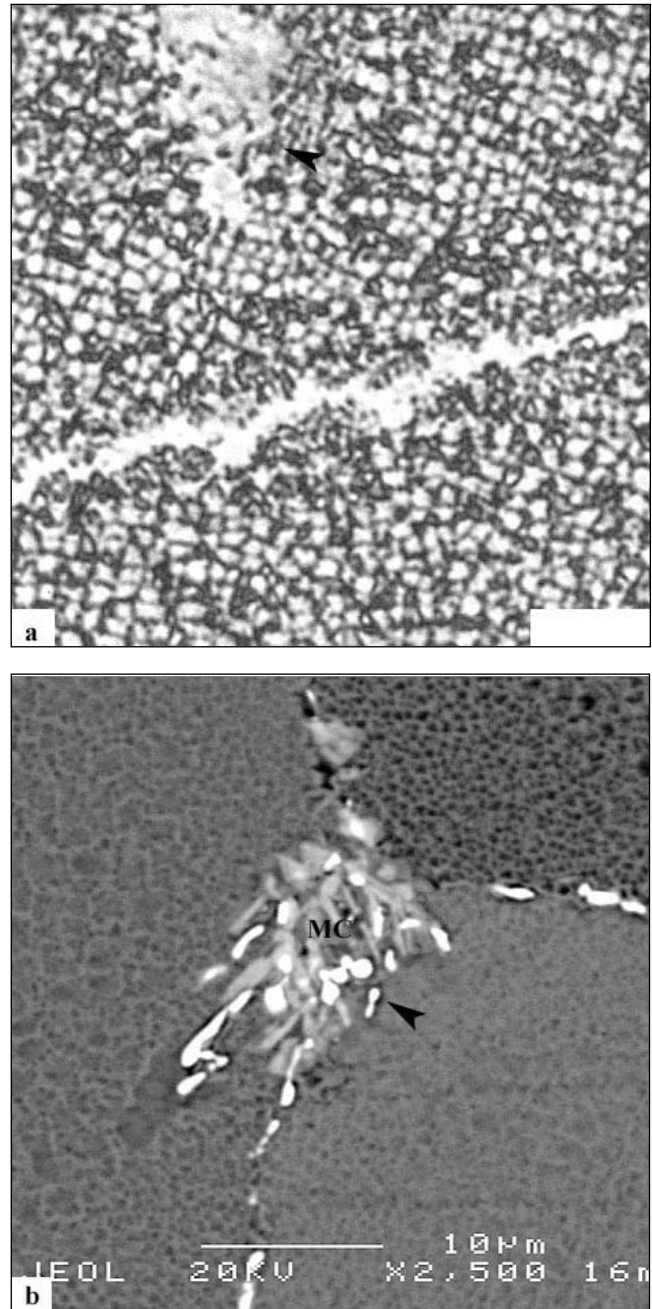
showed no primary MC carbide decomposition during service. The micrographs of the rejuvenated shank and leading edge specimens after 1000 hr aging at 1550°F are presented in Figures 15, 16, 17, and 18; they reveal a significant acceleration of the aging process in the leading edge compared to the shank. While the microstructure of the rejuvenated Blade 1 shank is similar to that in the as-received condition (practically “as-new” material, Figure 15a), the Blade 1 leading edge microstructure demonstrates characteristic signs of overaging: excessive secondary carbide precipitation on the grain boundaries (Figure 16a) and γ coarsening (Figure 18a). The SEM backscattered electron image in Figure 16a shows a change of the contrast of the MC fragments, that is, a previously degenerated MC carbide readily decomposed during aging.

Figure 16. Micrographs of Rejuvenated Blade 1 Leading Edge Specimen after 1000 Hours Aging at 1550°F. (Arrowheads indicate previously degenerated MC carbide continuing to deteriorate during aging. (a) Optical micrograph (etchant, electrolytic chromic acid); (b) SEM-BEI micrograph (as-polished).)

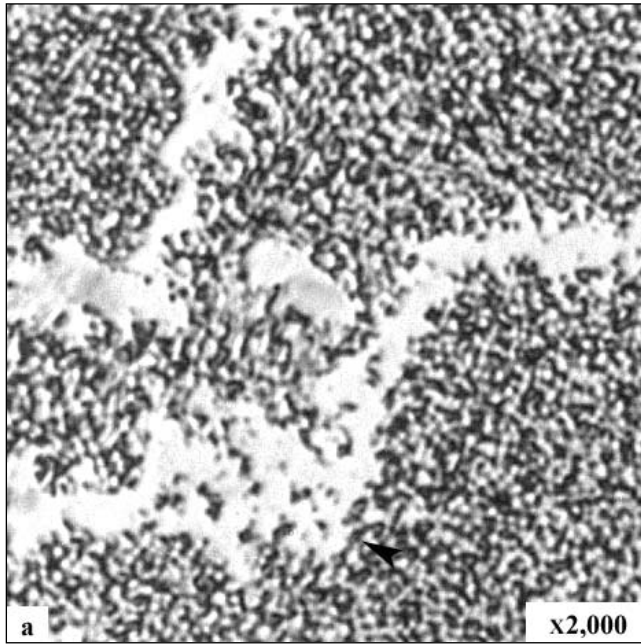
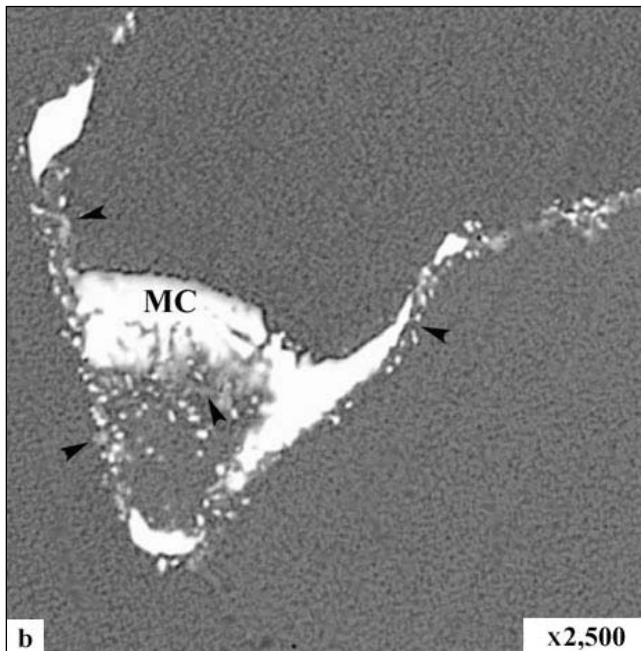
The comparison of the rejuvenated Blade 2 shank and leading edge microstructures after aging demonstrates a similar tendency, although the aged shank specimen reveals a presence of early stages of the MC decomposition: the SEM secondary electron image in Figure 15b shows a number of very fine globular $M_{23}C_6$ carbides formed around primary MC carbides. The microstructure of the rejuvenated and aged Blade 2 leading edge is typically overaged, with the grain boundaries overloaded by $M_{23}C_6$ carbides (Figure 17a) and coarsened and coalesced γ (Figure 18b). The SEM backscattered electron micrograph in Figure 17b shows gradually changing MC carbide contrast due to additional decomposition of the previously degenerated MC carbides.

Figure 17. Micrographs of Rejuvenated Blade 2 Leading Edge Specimen after 1000 Hours Aging at 1550°F. (Arrowheads indicate previously degenerated MC carbide continuing to deteriorate during aging. (a) Optical micrograph (etchant, electrolytic chromic acid); (b) SEM-BEI micrograph (as-polished).)

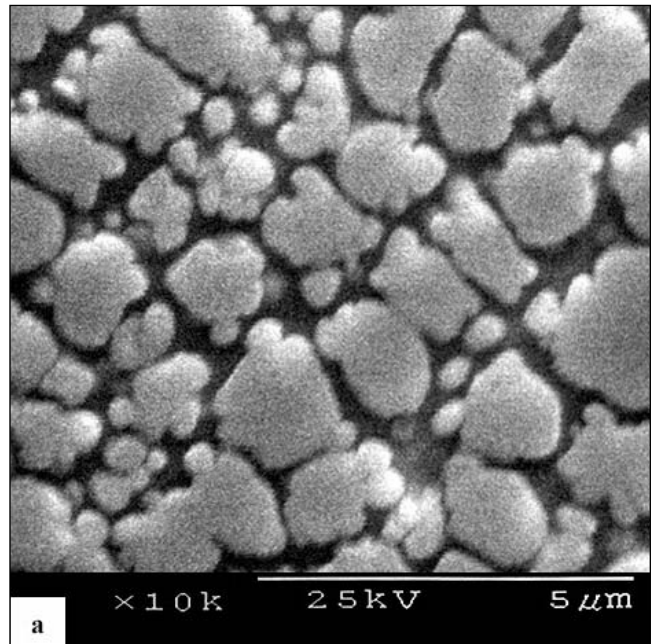
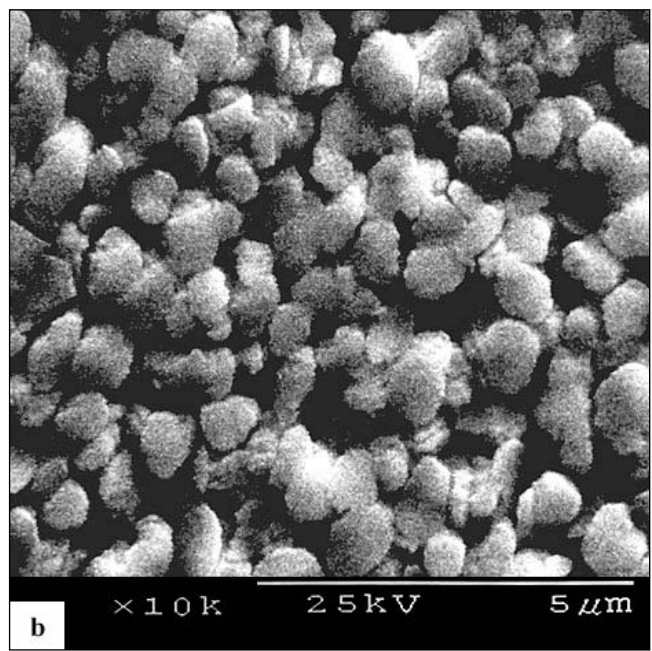
Figure 18. SEM Micrographs of Rejuvenated Blade 1 (a) and Blade 2 (b) Leading Edge Specimens after 1000 Hours Aging at 1550°F. (Etchant—electrolytic chromic acid)

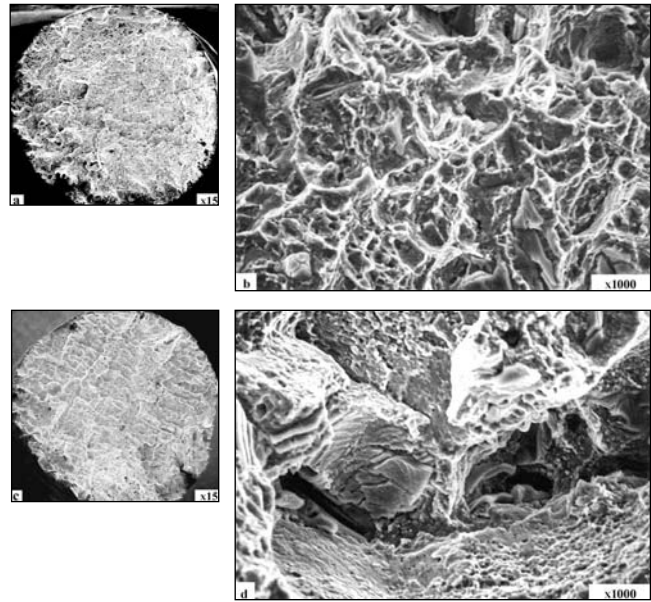
Blade 4 demonstrates predominantly transgranular ductile fracture (Figure 21a, b), while the fracture surface of the mid-airfoil specimen shows distinct interdendritic-intergranular fracture with a formation of the grain-boundary cavities caused by a heavy secondary carbide precipitation (Figure 21c, d).

Figure 21. SEM Micrographs of the Fracture Surfaces of Rejuvenated and Aged Blade 4 Stress-Rupture Test Specimens. ((a, b) Shank specimen; (c, d) Airfoil specimen. Arrowheads indicate grain-boundary cavities (d).)

be prudent to avoid the extensive primary MC carbide decomposition by reducing the periods between rejuvenations, in order to prevent the advanced development of this process. More frequent rejuvenations will prolong blade life and, despite the extra cost of additional rejuvenations, will save money on the blade replacement in the long run.
