# ROOT CAUSE ANALYSIS OF A LONG TERM RELIABILITY PROBLEM WITH RECIPROCATING COMPRESSORS IN H<sub>2</sub> SERVICE

Equilon Enterprises LLC

Shell Norco Refining Company

This paper describes the overall root cause analysis study of these compressors and presents the conclusions and recommendations. It also details one phase of the analysis, evaluation of a specific valve failure, in order to permit the reader to follow the rigor utilized in the application of this type of analysis process.

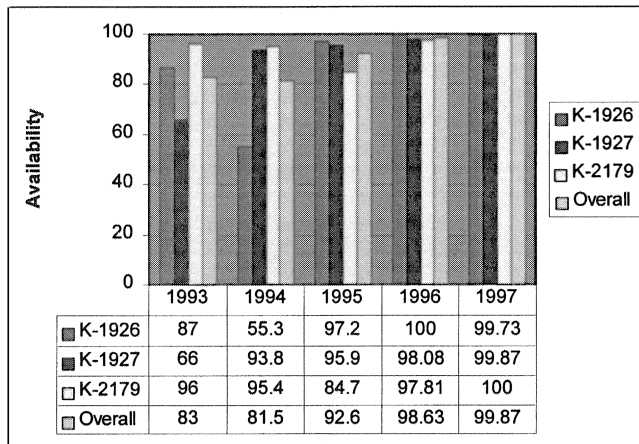
Figure 1 shows the availabilities of these compressors for 1993 through 1997. Figure 2 shows the maintenance spending for 1995 through 1997. As shown, the improvement has been considerable, more than paying for the cost of the RCA study and the implementation of its recommendations.

Figure 1. Availabilities of Makeup Compressors from 1993 to 1997.

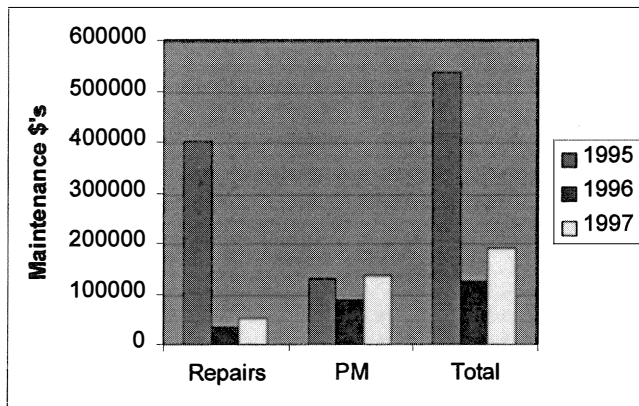
Figure 2. Maintenance Costs of Makeup Compressors from 1995 to 1997.

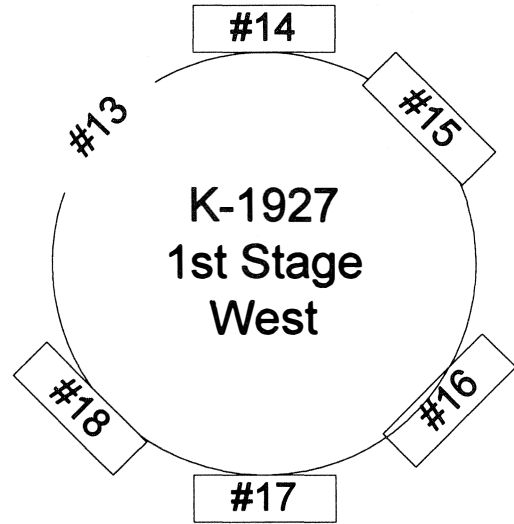
- Valve #13: Relatively oily. Leak checked OK.  
 Temperature before: 105°F  
 Temperature after: 115°F

Figure A-1. Location of Valve on K-1927 First Stage West Cylinder.

- Valve #14: Same as #13. A piece of a broken poppet from another valve is lodged on the cylinder side of this valve.  
 Temperature before: 99°F  
 Temperature after: 114°F

- Valve #15: Unloader valve. Oily, but all poppets in place. Two out of the 12 poppets leaked slowly.  
 Temperature before: 172°F  
 Temperature after: 251°F

- Valve #16: Some black residue found around center poppets. Three outside poppets initially leaked slowly, but sealed after being solvent washed.  
 Temperature before: 244°F  
 Temperature after: 314°F

- Valve #17: One poppet and spring found missing on outside ring. Found one piece of a broken poppet stuck on the cylinder side. One complete spring was found stuck between the top of the poppet and the seat, and a piece of another spring was found stuck in the same position on another poppet. Seven of the 17 poppets had grooves cut around the outside of the poppets, probably from pumping against springs. This valve was not leak checked, because it would have leaked.  
 Temperature before: 254°F  
 Temperature after: 332°F

- Valve #18: One poppet and spring missing. Valve was oily, but had no debris. No foreign object damage to poppets.  
 Temperature before: 106°F  
 Temperature after: 107°F  
 Note: Thermocouple was assumed not accurate on valve #18.

- A discharge spring fails in valve #18.
- Due to the spring failure, the poppet fractures and comes out of the valve holder.
- The broken spring pieces fall into #17.
- The pieces cause a poppet to fail in valve #17.
- In addition to the failed poppet on #17, seven other poppets are damaged.

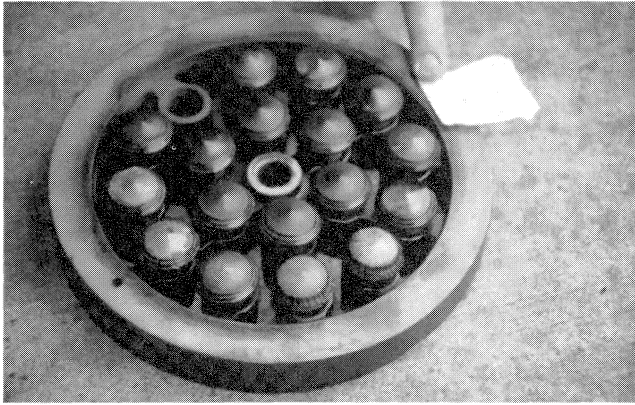
Figures A-2 and A-3 show the type of damage experienced on the valves.

Figure A-2. Poppet Valve with Failed Poppets. (Note the poppets at locations 5:00, 6:00, and 7:00. You can see where springs have "rolled over" the head of the poppets, causing indentations. Poppet at location 11:00 is missing.)

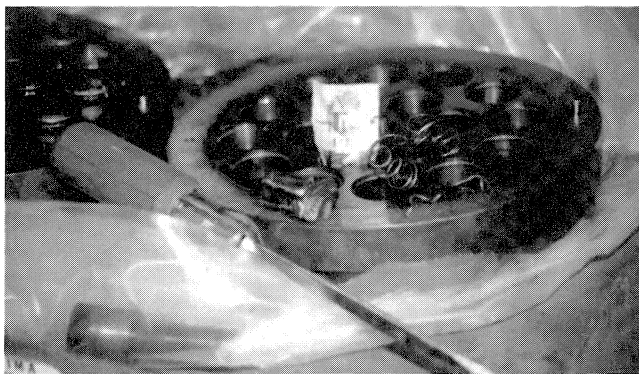
Figure A-3. Poppet Valve Cover Showing Damaged Springs. (Springs had extended and gotten under the heads of the poppets.)

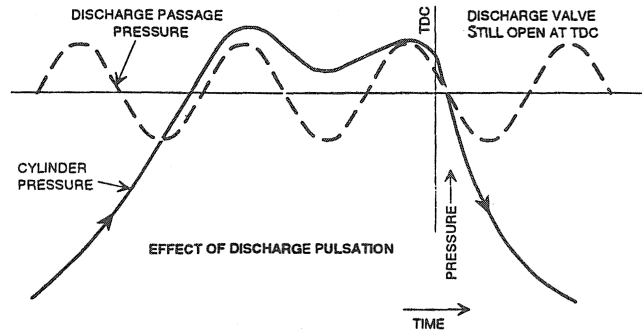
Factors such as relative speed of sound, gas velocity, and compressor speed determine the level of pulsation present. Pulsation can cause late valve closing and valve slamming into seats. Piping changes and orifice plates can eliminate pulsation. Figure A-4 gives an illustration of pulsation on discharge valves. Figure A-5 shows evidence of pulsation on K-1926 third stage.

Figure A-4. Effect of Discharge Pulsation.

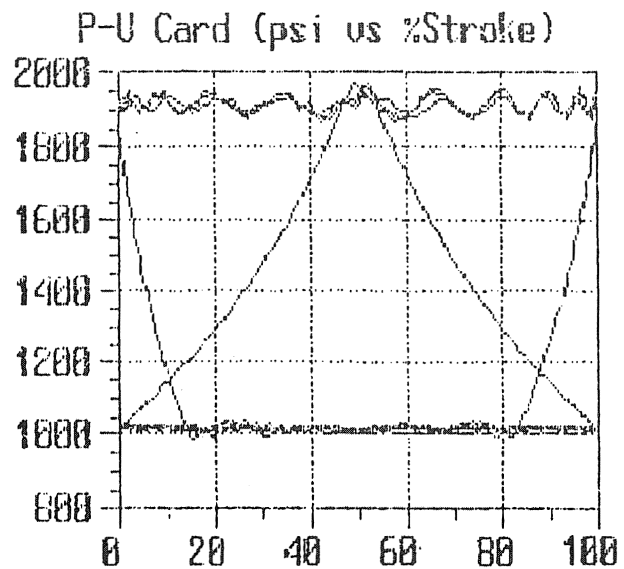
Figure A-5. K-1926 Third Stage PV Card (July 1, 1994).

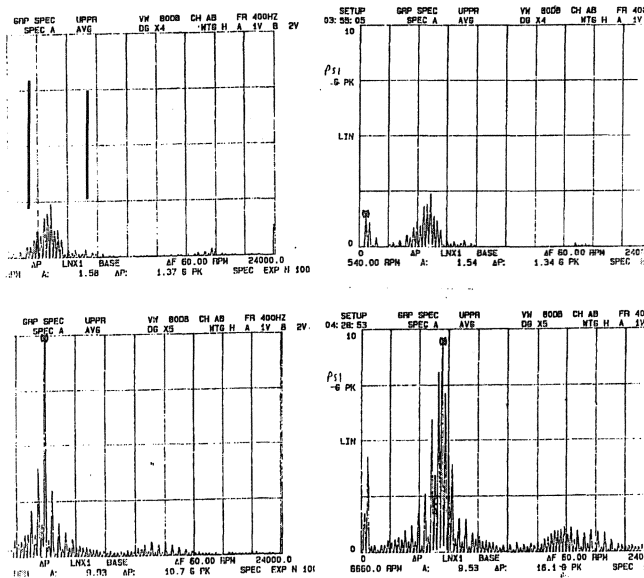
Pulsation contributed to excessive loading. These pulsations were measured at the valve covers on K-1926 on July 1, 1994. Cylinder pressure monitoring found that valve movement was in phase with pressure pulsation (Figure A-5). A pulsation study verified that the pulsation at the valves was of correct frequency and sufficient amplitude to effect valve performance (Figure A-6).

This pulsation was the result of the combination of physical dimensions, running speed of K-1927, and the acoustical properties of hydrogen at the pressures and temperatures in K-1927. Classical pulsation problems normally occur in downstream piping where they cause the piping system to vibrate excessively. Pulsation bottles address these. This pulsation occurred between the valve and nozzle. Prior to the root cause analysis, pulsation was not considered as a cause, since there were no known piping system problems.

Figure A-6. K-1926 Discharge Pulsation Amplitudes Measured July 13, 1994. (From top left, first stage east, first stage west, second stage, third stage.)

3. Valve pulsation elimination. Install orifice plates to eliminate valve pulsation. These orifices were recommended from an August 1994 acoustic study of K-1926 and K-1927 done by an engineering consultant.

These orifices were installed on K-1926 in October 1994. Noticeable decreases in pulsation levels were recorded. See Figure A-6 for preorifice pulsation levels and Figure A-9 for postorifice pulsation levels.

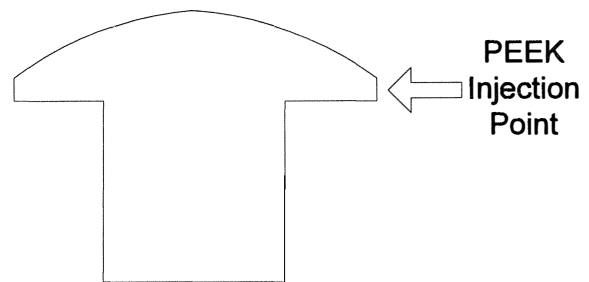
The failed poppets were manufactured by injecting resin and glass fibers at the corner of the poppet seat, as shown in Figure A-7. By injecting the resin and fibers at this point and in this direction, the glass fibers must turn a corner to fill the mold.

Figure A-7. Type 1 Poppet Injection Point.

To prove that the failed poppets had a lower strength than other poppets, a test was conducted at the plant central shop. At 200°F, the Type 1 poppets had 65 percent of the strength of the Type 2 poppets.

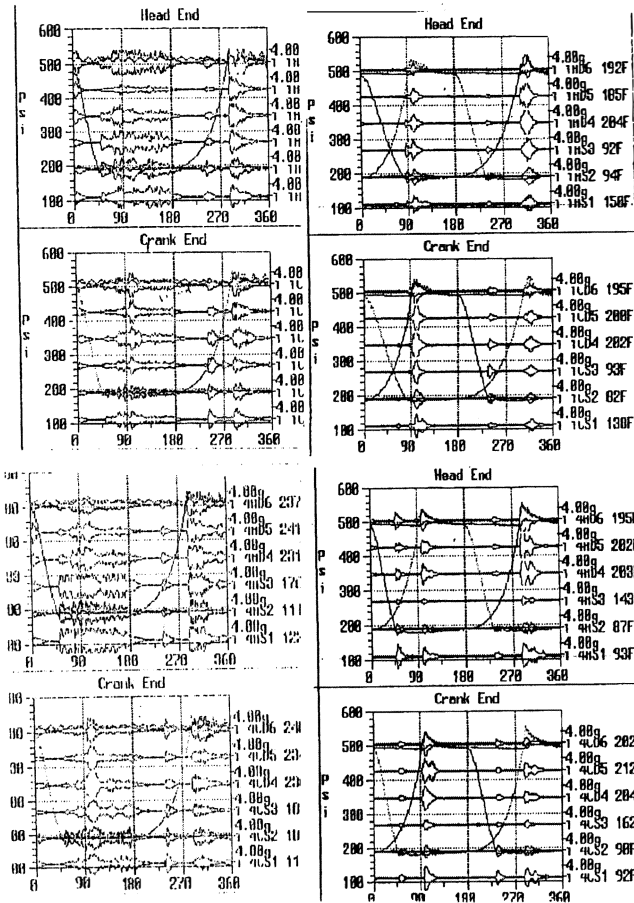
Figure A-8. Cylinder Noise Trace of K-1926 First Stage East and West. Before and After Type 2 Installation.

Redesigned Type 2 valves were installed in K-1926 on November 4, 1994, except for the first stage discharge. Cylinder pressure monitoring taken one week later revealed improvements in valve motion. An example of this is shown in Figure A-8 that shows a reduced noise trace following the installation of the new valves.

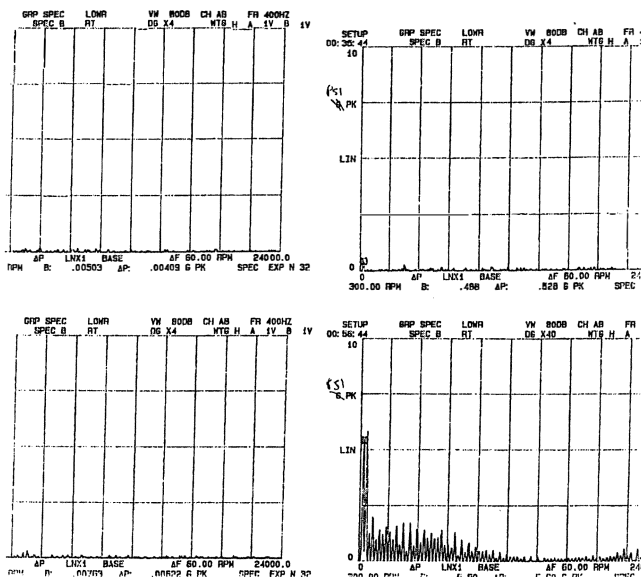
Figure A-9. K-1926 Discharge Pulsation Amplitudes Measured October 28, 1994. (From top left, first stage east, first stage west, second stage, third stage.)
