# FATIGUE DAMAGE OF STEAM TURBINE BLADE CAUSED BY FREQUENCY SHIFT DUE TO SOLID BUILDUP—A CASE STUDY

The case history is presented of a large steam turbine that experienced blade damage after about eight years of service. The probable cause and subsequent solution to the problem are addressed. A discussion of the metallurgical analysis of the damage, Campbell diagram, SAFE diagram and modal test results is provided. The damage is believed to have been caused by a solid build up at the blade root that shifted a natural frequency into an interference region, and changed the response characteristic of the bladed disk assembly.

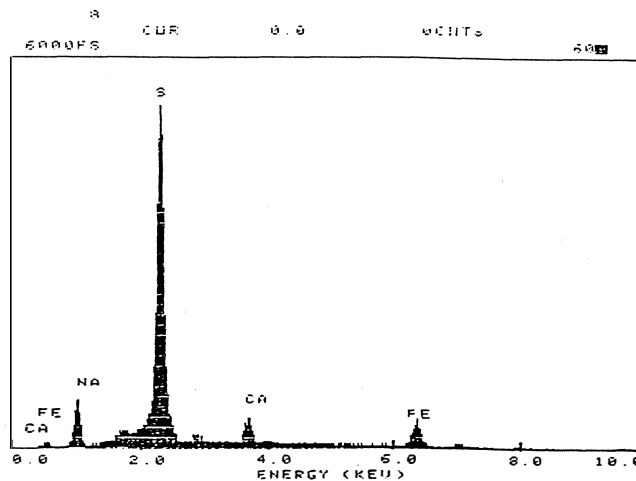
X-ray electron dispersive spectroscopy (EDS) analysis was performed on the deposit samples collected. The sample from the midspan of blade to shroud area indicated the presence of iron and noncorrosive metallic elements. The EDS analysis of the second sample from the base of the blade and wheel-rim area revealed the presence of sulphur, calcium and sodium. These elements produced medium to large peaks on the EDS spectrum. The deposit was also viewed as a back scatter image and the material showed patches of low average atomic number. A spectrum of low atomic numbers showed a significant quantity of sodium, as shown in Figure 1. Sodium is considered to be an aggressive corrodant causing stress corrosion cracking. Chlorine was not discovered, even though pitting was observed on the fracture surface. However, a similar analysis done at an earlier time revealed the presence of chlorine but not sodium. A chemical analysis of the material taken from blade 123 is shown in Table 1. Hardness testing and microstructure analyses confirmed that the blade material met the required specification.

Figure 1. Low Atomic Number Material Decorating Airfoil/Wheel Rim Sample.

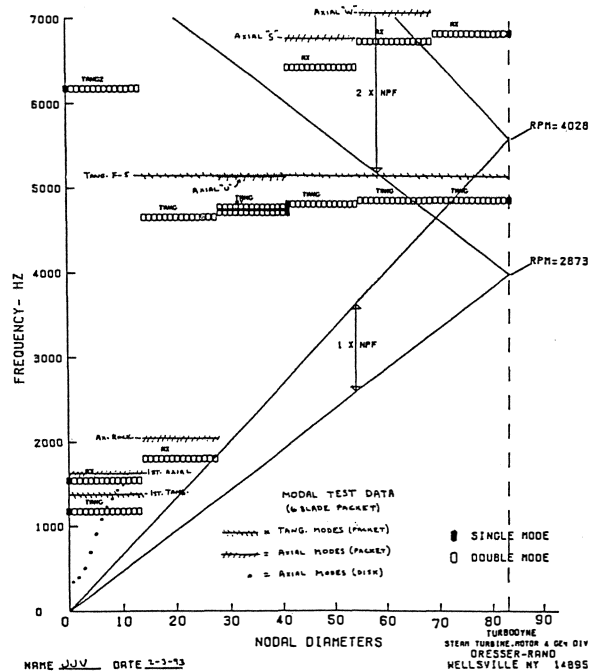
Figure 17. SAFE Diagram of the Original Design with Test Data.

results overlaid on the analytically predicted results for a six blade packet (as shown in Figure 6). The experimental results are consistently higher than the analytical results. All the analytically predicted and experimental results are listed in Table 2. Past experience of the correlation between analytical predictions and experimental results has been very good. However, such difference has occasionally been observed. This difference is due to a change in the root attachment boundary conditions with time. The clearance between the blade root and the disk groove is small, and steam deposit build up or a material corrosion/oxidation build up can fill these clearances. This can stiffen the support of the root in the groove, and hence raise the blade frequency. To investigate this possibility, a dynamic analysis was performed to see how sensitive the blade frequency is to changing root conditions. The results are listed in Table 3 for different root support conditions together with the results of the modal test. This comparison shows that the modal test results fall somewhere between the blade root being considered at the standard location (upper root lock) and the wheel outside diameter. It seems plausible that the solid deposit build up in the root could have contributed to this condition and raised the blade frequency.

The turbine at the time of damage was reported to be running at 3930 rpm. Examination of the SAFE diagram (Figure 17) indicates an interference of the blade frequency of the axial "W" mode with  $2 \times$  NPF at 3930 rpm. In summary, the following conclusions can be drawn

- There is a possible shift in the blade resonant frequency due to solid buildup.
- No resonance is predicted at operating speed without this shift.
- The location and direction of cracks match with the axial "W" mode shape.
- Failure was due to high cycle fatigue.
