IMPROVING THE MECHANICAL RELIABILITY OF A TURBINE-COMPRESSOR-EXPANDER USED IN A NITRIC ACID PLANT

ABSTRACT

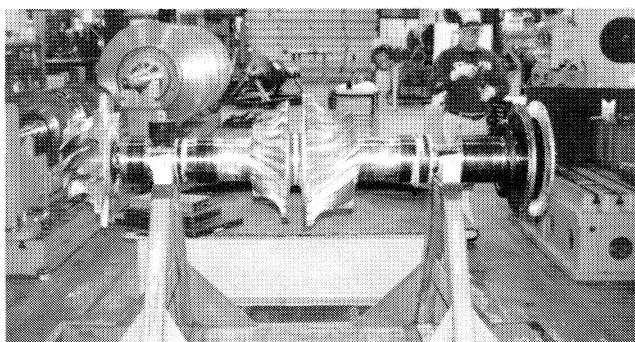
Figure 2. Rotor Assembled for the "As Received" Inspection.

The center body of the rotor was removed from the case, and the entire rotor was reassembled. The "as received" runouts and balance were checked on the rotor (Figures 2 and 18). The runouts indicated that the rotor was bowed. It was thus decided that the entire rotor had to be disassembled, and the curvic faces had to be closely inspected. The curvic faces were blue checked for contact, and it was found that the contact between a number of the faces was not adequate. To further investigate the cause of the bow in the rotor, the axial runouts on the compressor wheel curvic faces were also checked.

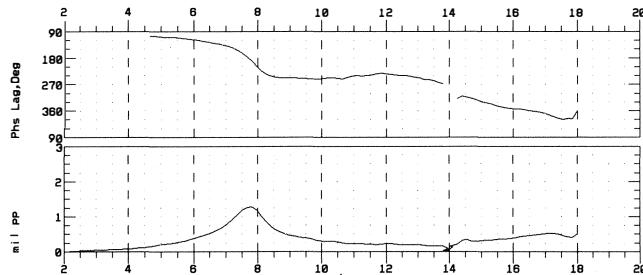
damped and the first peak response occurs at the third mode at 7,900 rpm. The calculated amplification factor at this location is 9.8. No other resonances are present up to 20,000 rpm. This plot closely matches the experimental amplitude shown in Figure 14.

Figure 14. Startup Amplitude and Phase from the Expander End Horizontal Proximity Probe.

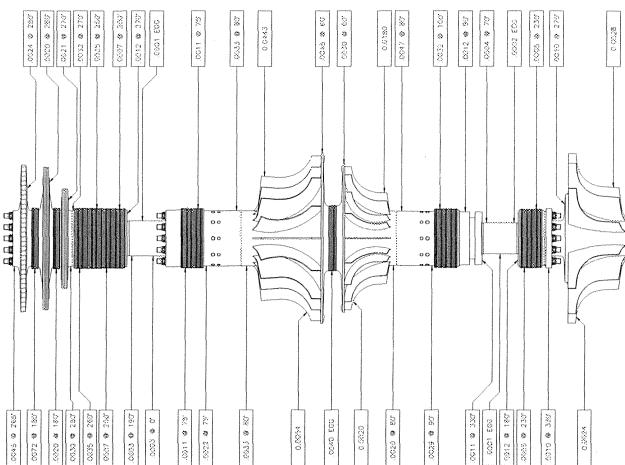
Figure 18. "As Received" Runouts on the Rotor.

In the absence of the curvic masters, the axial runouts on the compressor wheels were individually mapped on a coordinate measuring machine. The axial runout was found to be around 0.003 in, which was considerably greater than the 0.0005 in tolerance set for these parts. The results found using the masters were in agreement with these results. A decision was made to skim grind (0.005 in per curvic face maximum) all the curvic faces to get them within tolerance. The shortening of the rotor resulting from the grinding would be compensated for by the manufacturing of slightly oversized stub shafts.

runout problems, provided sufficient justification for the manufacture of the new oversized stub shafts. The rest of the curvic faces were skim ground to improve the contact between the mating curvic faces.

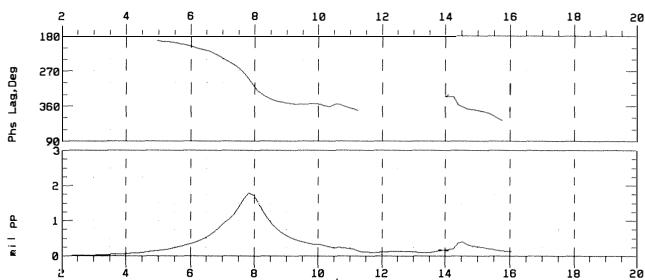
A similar plot for the turbine end vertical probe location is shown in Figure 28. The calculated amplification factor is 9.2 for this critical speed peak. Again, this is lower than the predicted amplification factor.

Figure 28. Startup Amplitude and Phase from the Turbine End Vertical Proximity Probe.

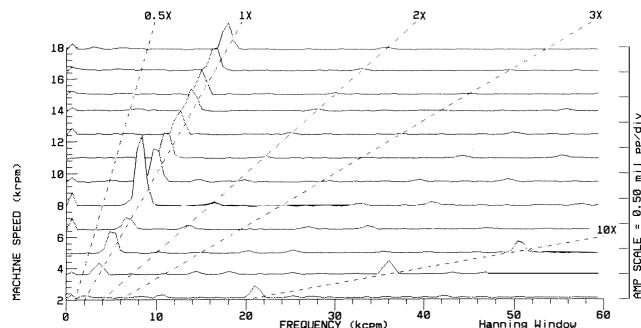
Additional information is available from the transient data sets. These measurements are also from the turbine end vertical probe. A spectrum is generated every 750 rpm and combined as a cascade plot in Figure 29. This plot shows that the primary vibration component is synchronous. There is no evidence of any subsynchronous vibration, and the lack of twice running speed vibration is convincing testimony to the integrity of the rotor construction and absence of any internal misalignment. There is an interesting ten times vibration component that is easily explained as a minute distortion of the probe surface area from the force of the ten main body through-bolts.

Figure 29. Cascade of Spectrums from the Turbine End Vertical Proximity Probe During Startup.

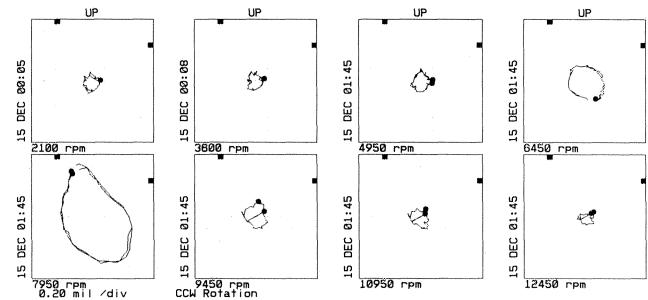
Finally, it is informative to examine the orbits generated from the orthogonal probes. The horizontal and vertical signals are combined in Figure 30 to show shaft centerline orbits from 2,100 rpm to 12,450 rpm. These orbit are the unfiltered vibration signal and clearly show a nearly circular orbit, even at resonance. This is additional evidence that there are no significant internal forces or preloads. All of the vibration levels in these plots are low. This means that this machine not only operates with low stress levels, but also is able to repeatedly traverse a potentially damaging bending mode critical speed without damage.

Figure 30. Orbit Plots from the Turbine End Proximity Probes During Startup.

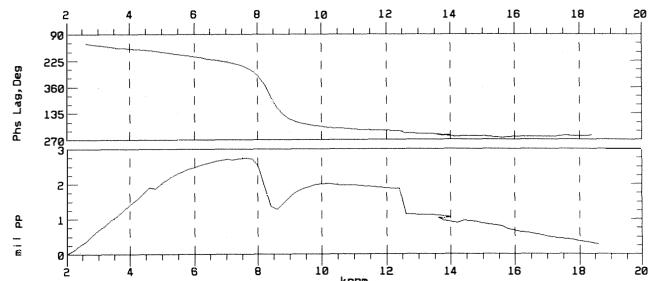
For comparison, a typical startup plot from the SN-1 module, expander end horizontal displacement probe is shown in Figure 31. This rotor runs well at operating speed, but has difficulty in passing through the first bending critical. The rotor is also extremely difficult to field balance.

Figure 31. Typical Startup Plot From the SN-1 Module, Expander End Horizontal Displacement Probe.
