TAKE TRANSIENT STARTUP AND SHUTDOWN DATA—RULE NUMBER ONE

Charles Jackson

Turbomachinery Consultant

FIRST CASE—22 MW GAS TURBINE GENERATOR

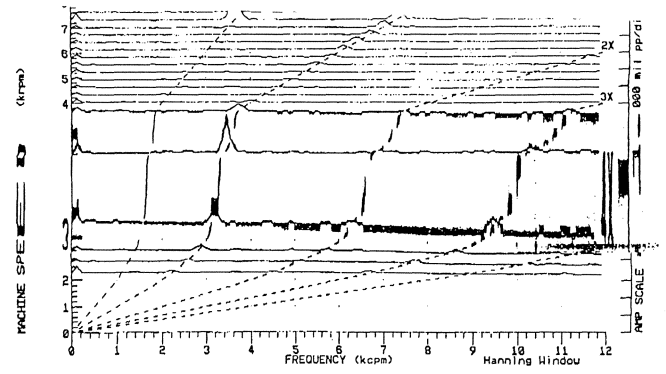
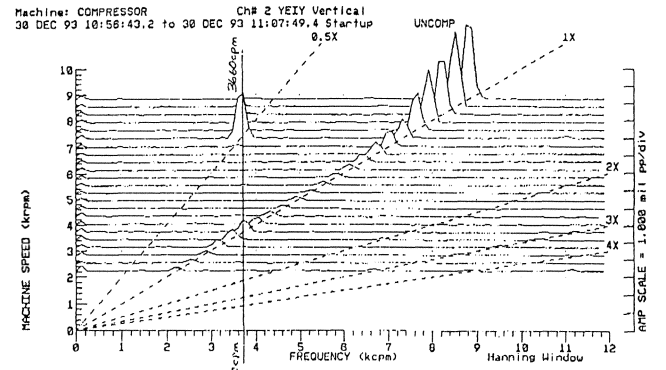
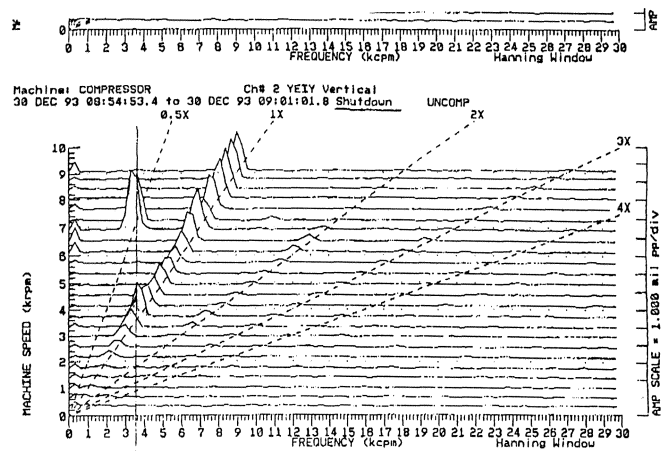
Figure 3. Cascade of Number Two Runup, Bearing 2 (2Y) with Whip @ 3660 CPM (a). Rundown Same Point, Number Two Run (b).

the number one bearing full scale is 2.0 mils p/p, taken on rundown. The interruption the plot is during the $1/2 \times$ instability.

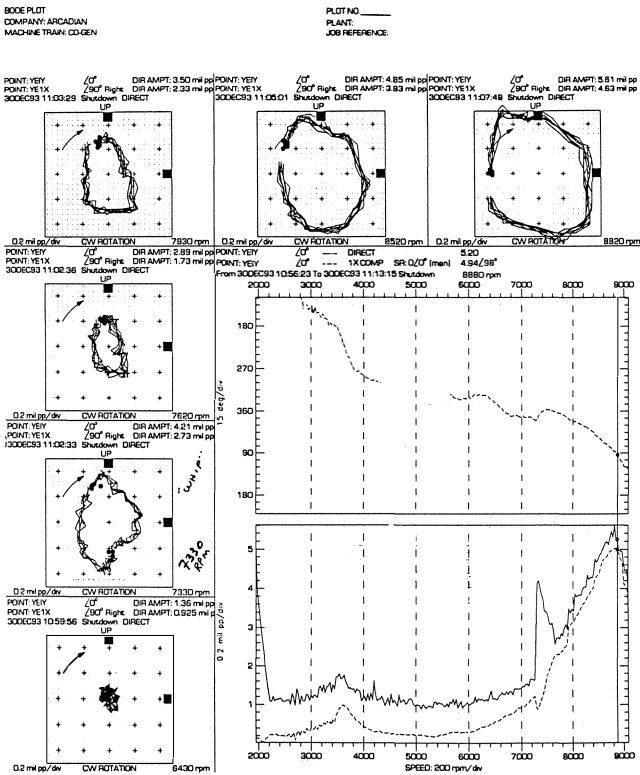
Figure 4. Third Startup After the Seismic Trip Reset to 18 mm/sec. This is the inlet bearing number one, probe 1 X. The vibration at full speed exceeds 5.0 mils p/p. The shaft “whips” @ 1/2 × @ 7330 rpm. The responsive resonance, second mode of gas generator is excited at its resonance of 3690 cpm. Bodé confirms orbit.

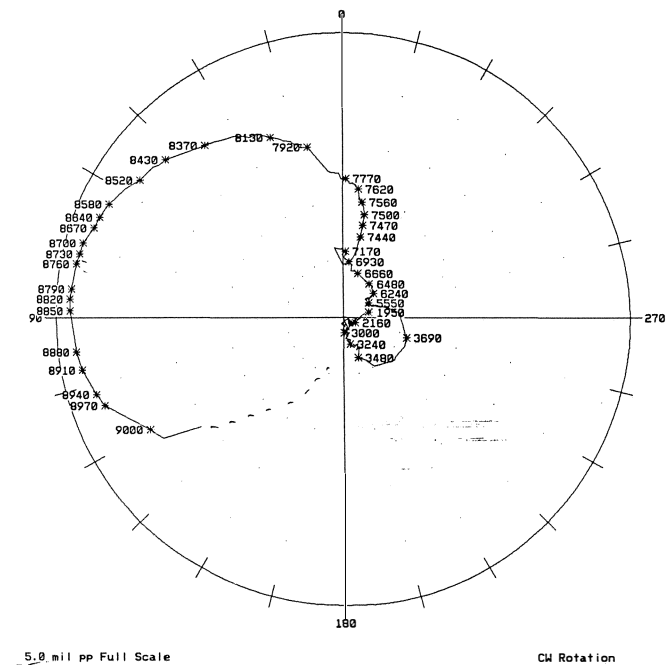
5.0 mil p/p Full Scale
 CW Rotation
 BIGGER SCALE
 Third start up attempt, with trip levels raised.

Figure 5. Polar Plot of Bearing 2, 2Y, during the Runup Number Three to Full Speed with Higher Trip Setting. (Seismic @ 18 mm/sec). Full Scale Polar = 5.0 mils p/p.

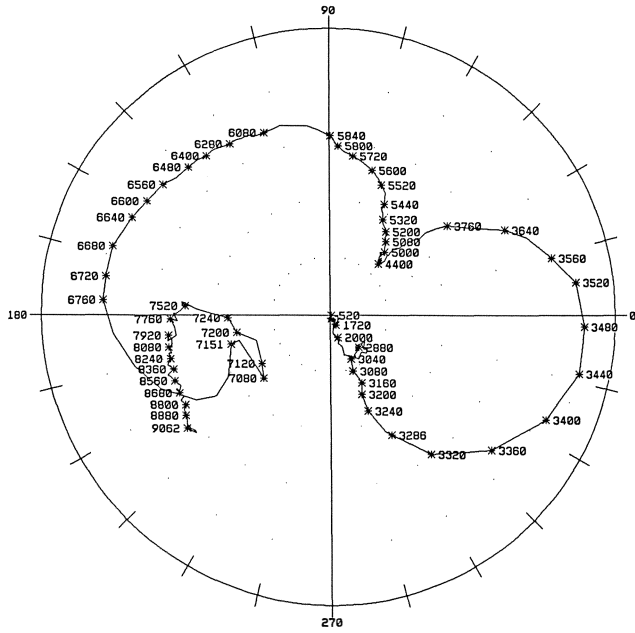
Figure 6. Polar Plot of Bearing Number One During Rundown, Run Number Three, Probe 1X Horizontal. Note second mode @ 3440 cpm, i.e., lower on rundown. High spots 180 degrees out.

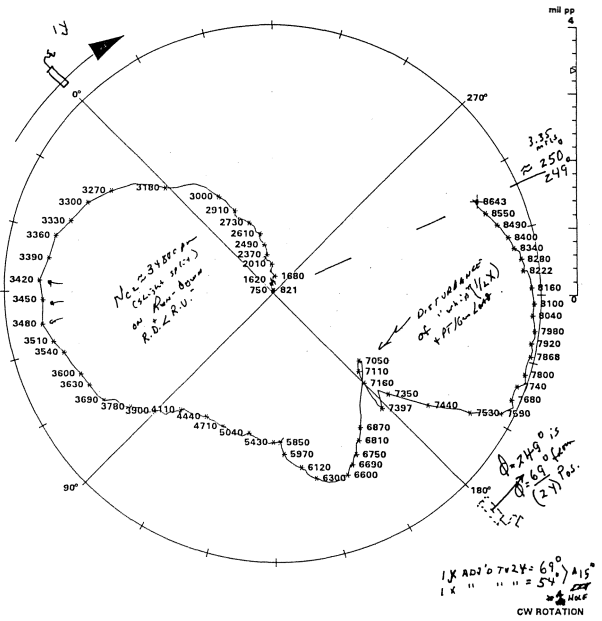
Figure 7. Bearing Number One, 1Y Shutdown, 2/9/94, to 8643 RPM. Full scale circle = 5.0 mils p/p. 1x phase angle corrected for 2Y position. Disturbance 7000 rpm is “whip” at the power turbine takeover point. Whirls then “whip.”

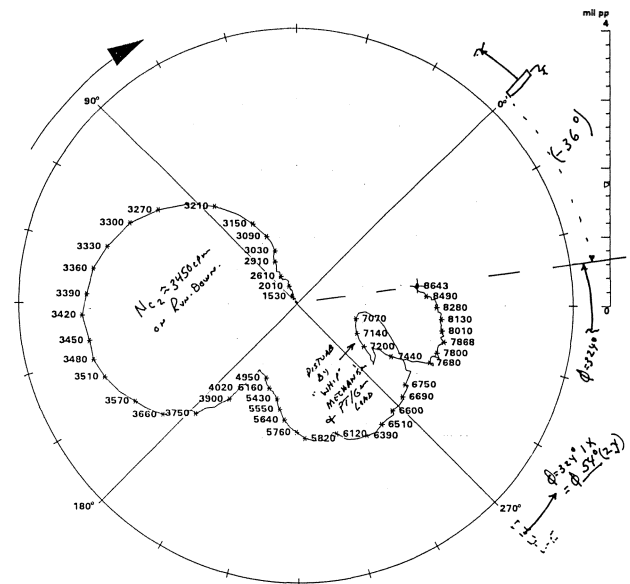
Figure 8. Polar Plot of Bearing Number One, 1X Shutdown. Bearing number one does not show Mode 1 ~ 2400 cpm response. Second mode is @ 3450 cpm. φ @ 324 degrees = 54 degrees @ 2Y pt. Unbalance ~ Bearing 2, but highest vibration @ Bearing 1.

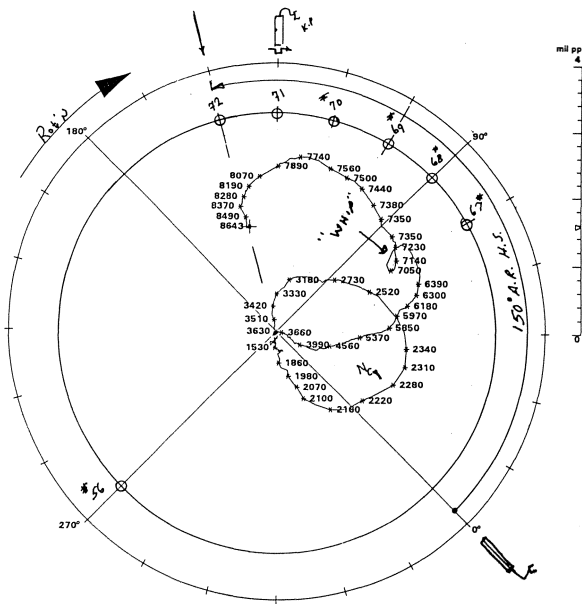
Figure 9. Polar Plot of Bearing 2, 2Y, Shutdown. At nine MW load, logic would add trial weight ~24 gm @ 150 degrees. This data recorded with “existing 24 gms” @ number 68 hole.

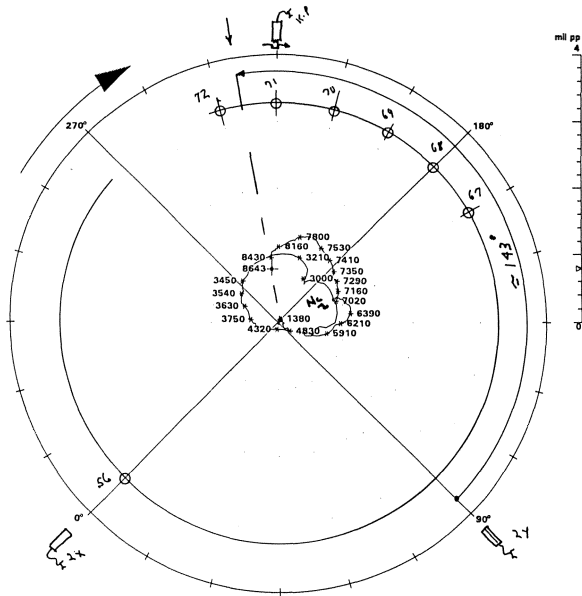
Figure 10. Polar Plot of Bearing 2, 2X, Shutdown. Phase logic agrees with 2Y within nine degrees (< Amplitude). Weights @ 68 and 72 vector sums to ~43 gms @ #70.

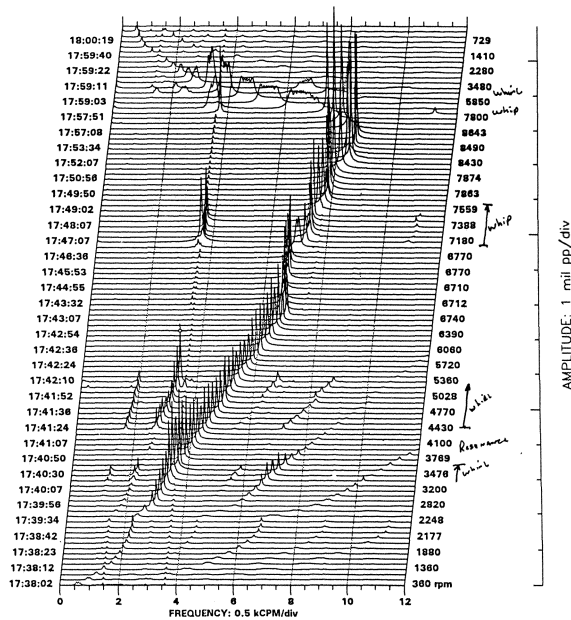
Figure 12. This is the Waterfall Plot of the First Run to 8643 RPM and Nine MW Load. It includes the rundown.

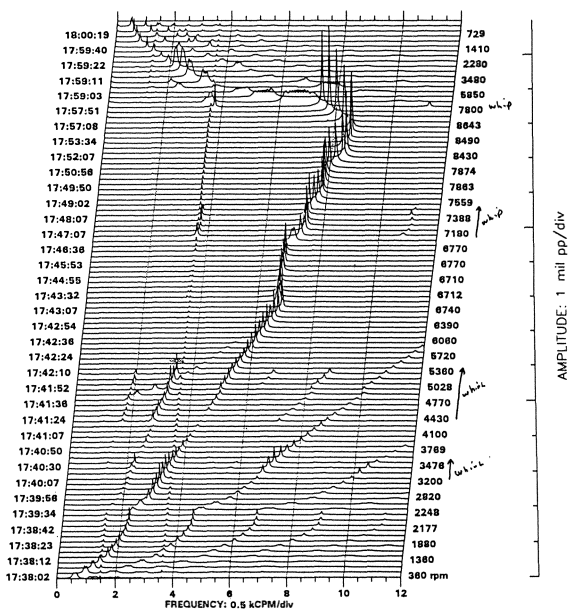
Figure 13. Same as Figure 12, but of the Second Bearing. These "waterfalls" are very vivid on the instabilities.

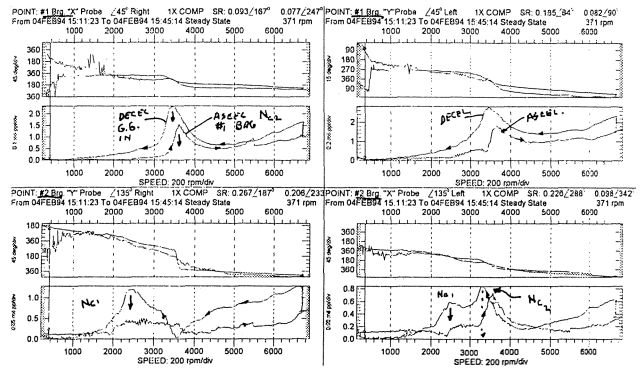
Figure 14. Bodé Runups and Rundowns of Bearings 1 and 2. First mode is 2400-2500 cpm; second mode 3600+ up/3400+ down, cpm. Bearing 2 sees both modes. Bearing 1 sees only the second mode.

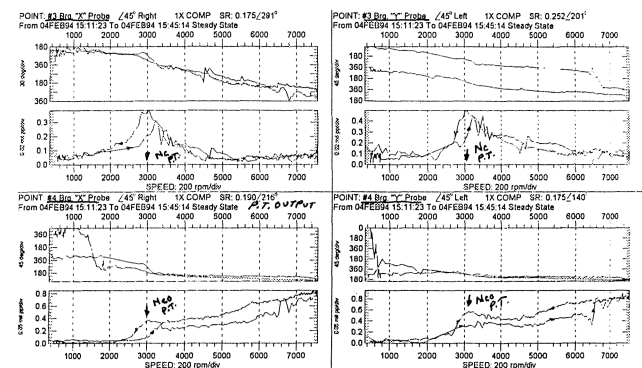
Figure 15. These are Bodé Runups and Rundown of Bearings 3 and 4. Power turbine rotor has critical @ 3000 to 3200 cpm. Mode is better defined at hot turbine end (Bearing 3).

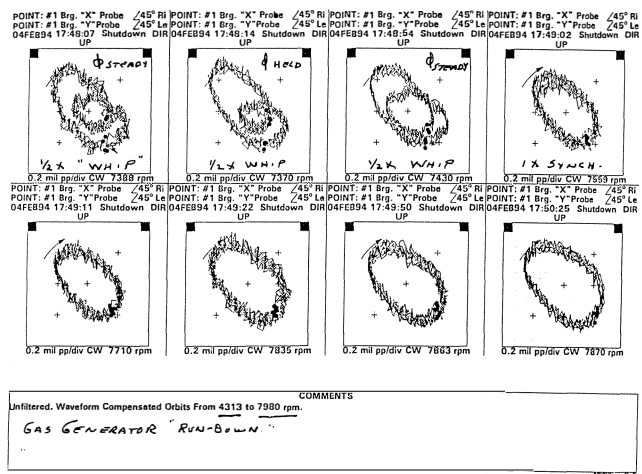
The confirmation of "whirl" and "whip" are determined from the Cascades 12 and 13 but more accurately from the orbits (Figure 16) where the inside loop and two key phasor marks are seen per period. Hint: the completion of the orbit loop equals one period... best seen in the "blanked" timewave (not shown here to reduce figures). Further, the fact that the orbit is frozen, i.e., not moving in either forward (normal) or reversed precession (typical of heavy rubs); means that exactly 1/2 running speed

Figure 16. Unfiltered Orbits of Bearing 1. Rotor is "whipping" @ 1/2X in first 3 7388 to 7500.

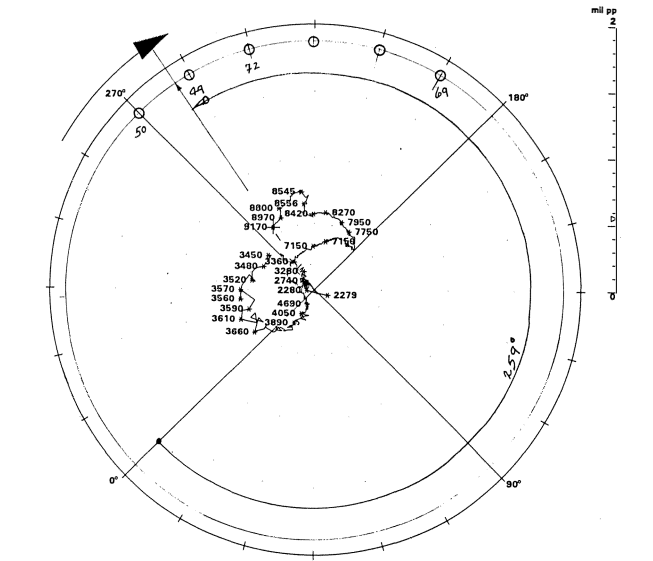
Figure 20. Polar Plot on Running to Full Load and 9170 RPM. Full Circle Is 2.0 Mils p/p. The effects of the thermal transient can also be seen.

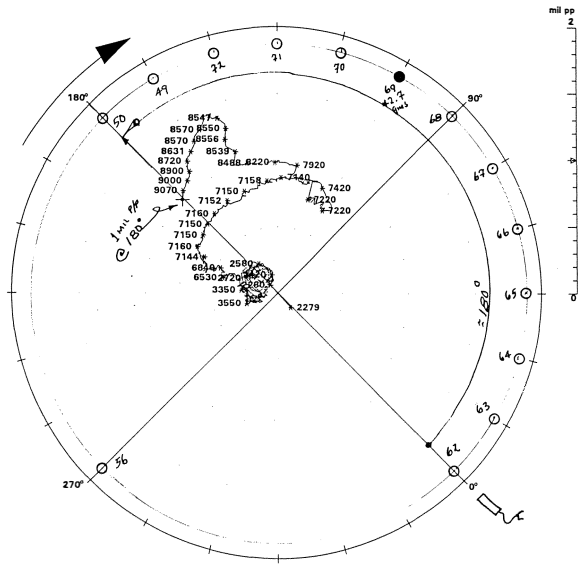
Figure 21. Polar Plot of 2Y, Bearing Number Two, Showing that the Number 70 Hole Was a Better Choice than 69 and the Reversal of Lag Angle Normally "Rub" Is Thermal.

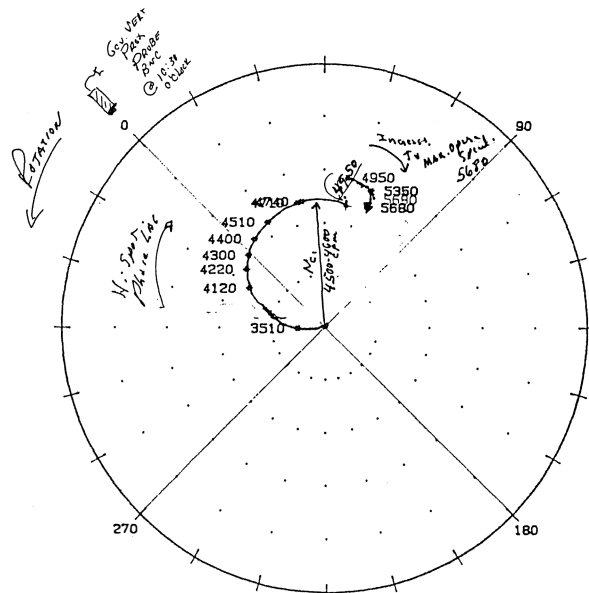
Figure 27. First Transient Data Taken. Polar of Startup to Operating Speed, ~4950 rpm, then slowly to 5680 rpm > 5680 rpm. Note the amplitude/phase variations @ operating speed. The Critical Speed is 4500 cpm. Operating Speed ~N_c.

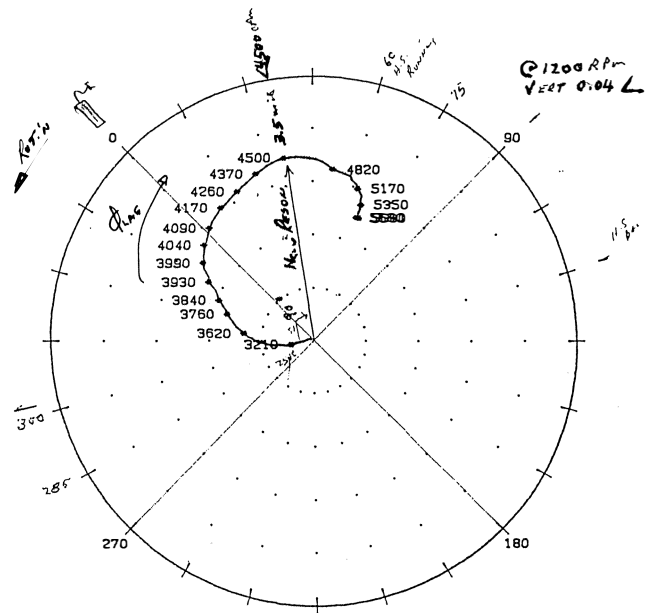
Figure 28. Polar Plot of Shutdown from Overspeed Trip. Plot here does not have amplitude/phase variations during continuous rundown. 4500 is peak. Going to full speed and trip is within N_c envelope.

second stage rows. Therefore, the rotor shaft was turned down about 1.5 in on the diameter and a second wobble plate was installed on the steam end bearing pedestal. Further, stress corrosion cracking due to high stress at resonance operation had cracked some 80 to 90 percent through the first disc, so a built-up rotor was incorporated.

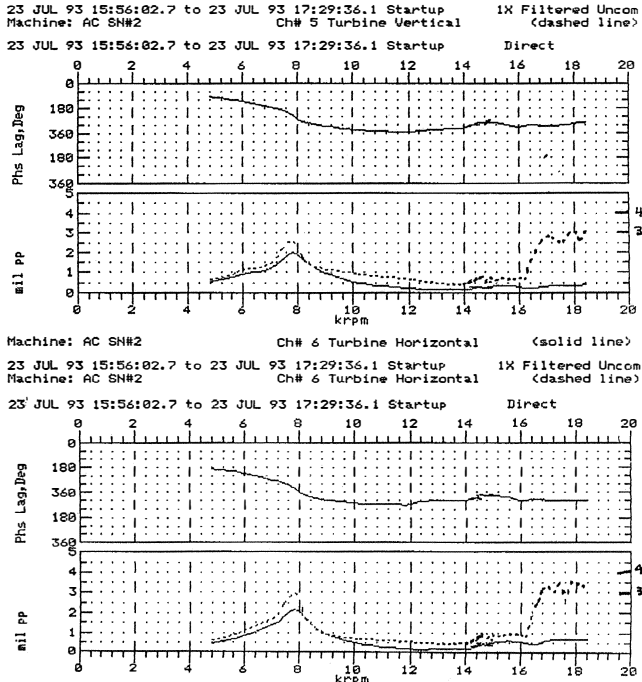
Figure 32. Bode Plot of Exp-Compressor Reaching an Instability about 16,000 RPM with High Vibration.

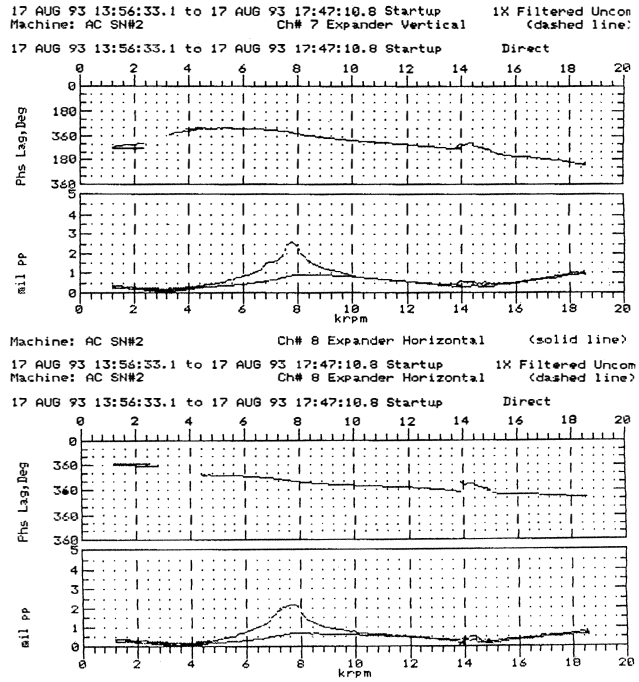
Figure 34. Bode Plot after Progressive Balance of Individual Components, Regrinding Curvic, Replacing Some Rotor Elements, and Great Care to Bearing Lift. NO INSTABILITY OCCURS! Critical speed amplitude is low.

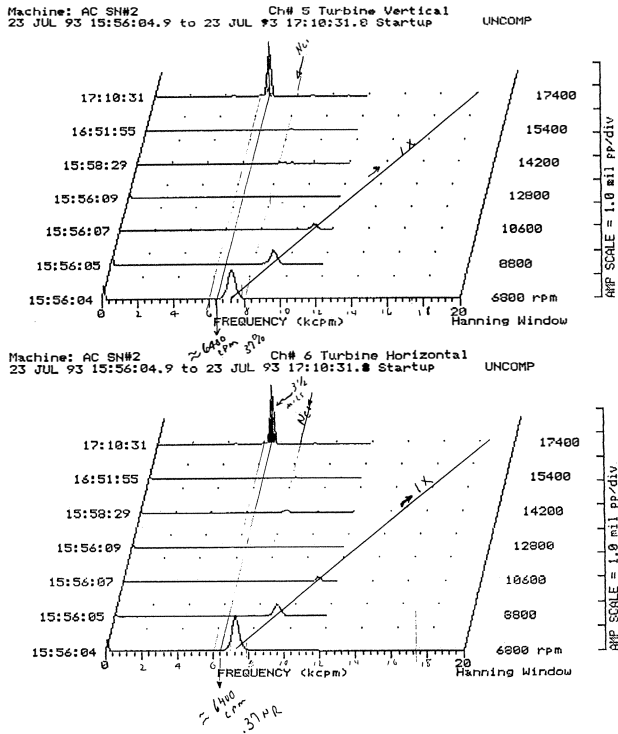
Figure 33. Partial Cascade (Waterfall) Showing the Subrotative Speed (~0.37N) Resonant "Whip" (= Trip-out).
