# RETUNING A GEAR DISC PROFILE TO ELIMINATE HIGH GEAR VIBRATION

**James H. Hudson**  
Engineering Consultant  
A/C Compressor  
Appleton, Wisconsin  
and

**Keith Rouch**  
Professor of Mechanical Engineering  
University of Kentucky  
Lexington, Kentucky

High gear case acceleration levels, experienced during shop string testing of a compressor train, were traced to gear element structural resonance, which was excited by the gear tooth meshing frequency.

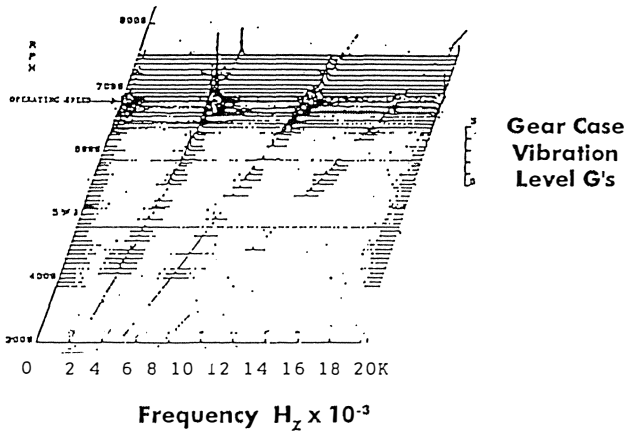
During the compressor string testing, the signal levels from gear case accelerometers, which through most of the testing were approximately 1.0 G, increased to 8.0 to 10.0 Gs in a very narrow speed band. The nature of this problem is presented in

Figure 1. Gear Case Accelerometer Coastdown. Frequency Hz  $\times 10^{-3}$ .

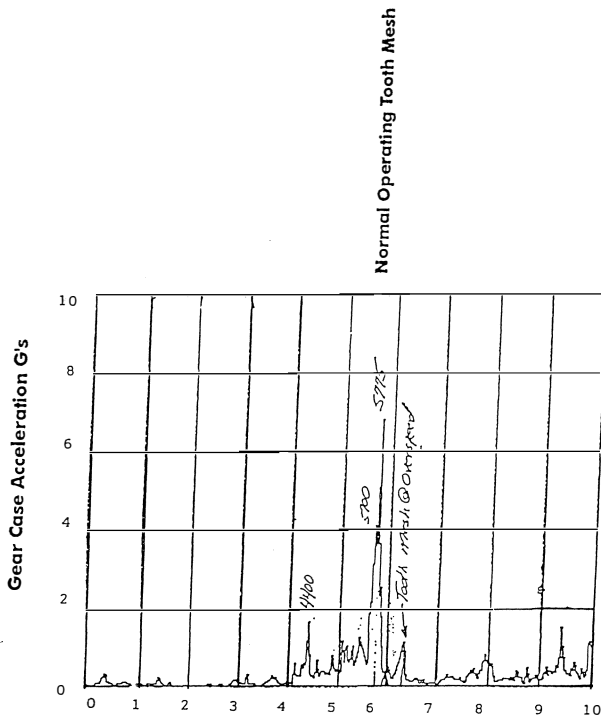
Figures 1 and 2. A waterfall plot is shown in Figure 1 of the gear accelerometer magnitudes recorded during coast down from overspeed. A spectrum plot is shown in Figure 2 of the gear accelerometer magnitudes recorded at 1785 rpm. In addition to the high accelerometer readings, an audible high pitched noise emanating from the gear box could also be heard. A spectrum analysis (Figure 3) of the sound pressure level was recorded with a microphone about 6.0 in from the side wall of the bottom of the gear box. Unfortunately, the 1785 rpm input speed to the gear, at which the problem occurred, was very close to the full load slip speed of the induction motor. The frequency at which these high accelerations occurred, 5720 Hz, corresponded very closely to the tooth mesh frequency. The gear had 196 teeth which created a tooth mesh frequency of 5831 Hz at 1785 rpm. The horizontal and vertical proximity probes at each end of both the gear and pinion did not exhibit any indication of the problem.

Figure 2. Gear Case Accelerometer Frequency (Hz  $\times 10^{-3}$ ).

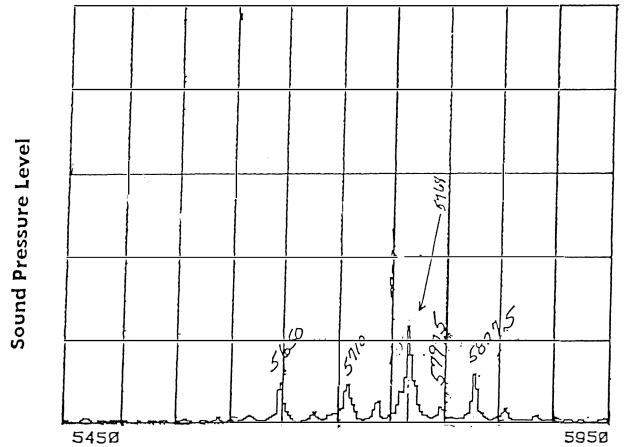
Figure 3. Sound Level Spectrum Hz. "Zoom" Range 5450 to 5950 Hz.

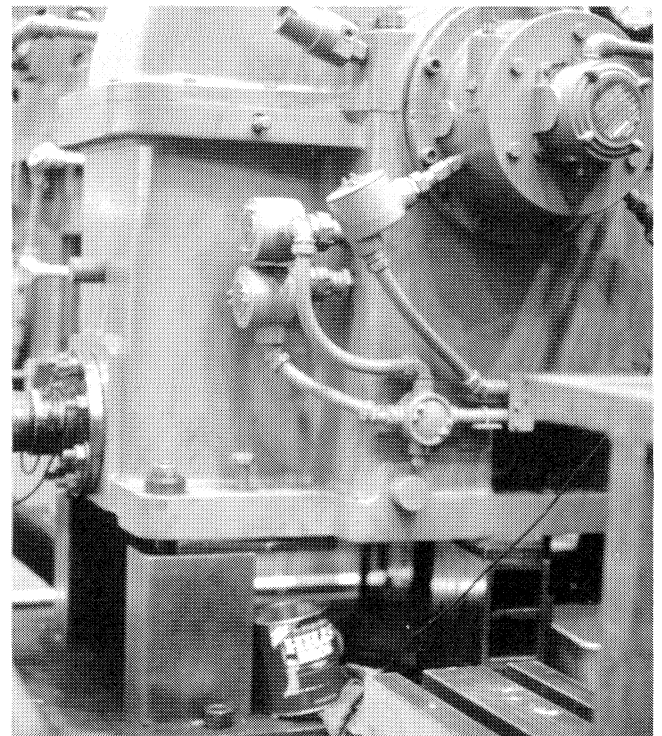
After the problem had been documented, A-C Compressor and the customer, who was witnessing the test, contacted Lufkin Industries, the gear vendor. Lufkin did not have an explanation for the problem and questioned the temporary gear test setup at A-C Compressor. The gear had been supported on a large massive cast iron support structure. "Riser" blocks were used at the four corners of the gear to adjust the gear shaft centerline to that of the test driver. The photograph in Figure 4 is used to depict the gear support during the test. Lufkin questioned whether the nonuniform support under the gear may be causing the problem. A-C Compressor had prior experience of test problems caused by support pedestals, however, the problem frequencies were less than 100 Hz.

Figure 4. Original Support under the Contract Gear.

The base was modified by replacing the “riser” blocks with a solid 5.0 in thick steel plate machined parallel on both sides (Figure 5). The gear was retested after the base was modified. The base modification did not eliminate or minimize the problem or alter the speed at which it had occurred.

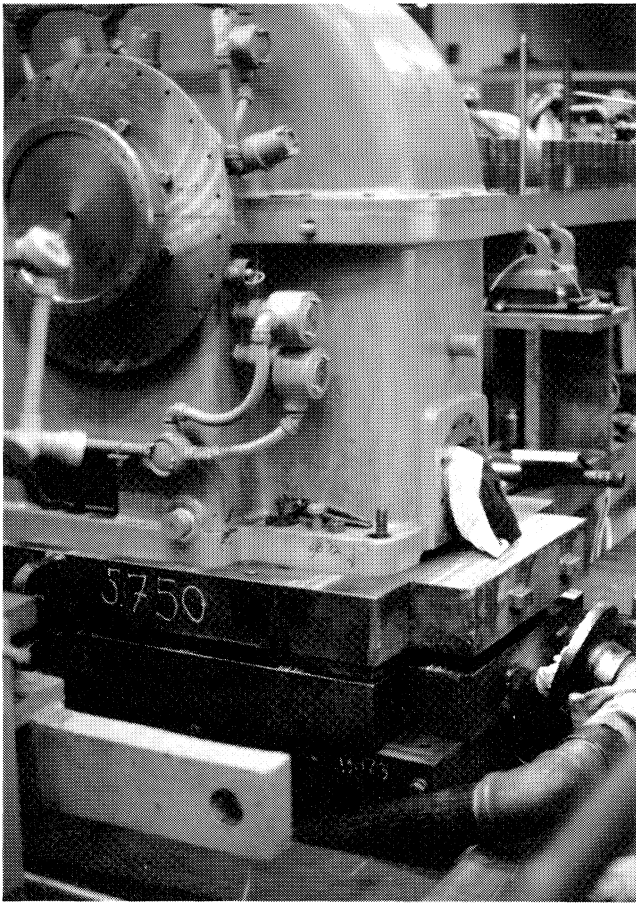
Figure 5. Contract Gear Test Support Modified with a 5.0 In Support Plate.

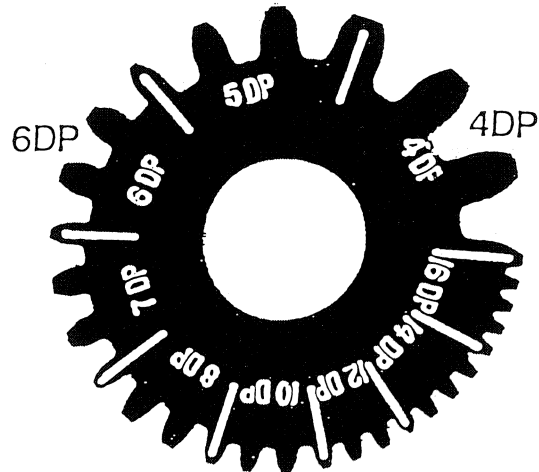
When the gearing details were compared, it was found that the two operating gears were constructed with a four diametral pitch, whereas the problem gear was constructed with a six diametral pitch. A comparison of diametral pitch is shown in

Figure 6. The design change was intended to increase the number of teeth in mesh to lower the noise level of the gearing. The result of the change had increased the tooth mesh frequency by 50 percent. The two operating gears had tooth mesh frequencies of 3088 Hz and 3956 Hz, whereas the problem gear had a tooth mesh frequency of 5831 Hz.

Figure 6. Gear Pitch Template.

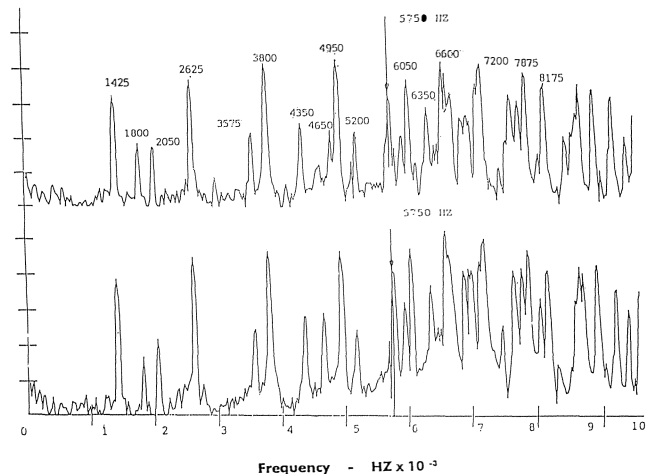
It was decided to remove the gear cover and “rap” test the gear and measure its resonant signature. Both the gear and pinion rested in their bearings during the test. A plot of the rap test is shown in Figure 7. A multitude of natural frequencies were found in this test but the most notable was a frequency found at 5750 Hz, very close to the accelerometer frequency of 5720 Hz, found during the shop string test.

Figure 7. Spectrum from Ring Test—Upper Plot Pinion and Gear in Gear Case. Frequency Hz.  $\times 10^{-3}$ .

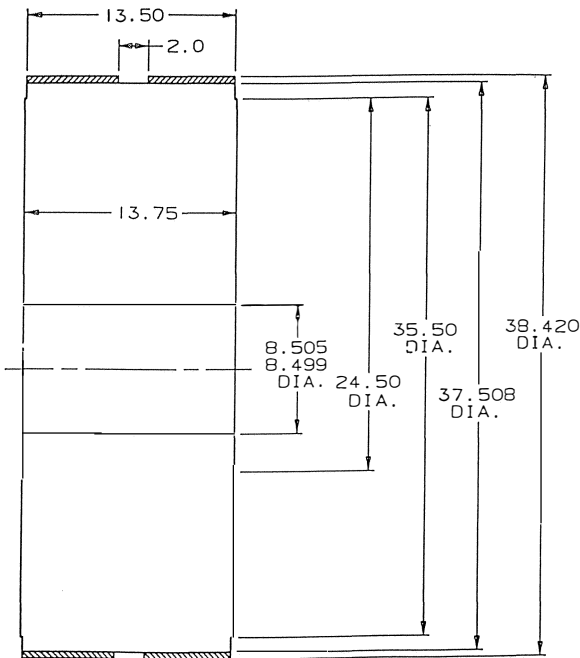
The results of the testing convinced everyone that the gear geometry should be altered to "retune" the gear. The gear geometry can be seen in Figure 11. The gear blank was a single piece forging approximately 38 1/2 in diameter and 13 1/2 in thick. It was shrunk and keyed on a 8 1/4 in shaft.

The first analysis was of the gear blank alone, as depicted in Figure 11, without a shaft. The model was an accurate representation of the machined details of the gear except for the gear teeth. The gear teeth area was modelled as the outer diameter of a simple cylinder with a diameter equal to the turned diameter between the helix. The calculation was evaluated through a frequency equal to twice the tooth mesh frequency. When the results were analyzed, it was determined that six disc modes did exist within this frequency range. In addition, it was revealed that for each of these disc modes there were complex mode shapes that included axial and/or radial displacements within a given circumferential “pie” shaped mode. The frequencies of this first analysis are contained in Table 1.

*Figure 11. Machined Gear Geometry (Original Design).*

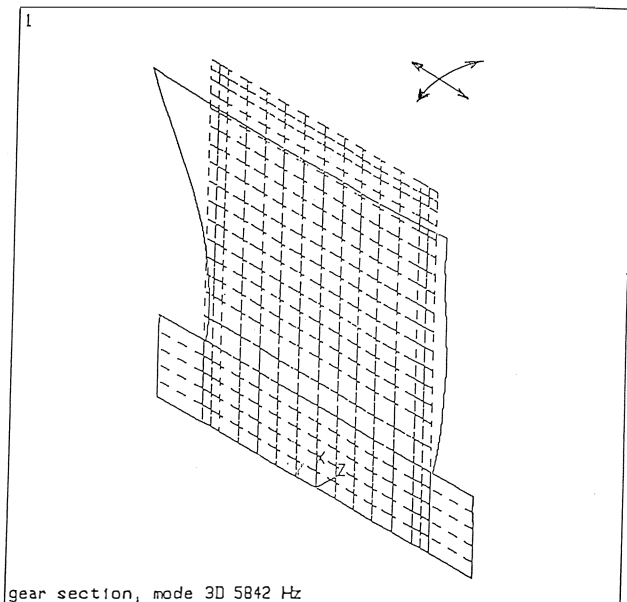
This mode is rather difficult to show in a planer plot. The side walls deflect axially out of phase with each other in conjunction with a substantial tangential deflection along the gear pitch line. This mode shape is depicted in Figure 15.

Figure 15. N-3D Gear Mode Shape (Original Design).

The previous electromagnetic testing had revealed a N-3 mode at 5767 Hz. The calculations revealed that there are two N-3 frequencies. A "C" mode existed at 5732 Hz and a "D" mode at 5842 Hz. The exciter test frequency, 5767 Hz, was 0.61 percent above the "C" mode and 1.28 percent below the "D" mode. The relative proximity of the test data and analytical results was very encouraging and indicated the finite element approach to redesign might indeed be successful.

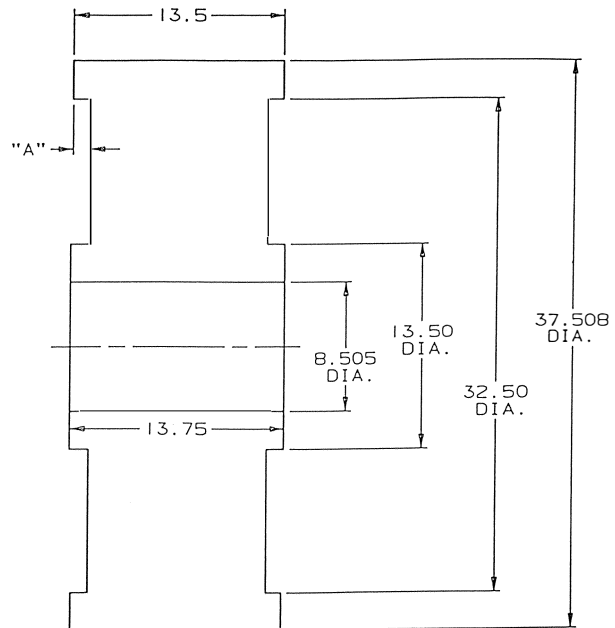
Two styles of redesigns were considered. Type 1 included coped side walls. A sketch of the modified design is presented in Figure 17. Two cope depths 1.0 in and 2.0 in were analyzed. The type 2 design included four 4.0 in diameter holes entirely through the gear, as shown in Figure 18. The analysis determined that the holes made very little change. The largest change of any frequency was 2.2 percent (Table 4). It was decided not to pursue this design.

Figure 17. Proposed Redesign with "Coped" Sidewalls of Depth "A."

The results are contained in Table 5 for the 1.0 in side wall coping. Previous testing had shown that the responsive frequencies, except for the N-2/C mode, were lower than calculated. The N-3/D mode was calculated to occur at 5917 Hz. If the modified design had the same test variance (- 2.0 percent) as the original gear, its modified N-3/D mode would occur at 5798.7 Hz. It was felt that this would be too close to the tooth mesh frequency.

The results are contained in Table 6 for the 2.0 in side wall coping. It is of interest to see that where the 1.0 in coping had raised the N-3/D mode 65 Hz, the 2.0 in coping resulted in a frequency only 12 Hz higher, an increase of only 0.2 percent above that of the original gear. In addition, the N-4/C mode had reduced to 5749 Hz a location for concern. This modification was obviously not the answer.

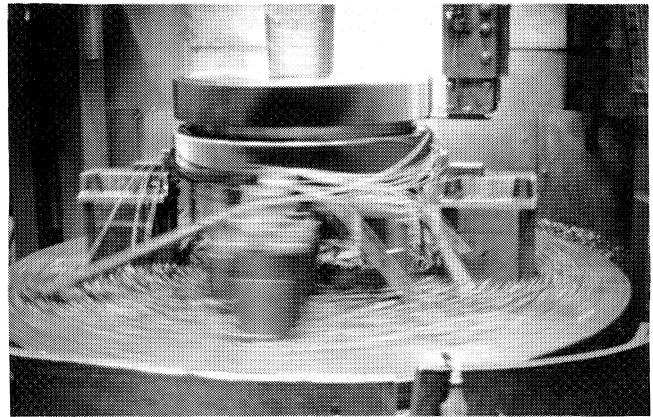
The remachining of the gear proved to be somewhat of a challenge. The gear was AISI 4340H through hardened to 335-377 Brinell hardness (335-377 BHN). It took nearly 24 hours of round-the-clock machining to recontour the gear. The gear was left mounted on the shaft for the remachining. A photograph of the remachined gear is presented in Figure 24.

Figure 24. Gear Being Machined for the Modified Design Center Groove Addition.

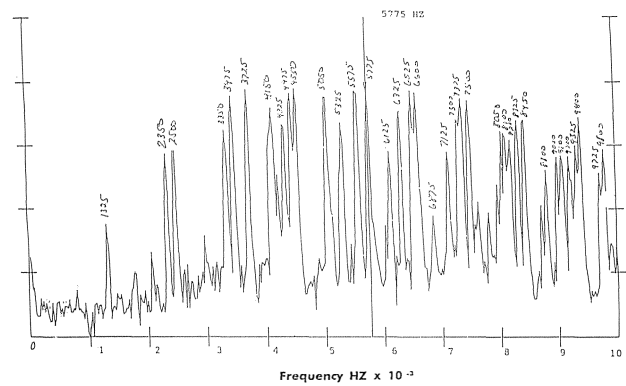
resonant frequencies. Unfortunately one of the peaks occurred at 5775 Hz, only 25 Hz different from the original gear design. This frequency appeared whether the hammer blow was given in the radial or axial direction. The signature of the machined gear is represented in Figure 25.

Figure 25. Spectrum from Ring (Modified Design). Frequency Hz  $\times 10^{-3}$ .

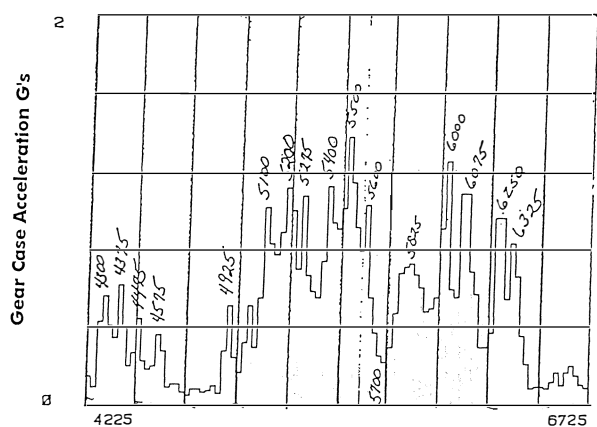
Shortly after the calculations were completed, the gear was retested. To the amazement of all involved, the gear accelerometer never registered above 2.0 Gs throughout the range of operation up to and including overspeed. A peak hold plot is shown in Figure 26 of the accelerometer on the gear.

Figure 26. Peak Hold Gear Case Acceleration (Modified Gear Design) "Zoom" Range 4225 to 6725 Hz.
