TEMPORARY REPAIR OF A LARGE AXIAL BLAST FURNACE MOTOR-BLOWER AS A SOLUTION FOR A STEEL MILL OPERATIONAL CONTINUITY

Promentec Ltd.

Brazilian National Steel Company

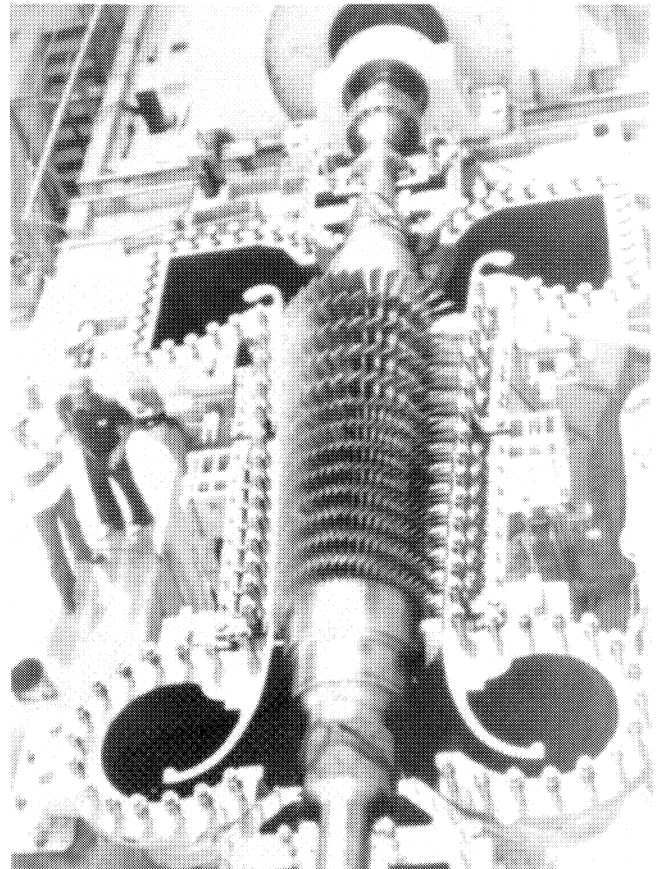
Figure 2. View of Open Blower Showing Blade Arrangement.

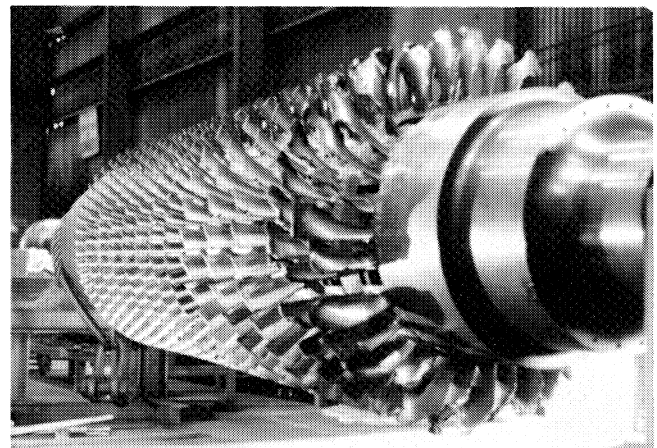
Figure 3. View of Damaged Rotor Blades.

Inspection of the broken blade roots indicated fatigue crack propagation and visual signs of fretting corrosion. This fact also brought a concern about the other Number 1 motor-blower that could be in similar condition, as the cumulated operating time was about the same for both blowers.

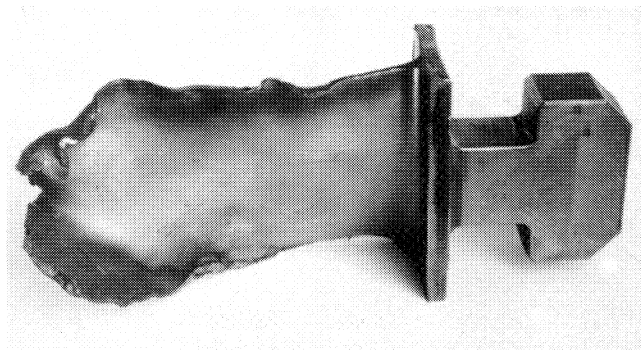
Figure 4. View of a Damaged Airfoil of a First Stage Blade.

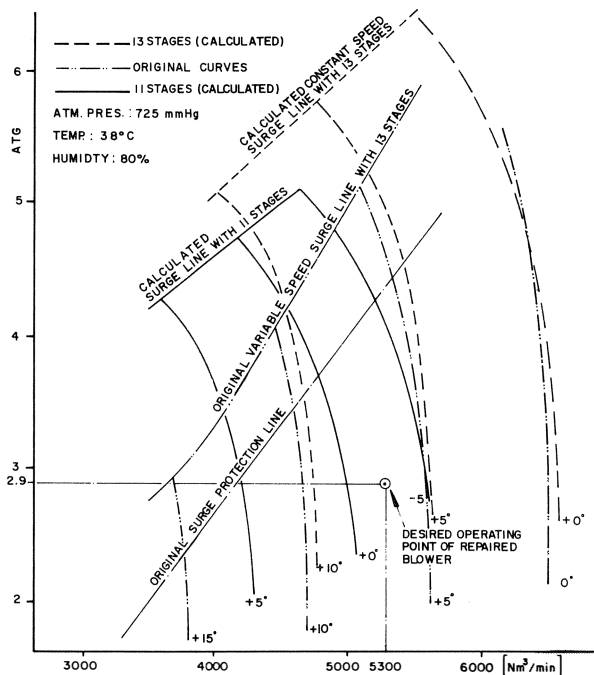
It was necessary to demonstrate to the steel company that even with the reduction in capacity (with only 11 stages instead of the original 13 stages), the blower could still meet their production needs. The original blower performance curves with 13 stages were duplicated by computer simulation to determine the basic parameters [1], and a new set of curves were generated using the parameters for the remaining 11 stages. The original surge limits were retraced, and a new operating range was determined (Figure 5). Meanwhile, CSN determined their minimum needs of air flow and pressure to attend the production with blast furnaces 1 and 2. The corresponding point was within the new operating range with enough margin for surge protection as indicated. In this way, it was quite sure that the existing settings of the surge protection system would not have to be altered.

Figure 5. Original (13 Stages) and Modified (11 Stages) Performance Curves.

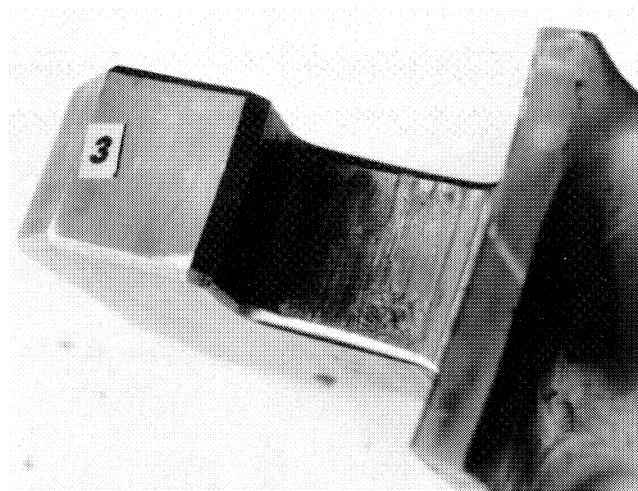
On the first visit to the plant for a visual inspection of the blower after the accident, clear signs were observed of fretting on the "neck" of the inverted "T" type root (Figure 6) of broken blades in their contact surfaces with the rotor grooves. Those surfaces presented a thin layer of a typical reddish brown color oxide. All blades generally were found loose in their grooves, and they could easily be moved by hand [2]. Although the centrifugal force in normal operation would keep the blades forced against the "shoulders" of the inverted "T" grooves, the freedom of the blades to make small movements within the existing clearances between them was the most likely cause of fretting.

Fretting corrosion was confirmed in a study made by a specialized research institute [3]. All cracks initiated on those contact

Figure 6. View of a First Stage Blade Root Showing Fretting Corrosion.

In order to improve the resistance of the roots of repaired blades against fretting corrosion, it was decided to shot peen the lateral surface of the root. This process could inhibit potential microcrack development and crack propagation by fatigue. The surfaces of the blades were also micropeened with jets of glass beads oriented from the base to the tip to ensure an adequate and uniform surface finishing and reduce any residual stress concentration.

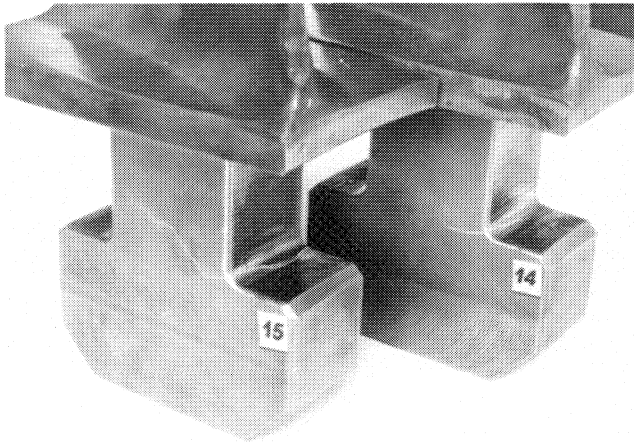
surfaces and propagated transversely across the root neck (see Figure 7). Micrographic analysis also indicated that several other microcracks existed on those surfaces.

Figure 7. View of Cracks in Blade 14 of First Stage and Blade 15 of Second Stage.

The fretting that resulted was most likely due to a process in which the initial blade close clearance was slowly increasing with time, allowing the increase in the relative movement. The crack propagation was then due to fatigue process caused by the combination of high static centrifugal load and the variable stresses due to blade vibration. The blade root surfaces were showing a poor finishing, as there were clear machining marks and irregular surface roughness in the original blades (Figure 8), and this problem certainly made conditions favorable for fretting to occur. The spare blades in stock had been recently ordered by the steel company, and the surface finish of the root surfaces was superior, when compared to the original blades.

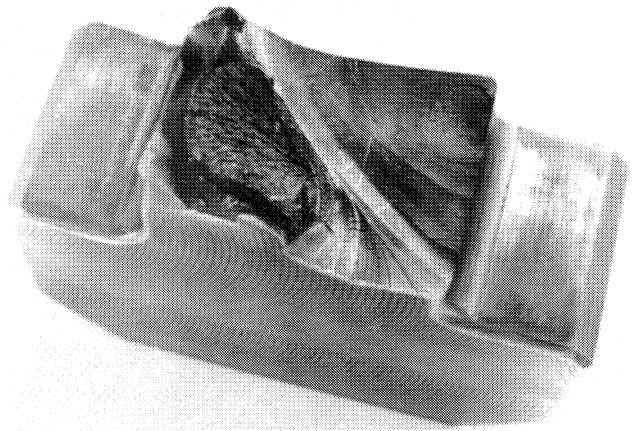
Figure 8. Machining Marks in a First Stage Blade Root and Typical Fractured Neck.

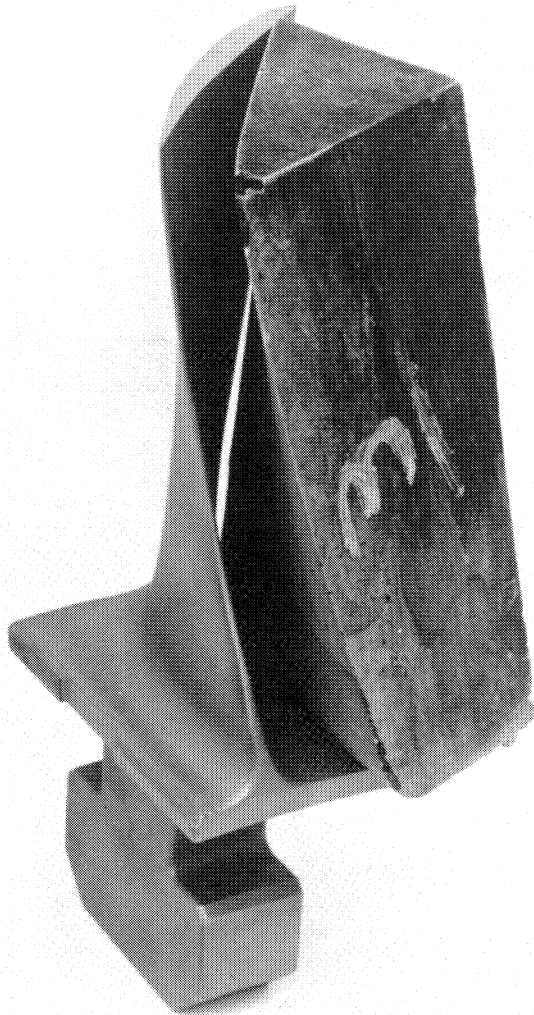
Figure 9. Template and Repaired Blade.

Damaged blades were first mechanically straightened and the original profiles were manually restored by trained personnel, using templates specially prepared, based on the shape of new blades (Figure 9). In particular, the smoothness of the curvatures and the angles of leading and trailing edges were carefully controlled to keep them as close as possible to their original values. To make this possible, a "production line" was prepared, and each individual blade was selected and repaired in accordance with the classification previously made to avoid working on excessively damaged ones.

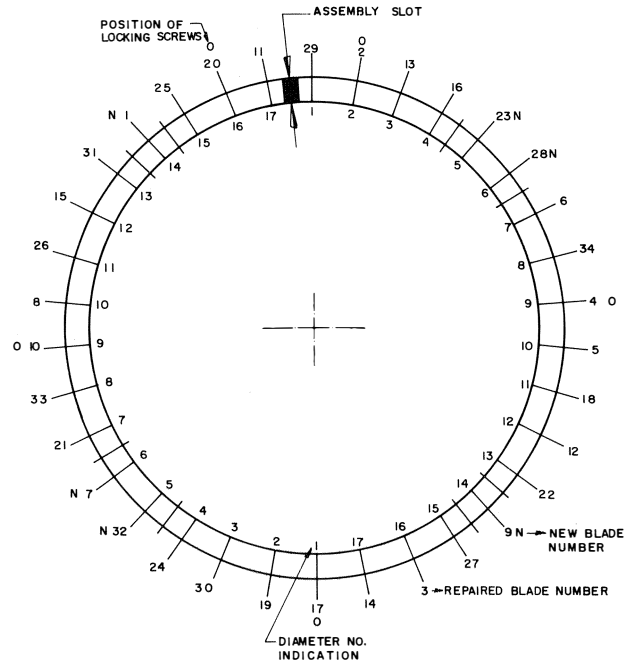
Figure 10. Example of a Weight Distribution Sheet for Rotor Blades.

The repaired and new spare blades prepared for each of the rotor stages were carefully weighed to a tolerance of one gram, and groups of blades were made to arrange equal weight blades in opposite sides on the mounting grooves in order to minimize final unbalance due to weight distribution around the rotor (Figure 10).

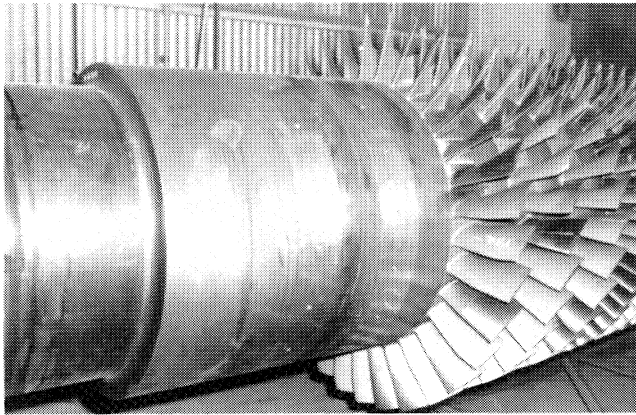
Figure 11. View of the Repaired Rotor.

After finishing the assembly work, the rotor first and second stage rows were machined flush to the shaft surface to allow an undisturbed air flow. The tips of the other blades in each row were ground to their original heights to keep the previous existing clearances (Figure 11).

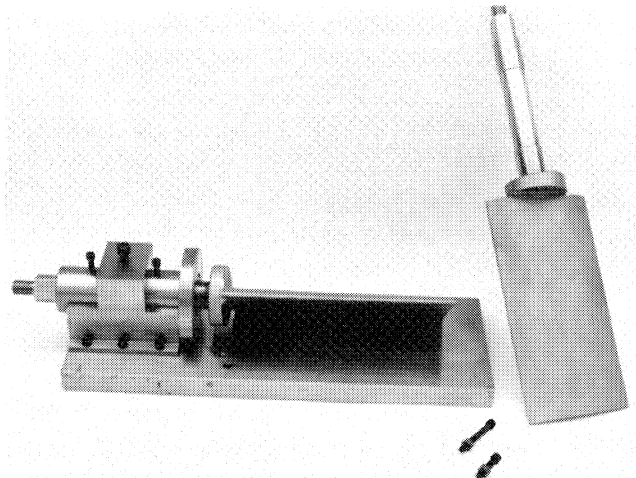
Figure 12. Template for Stem and Airfoil Straightness Check.

was checked for straightness to ensure freedom of movement of rotation in their bushings, and each blade airfoil surface was checked for any bend or twist by means of specially made templates (see Figure 12).

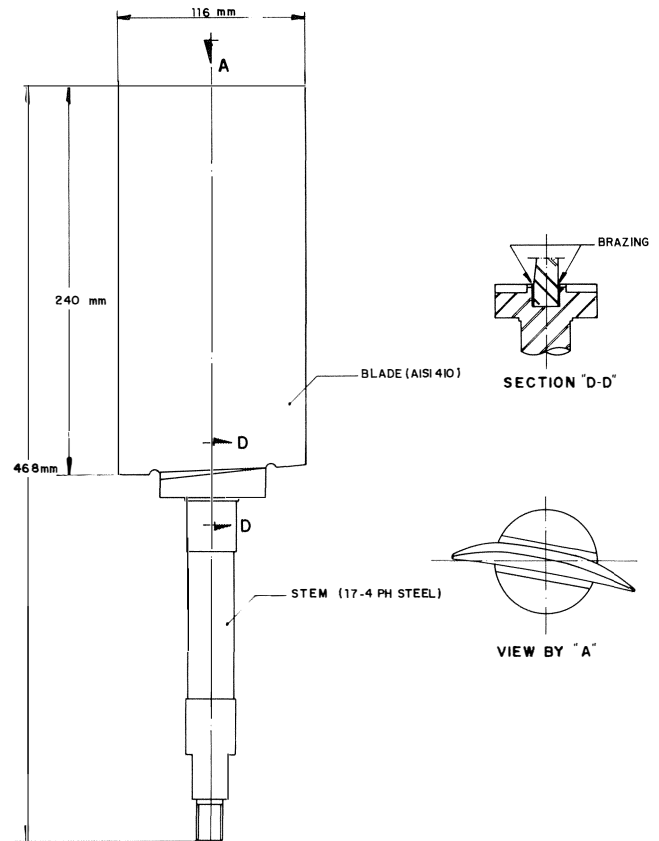
Figure 13. New Inlet Guide Vanes.

With the elimination of the original inlet guide vanes and the first stage stator blades, it became necessary to install a new set of inlet guide vanes at the inlet of the third stage. The time necessary to get special forgings, and the machining time to manufacture a complete set of new integral guide vanes, would result in a large increment of cost and repair time. Thus, a special design was developed in which the blade and its shaft were separately manufactured and silver brazed together (Figure 13).

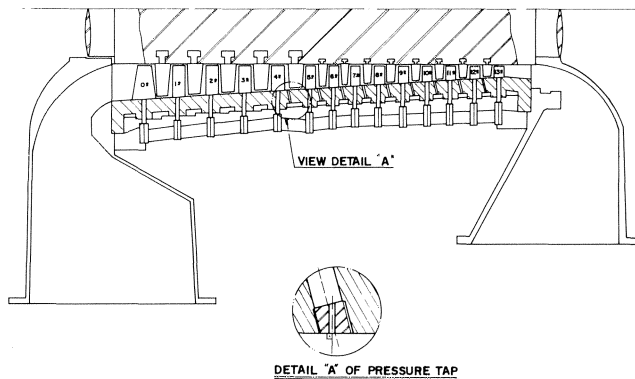
Figure 14. Lower Casing with Holes Made for Pressure Taps.

In the plant, the cast iron stator casing was cleaned to remove all residual blade material that had been stuck to its internal surface due to the heavy friction. Nine holes were drilled at the bottom of the lower half (Figure 14) to install pressure gauges to monitor the pressures between stages as a reference for stator blade angle adjustment in case of surge problems. All burrs and nicks were

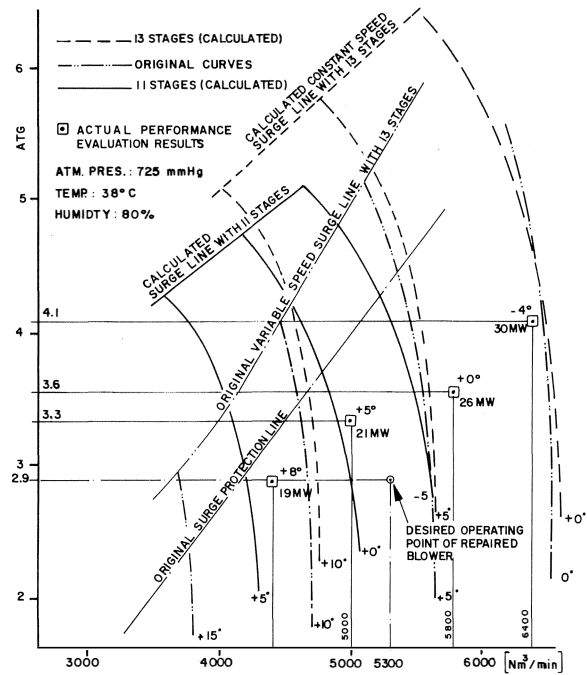
several performance points that were obtained are indicated in Figure 19. In particular, the point 4 was enough for the blower to supply air to the blast furnace Number 3. The previous expected condition was intended to supply air only to the blast furnaces 1 and 2, which required less air flow.

Figure 19. Results of Performance Evaluation.
