MAJOR FOUNDATION REPAIR OF A TWENTY TON CENTRIFUGAL COMPRESSOR

Walter L. Garrett

Rohm & Haas Texas, Inc.

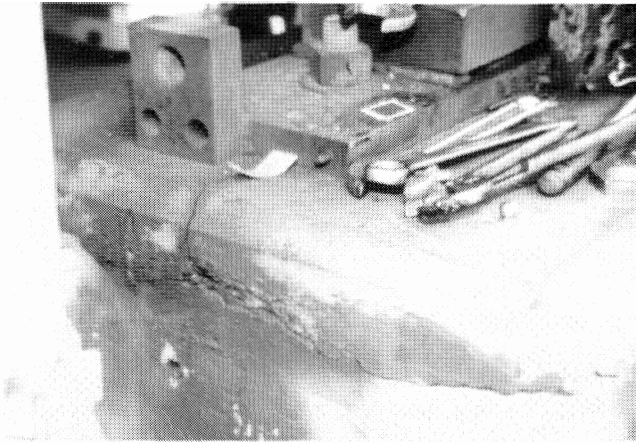
Figure 1. Cracking in the Grout After 15 Years of Service.

foundation had not been properly prepared, as well as the corners and bottom of the soleplates had not been rounded, forming stress risers.

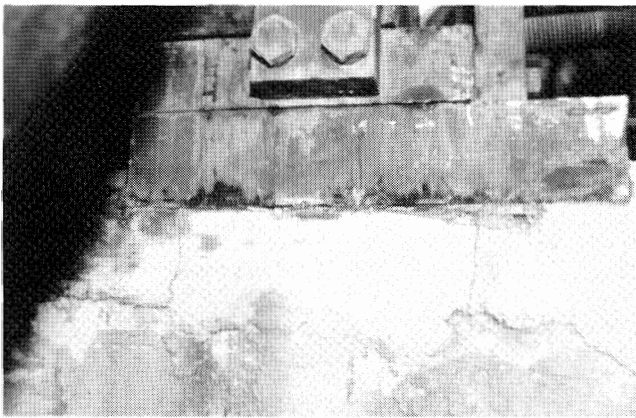
Figure 2. Soleplates with Squared Corners.

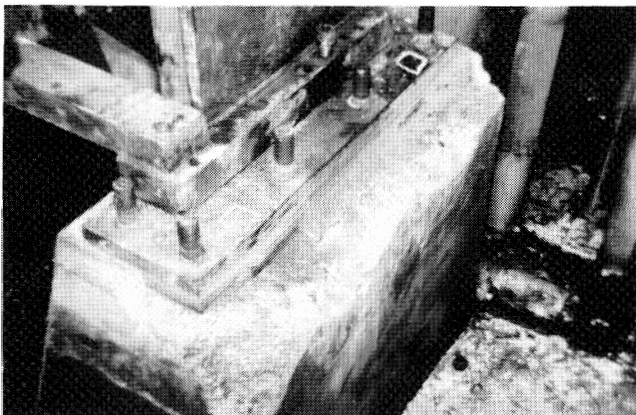
Figure 3. Grout Was Broken Easily with a Strike of a Hammer.

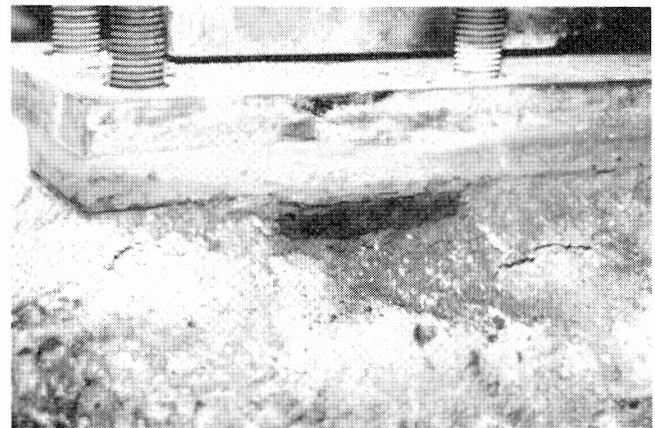
Figure 19. Soleplate Resting on the Chock Block, Not the Grout.

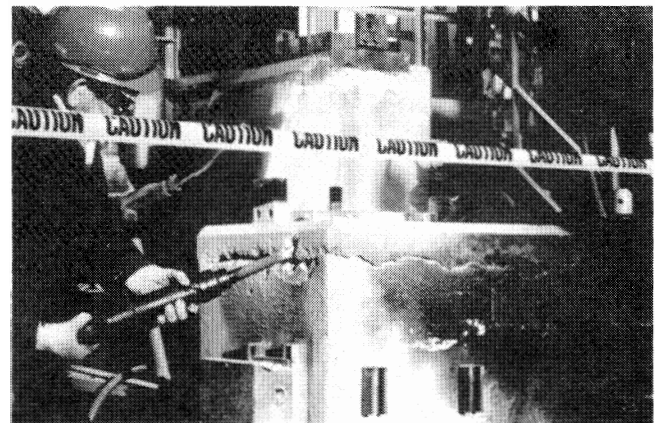
Figure 20. Chipping of Existing Grout Should Begin between the Concrete and the Grout.

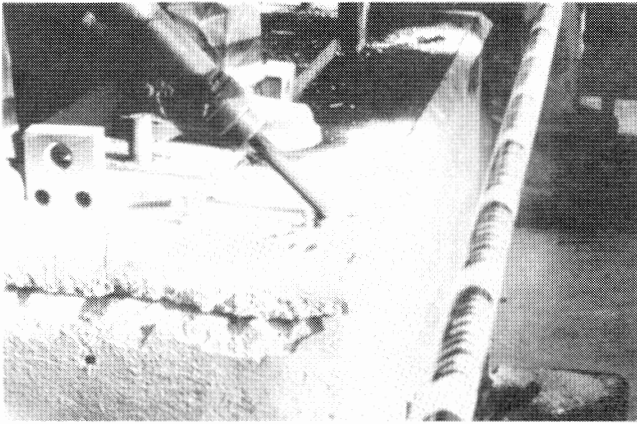
Figure 21. Chip Off Pieces of Grout after Breaking the Bond with the Concrete.

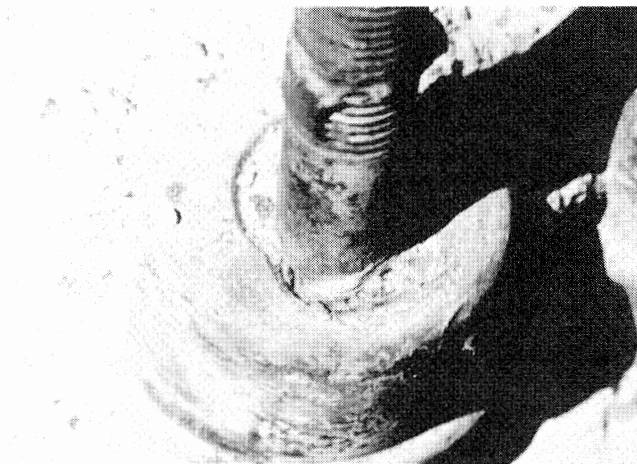
Day 5: After the grout and mounting rails were removed, it was discovered that epoxy grout had filled the anchor bolt sleeves (Figure 22). This grout must be removed in order for the anchor

Figure 22. Anchor Bolt Sleeves Were Filled with Grout. Not a good practice.

Step 3. Foundation bolts shall be covered with duct seal over the entire exposed length. Sleeved space in the foundation shall be packed with a nonbonding compliant material to prevent the annular space around the anchor bolt being filled with epoxy.

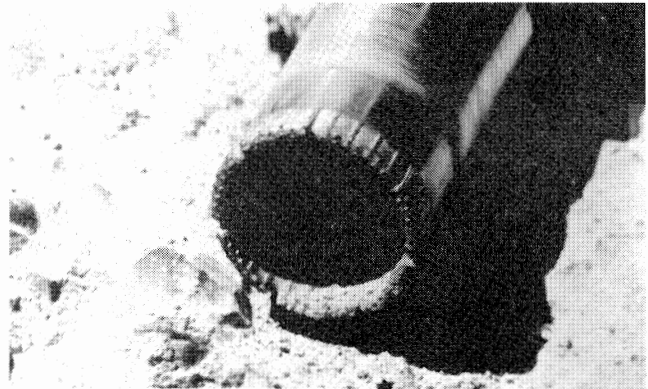
Figure 24. Trepan Tool Used to Cut the Annulus around the Anchor Bolt.

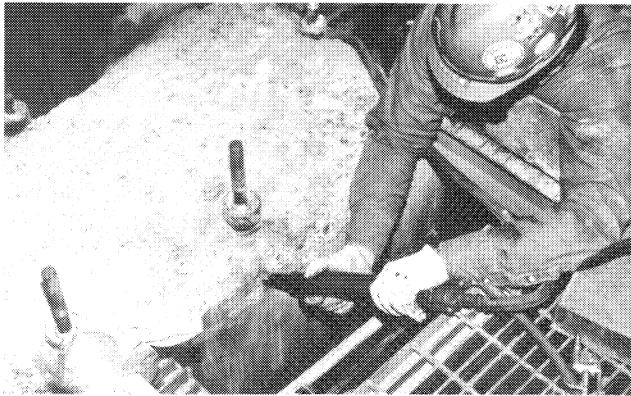
Figure 27. Chipping Away of the Oil Stained Concrete.

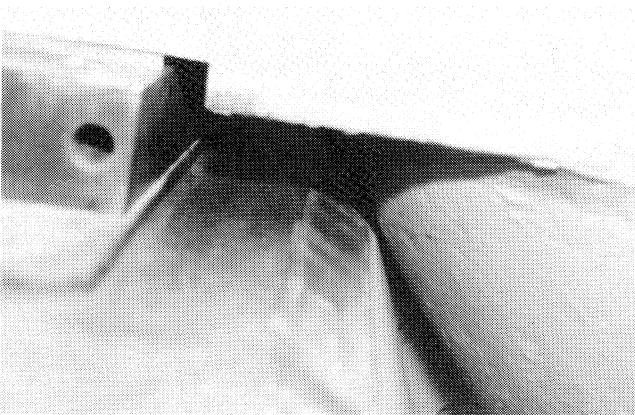
Figure 55. Compressor Case Contacting the Grout.

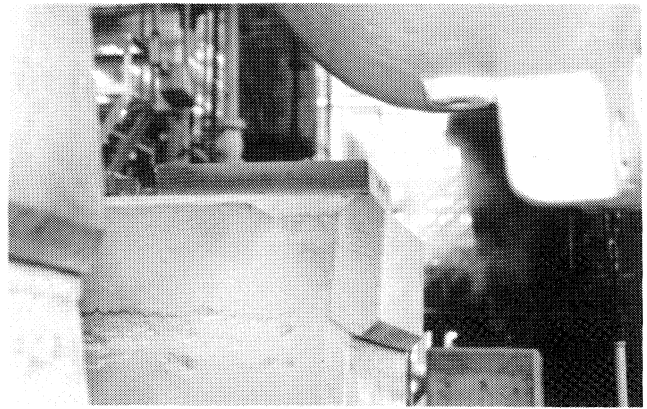
Figure 56. Area of Grout Contacted Relieved by Grinding.

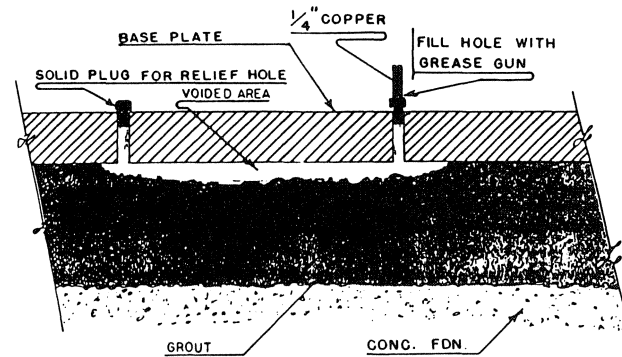
Figure A-2. Baseplate with Void.

Step 7. If voids are found, a hole shall be drilled in the soleplate at each end of the void. The void is then filled without aggregate (one of the holes will be used as a fill hole, the other as a vent). A grease gun and fitting are normally used for the application Figure A-2.
