# REAPPLICATION OF AN INDUCTION STEAM TURBINE TO EXTRACTION COGENERATION SERVICE

**Richard E. Nemec**

**Barnett F. McLaughlin**

## ABSTRACT

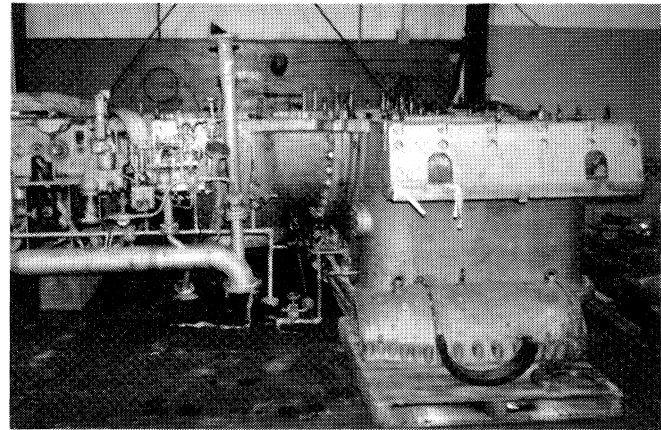
Figure 3. Turbine Lower Half Case as Purchased. Note existing governor relay system.

The internal investigation revealed that the equipment was in excellent shape with the exception of the first five stages of the turbine. A leaking high pressure trip and throttle valve had admitted hot steam condensate into the front section of the turbine causing mild corrosion, rust, and pitting damage to the blading and rotor disks. The inspection was limited to splitting the turbine case and one bearing. No other equipment was disassembled at this time. The good condition of the rotor and case is essentially attributed to the fact that the refinery had kept up continuous warm oil lubrication and weekly shaft rotation from the date of shutdown until demolition and removal six years later. These practices minimized corrosion damage from the presence of the hot condensate.

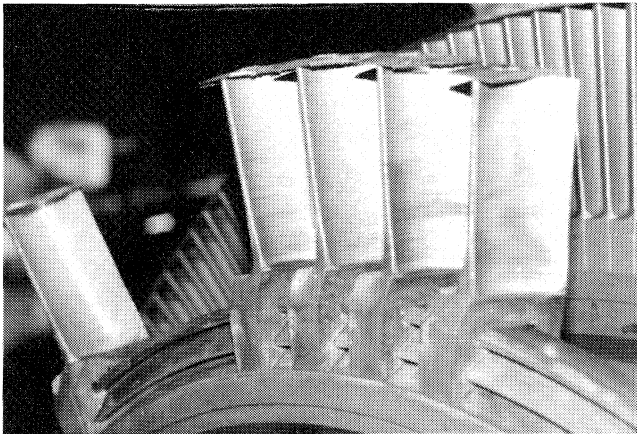
The turbine condensing section was also a cause of concern. Although the first extraction (sixth) stage would be modified for a maximum 170,000 lb/hr flow, the remaining stages were physically capable of passing nearly 350,000 lb/hr steam flow. Two potential problems existed. The first was that at low steam flow, below 50,000 lbs/hr (Figure 4), the blades would be moving faster than the steam. Moisture droplets formed in the last stages would cause rapid erosion and increasing drag losses. Removal of the last stage was considered, but rejected for the following reasons. At four inch HgA condensing pressure, the maximum flow that the remaining stage could pass without going into "shock" flow is only 130,000 lb/hr. At two inch HgA, which is the normal winter condensing pressure in this climate, the maximum flow would be only 65,000 lb/hr. Since the turbine was expected to operate as a spare for the existing 17 MW condensing turbine generator, 130,000 lb/hr flow was considered below the requirement for condensing capacity. In addition to flow restriction, removal of the last stage decreased overall efficiency significantly.

Figure 4. Sixth Stage Blading Before Modification in Removal Process.

As previously stated, a major obstacle was excessive blade stress in the stage after extraction, stage six. The ideal solution would have been a new redesigned stage, however, due to time constraints, modification was the chosen alternative. The extraction stage was modified by shortening the blades and welding specially machined inserts into the diaphragm to maintain efficiency while reducing blade stress. Performance and blading studies were conducted on these modifications (Figure 4).

The turbine redesign study required that the stage six row of rotating blading and the mating diaphragm openings be shortened (reduction in area). Stage six rotating blades were marked for location and removed. Blade height reduction, incorporating new tenons, was machined by standard methods, including surface treatment with shot peening (Figure 8). Stage six blades were reinstalled, shrouds fit and tenons hydraulically upset. Ultrasonic testing and shroud trimming completed the stage six rotating blade revamp.

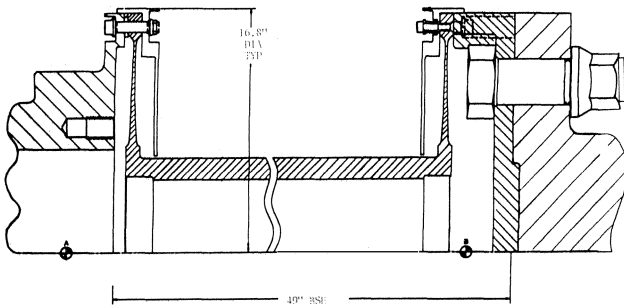
The generator and steam turbine were not a matched set. A new dry coupling was selected and installed to replace the original geared coupling (Figure 5) on the steam turbine and the solid coupling originally used on the generator. There were also many minor changes such as the addition of vibration and temperature probes required to bring the entire package up to current API standards.

Figure 5. Coupling Design.

The coupling selection received a great deal of attention. In addition to the previously mentioned lateral and torsional analysis, a coupling consultant was contracted to audit the design. The successful coupling bid was scrutinized for low windage, ease of maintenance, design reliability and, of course, cost and delivery.

This detailed analysis resulted in several suggested modifications to the manufacturer's standard design. Some changes, which were believed to be improvements, were reluctantly accepted by the vendor while many modifications were strongly resisted. The final contract design was a 49 in diameter between shaft ends (DBSE) diaphragm coupling with a custom adapter to match the existing generator's integral hub (Figure 5). The long coupling was required so as to provide adequate access room between the turbine and the generator.

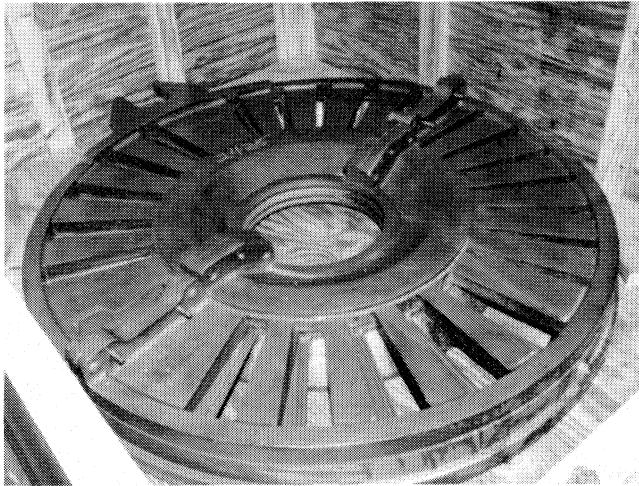
Figure 6. Grid Valve Assembly.

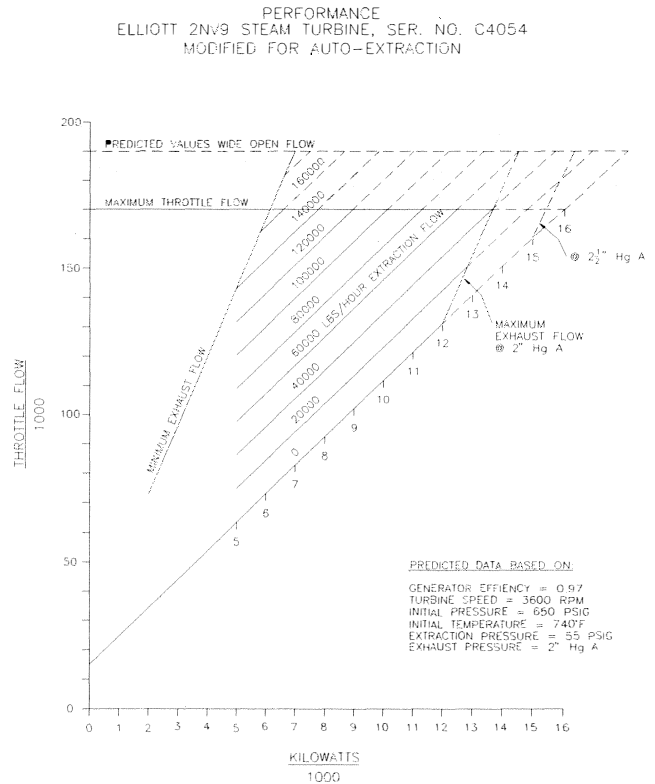
After review of all design goals, a reasonable compromise was reached and the rehabilitation of the turbine with new COS could go forward (Figure 7).

Figure 7. Performance Map After Modification.

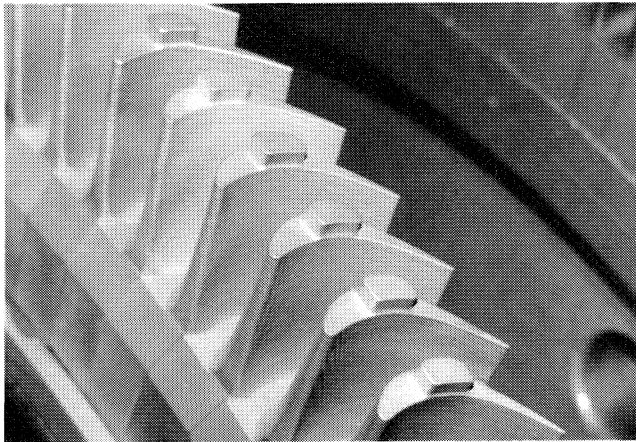
Figure 8. Sixth Stage Blading After Modification in Installation Process.

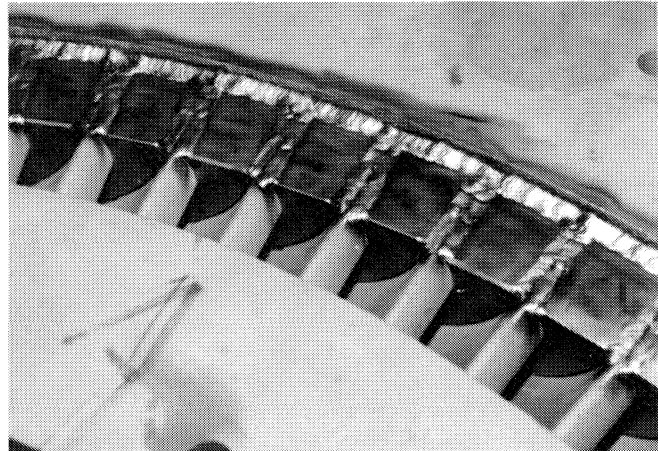
Figure 9. Sixth Stage Diaphragm After Filler Blocks Installed.

Modification to the stage six diaphragm was somewhat more difficult. Area reduction required installing three-dimensional fillers between vanes of the diaphragms (Figure 9).

Epoxy molds were made and tried in each vane opening. A compromise shape was finalized and a complete set was machined on a special purpose milling machine. Individual dressing on each filler piece allowed for very close fits; the fillers were secured by welding. Thorough nondestructive testing

completed the grid valve diaphragm modification. Modifications to bearings/housings were made to allow for temperature and vibration sensing elements. Valve chest parts were renewed where required.
