FAILURE OF TURBOMACHINERY COMPONENTS

Paul Lowden

Joseph Liburdi

Liburdi Engineering, Limited

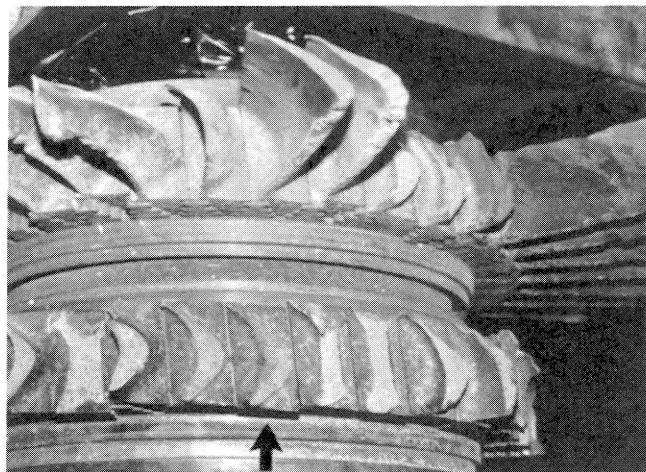
The first task of the metallurgist is to sift through the wrecked or cracked components looking for the piece that started the event, so that the laboratory analysis can be performed on the most significant (representative) fractures. This is often accomplished by visually reviewing both the overall appearance of the wreck as well as examining individual pieces for evidence of prior cracking (Figure 1).

Figure 1. Blade Root Section (Identified by the Arrow) Chosen for Analysis Due to Its Discoloration. This blade was found to have failed in creep, causing the remainder of the damage.

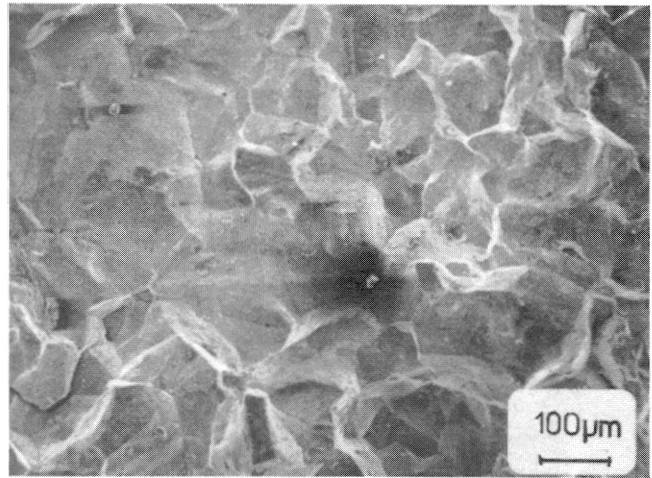
Figure 3. Creep Region of the Fracture Shown in Figure 2, Illustrating the Intergranular Nature of Creep Crack Growth.

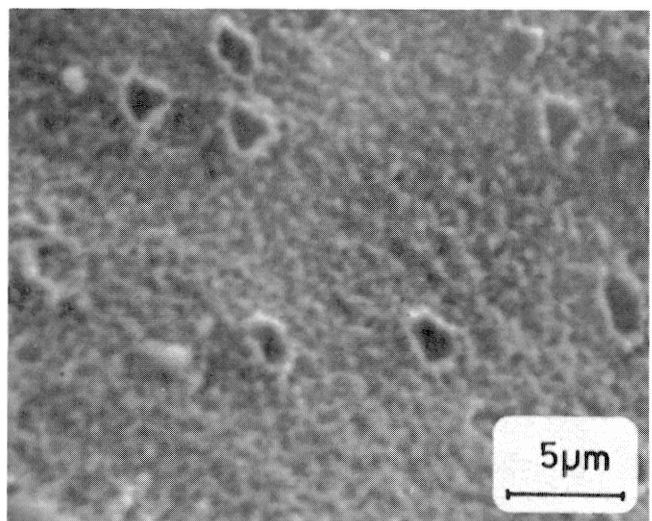
Figure 4. Voids Just Ahead of the Main Creep Crack in Figure 2.

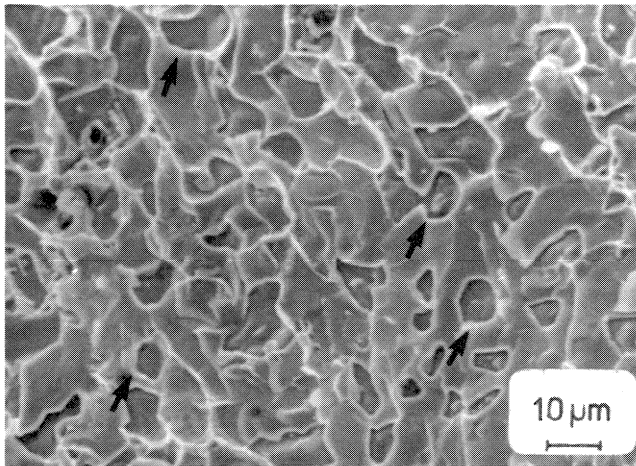
Figure 9. SEM Fractograph of Voids Formed by High Temperature, Low Cycle Fatigue in the Cracked Vanes Shown in Figure 8. The cavities are generally larger and more numerous than those formed by pure creep mechanisms, allowing the two modes of failure to be distinguished.

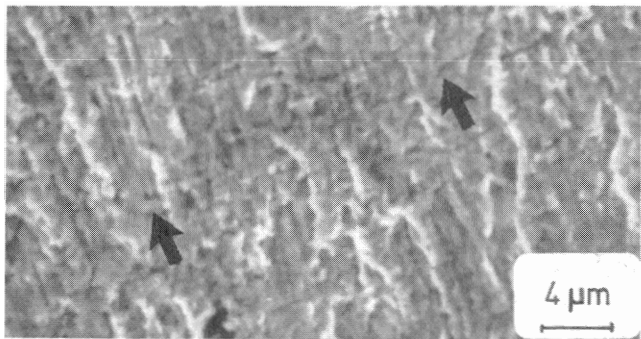
Figure 18. SEM Fractograph Showing Fatigue Striations Typical of a High Cycle Fatigue Mechanism.

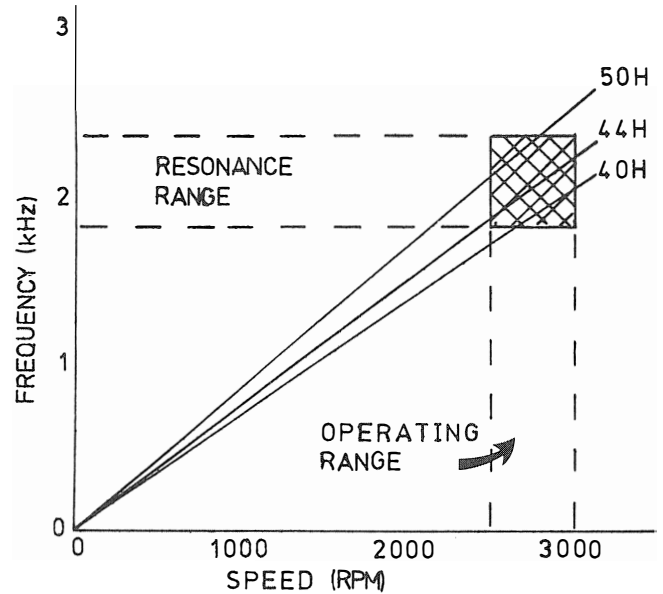
A mechanical analysis was performed to determine whether some feature of the design may have predisposed the blade to fail in fatigue. It was discovered that the natural vibration frequency of the blade in the third transverse bending mode was potentially in resonance with the excitations caused by the inlet guide vanes and first and second rows of stator vanes at normal operating speeds (Figure 19). Cracks occurring by this mode would be expected to initiate at approximately 75 percent of the airfoil height, at the point of highest bending stress which, for this particular airfoil geometry, is on the convex side. This exactly corresponded to the observed initiation point of both the crack and the fracture of the failed blade. Thus, the major mechanical factor contributing to the failure was the resonance of the blades with the preceding stator stages.

Figure 19. Campbell Diagram Showing Fatigue Excitation Resulting from Harmonics of the Running Speed. The excitation resulting from the inlet guide vanes and row 1 and row 2 stator vanes is resonant with the blades' natural vibration frequency in the third transverse bending mode.
