ON STREAM SOLUTION OF A PROTOTYPE 8000 HP MOTOR INSTABILITY PROBLEM

Perry C. Monroe, Jr.

Dana J. Salamone

ABSTRACT

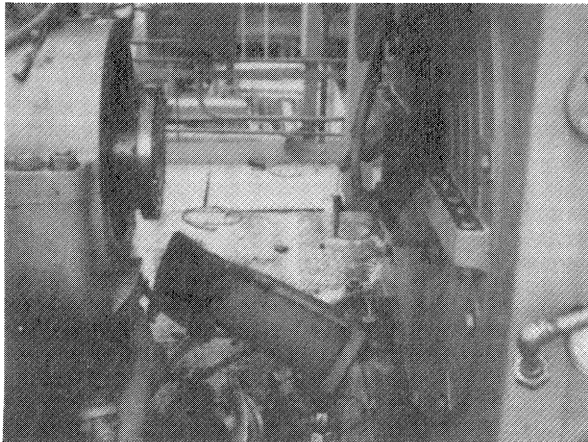
Figure 2. Compressor on Left and Inboard Motor at Right. Note Half of Coupling Guard and Damaged Oil Piping.

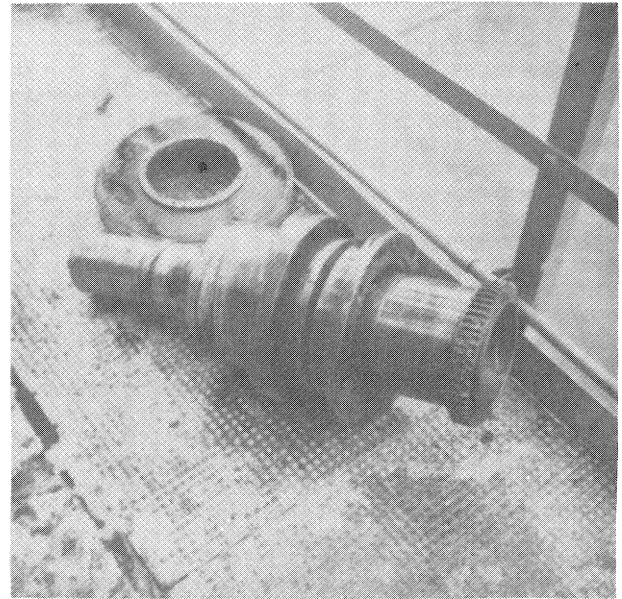
Figure 3. Inboard Motor Shaft and Coupling.

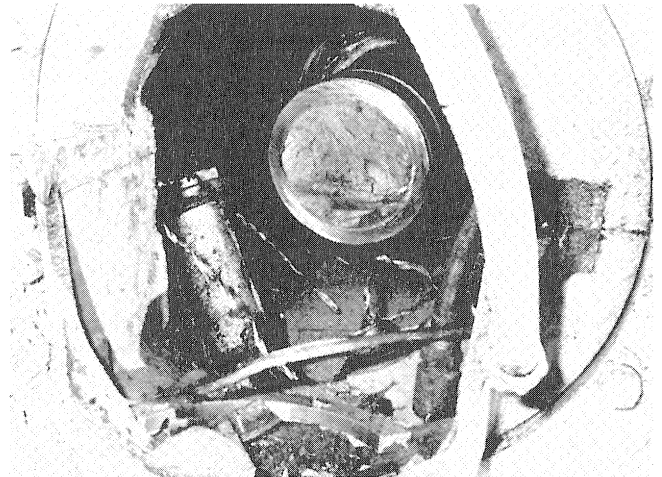
Figure 4. Looking Through Damaged Bearing Housing of Inboard Motor at Broken Shaft End.

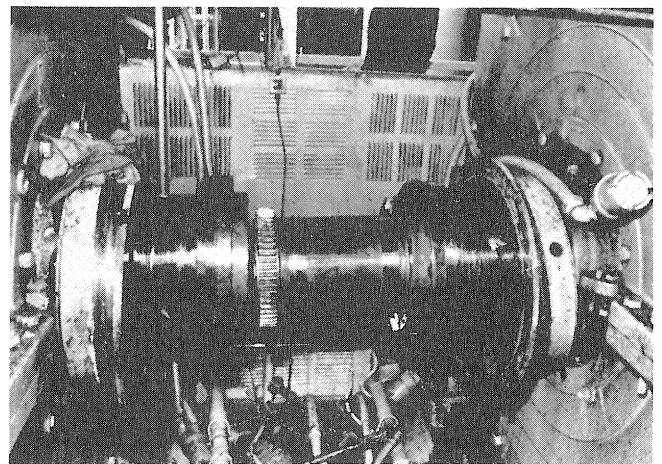
Figure 5. Condition of Coupling Between the Two Motors After Removal of Guard.

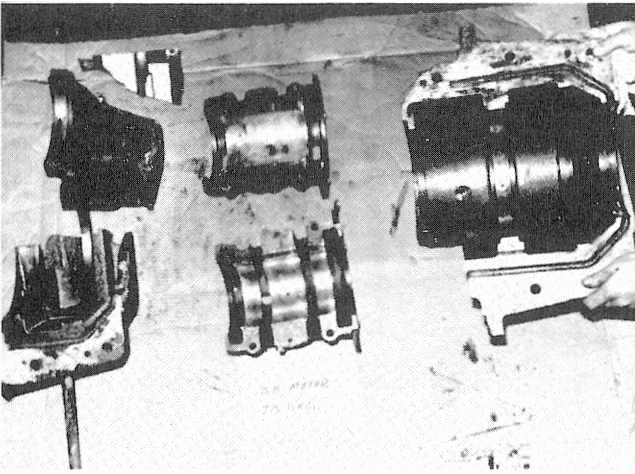
Figure 6. Part of Lower Bearing Housing at Left and Upper Housing at Right. Note Minimum Babbitt Damage from Radial Loads, but Severe Axial Shear Damage to the Bearing Shoulder.

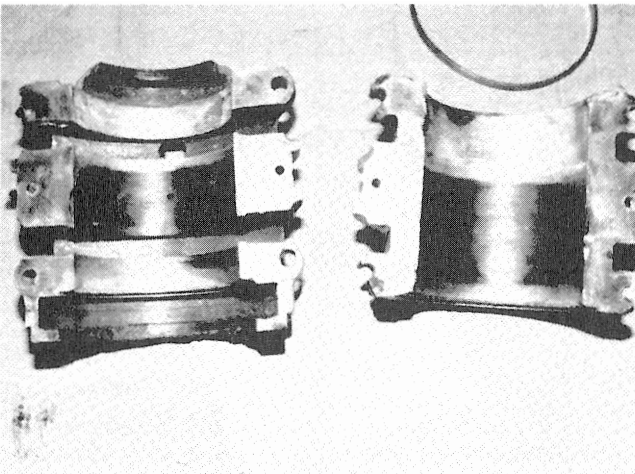
Figure 7. Outboard Bearing of Inboard Motor—Top Half on Left. Note that all Babbitt Damage from Radial Loads, but Severe Axial Shear Damage to the Bearing Shoulder.

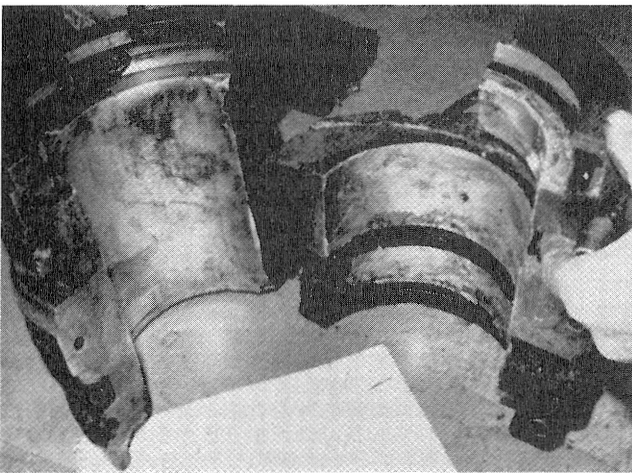
Figure 8. Inboard Bearing of Inboard Motor. Note Only Impact Type Damage to Babbitt and Shell.

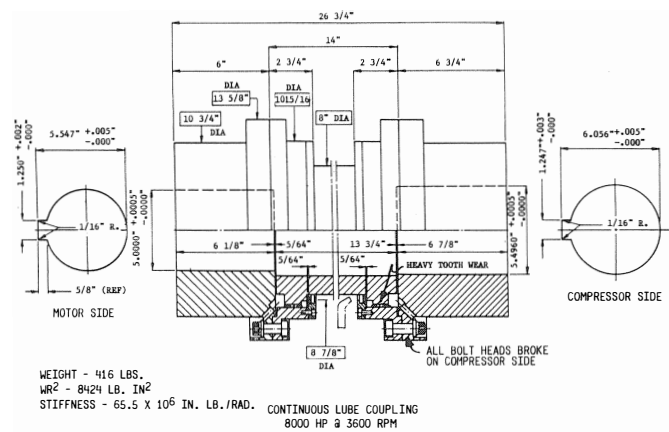
Figure 9. Continuous Lube Coupling, 8000 hp/3600 rpm.

Figure 9 illustrates the heavy tooth wear on the compressor side coupling shroud and hub, as well as the bolt head failures. Because of the extensive damage, reconstruction of the initial failure point was impossible. However, after talking to the coupling manufacturer, it was felt that a failure of the compressor-motor coupling was the cause of damage to the outboard bearing of the inboard motor. This led to the coupling bolt head breakage, which caused the coupling spacer to rotate off center and out of balance with the motor. The rotating wedge action of the coupling spool between the motor and compressor shafts produced a heavy axial impact load that fractured the motor bearing housings. Rotor and stator damage to the inboard motor caused a phase-to-ground short, which shut the compressor train down.

Examination of the compressor train files revealed a history of rapid gear tooth wear on the compressor-motor coupling. In 1978 the coupling specification was changed to incorporate nitrided gear teeth, in order to reduce this tendency. A nitrided coupling was not available during the 1980 downtime, so standard couplings were installed. Excessive gear tooth deterioration was very likely after twenty months of operation.

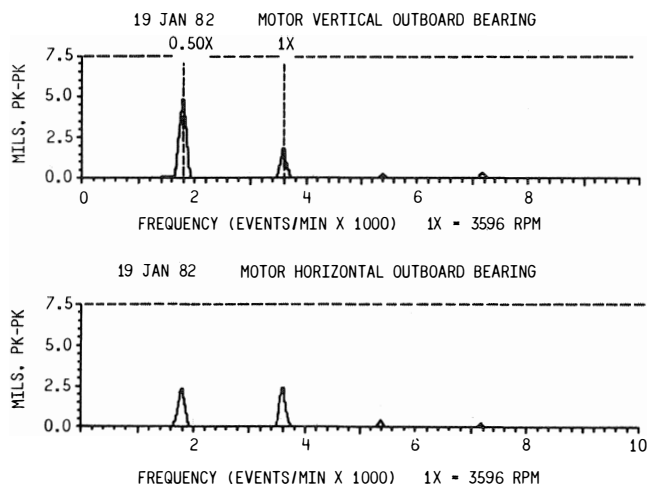
Figure 10. Start-up Vibration Data of 8000 hp Motor Outboard Bearing with 180° Design. Notice the Half Running Speed Vibration Level.

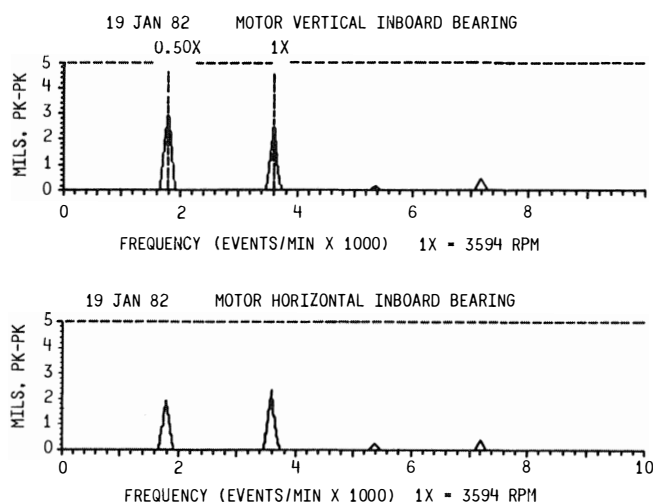
Figure 11. Start-up Vibration Data of 8000 hp Motor Inboard Bearing with 180° Design. Notice the Half Speed Vibration Level.

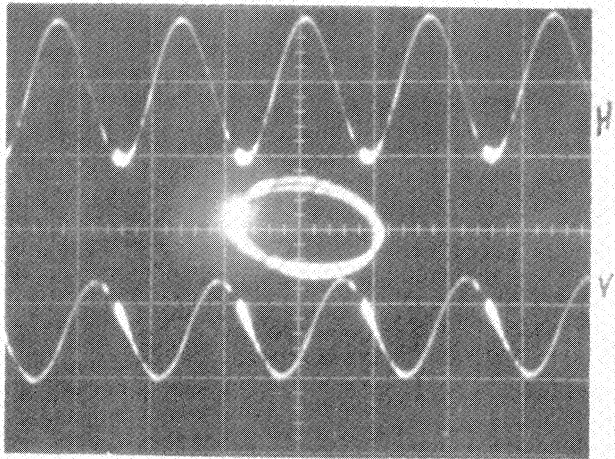
Figure 14. Orbital Display of Inboard Bearing Vibration. Notice the Orbit Fluctuation.

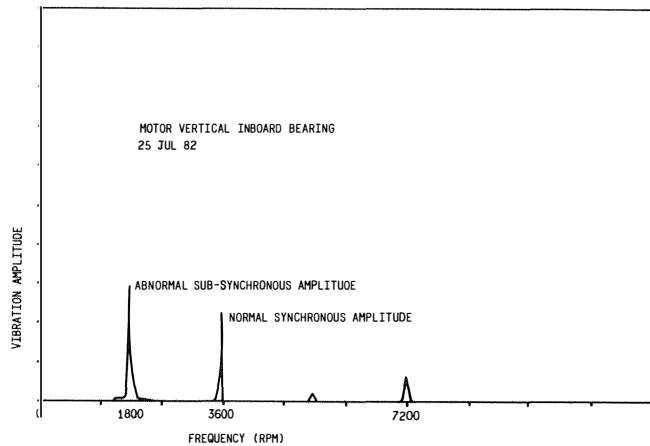
Figure 16. Inboard Motor Bearing Vibration Data in Vertical Direction. Notice High Sub-Synchronous Vibration.

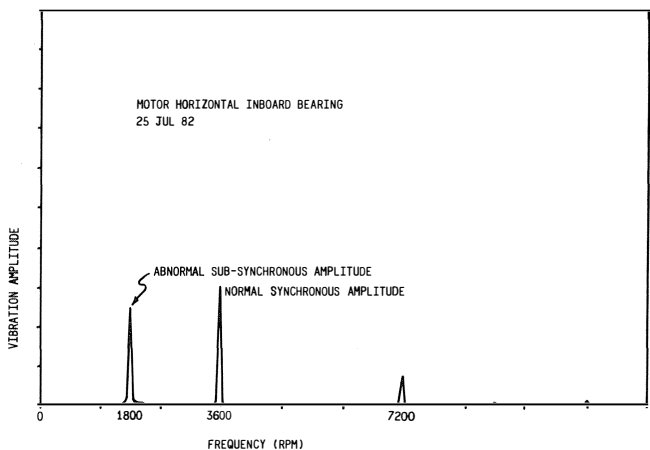
Figure 17. Inboard Motor Bearing Vibration Data in Horizontal Direction. Notice High Sub-Synchronous Vibration.

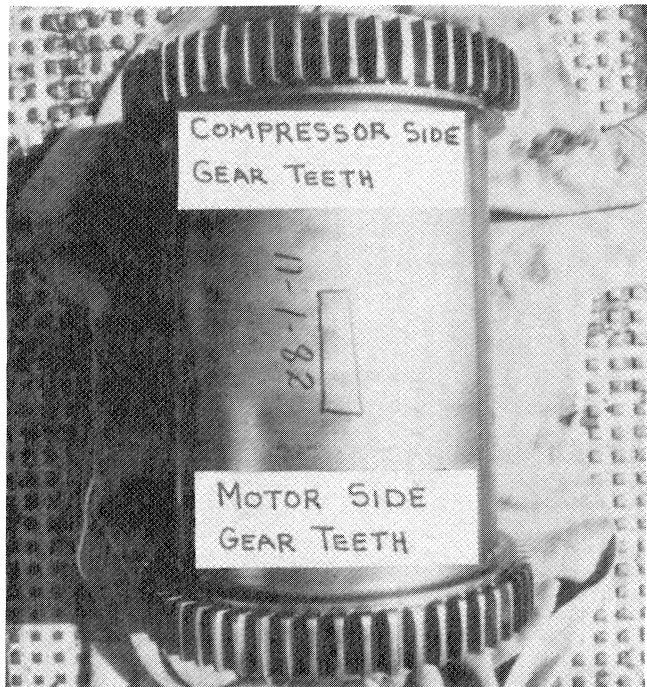
Figure 19. Teeth on the Coupling Spool Piece Showed Excessive Wear for a Nine Month Run.

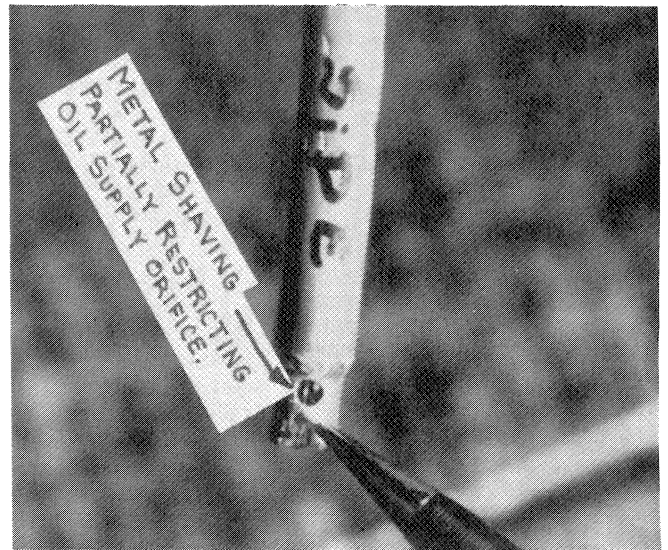
Figure 20. A Metal Shaving Was Found Lodged in the Compressor Side Coupling Oil Supply Nozzle.

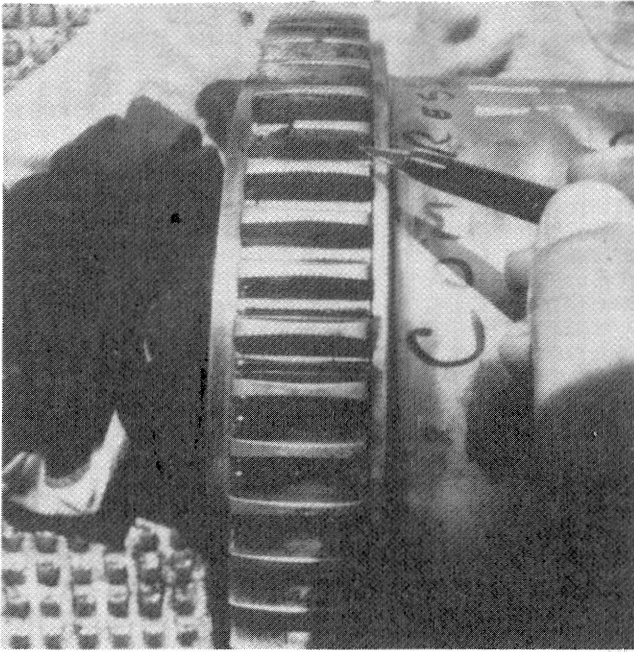
Figure 21. A Broken Tooth and Heavy Tooth Pitting Were Found on the Compressor Side of the Spool Piece.

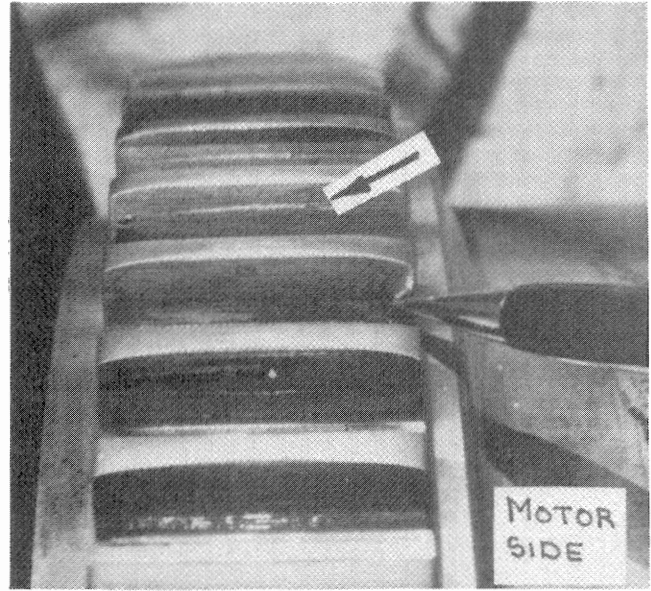
Figure 23. Motor Side Coupling Spool Piece Gear Teeth Showed Excessive Wear for Only Nine Months of Service.

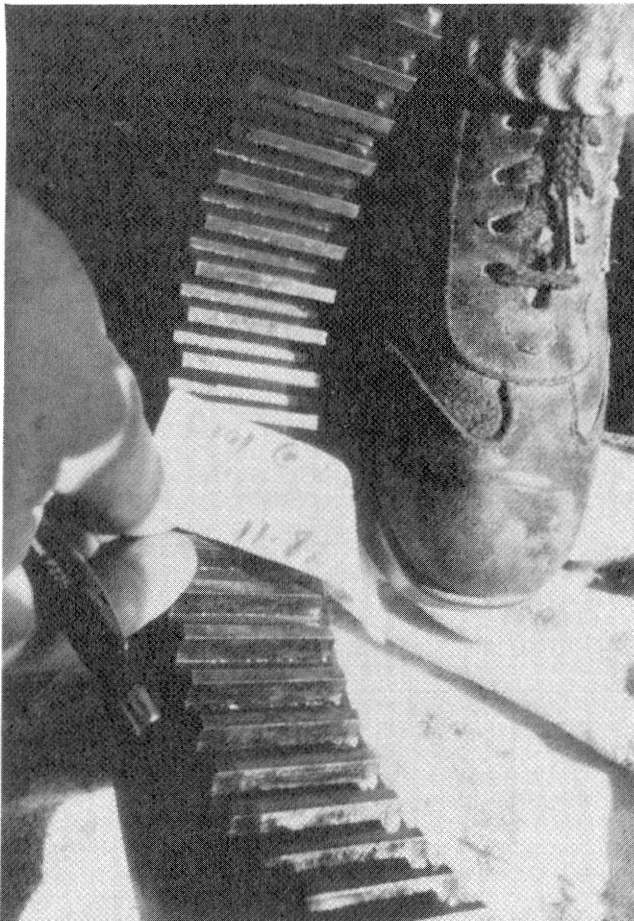
Figure 22. Compressor Side Coupling Shroud Gear Teeth Showed Excessive Wear for Only Nine Months of Service.

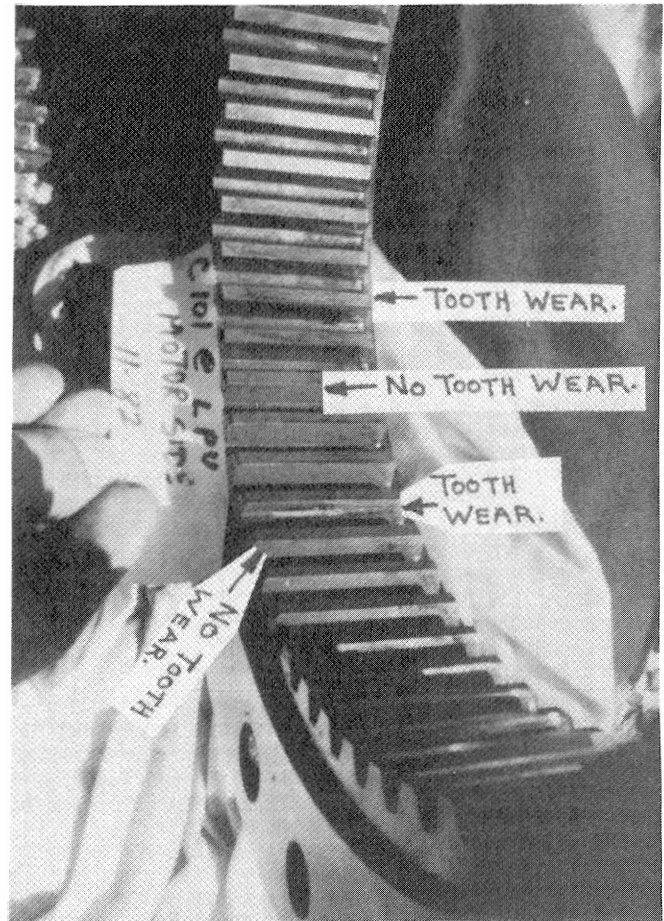
Figure 24. Motor Side Coupling Shroud Gear Teeth Indicated Some Teeth Were Taking Little or No Load.

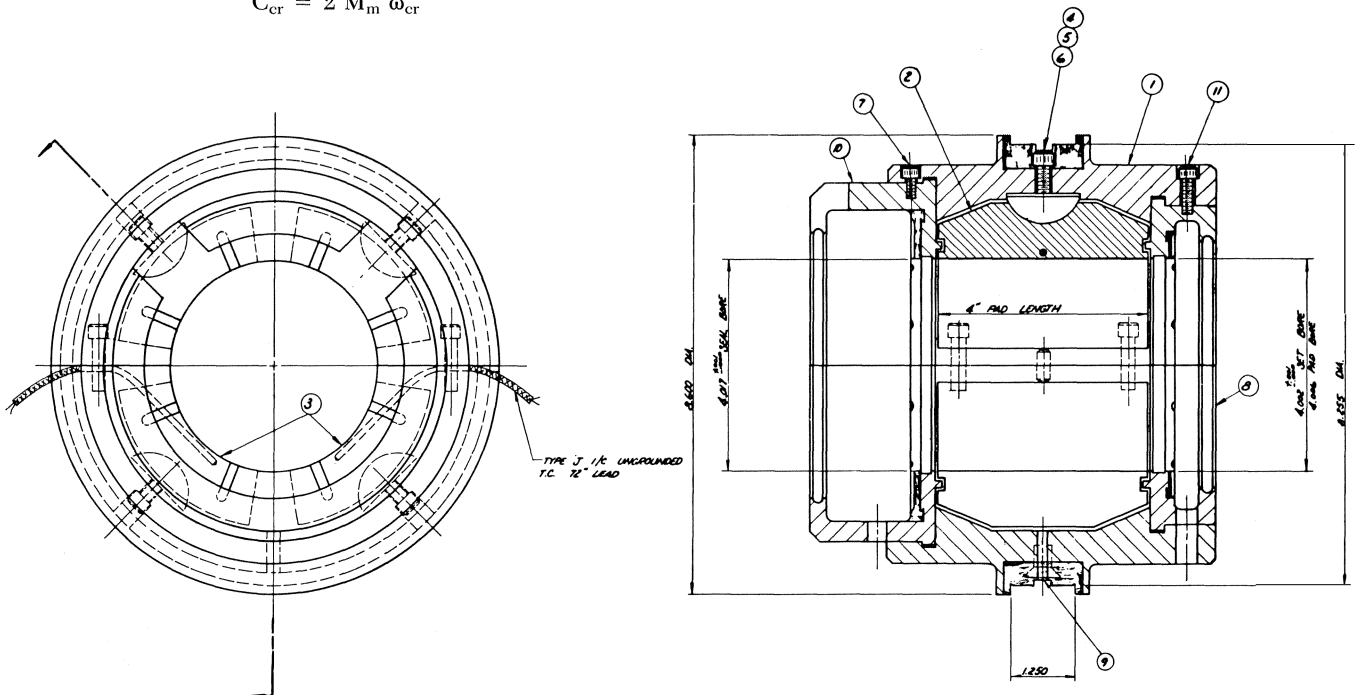
Figure 36. New Tilt Pad Bearing Design.

A new set of journal bearings was designed to eliminate the instability problem and to minimize synchronous vibration. The optimum bearing is a four shoe tilting pad type. The bearings are identical on both ends of the machine. The geometry is L/D = 1.0, preload = 0.33, and set clearance = 0.008 in., and the orientation is load-between-pad. It is also recommended that the oil be changed to ISO 68.

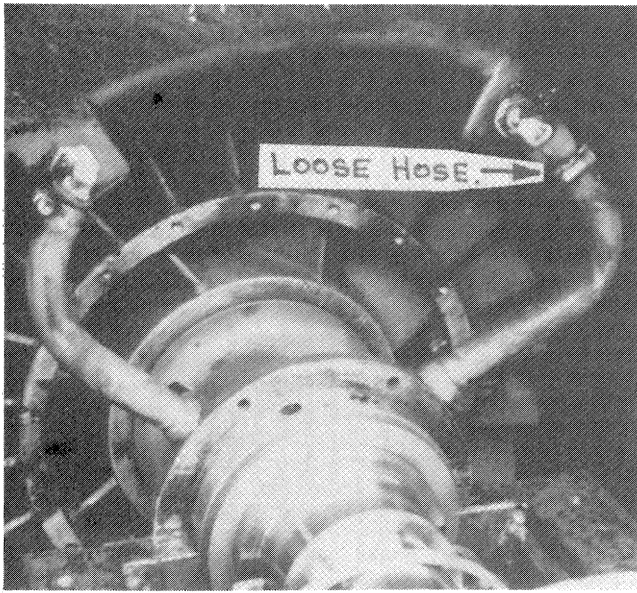
On December 2, 1982, the top end bells of the motor were removed to install the new tilting pad bearings. This action revealed an oil soaked stator and rotor. A loose connection on the pressure balancing line from the motor fan shroud to the bearing labyrinth seal housing had allowed oil to be sucked into the eye of the fan. Once at the eye of the fan, the oil was circulated throughout the stator and over the rotor. Even though the loose connection was on the coupling end bearing, the outboard end of the motor was also oil soaked (see Figure 41).

Figure 41. A Loose Pressure Balancing on the Coupling End of Motor Caused Bearing Oil to be Sucked into the Windings.

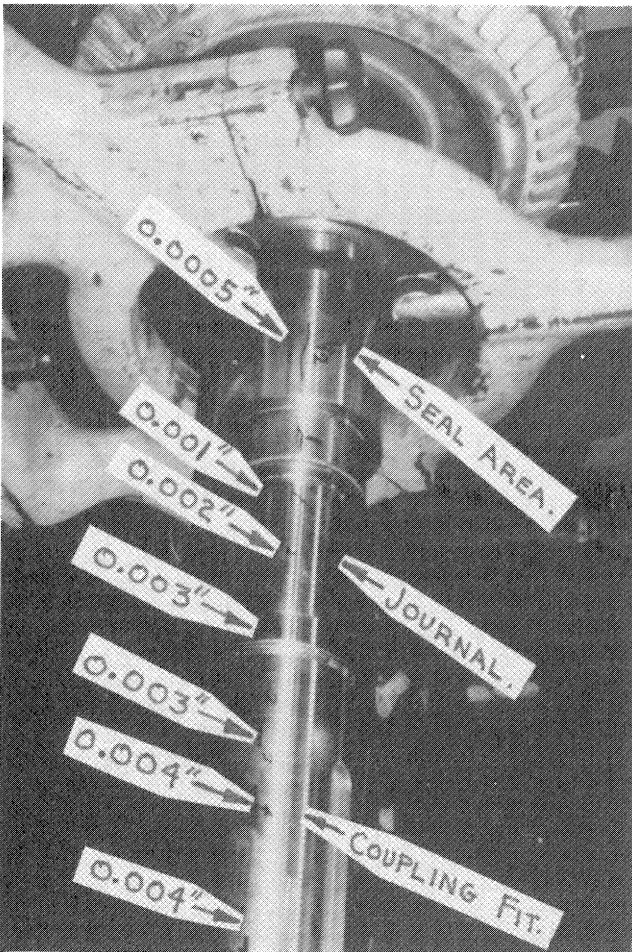
Figure 42. Runout Check of Motor Rotor Indicated a Bent Shaft Starting at the Bearing Journal.

bearing journal and running to the end of the shaft (see Figure 42). Since the shaft was made from heat treated 4140 steel and the bend was in the bearing journal, the decision was made to

go with the .004 in. runout. If localized heat had been used to straighten the shaft, the heat treatment could have been affected, increasing the runout. Shaft straightening by peening would have damaged the bearing journal.

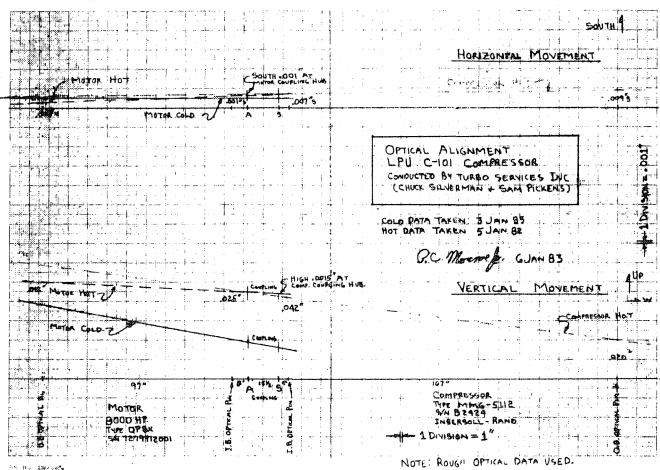
The optical alignment revealed that the compressor had risen .020 in. at the outboard bearing and .042 in. at the inboard bearing. This particular compressor has its discharge nozzle on the inboard end. Since the inboard end of the compressor was the hottest, and the motor cooling air intake was located on the inboard end, the motor raised .025 in. at the inboard bearing and .012 in. at the outboard bearing. No attention had been paid to the location of the motor air intake, but, as illustrated, large thermal growth caused by such an oversight could cause alignment problems. However, in this case, it was not a problem, as illustrated by Figure 46. This alignment plot shows the motor to be .0015 in. high at the compressor coupling hub. An acceptable alignment limit for a coupling of the size used in this installation would be .007 in. Horizontal alignment was also good, with the motor being .001 in. north at the motor coupling hub.

Figure 46. Optical Alignment Plot of Hot Mechanical Alignment.
