FATIGUE FAILURES OF COMPRESSOR IMPELLERS AND RESONANCE EXCITATION TESTING

Fred L. VanLaningham

Union Carbide Corporation

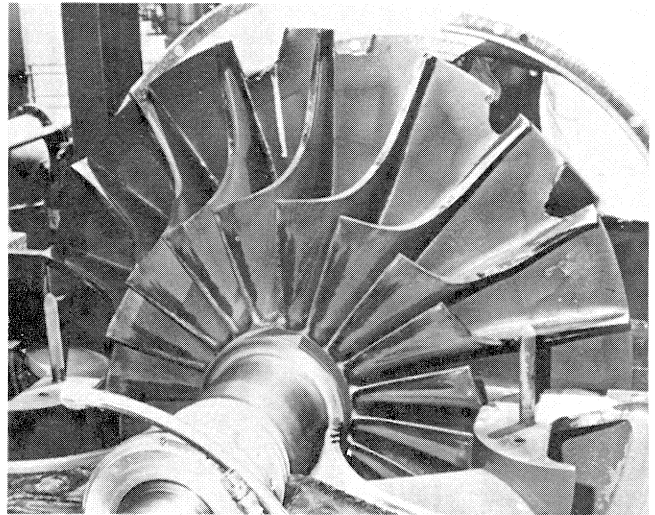
The results of the metallurgists' studies indicated that failure started by fatigue in several locations on the impeller and progressed through a large number of cycles at *low overstress* until radial cracks had formed.

Figure 1. Open Welded First Stage Impeller after Failure as Viewed from Inlet Side.

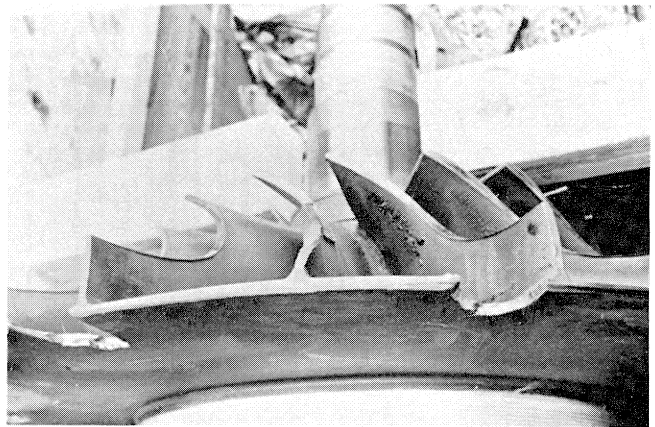
Figure 2. Open Welded Impeller after Removal from Machine Showing Two of the Nine Fracture Surfaces, Impact and Rubbing Damage.

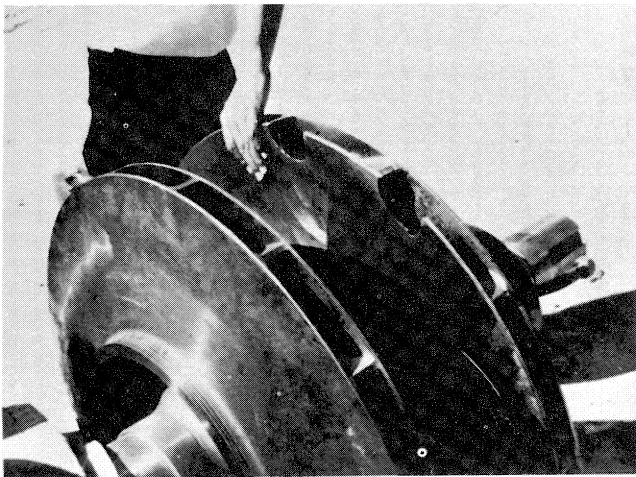
Figure 3. Closed Discharge Stage Impeller after "Half-Moon" Pieces at Two Adjacent Blades had Separated from the Cover.

The results of the field and shop shaker testing and measurements indicated that the failed impeller cover was resonant at or near the blade pass frequency of 980 Hz. The main source of excitation was the stationary discharge tongue or "cut water" that each blade of this discharge stage wheel passed. The mode shape was a scalloped pattern between each blade and followed very closely the crack path and can be seen in Figure 4. It was also interesting to note that material hardness had a significant and more than expected effect on the response of the wheel to a given excitation. The frequency of the resonance was not materially changed by variation in hardness, but the change in response was dramatic. The wheels, heat treated to a higher hardness, exhibited much higher amplitudes and extended decay times. Also, the variations in disc and cover thickness appeared to enhance the response of the impellers to a much broader range of excitation frequencies.

The radii of the blades to disc and cover or absence of radii also acted as stress risers to help initiate cracking. The manufacturer modified his drawings and tooling to eliminate the problems.

A new impeller was manufactured with special attention to quality control, i.e., very generous machined radii at blade to cover, large radii at fillet welds where blades join disc, uniform thickness of disc and cover between blades, attention to heat treating and maintaining hardness at the low end of the tolerance range. This and dynamic balancing of each individual impeller were followed by their inspectors, as well as our own resident inspector. The attention to quality control plus increasing the disc and cover thickness shifted the 13 scallop mode (once per blade) frequency from 975-980 Hz on the failed discharge wheels to 1210 Hz on the replacement impellers.

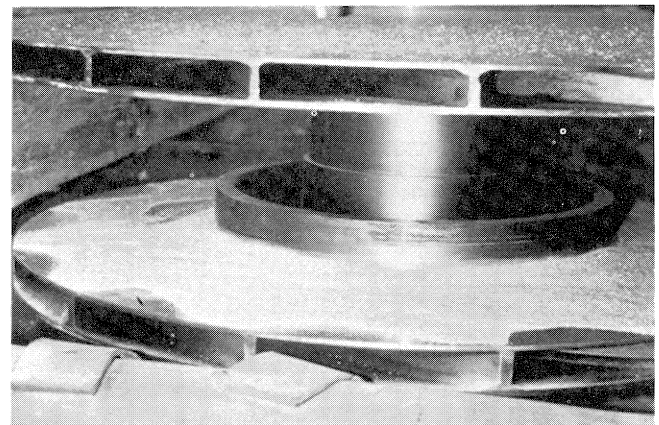
Figure 4. Closed Discharge Stage Impeller with Sand Pattern Formed by 980 Hz Excitation During Field Shaker Test. Note the "Half-Moon" or Scallop Shape.

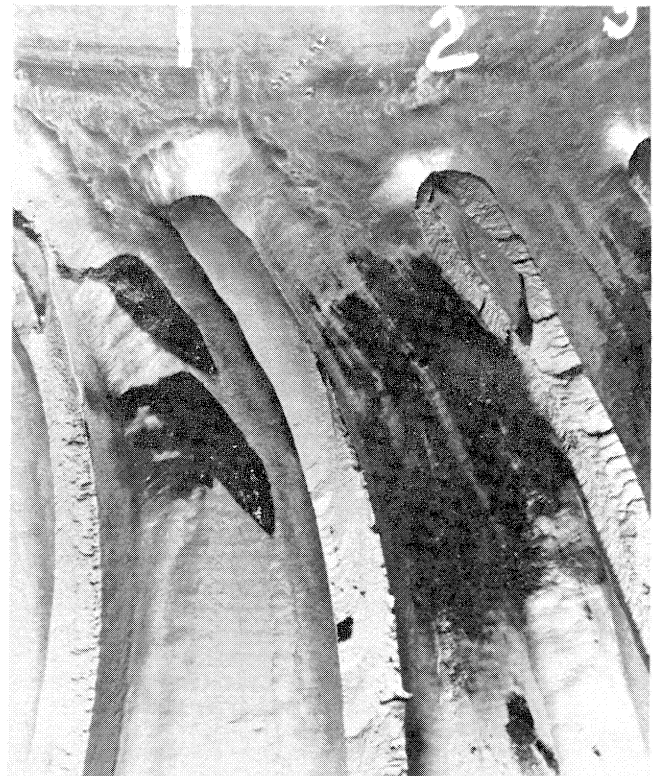
It can be seen from Figures 5 and 6 that all of the blades left the disc. One blade marked #1 failed in fatigue. All the rest were torn off by impact overloading and associated rupture. The metallurgists' conclusion indicated that the crack of Blade #1 formed and propagated at the nose or leading face near the weld to the hub. Progression was due to *low overstress-high cycle fatigue* for about four inches and then separated from the disc and impacted on and separated the other blades from the disc.

Figure 5. Open Impeller (Second Open Type Fatigue Failure in the Same Compressor) Showing Fracture Surface at #1 Blade Location.

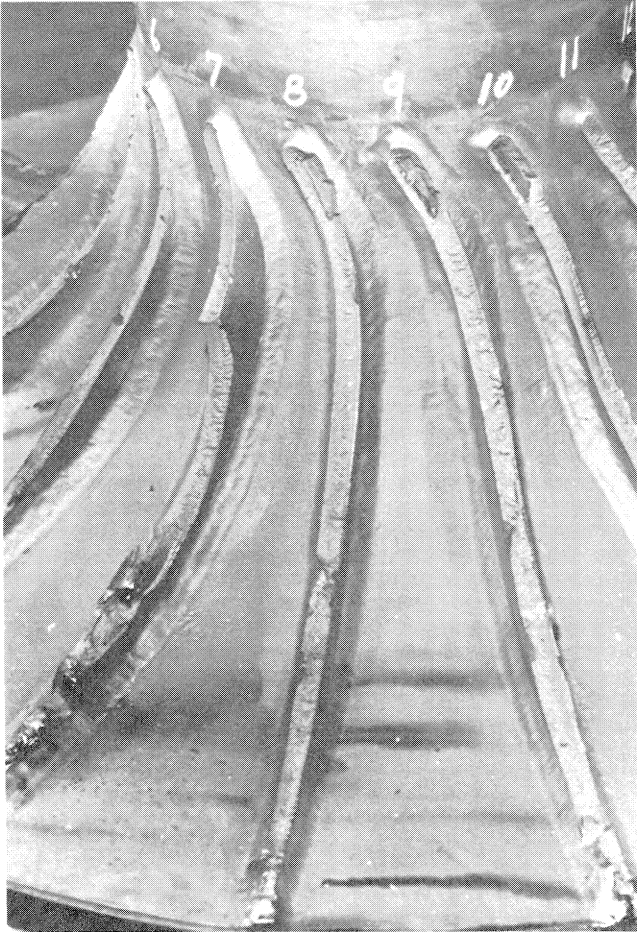
Figure 6. Open Impeller Showing Fracture Surfaces where Other Blades Separated from the Disc.

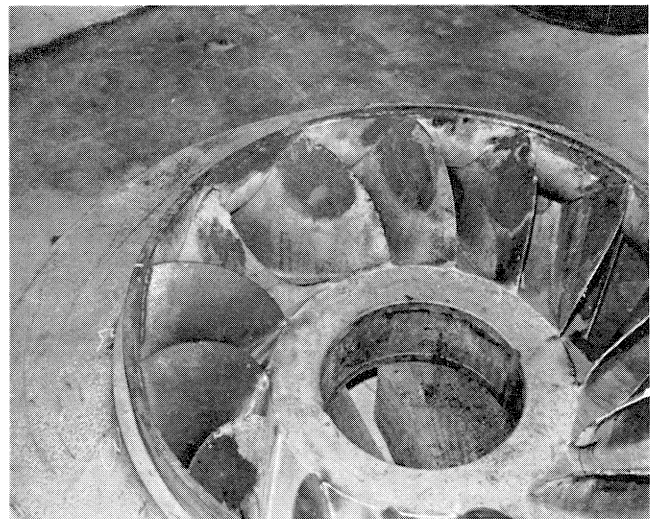
The three-piece type, first stage impeller had lost part of one vane, as can be seen in Figure 7. The fragment was ingested deeper in the machine causing more extensive damage. The blades had a leading or inlet lip at the eye and were stitch welded to the disc and the cover. This impeller operated at a tip speed range of 945 to 990 ft/sec.

Resonance and overstress were the most probable causes for failure.

Figure 7. Closed First Stage Impeller Blade Failure Near the Leading Edge after Seven Years of Operation can be Seen at 10 O'Clock. Impact Damage is also Apparent on the Leading Edge of the Other Blades.

The manufacturer conducted a finite element analysis. As a result of the finite element analysis, the manufacturer increased the length of the stitch welds near the inlet eye where the blades join the disc and the cover from 1½" to 4½". Although many suggestions were analyzed, this was the only modification that was made to the new impeller. The old impeller was forwarded to the Acoustics and Dynamic Measurements Laboratory in Charleston, West Virginia, for shaker testing.

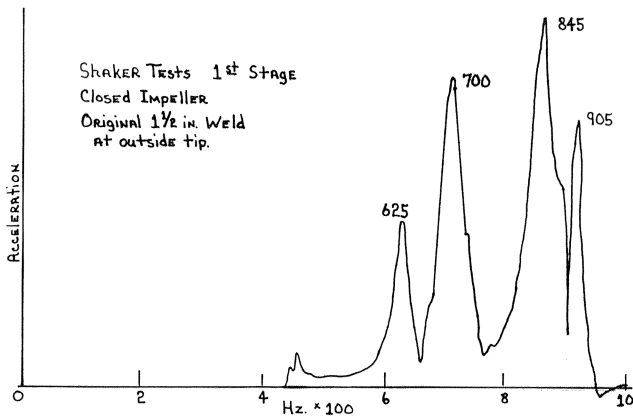
The shaker tests indicated that the natural frequencies of the unfailed blades with 1½ inch welds fall in the range of 700-905 Hz and that by extending the weld to 4½ inches, as

Figure 8. Plot of Acceleration vs Frequency of Closed Impeller Blades Indicating Response Range and 845 Hz Peak. Welds at Disc and Cover and 1½ Inches Long as Originally Manufactured.

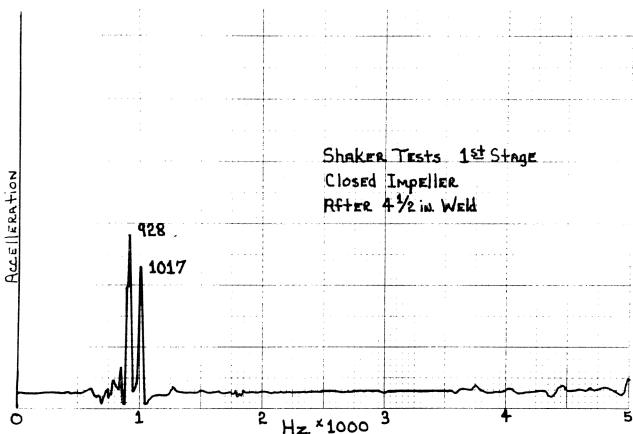
done on the new impeller, this range shifted to 928-1017 Hz. All the modes had nodal points near the welds, but the 845 Hz mode was strongest and was shifted to 928 Hz by the welding, as can be seen in Figures 8 and 9.

The inlet guide vane passing frequency range was 800 to 841 Hz and was assumed to be the source of the excitation since additional field tests indicated that the intermittent buzzing was near 840 Hz and could be brought on by adjusting load more than speed. The inlet vanes, however, were far upstream, and it was not expected that trailing wakes would excite the impeller blades — but they did.

Figure 9. Plot of Acceleration vs Frequency of Closed Impeller Blades Indicating Change in Response and Shift of 845 Hz Peak to 928 Hz after Increasing Welds at Disc and Cover to 4½ Inches.

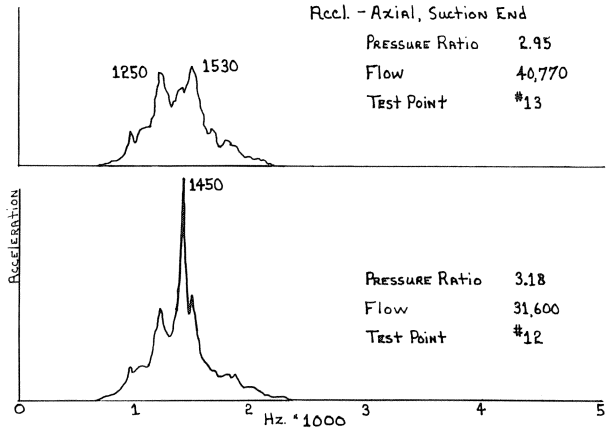
Others have successfully experimented with case accelerations and frequency measurements to detect incipient surge, and they report that at near surge conditions the flow incidence across the impeller blade can excite the blade natural frequency. At an average or high flow, the 1450 Hz acceleration was barely noticeable. At a low flow-high pressure ratio condition the 1450 Hz acceleration amplitude increased considerably.

Figure 13. Compressor Case Axial Acceleration vs Frequency Plots of Two Test Runs Indicating an Increase of the 1450 Hz Component with a Flow Reduction of 22.5%.

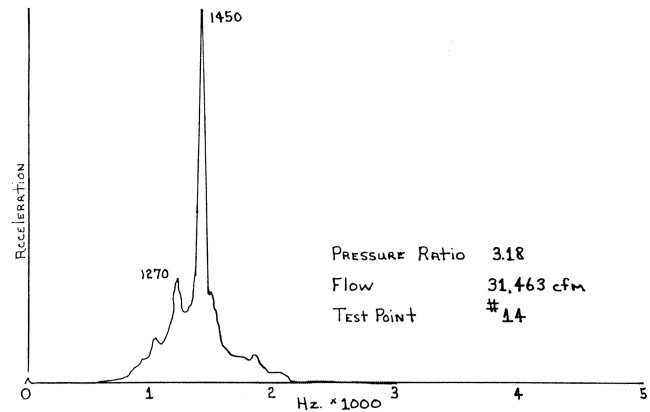
These tests seem to be conclusive in pinpointing that at a low flow-high pressure ratio condition, the open wheel blades are excited at the 1450 Hz mode, and eventually a blade will fail under *low overstress-high cycle* fatigue. The tests were inconclusive, however, in determining if a backward traveling wave existed, that is, that the first wheel was excited by a backward traveling wave from the second wheel at its blade pass frequency.

Figure 14. Compressor Case Axial Acceleration vs Frequency Plot at Further Reduction in Flow to 22.8%. Note the Dramatic Response of the 1450 Hz Component to Such a Small Change in Flow.
