# ELECTROMAGNETIC SHAFT CURRENTS AND DEMAGNETIZATION ON ROTORS OF TURBINES AND COMPRESSORS

**John S. Sohre**

**Paul I. Nippes**

A high percentage of large, high-speed compressor trains has suffered serious failures which were initiated by shaft current damage. These currents are generated by electromagnetic effects. The basic mechanics of various types of shaft currents are briefly reviewed, and the electromagnetic type is discussed in detail. Part I covers the theory of current generation, sources of magnetism, symptoms, modes of failure, remedial action, and case histories. Part II explains in more detail how small residual magnetic fields can generate currents, and how self-excitation and consequent self-magnetization may occur. Principles of demagnetization are also covered.

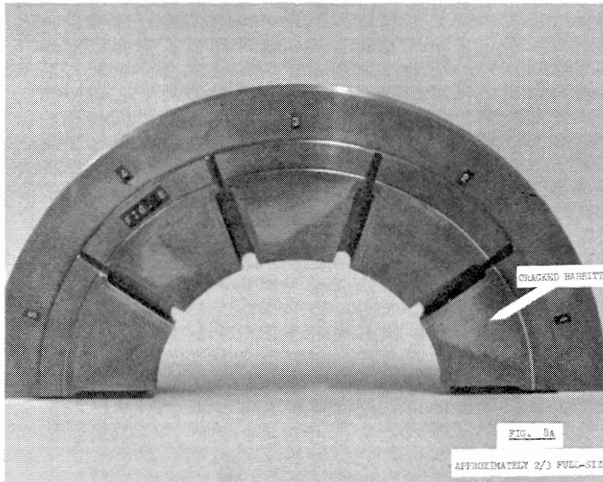
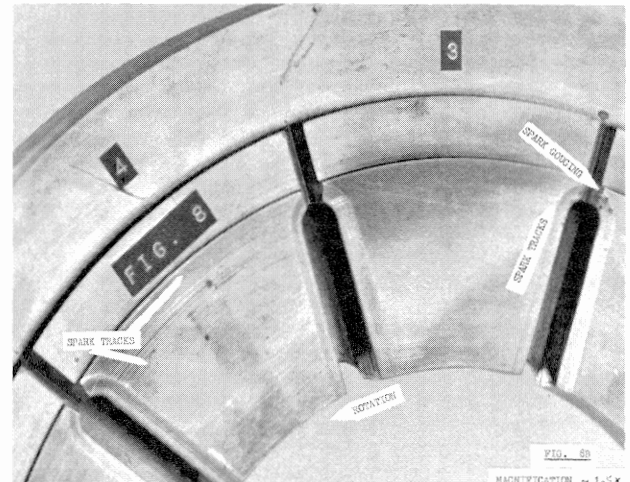
Figures 8 and 9 show the bearings that were affected greatly by the generated shaft currents. In Figure 8 frosting is medium to severe. The thrust capability was significantly reduced. The area near #3 land was overheated. Note the land discoloration, yellow blush ( $\approx 450^\circ\text{F}$ ) on steel next to land #3. Thrust failure was imminent.

**Land #1:** Severe spark frosting, most of the oil wedge is lost. Heat discoloration ( $\approx 375^\circ\text{F}$ ) and babbitt cracking from excessive load.

**Land #2:** A few isolated, light pits, over entire surface, heavy pitting at trailing OD. Note that this pad and #5 carried much less load than #1, #3, and #4. This is a result of manufacturing defects, these pads being slightly lower than 1, 3, and 4.

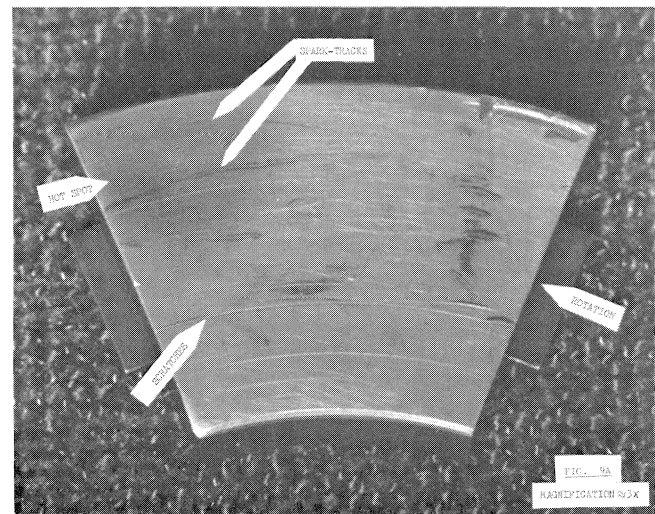
9A Shoe Surface

Figure 9A & B. Syngas compressor thrust shoe, damage caused by magnetic shaft currents (40,000 HP/11,000 RPM Train).
