REPAIR AND REHABILITATION OF TURBOMACHINERY FOUNDATIONS

E. M. Renfro

Adhesive Services Company

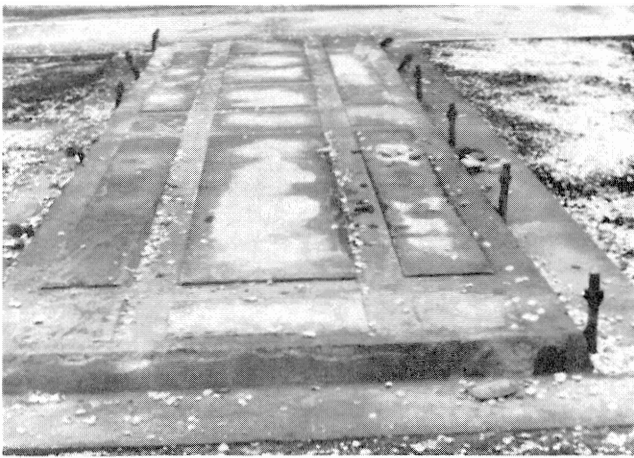
Figure 2 is a fine example of correct grout placement. This photograph, showing the grout intact after platform removal, would not have been possible if epoxy grout had been used in the original installation. Cement based grouts will not bond well to the platform load bearing surfaces. Note that portions of this grout are oil soaked. Over a period of time, lubricating oils will severely degrade both cement grouts and concrete. This problem is further aggravated by the fact that most platforms are not designed with oil drains. On several occasions the author has noted as much as 6 to 8 inches of oil trapped within the platform cavities. This condition not only provides head-pressure for an increased rate of oil penetration, but also creates a *severe* fire hazard.

Figure 2. A Properly Grouted Platform which Later was Removed from its Concrete Pad. Note that 100% Contact had been Obtained by the Grout on All Longitudinal and Transverse Supporting Beams.

All platforms, regardless of the type of grout to be used, should be designed with oil drains. Epoxy grouts are recommended on platform installations because they bond well to load bearing surfaces and because they provide an excellent oil barrier for the concrete below. Cement grouts should be used only for temporary installations.

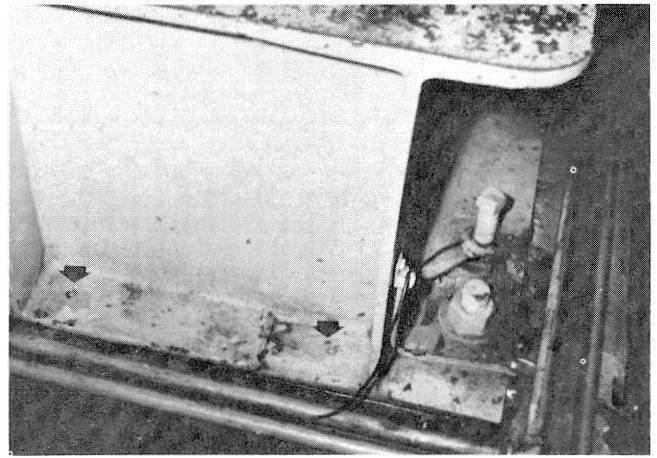
When differences in vibration amplitudes can be detected between the lower flange of the platform beams and the concrete structure, the decision to bond the entire lower surfaces of the platform to the concrete structure should be made. Bonding can be accomplished using a technique known as pressure-grouting. With this technique, holes are drilled through the lower flange at locations near the web on centers of approximately 18 inches. These holes are then tapped and ordinary grease fittings installed. The arrows in Figure 4 locate grease fittings and this configuration represents a typical injec-

Figure 4. A View of a Corner of a Platform where the Lower "I" Beam Flange has been Pressure-Grouted with Epoxy to Bond the Platform to the Concrete Foundation. Arrows Indicate the Points of Injection Through Grease Fittings.

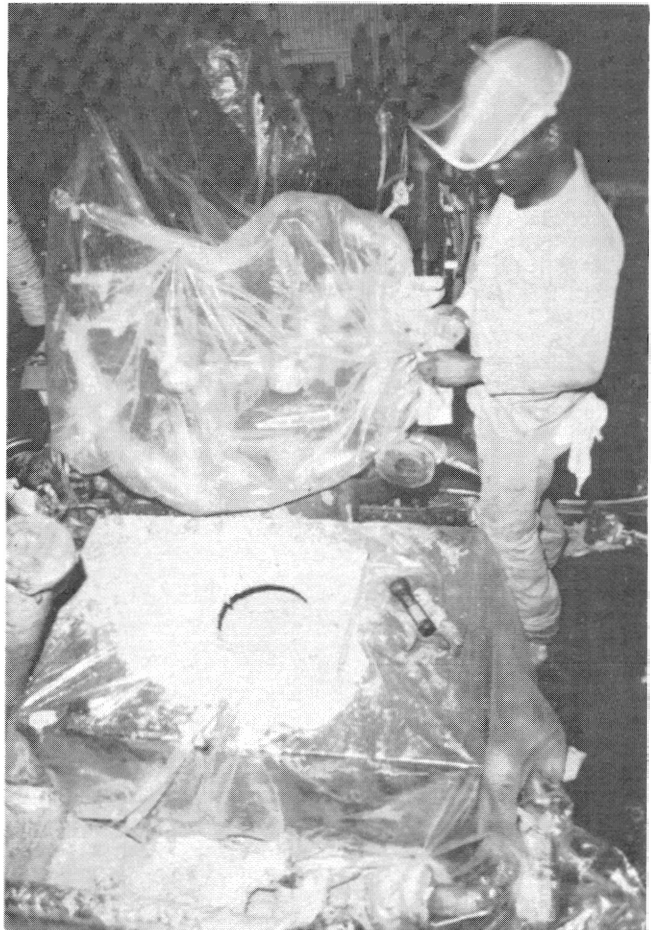
When excessive vibration is detected in the gear box of a compressor train, shown in Figure 1, and is transferred to the platform below, a dampening effect can be created by increasing the rigidity of the support below. This can be accomplished by first filling the platform cavity and then the gear box support with epoxy mortar. Figure 11 is a photograph of the gear box support after the gear box has been removed and an access hole cut in the plate at the top of the support. At the time this photograph was taken, epoxy mortar was being poured into the cavity. Since it is impossible to fill a cavity completely with mortar, filling was stopped at a level of approximately $\frac{1}{4}$ inch below the top. The access hole plate was then welded back into position, and injection sites drilled into each corner of the support. A vent hole was then drilled in the center of the reinstalled access plate to facilitate air removal when pressure-grouting the remaining air space below the top. Figure 12 is a close-up view of a typical injection site at each corner.

Figure 11. The Gear Box Support Cavity is Being Filled with Successive Pours of Epoxy Mortar to Unload the Box and Gain Rigidity.

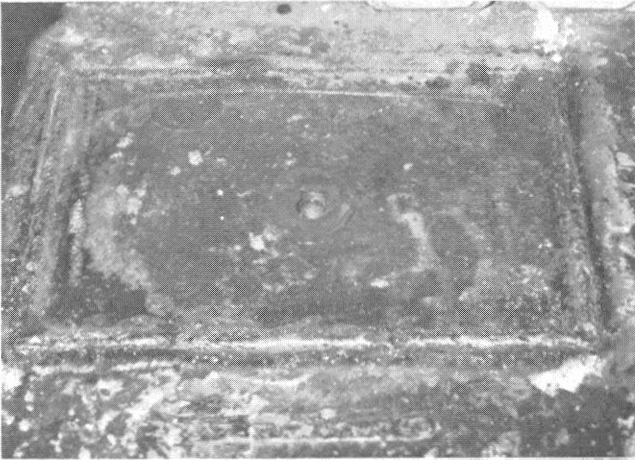
One interesting observation that brings home the fact that steel structures are not very rigid is illustrated in Figure 13. In

Figure 13. A Typical Vent Hole is Shown in the Access Plate After It has been Welded in Place.

this photograph we see a view of the plate covering the platform cavity alongside the gear box support. This cavity has been filled with epoxy mortar, the access plate reinstalled and pressure-grouting completed. The air vent hole in the center of the plate is one inch in diameter and the plate thickness is one inch. After pressure-grouting was completed, one workman in the process of cleaning up, placed his weight on the plate and this caused sufficient deflection to squeeze out epoxy equivalent to a volume slightly greater than the volume of the hole in the plate. In other words, the weight of one 160 lb. man was enough to cause a 0.001 inch deflection in the plate. This observation causes one to question the entire concept of platform mounting. The reason this solution has been successful is that unloading of the platform has been accomplished by providing load bearing capability all the way from the gear box to the concrete below.
