Reliability Improvement of End Suction Pump in Severe Service through Engineered Component Upgrade

20th International Pump Users Symposium
March 17-20, 2003. Houston, Texas

***RELIABILITY IMPROVEMENT
OF END SUCTION PUMP
IN SEVERE SERVICE
THROUGH ENGINEERED COMPONENT
UPGRADE***

César A. Morales Casanova
Rotating Equipment Specialist
PDVSA - Pequiven
Edo. Carabobo - Venezuela

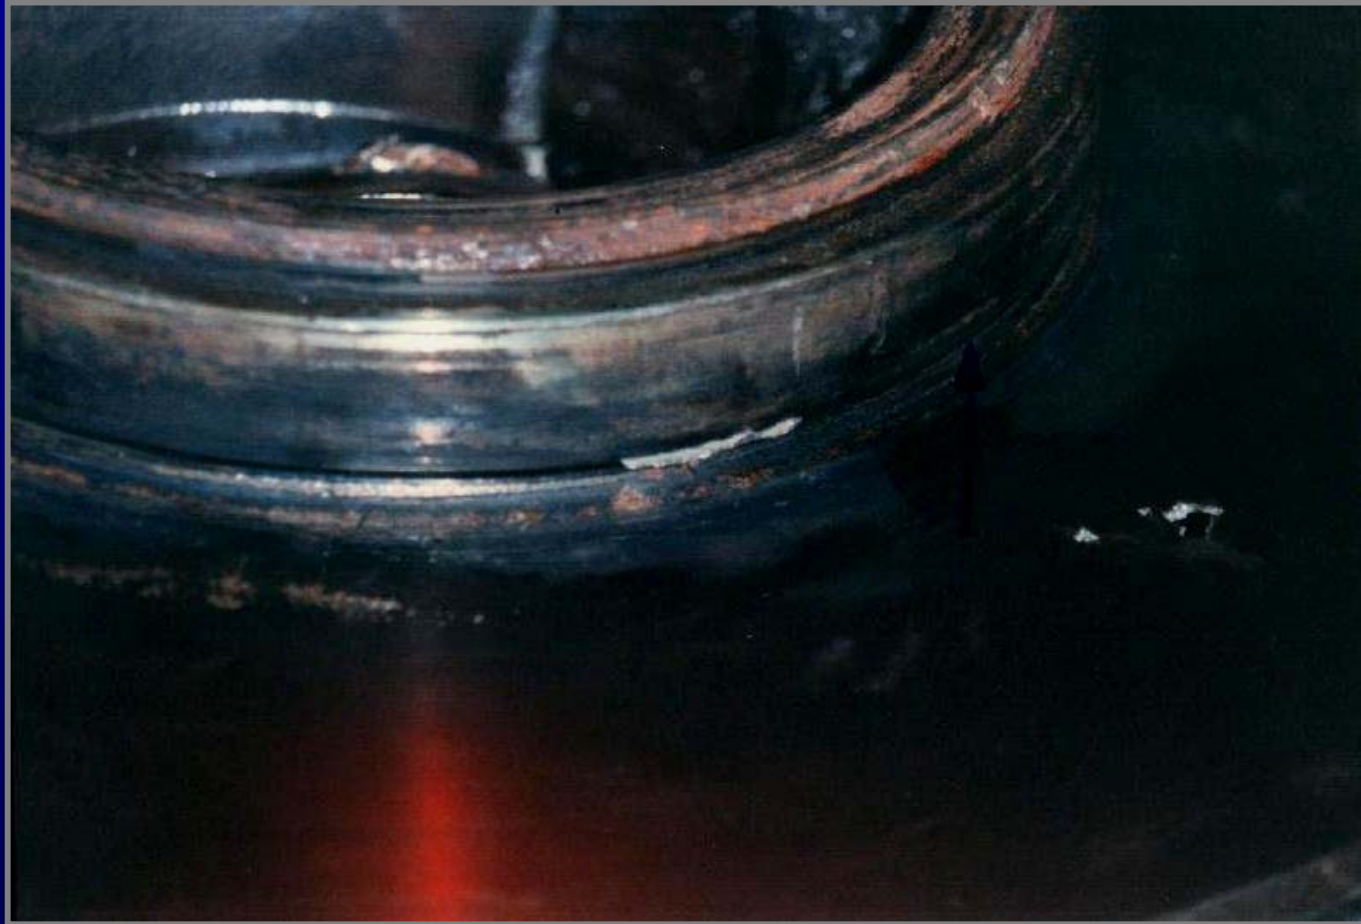
SEVERE RUBBING AT WEAR RINGS - 1996

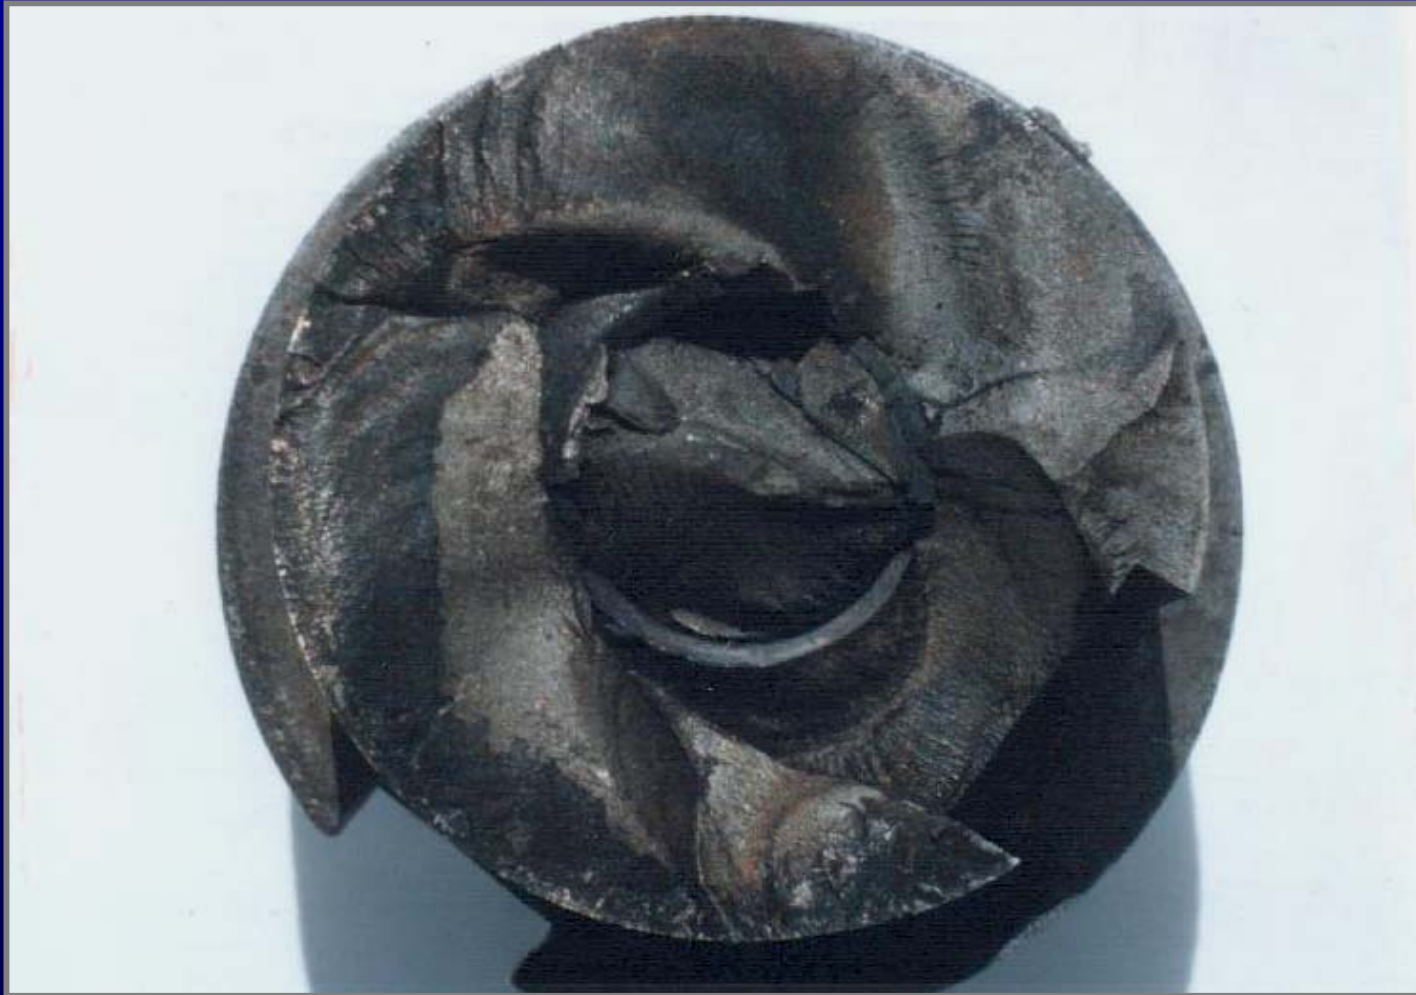
SHAFT FAILURE AT IMPELLER END - 1992

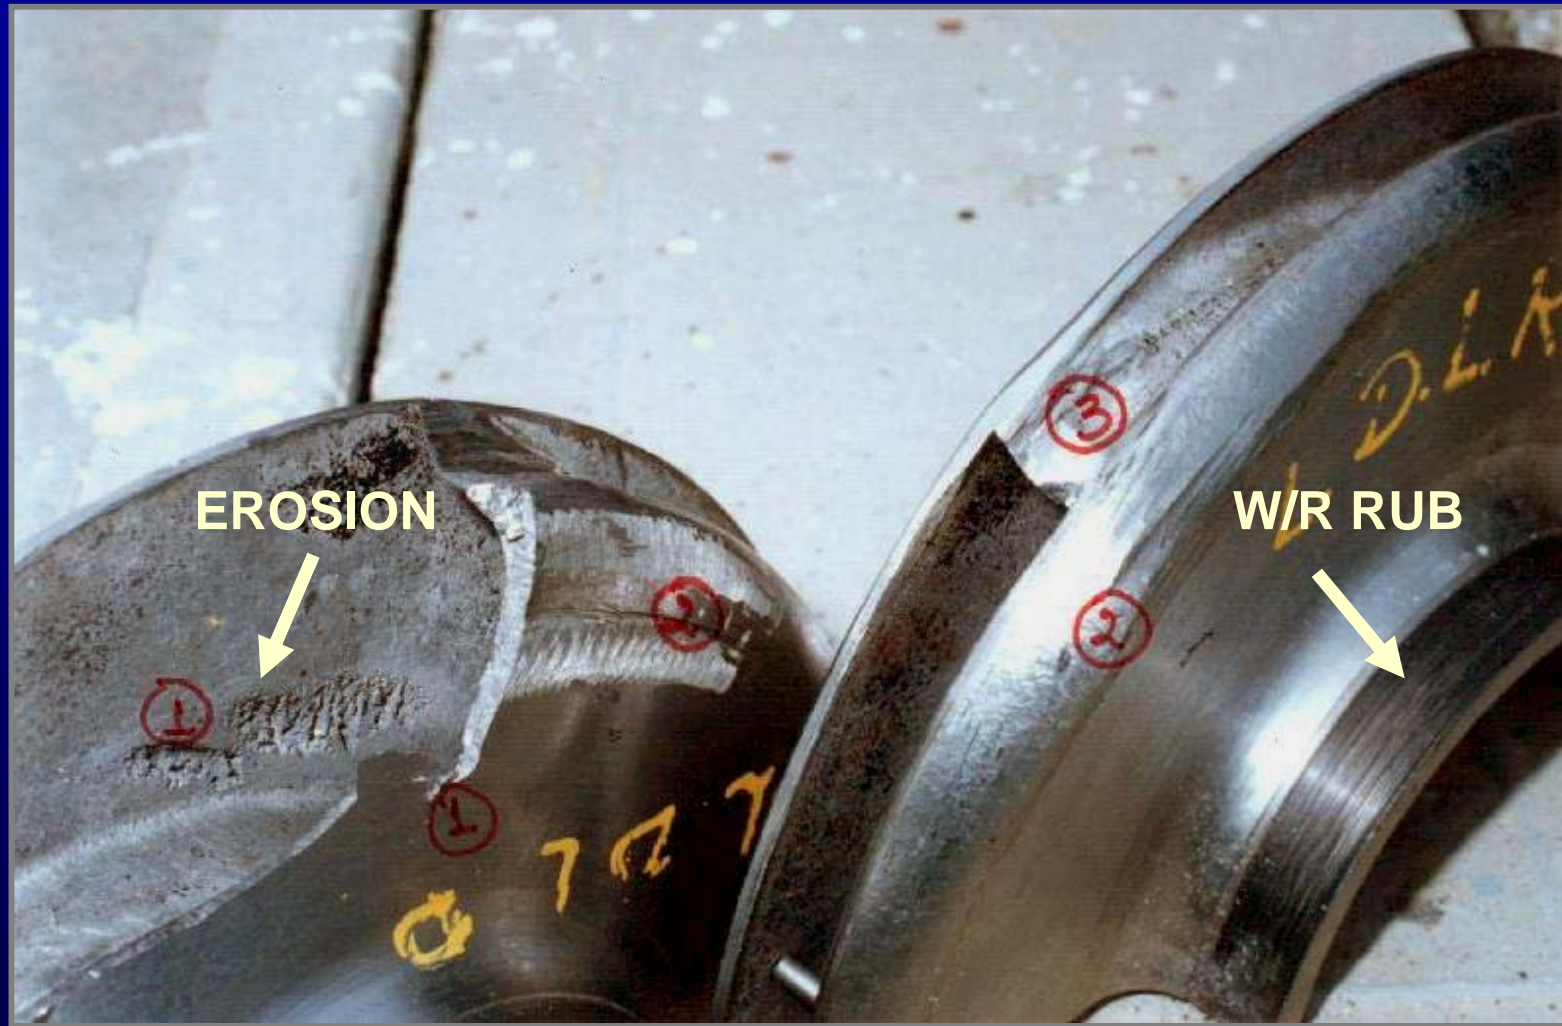
SEVERE IMPELLER FAILURE - 1992

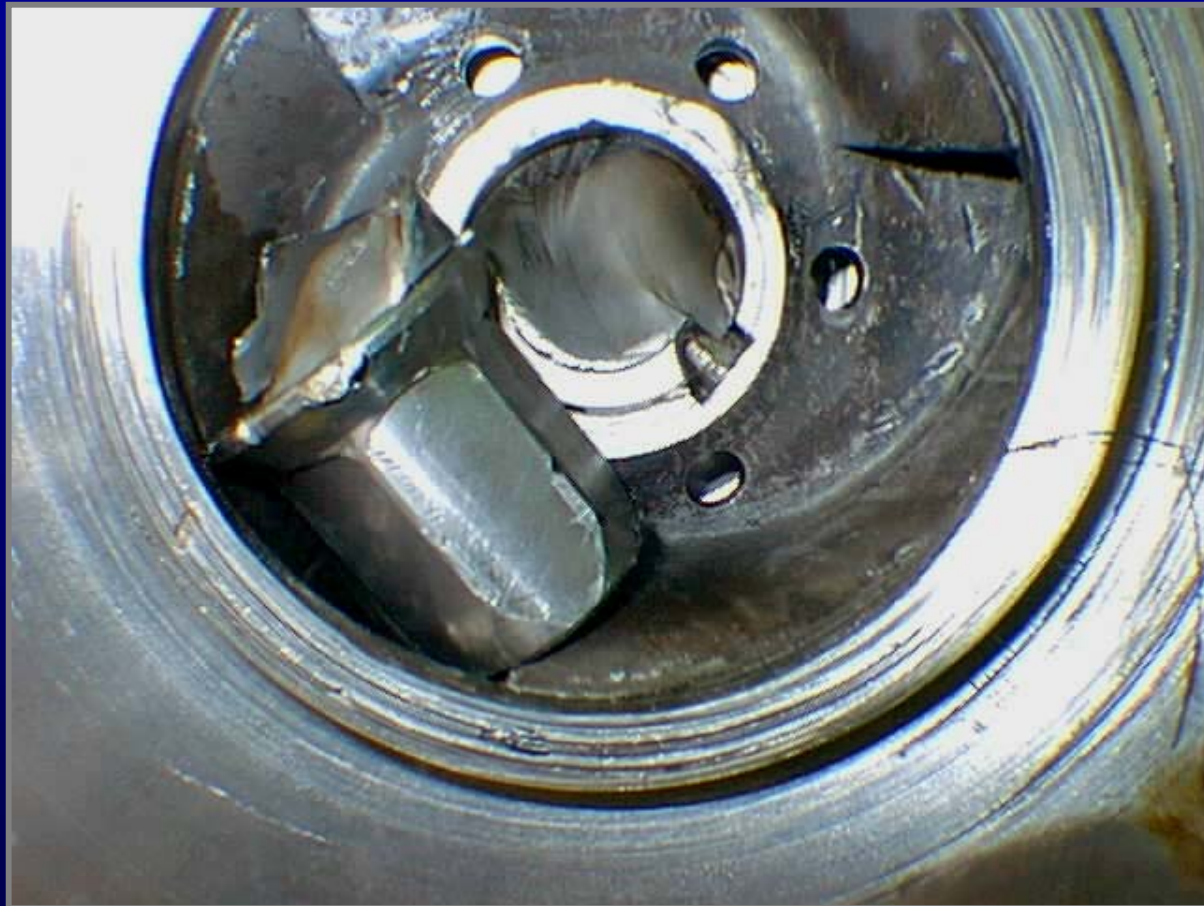
Pump “B”

SHAFT FAILURE AT IMPELLER END - MAY 1999

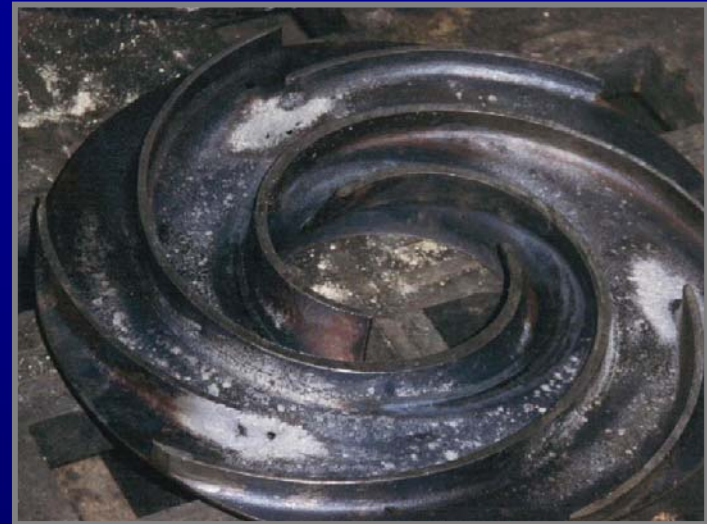
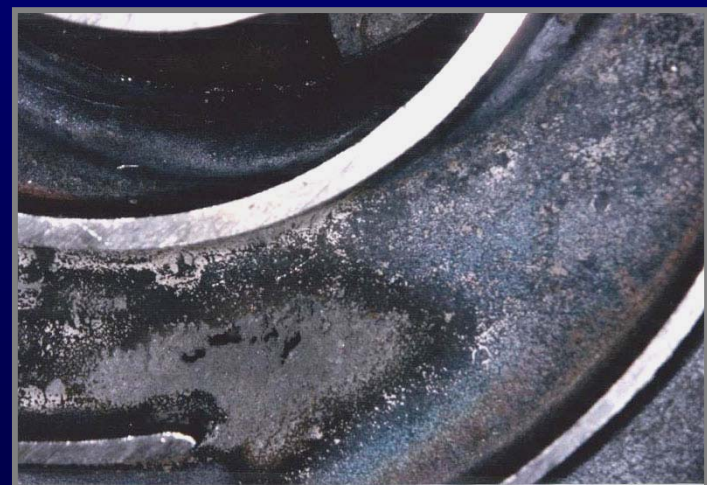
EROSION CONTINUED

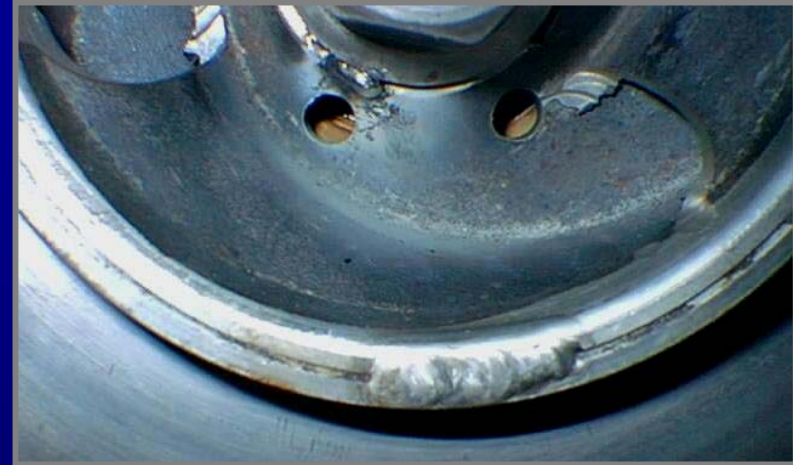
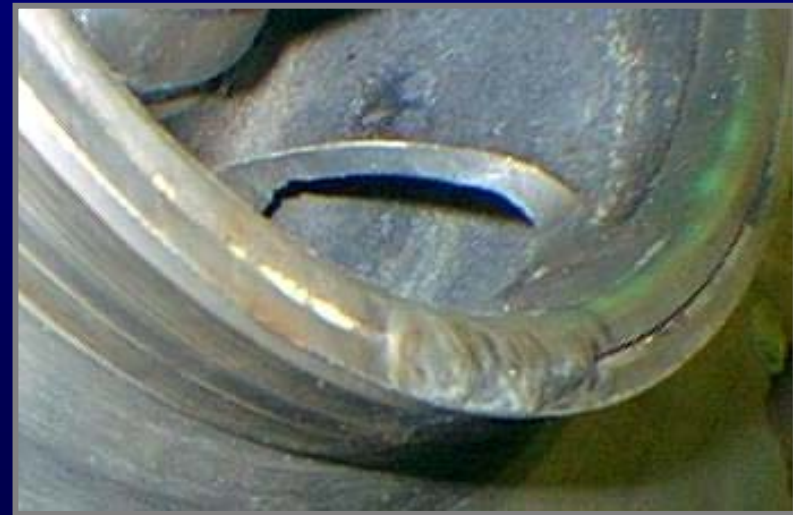
IMPROPERLY EFFECTED

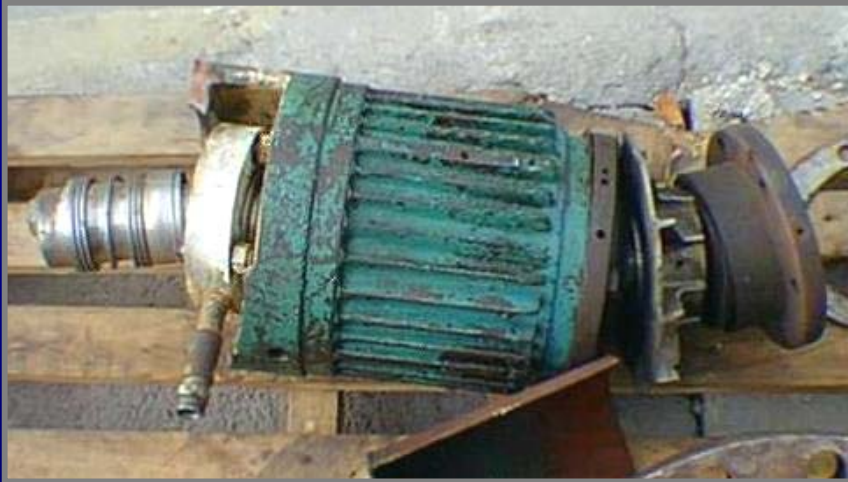
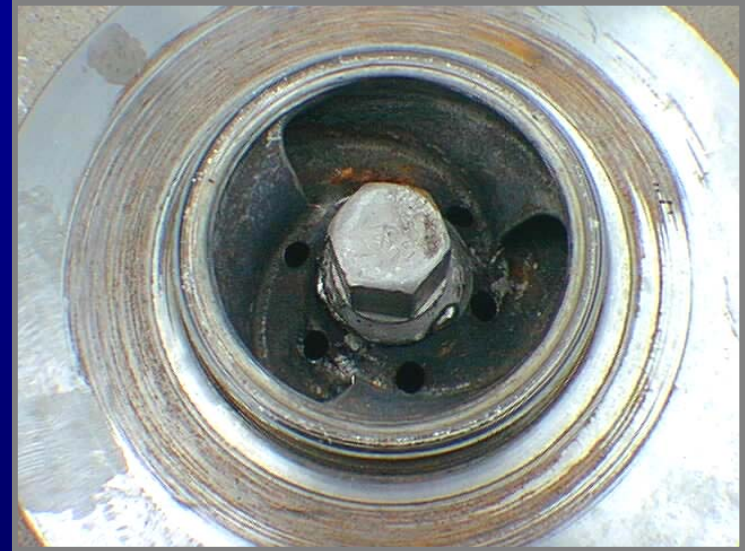
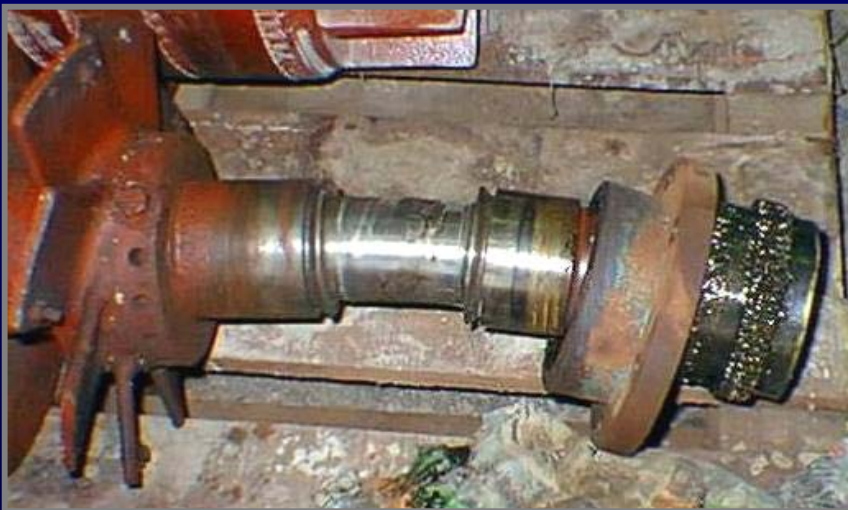
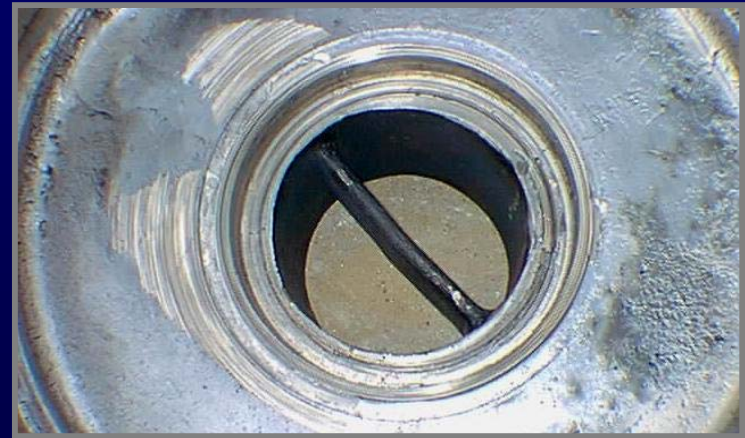
CATASTROPHIC FAILURE – PUMP “B”
SEPT 1998

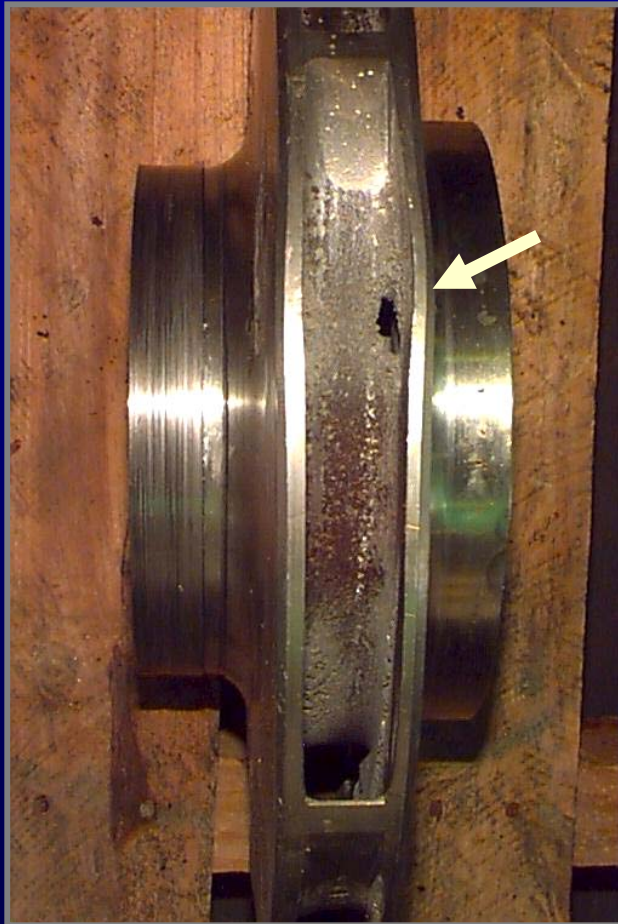
**EROSION &
SHROUD
SEPARATION**

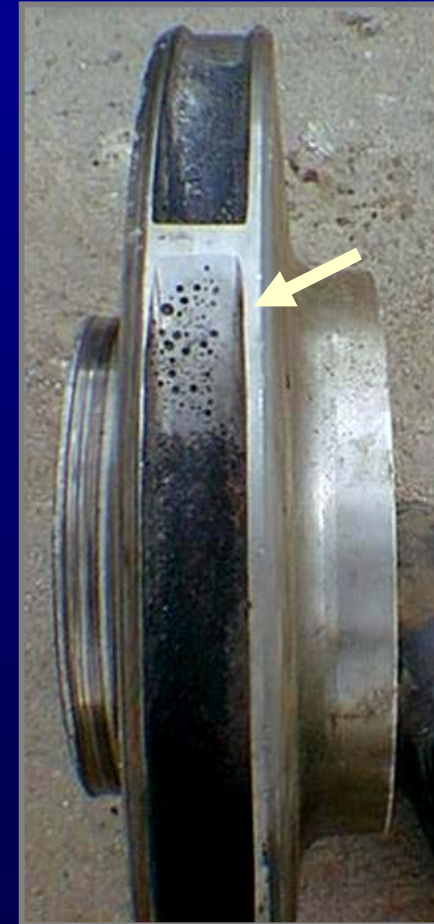
EVIDENCES OF RECIRCULATION AT DISCHARGE

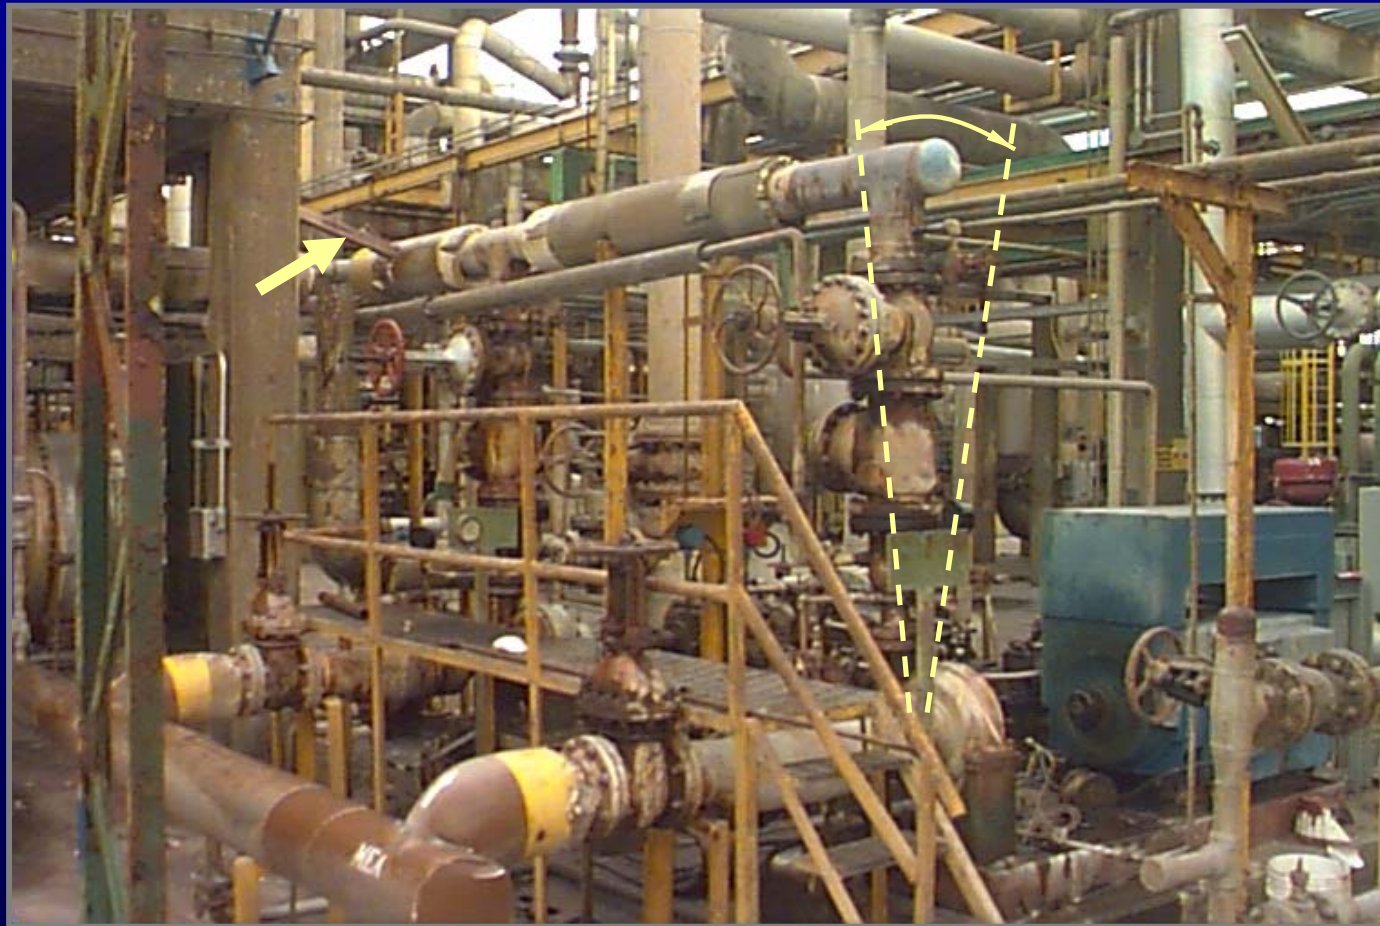
INOPERATIVE PIPE SUPPORTS
