SEVERE SUCTION BELL DAMAGE IN LARGE, OPEN IMPELLER, VERTICAL TURBINE PUMPS

Michael D. Smith
Pump Consultant
Dupont Company
Wilmington, Delaware

ABSTRACT

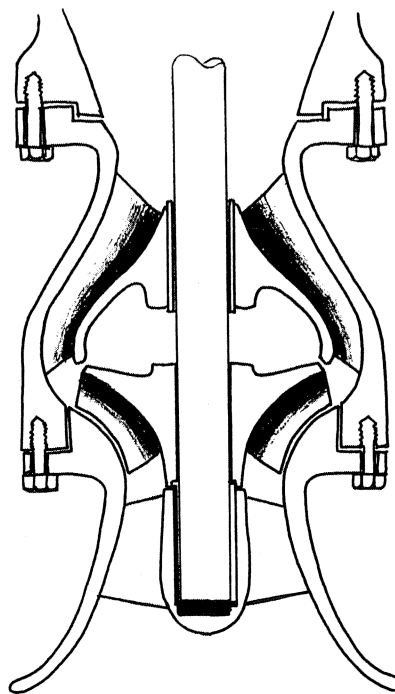
Figure 2. Vertical Turbine Pump with Semiopen Impeller.

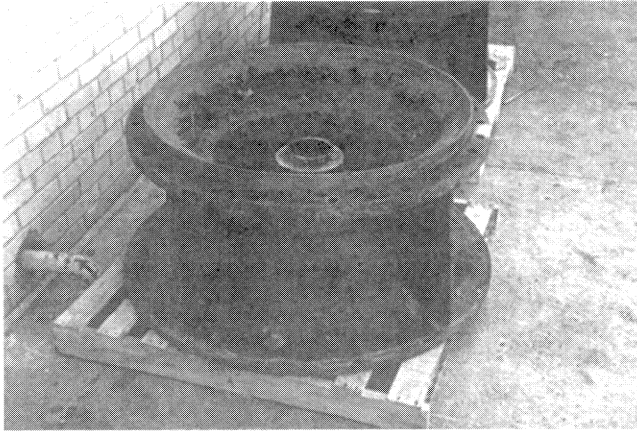
Nine 1500 hp single stage, vertical turbine, cooling water pumps suffered massive suction bell metal loss within 5000 operating hours (Figure 3). The same problem was observed, to a lesser extent, on seven 500 hp pumps in the same system. It took over 13,000 operating hours to reach the same level of damage as the larger pumps. Plant production depends on the availability of

Figure 3. Metal Loss Resulted in the Penetration of this 42 Inch Supply Pump Suction Bell.

The larger supply pumps had suffered much greater metal loss than the lift pumps, so there was no way to repair the suction bells or fit them with inserts. Also, there was concern that even the nickel-aluminum bronze might not be satisfactory in this service, given the inability of manganese bronze impellers to maintain an oxide layer (Figure 7). The long term solution was to convert the supply pumps to enclosed impellers. This allowed the new suction bells to be made from cast iron, since they would not be exposed to rising pressure. The new impellers contain all bubble collapse activity and are made of 316 SS, which was expected to be more than adequate for long life in these conditions.

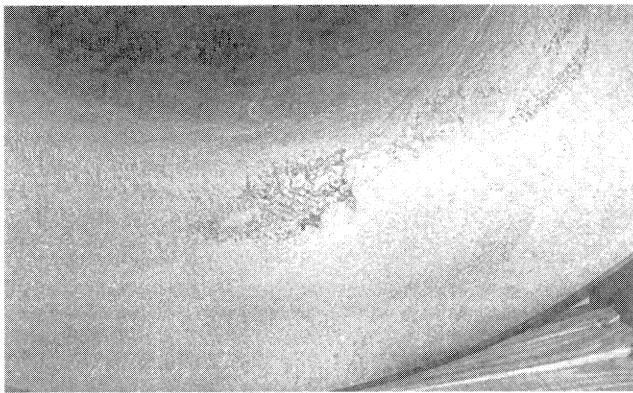
was removed for inspection. While the pump was apart for other work, a localized loss of metal was discovered on the suction bell in the area swept by the first third of the impeller vanes. The affected area was less than 3.0 in across, but had one pocket over 0.25 in deep (Figure 4). The belief at the time was that normal wear had uncovered a casting defect, and the supplier agreed to provide a free replacement bell.

Figure 4. Early Suction Bell Damage Is Localized.

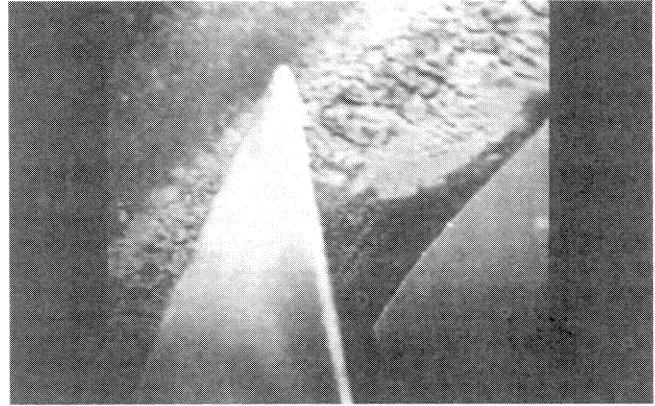
On July 24, 1995, one of the 500 hp lift pumps was removed to repair another problem, and its suction bell was found to have a more generalized attack, similar to Figure 5, within the vane-swept area. Again, the diagnosis of the damage cause was incorrect. In this case, it was assumed that two brief cooling water pH excursions, recorded in February and June of 1995, were responsible for the damage.

Figure 5. Late First Stage Damage.

Since the rate of metal loss was too high to be tolerable, and it did not appear to be due to any change in the cooling water chemistry, both groups of pumps had to be modified. The lift pumps were in the first stage of suction bell damage at the time (October 1995) the long term plan was developed. Since the suction bells were largely intact, the least expensive solution was fitting them with nickel-aluminum bronze inserts. The inserts were designed to be held in place by the clamping force of the suction bell-to-bowl flange and to extend beyond the vane-swept area. In this way, all possible bubble collapse sites have a surface much more resistant to damage.

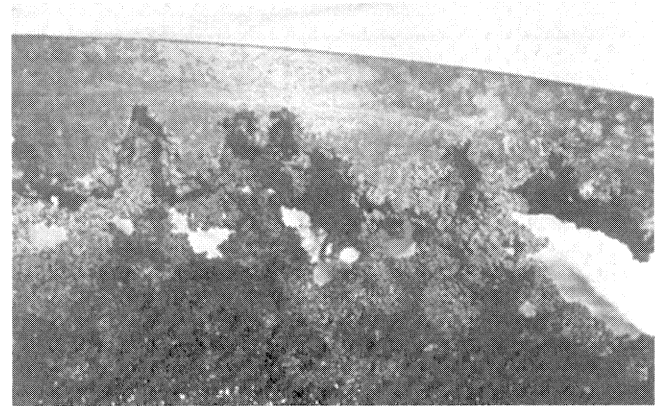
Finally, on September 13, 1995, inspection of another supply pump, removed because of high vibration, led to the realization that a major problem existed. Although the rest of the pump looked fine, the suction bell had suffered extensive, through-section, metal loss (Figure 6). The total area of the suction bell perforations was in excess of 1.0 sq ft, so the pump had probably not been a positive contributor to cooling system flow for some time prior to that date.

Figure 6. Late Second Stage Damage.

The suction bell damage looks like cavitation damage, but it is hard to imagine how vapor bubbles created in the impeller eye would preferentially cause damage at the bottom of pockets in the suction bell over one inch deep (Figure 6). Much of the surface area of the bronze impellers is clean and free from any visible oxide layer (Figure 7). This tends to confirm that some amount of cavitation is occurring, but conventional cavitation is not likely to be the sole cause of metal loss in these pumps. The pump performance details are given in Table 1.

The conclusion that there are two distinct stages of damage is supported by the appearance of the supply pump suction bells (Figure 6). It appears the deep pockets were progressing toward the last third of the vane swept area, even though there is no surface damage in that area.

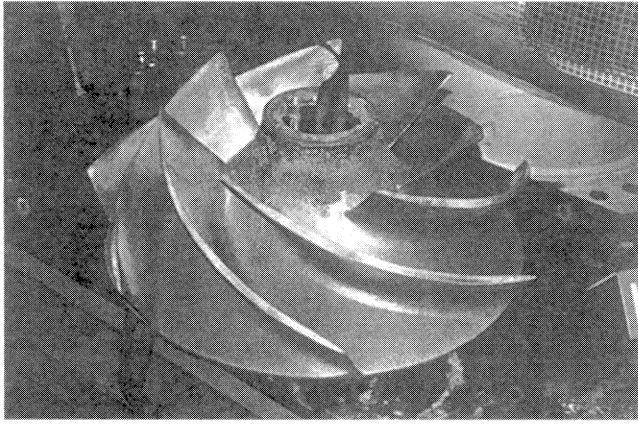
Figure 7. Supply Pump Impeller Has Developed a Dark Oxide Layer Only in the Hub Area.

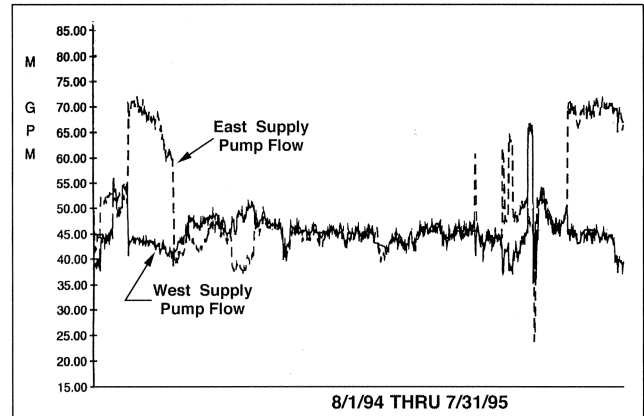
The plant cooling water system flowrates were also recorded (Figure 13). There is no pattern of operation above rated capacity and there were no reports from the field of the noise that would certainly occur if pumps of this size were cavitating.

Figure 13. Supply Pump Station Flowrates.
