46TH TURBOMACHINERY & 33RD PUMP SYMPOSIA
HOUSTON, TEXAS | DECEMBER 11-14, 2017
GEORGE R. BROWN CONVENTION CENTER

Resolving Structural Vibration Issues On a Multi Stage Pump

Nicolas Peton
Sankar Ganesh

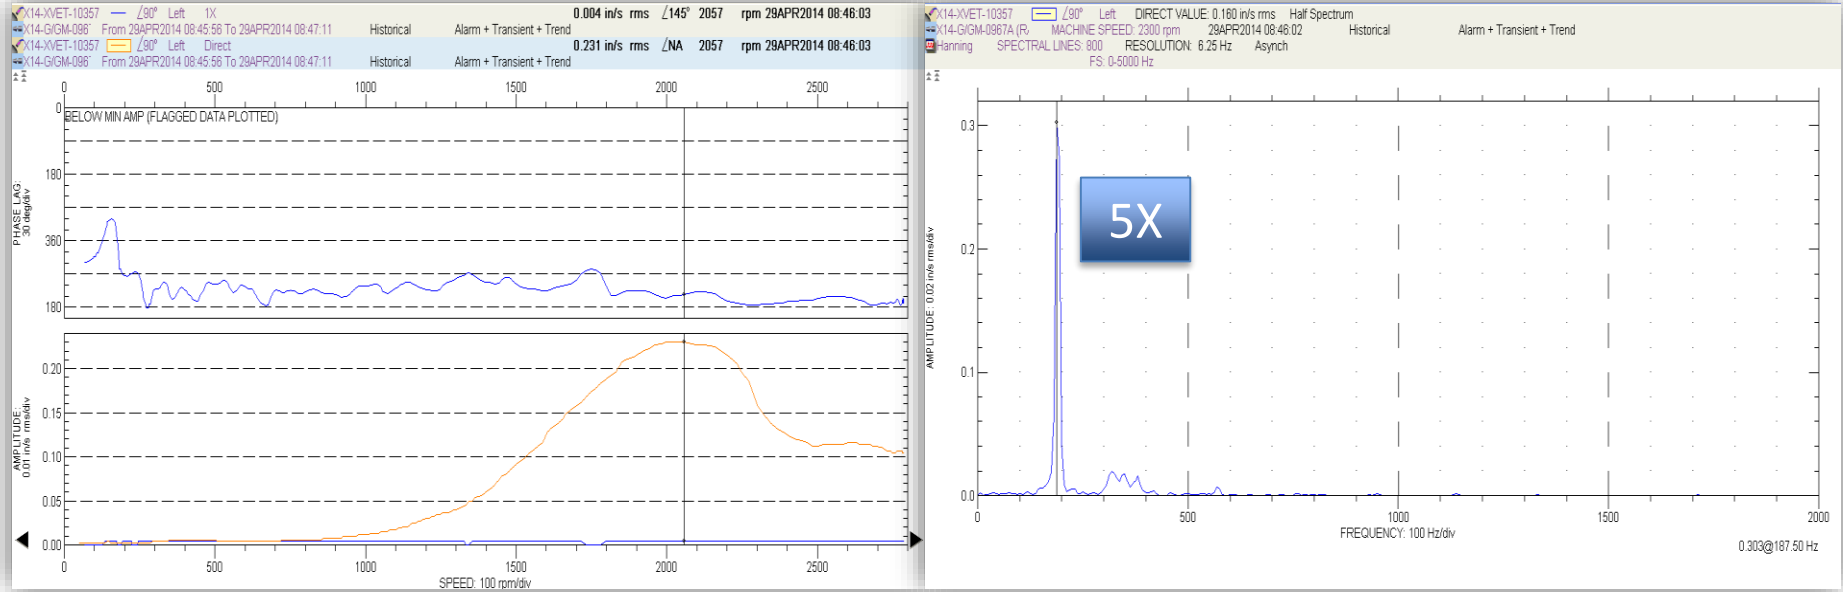
Data Analysis-Online Software

The online casing probe at Pump NDE Vertical showed high vibration (above 0.2 in/s rms) while crossing the speed range from 1850 to 2300 rpm.

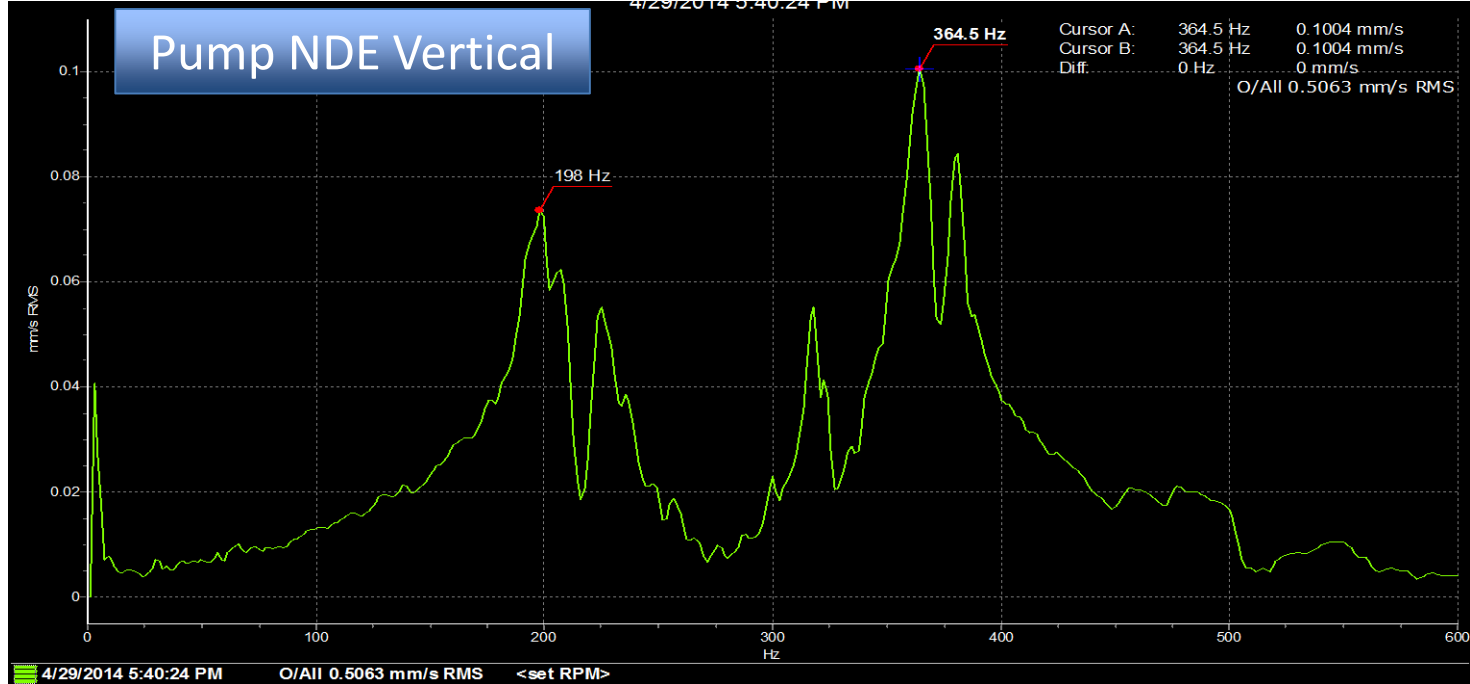
Data Analysis-Bump Test “Vertical”

Pump NDE Vertical showed natural frequency at 198 Hz which is 5 times the running speed of 39.6 Hz

- The pedestal of the pump support structure appears to be the weak point in the vertical and horizontal direction.
- The Non Drive End Bearing appears to move much more in the vertical direction than the Drive end bearing.
- Recommendation would be to modify the support pedestals of the pumps and to check the integrity of non drive end bearing housing mountings.

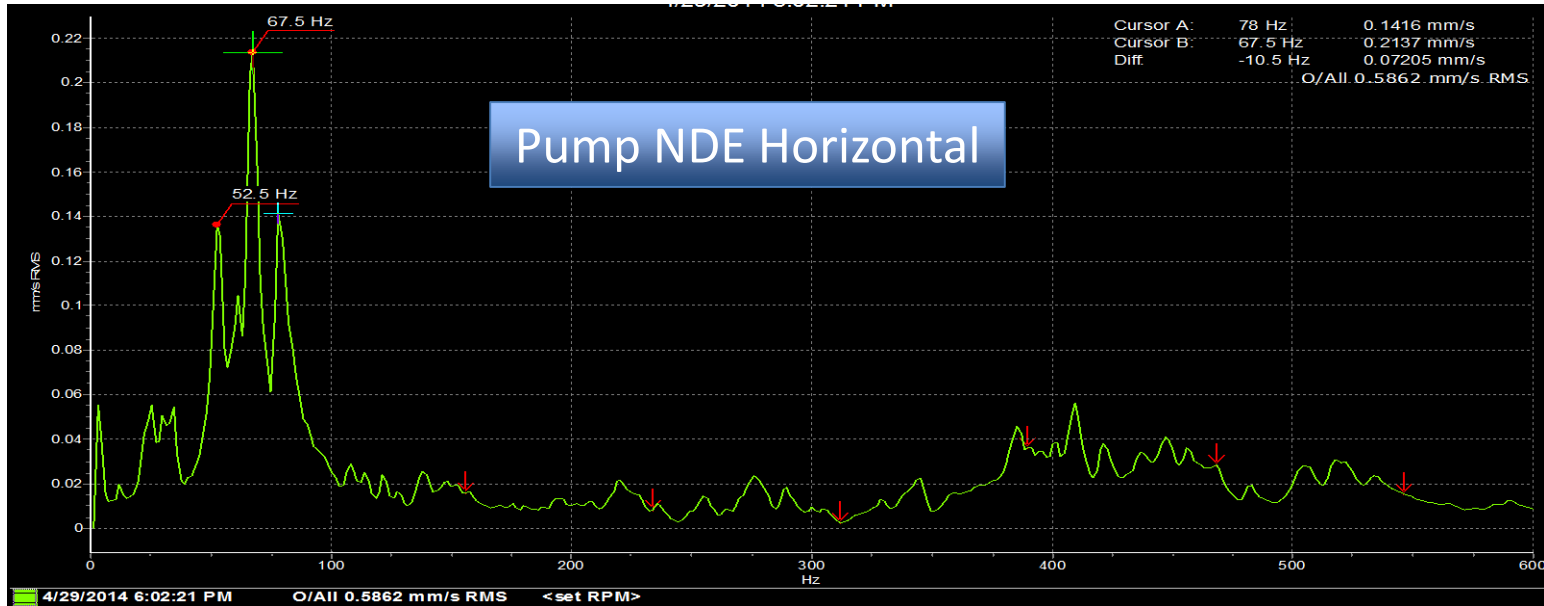
Data Analysis-Bump Test “Horizontal”

No evidence of natural frequency matching with the pump vane pass frequency in Horizontal direction

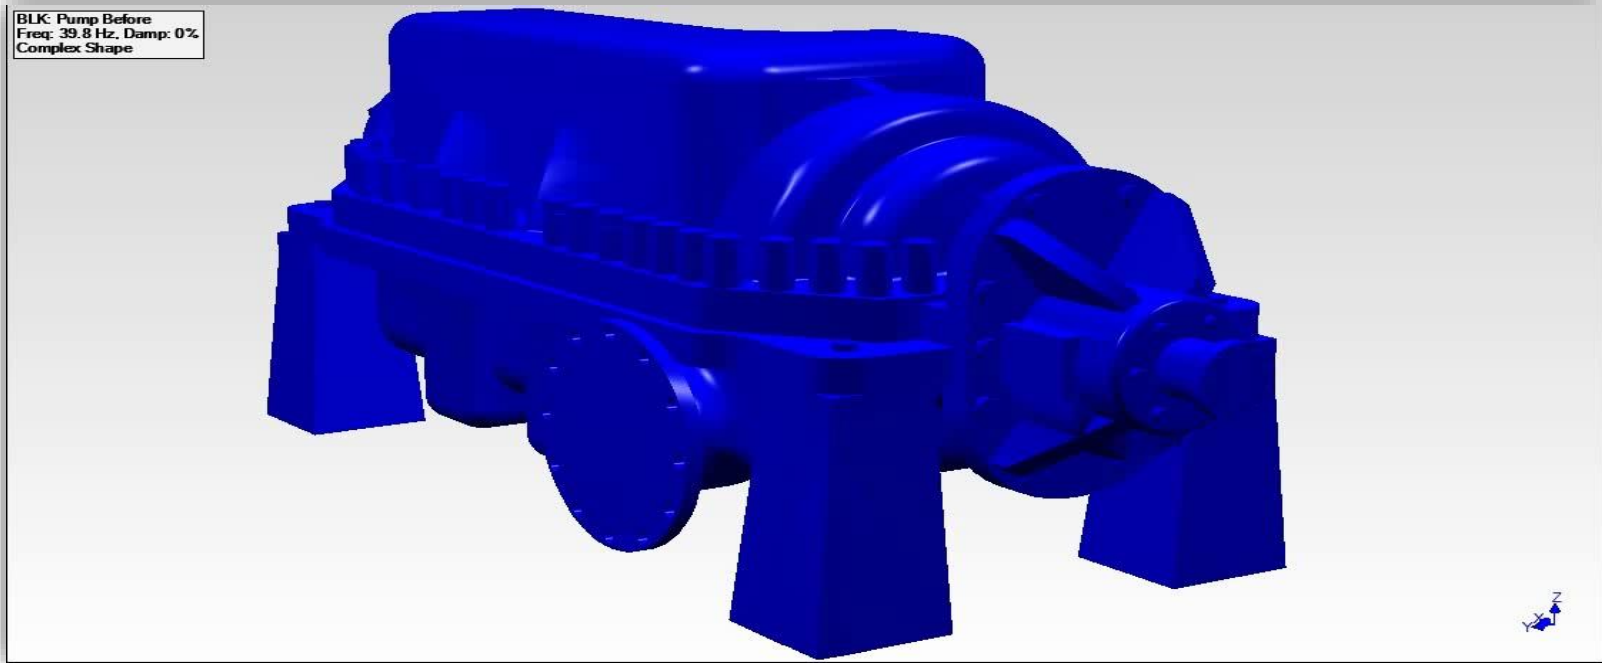
Data Analysis-ODS (At 39.8Hz "1X")

- The Operating Deflection Shape (cross spectrum) performed at 2388 rpm shows the motion of vibration at the rotating speed at 39.8 Hz and 199 Hz (5X).
- Both ODS from cross spectrum & ODS Frequency Response Function (FRF) shows a horizontal deflection at 1X.
- Both ODS from cross spectrum & ODS Frequency Response Function (FRF) shows a horizontal deflection at 5X.

Horizontal deflections at 1X (39.8 Hz)

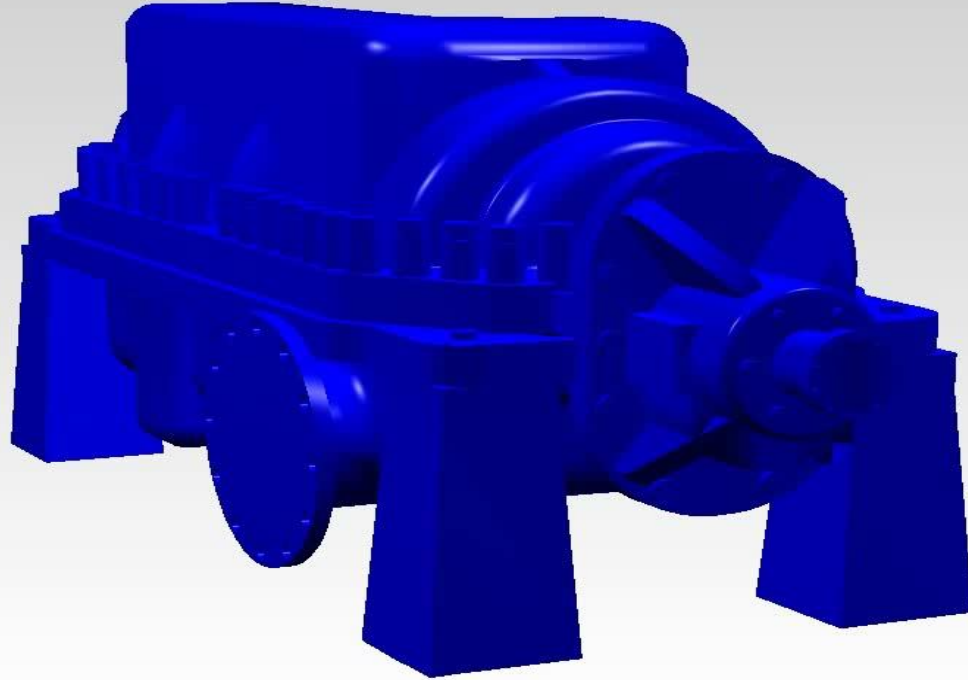
Data Analysis-ODS (At 199Hz “5X”)

Vertical deflections at 5X (199 Hz)

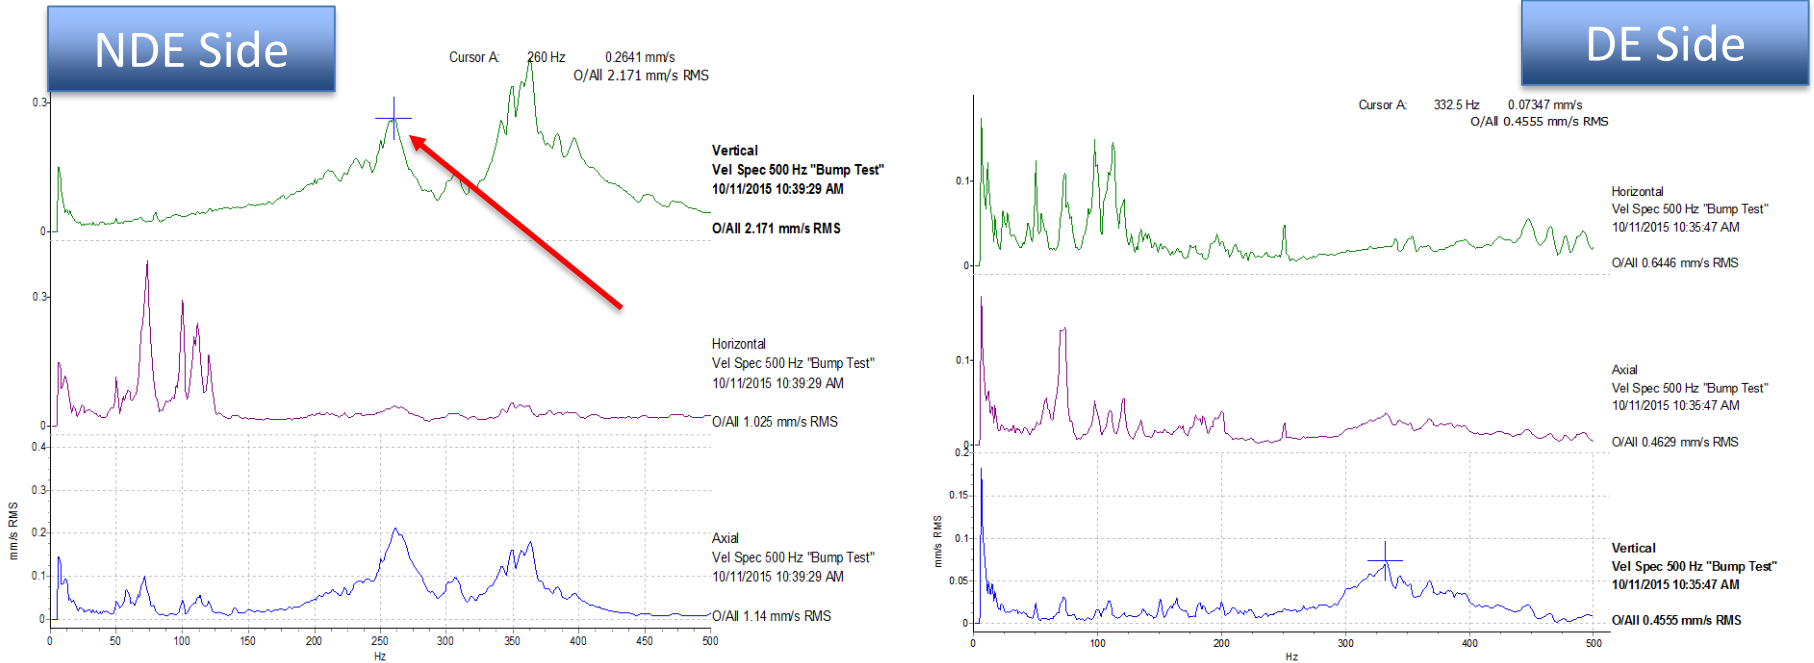
Post Analysis-Impact Test

Pump NDE Vertical showed new natural frequency at 260 Hz after the modifications

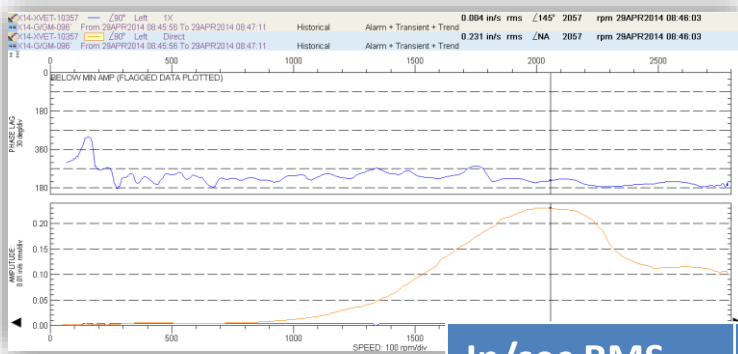
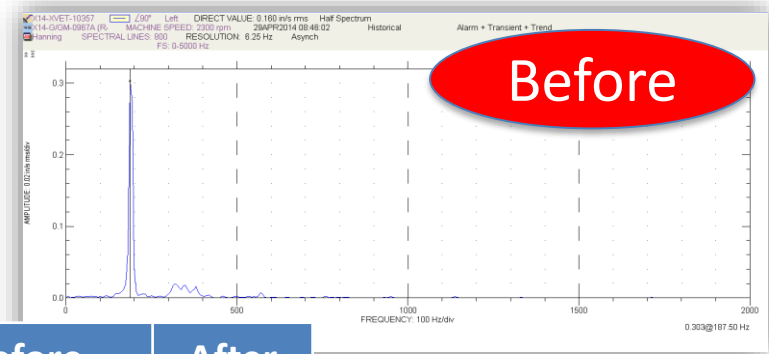
In/sec RMS	Before	After
Direct	0.231	0.107

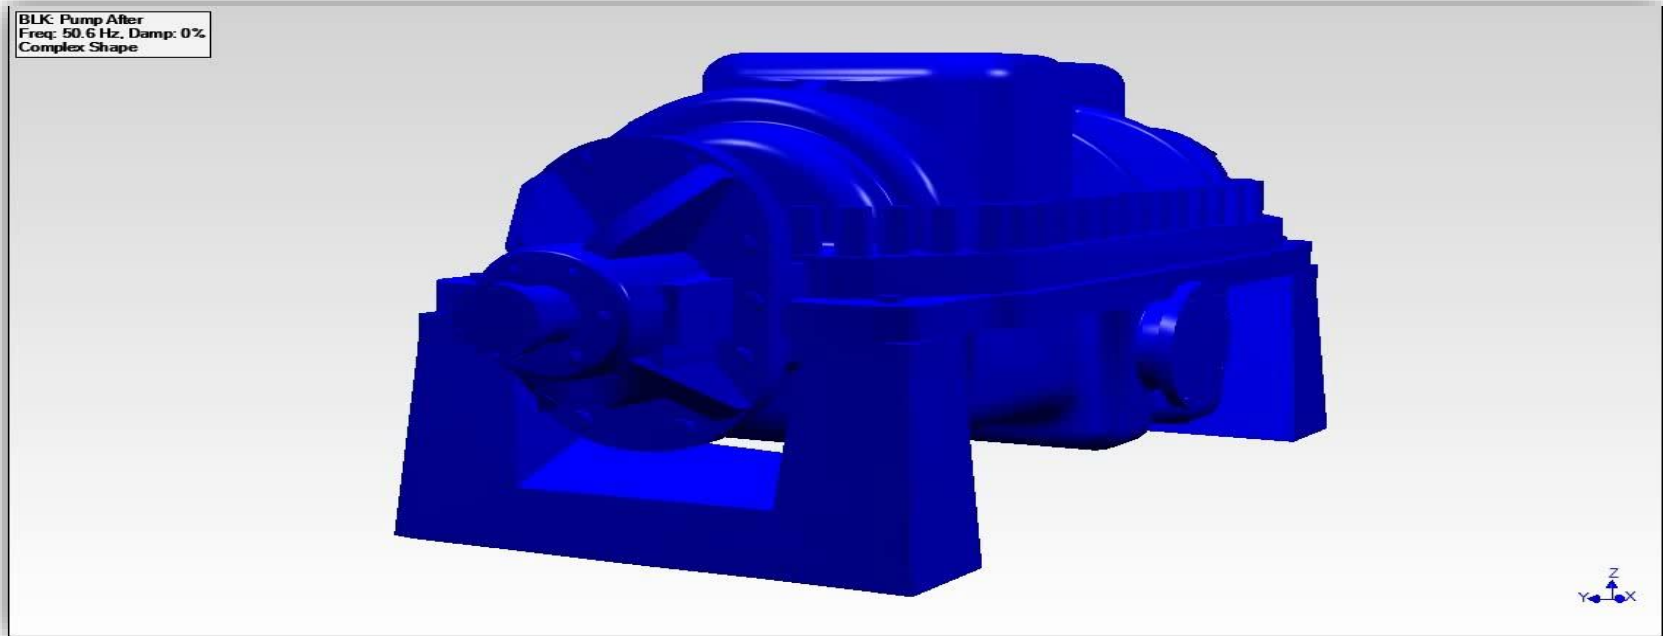
Post Analysis-ODS at 50.6Hz "1X"

Horizontal deflections at 1X (50.6 Hz)

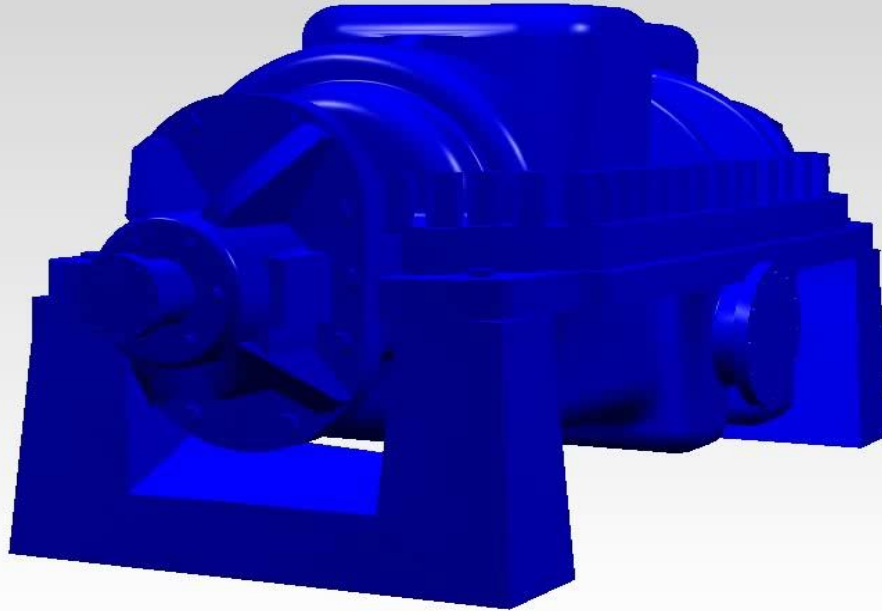
Post Analysis-ODS At 253Hz "5X"

Vertical deflections at 5X (253 Hz)
